107 Haussman Drive, Thornton North – proposed rezoning for residential development
Review of 2015 mine subsidence report for proposed new residential development

Proposed residential development - Thornton North Mine subsidence constraints

Figure 1 – Preliminary plan of mine workings

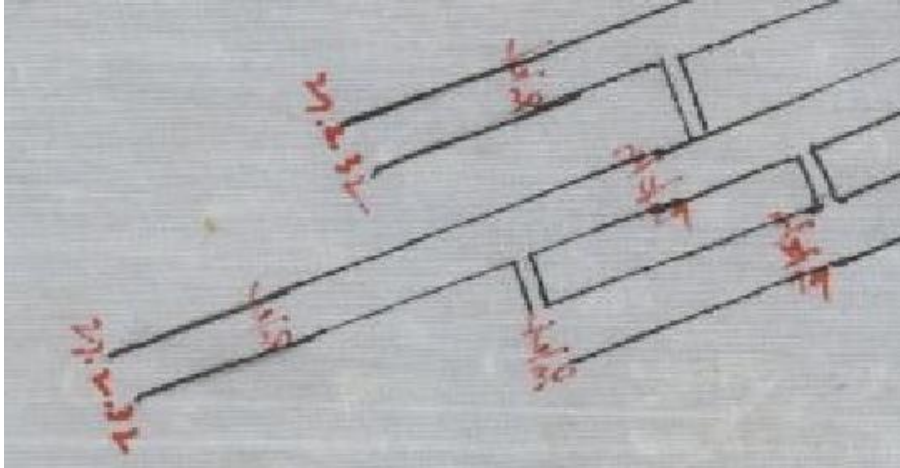
Image 1 Portion of record tracing RT 292 illustrating 'open ended' bords and dates

The mining activity between 1932 and 1952 is unknown and the record tracing (RT 292) is not marked as a 'plan of abandonment' and not signed by a mine surveyor. RT 292 includes dates of extraction in red and shows 'open ended' bords or headings. Image 1 below shows a portion of RT 292 illustrating these features.

The 'open ended' bords and lack of certified plan of abandonment suggest that the actual mine workings may be more extensive than shown on RT 292. This possibility would need to be investigated by borehole drilling.

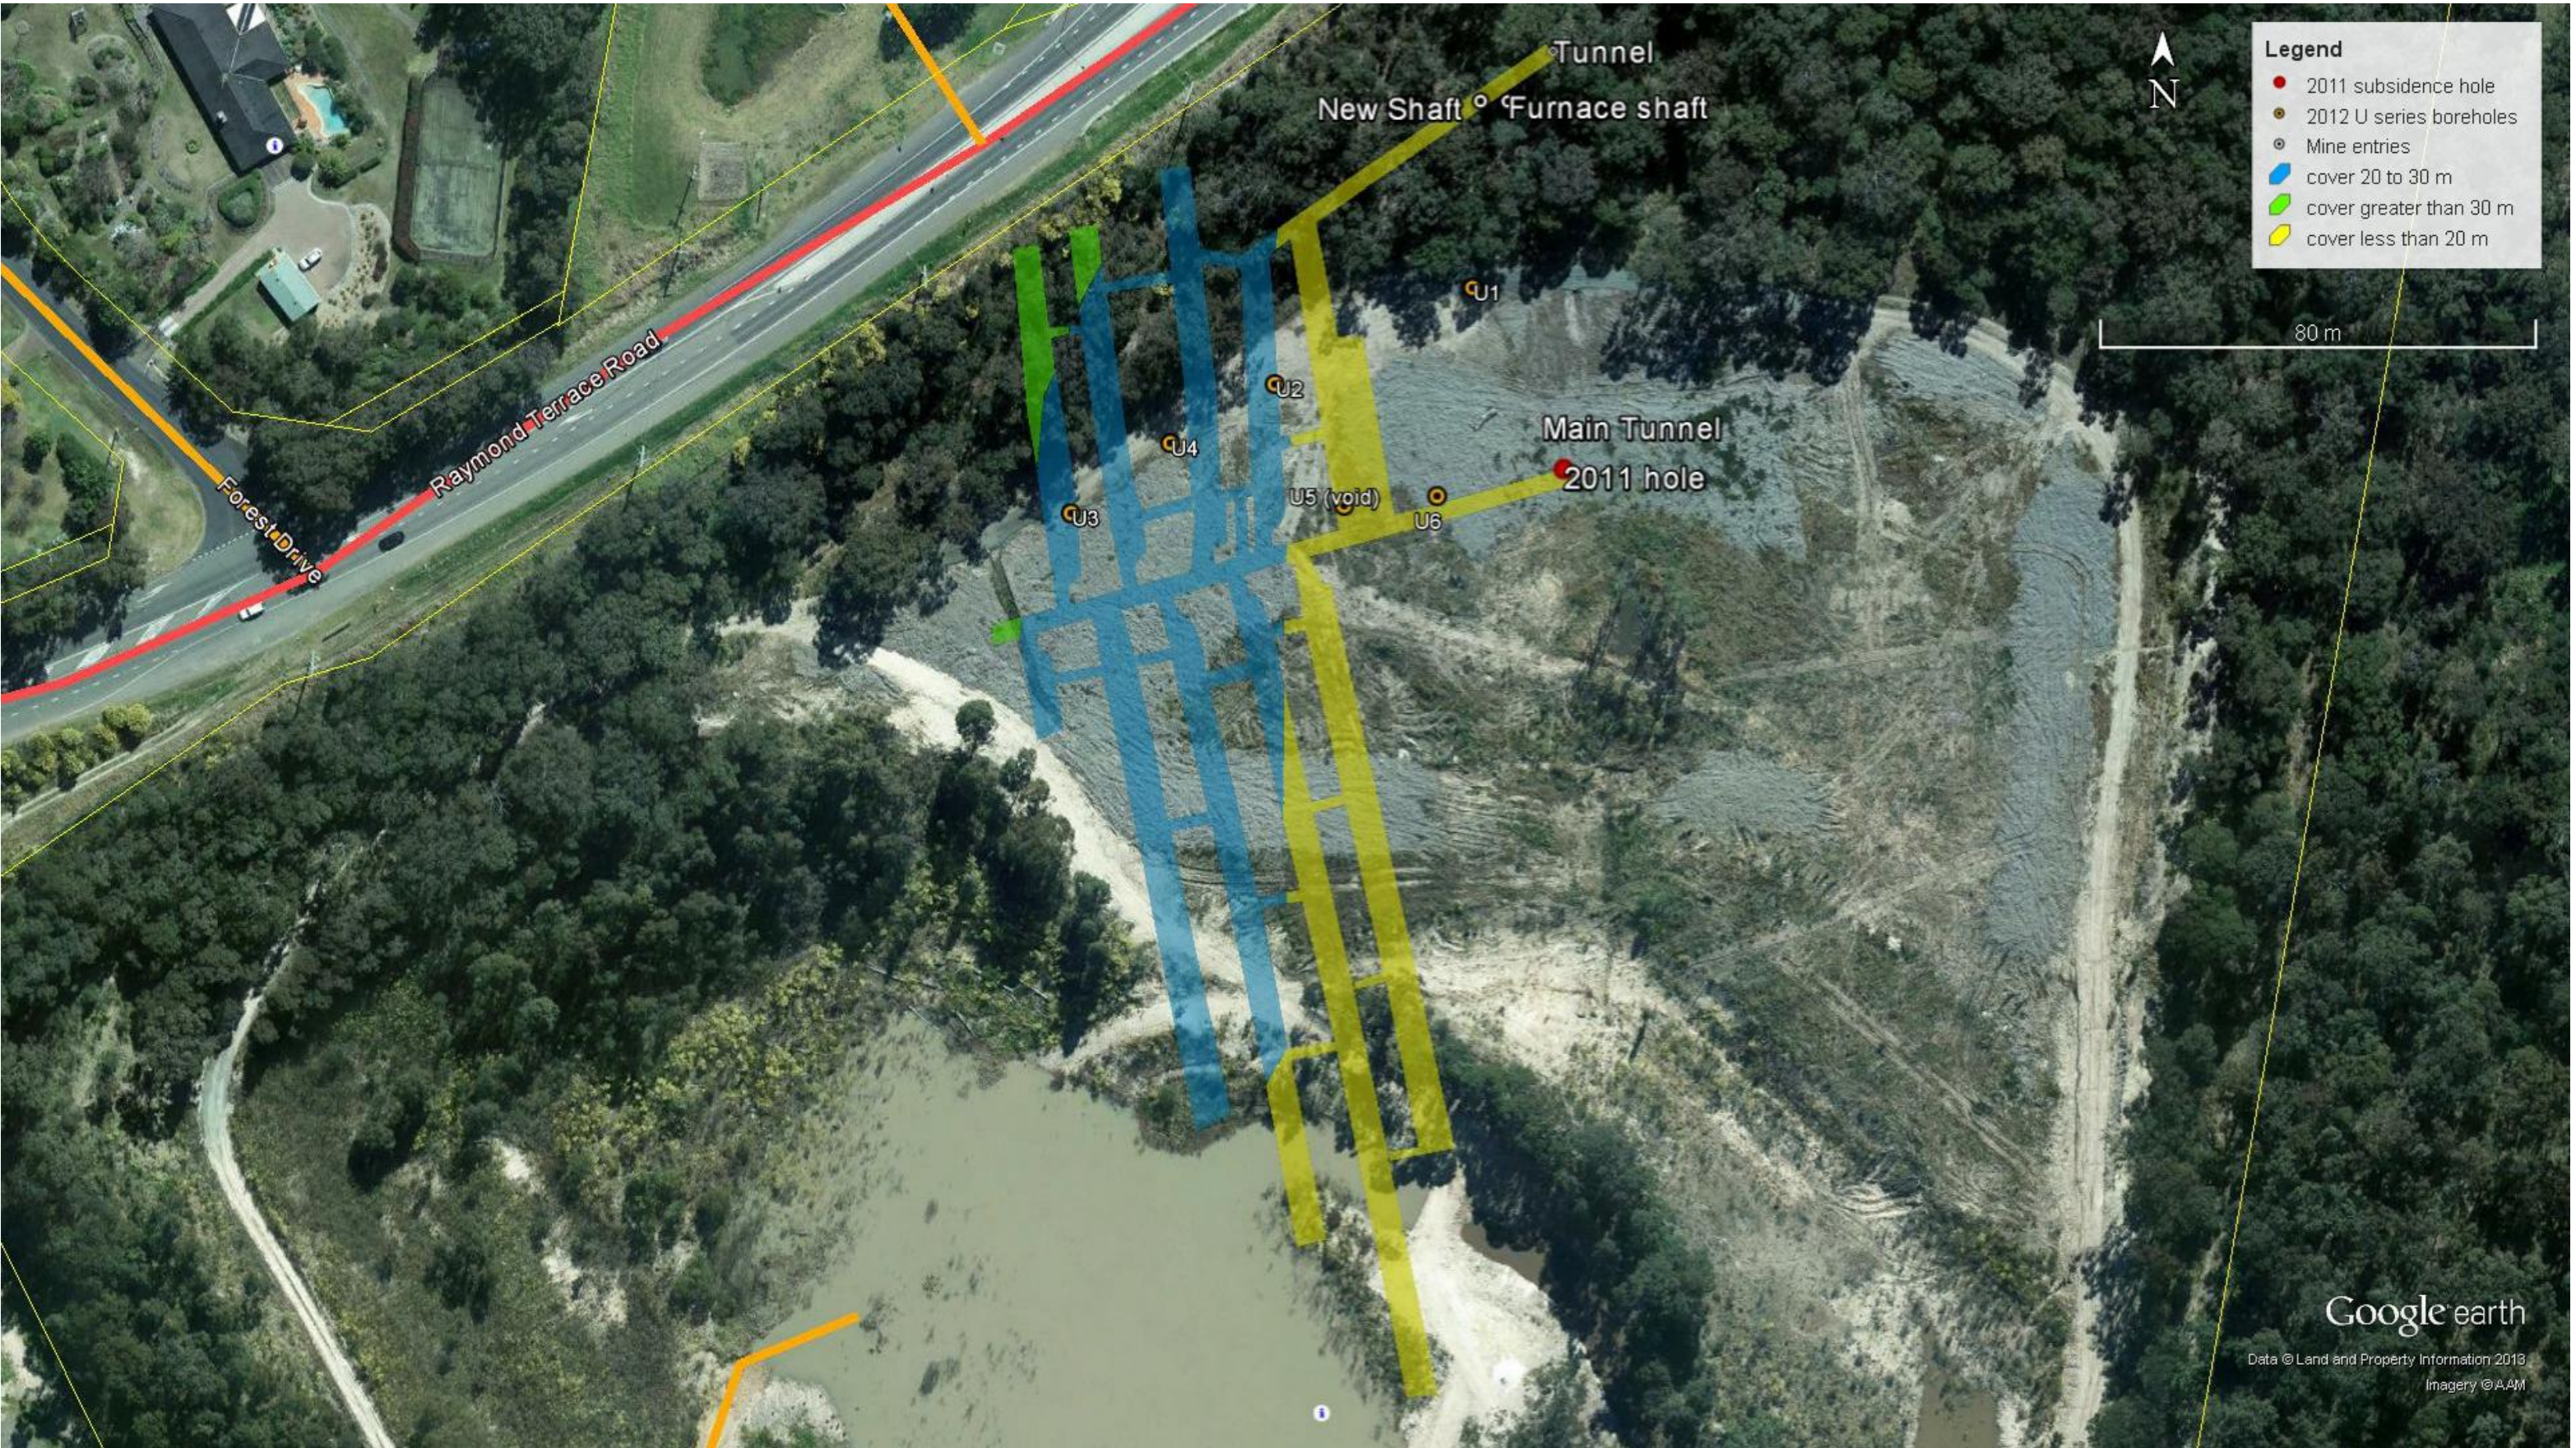
- The location and orientation of the workings not only are approximate (as shown in the attached Figure 1: note that this interpreted location is different to that shown on the MSB plan provided) but also represent a poorly defined layout at a particular time. This mine layout may not represent the actual extent or shape of the workings at the time of abandonment

The location of the '2011 hole' and 'U' series boreholes are shown in Figure 1 attached.

The position of the Glenvale Colliery workings has been interpreted from the location of the 2011 subsidence hole (as shown on the 2012 plan of surface contours and boreholes) as well as cadastre boundaries on the record tracing and positions of the U series boreholes. The interpreted location as shown on the attached Figure 1 is approximately 25 m east-north-east of where the MSB plan indicates.

Resulting cover ranges are shown on Figure 1. Overall, cover is judged to vary from about 9 to 36 m, not including the tunnel entries which will be shallower.
