## ***Arboriculture Impact Assessment***

**Lots 2 & 4 in DP29244  
77 Kulgoa Road, Pymble NSW 2073**

**Date:** 4 June 2025  
**Reference:** 20252167  
**Revision:** 5

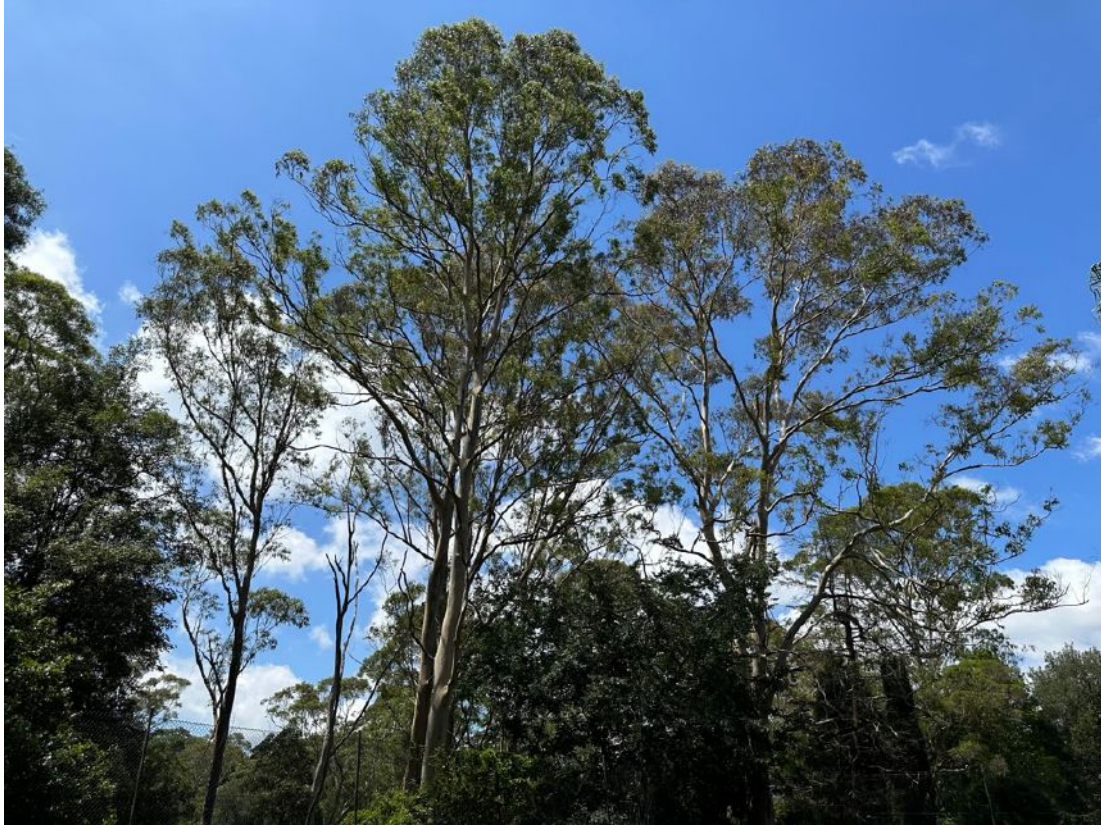
Figure 9. Tree No.'s 65, 66, 104, 67, 68 and 69

- 9.1.10. Tree No. 68 *Eucalyptus saligna* (Sydney Blue Gum)
  - 9.1.10.1. This seeded, indigenous tree is located on site and is protected by council. This mature tree has a spreading habit and is growing in a codominant class with adequate form. It is expected to increase in size by approximately 10% as it ages. It has a dominant trunk with the crown showing average (3) health. The amount of deadwood was determined as low and small being approximately <10% of the canopy with epicormic growth being low and young at approximately <10%. The tree has minor previously failed branches, therefore the structural condition appears to be fair.

- 9.1.10.4. The proposed storm water pit is located approximately 1.8m from the trunk, inside the 6m TPZ and 2.7m SRZ with a 7% encroachment, which is considered major in accordance with AS4970-2009. The proposed encroachment is likely to cause damage to roots. Any detrimental impacts will be significantly reduced if hand excavation occurred for the storm water pit and horizontal direction drilling pipe works within the 6m TPZ. The root system must be protected during the proposed excavations, preventing damaged or severance to any root measuring over 50mm in diameter.

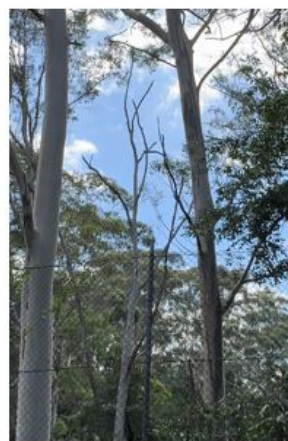
**67**

Dead
