## GEOTECHNICAL SITE INVESTIGATION

Prepared by ASCT – Northern Rivers office, for Jestermond Pty Ltd.

DP 601461 Lot 21, 70 Manifold Road, North Casino, NSW 2470.

H23-4027 REV.

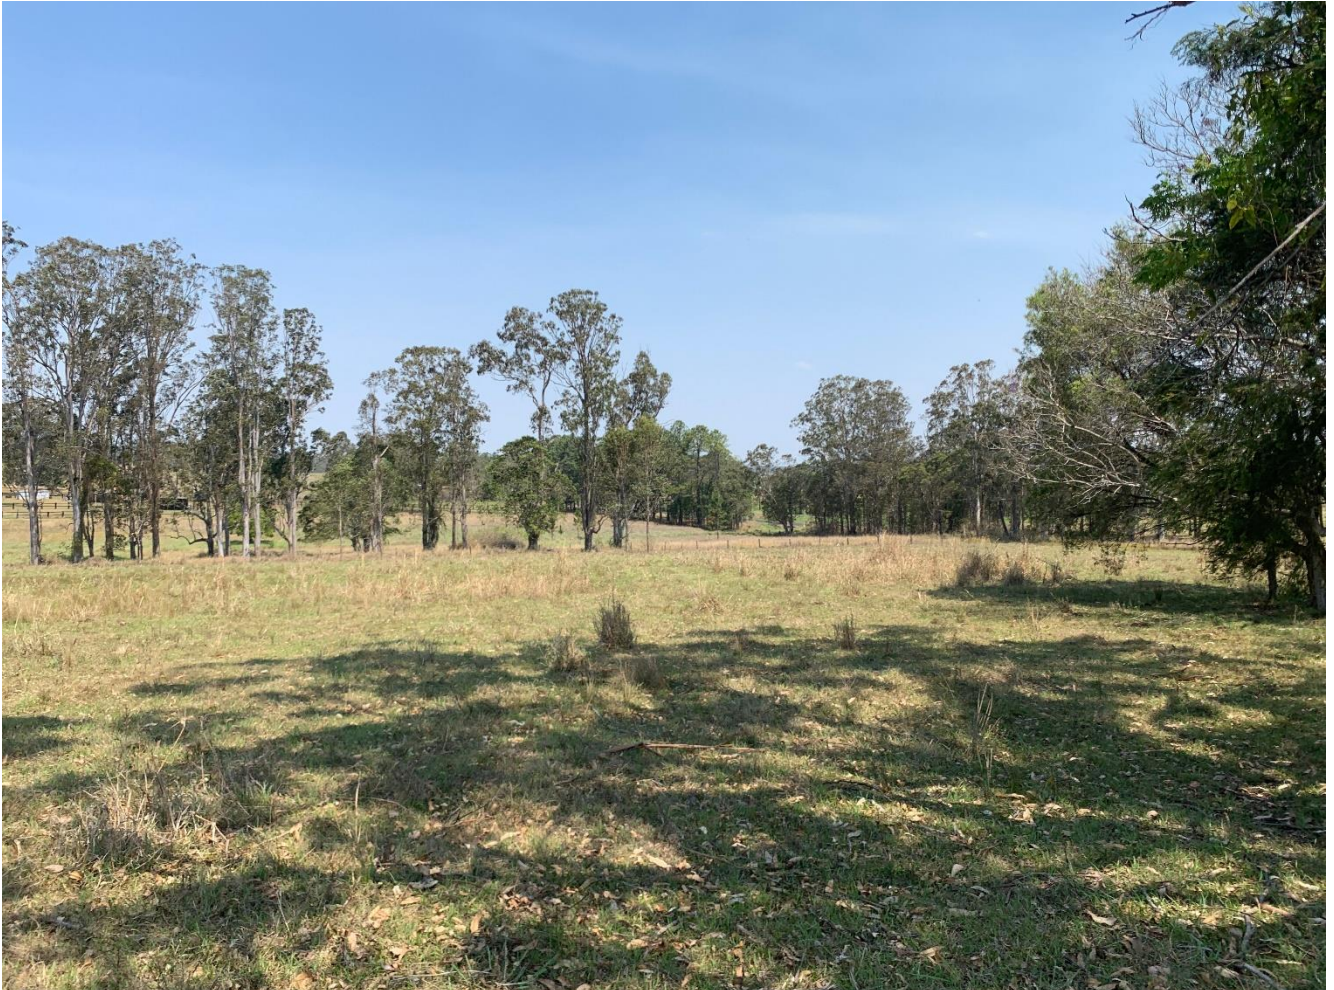
**Figure 1: Typical view of the site (lots 8 and 9 looking north).**

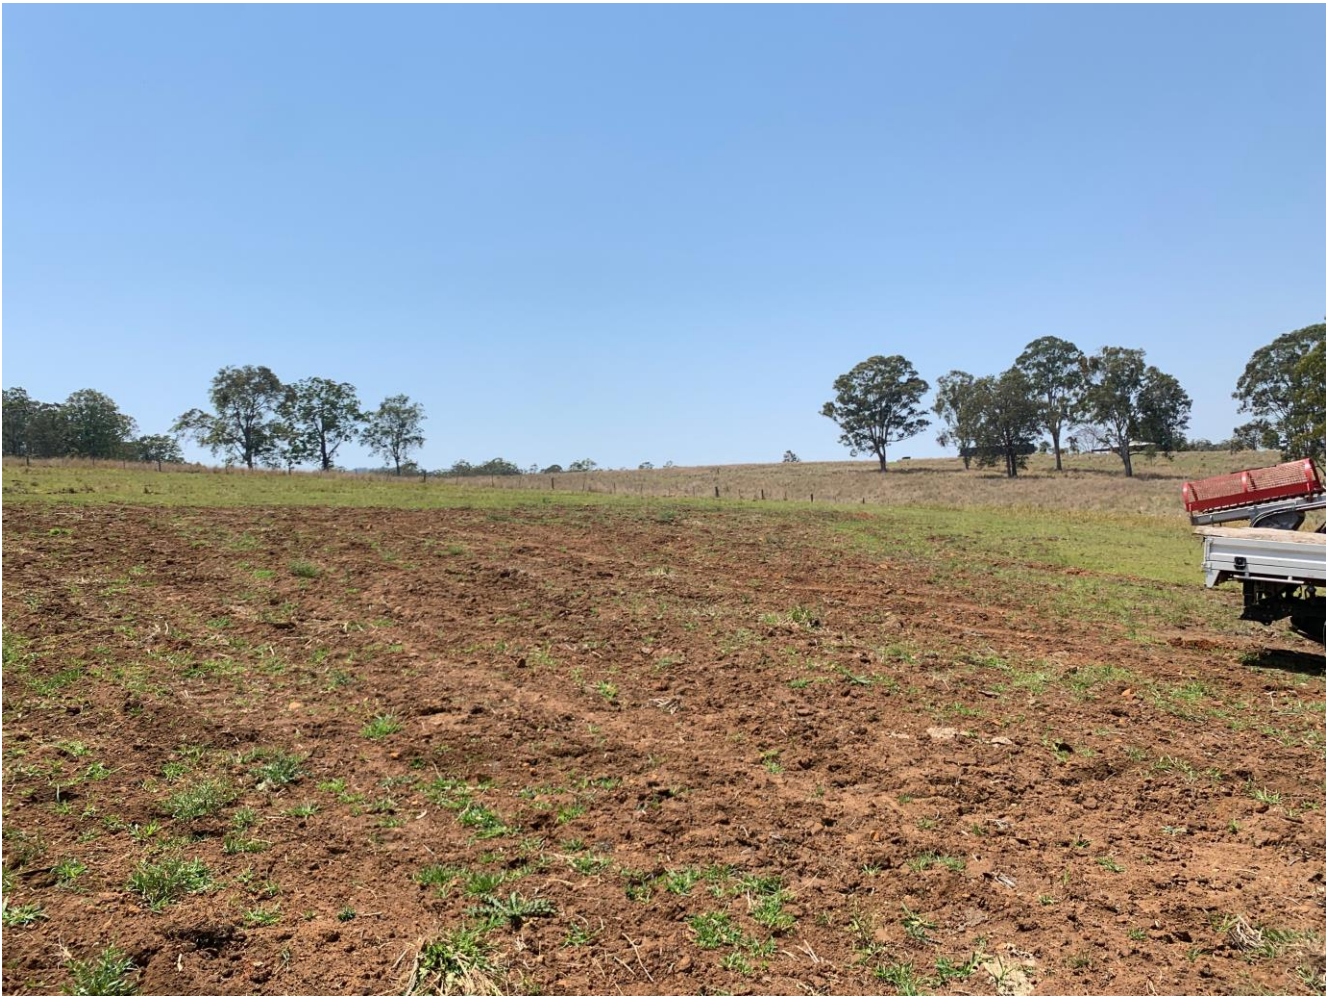
**Figure 2: Typical view of the site (lot 7 looking east).**

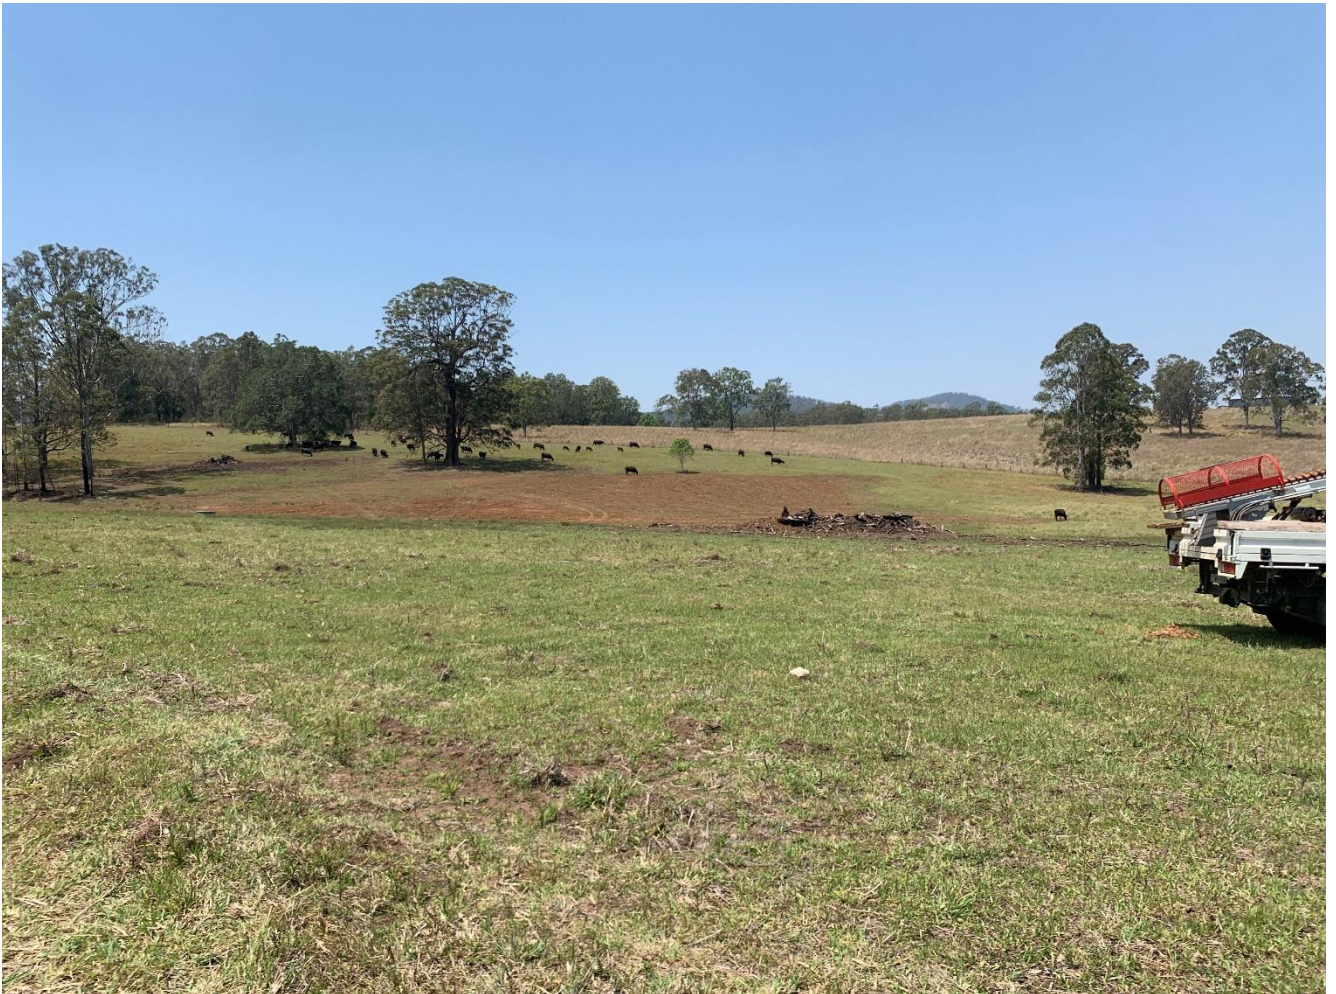
- A dam onsite (bordering proposed lots 4 and 5) has been filled with uncontrolled fill materials. Under AS 2870 sites containing reactive fill greater than 0.4m in depth are classified ‘P’ and require further engineering consideration. It is recommended that this uncontrolled fill material is not used as “structural fill”. Should any future buildings be constructed within this area further geotechnical testing is required and all footing loads shall be founded into underlying natural strata at the responsibility/discretion of the design engineer. It is also the responsibility of the design engineer to

**Figure 3: Typical view of the site (lot 3 looking northeast). Note: Filled dam visible in middle background of photograph.**
