PRELIMINARY SITE INVESTIGATION

PROPOSED REZONING AND DWELLING ENTITLEMENT

Lot 1 DP 818394
Clothiers Creek Road
Bogangar NSW

HMC2023.627.02

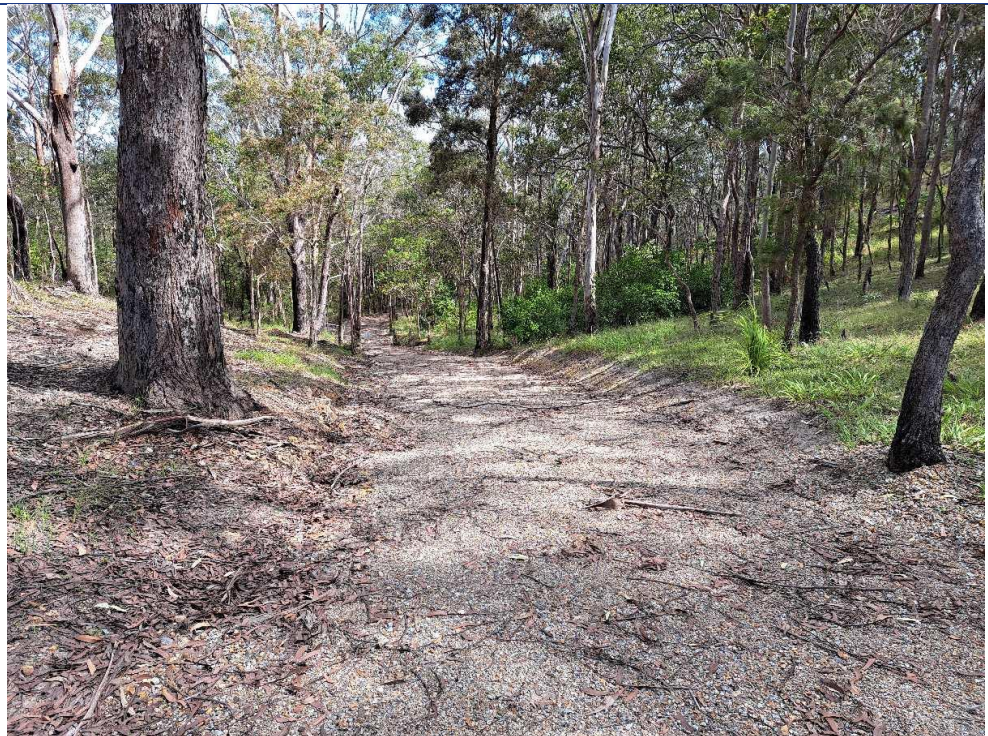
View south along the existing vehicle access from Clothiers Creek Road

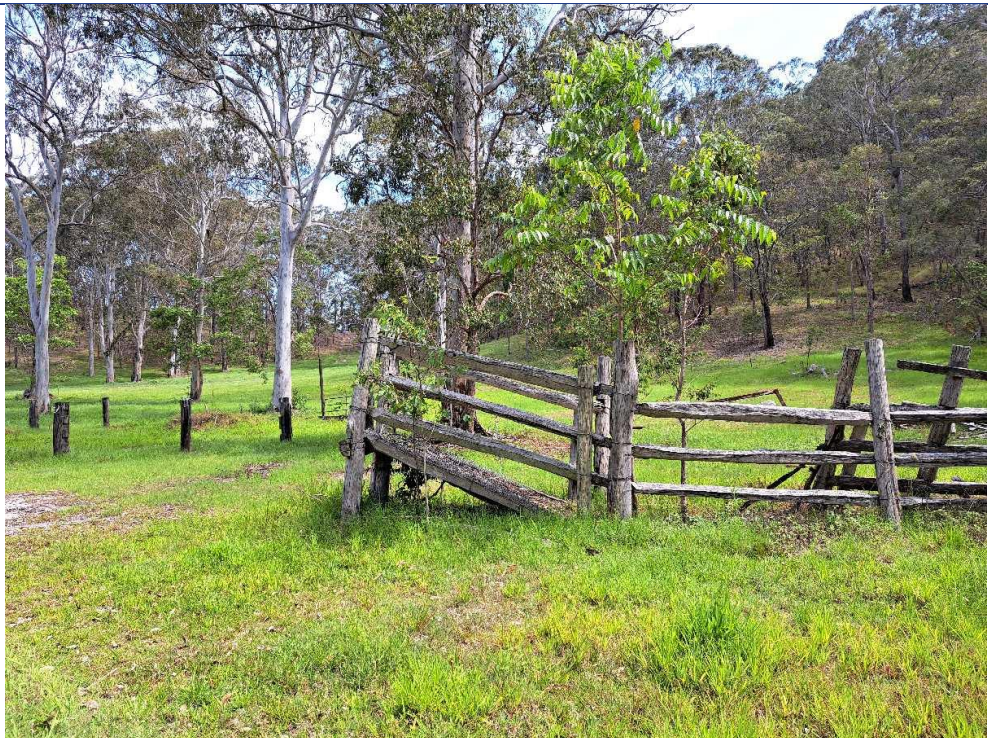
Photo No. 2	Date
	01.12.2023

View west overlooking the former donkey yards.

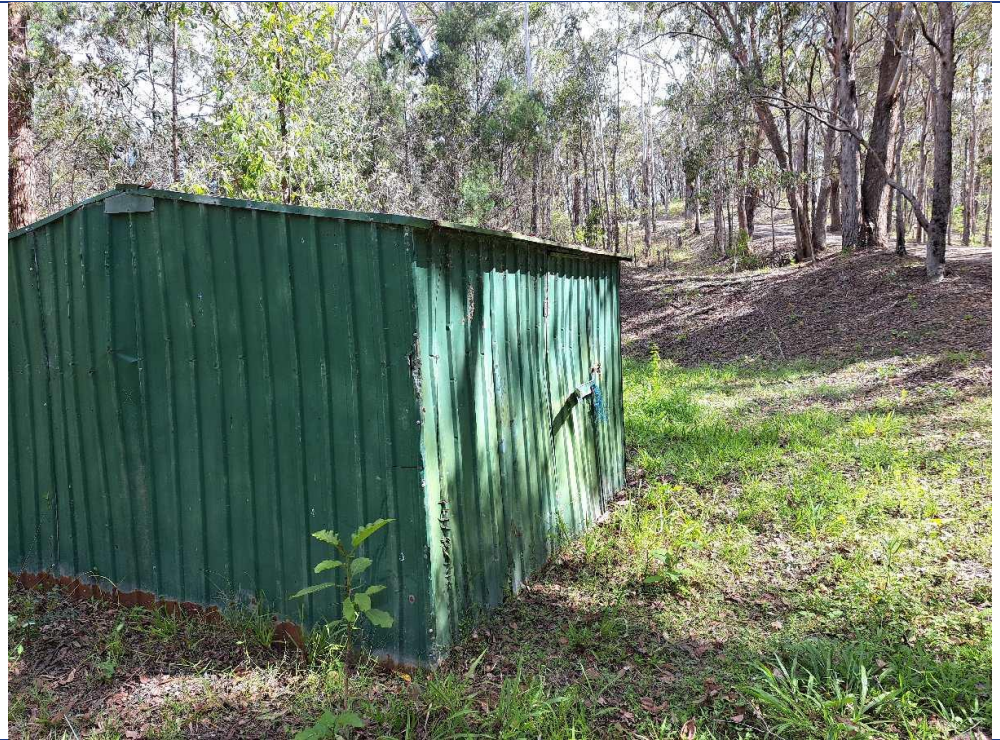
Photo
No. 3

View of the small existing shed on the northwestern corner of the property.

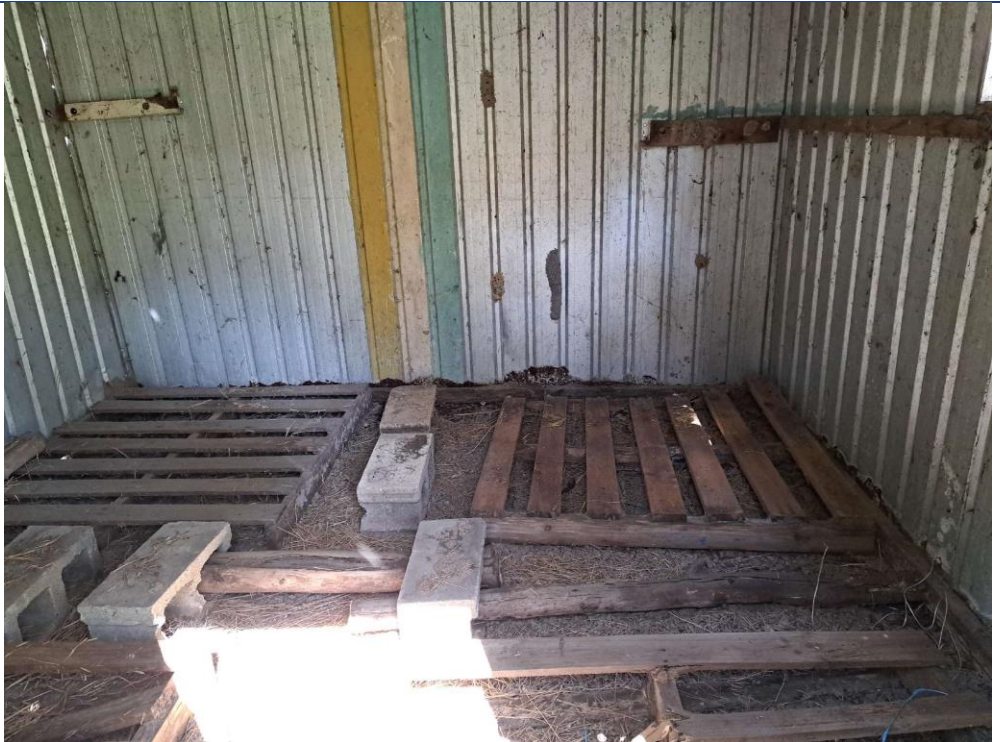
Photo
No. 4

There is a small existing garden shed and remnants of livestock yards on the north-western portion of the property. The interviews with the previous owner Mr Hansen revealed that these were used as part of a paddock which housed the donkeys used by the nearby Cudgen Lake Resort. This is supported by the existing vehicle track being named "Donkey Trail". Mr Hansen stated that the shed was only ever used for the storage

of donkey equipment and feed, and never the bulk storage of fuel and chemicals. A large concrete slab is existing at the end of the driveway access, which is the former location of the town water reservoir which has been removed.

View inside the empty garden shed showing the pallets previous used for the donkey feed storage.

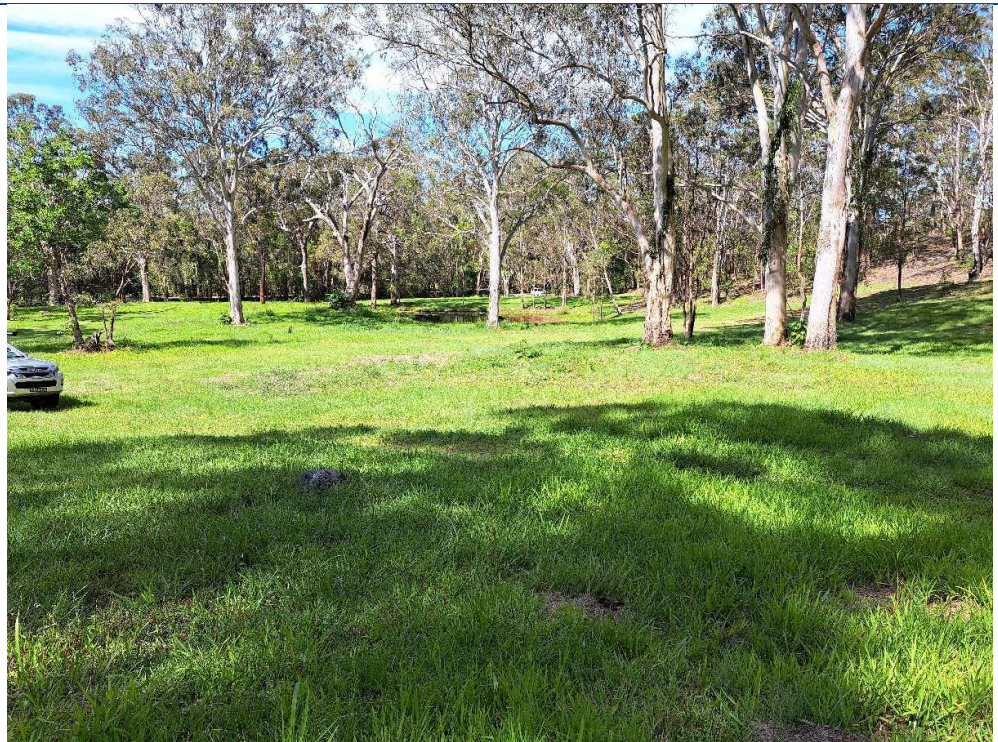
Photo No.	Date
5	01.12.2023

View northeast overlooking the partially cleared land on the northern portion of the property, and the existing dam.

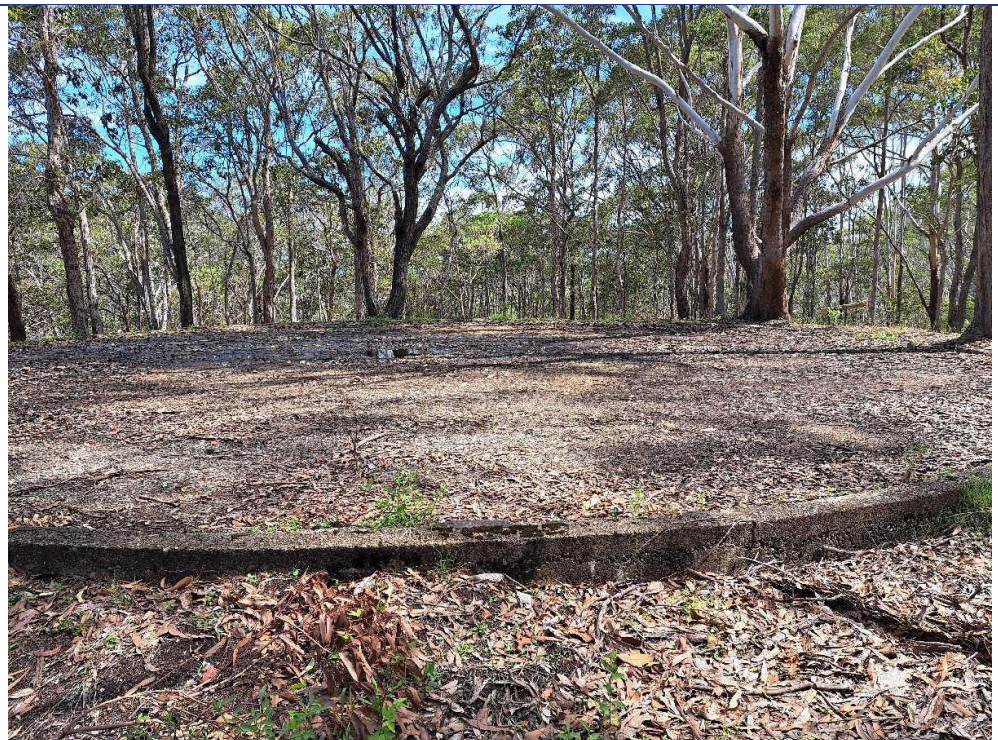
Photo No.	Date
6	01.12.2023

View of the large existing slab where the former town water reservoir was located.
