<b>Subject</b>	<b>DEVELOPMENT APPLICATION: 10.2009.155.1 89-93B LIVERPOOL ROAD ASHFIELD</b>
<b>File Ref</b>	10.2009.155.1
<b>Prepared by</b>	Andrew Johnston - Development Assessment Officer
<b>Reasons</b>	For Council to determine application prior to concurrence of Roads and Traffic Authority – report previously deferred
<b>Objective</b>	For Council to determine the application
<b>Strategic Plan Link</b>	N/A
<b>Management Plan Activity</b>	2.11 Development & Building Control, Strategic Planning

89-93 Liverpool Road Ashfield

AS14322

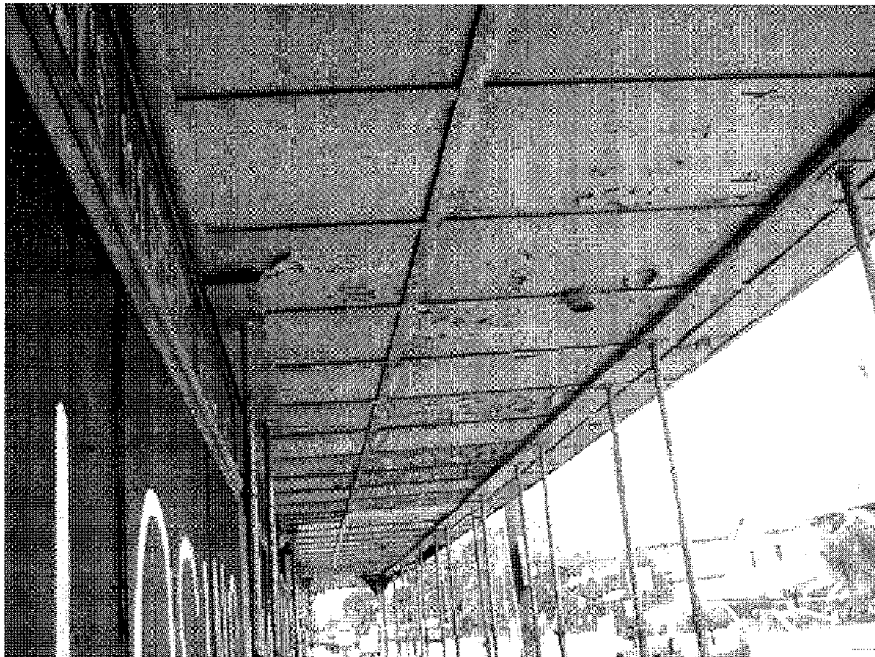
**Photo 1:** Asbestos cement sheeting located on the underside of the street awnings. Also shown is flaking white paint containing elevated levels of lead.

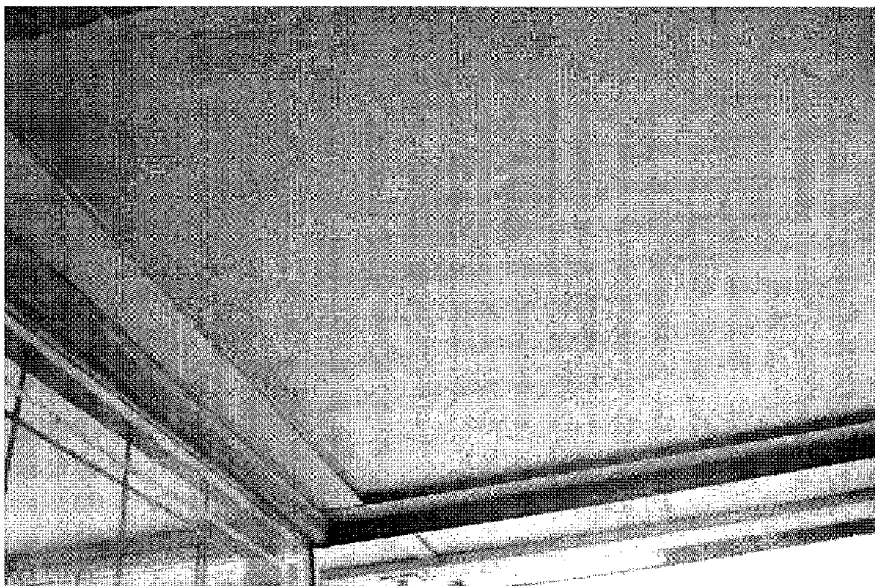
**Photo 2:** Example of asbestos cement sheeting located on the ceilings of the entrances to the street front commercial tenancies.

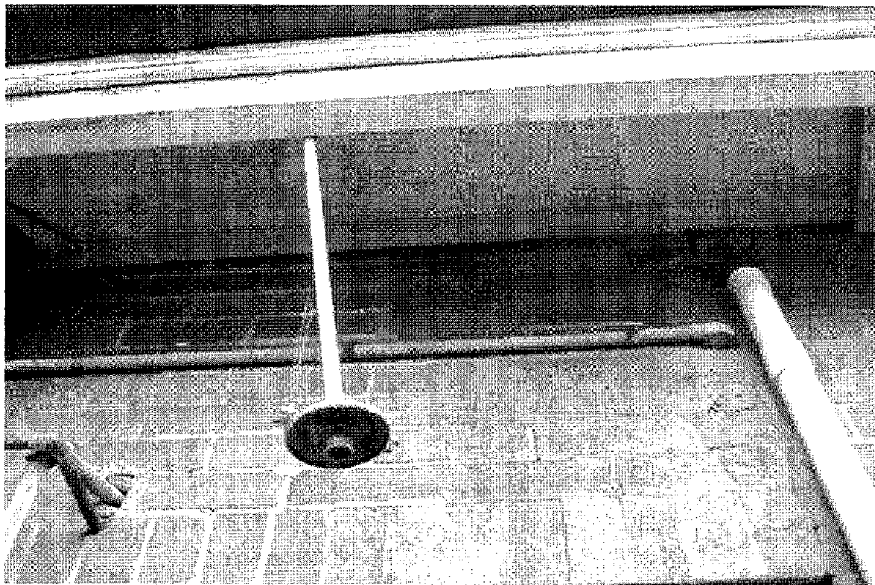
**Photo 3:** Example of asbestos cement sheeting located above the rear entrances to the commercial tenancies.

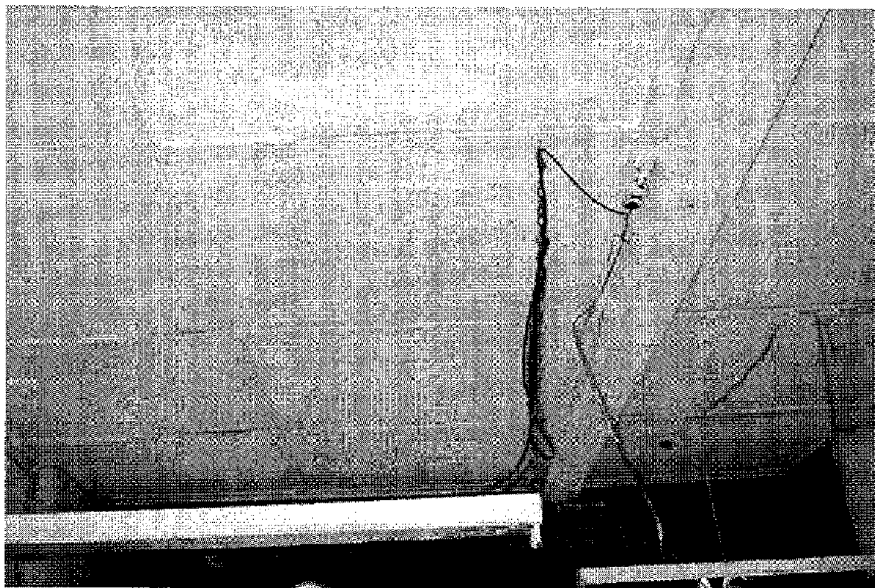
**Photo 4:** Example of asbestos cement sheeting located on the ceilings of the northern most rooms of the commercial tenancy at 89 Liverpool Road.

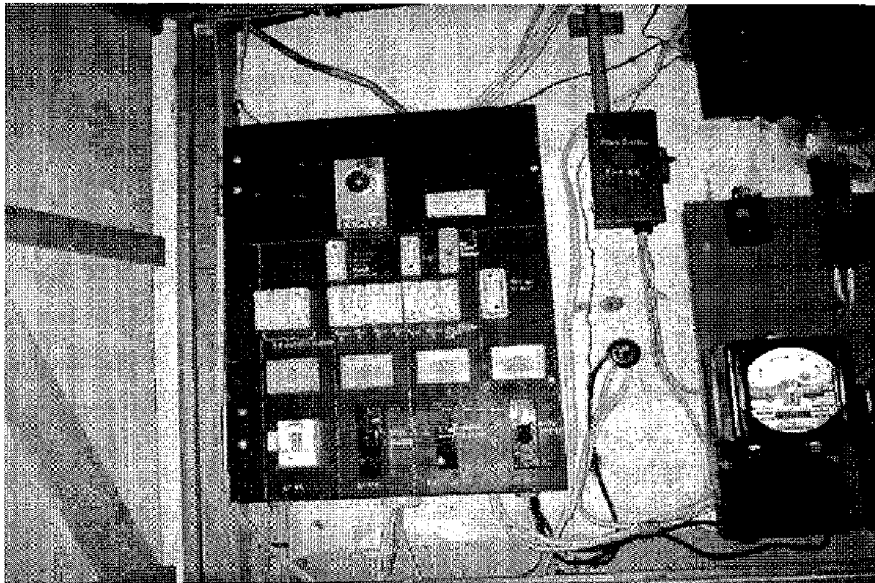
**Photo 5:** Example of a bituminous backing board suspected of containing asbestos located throughout the properties.

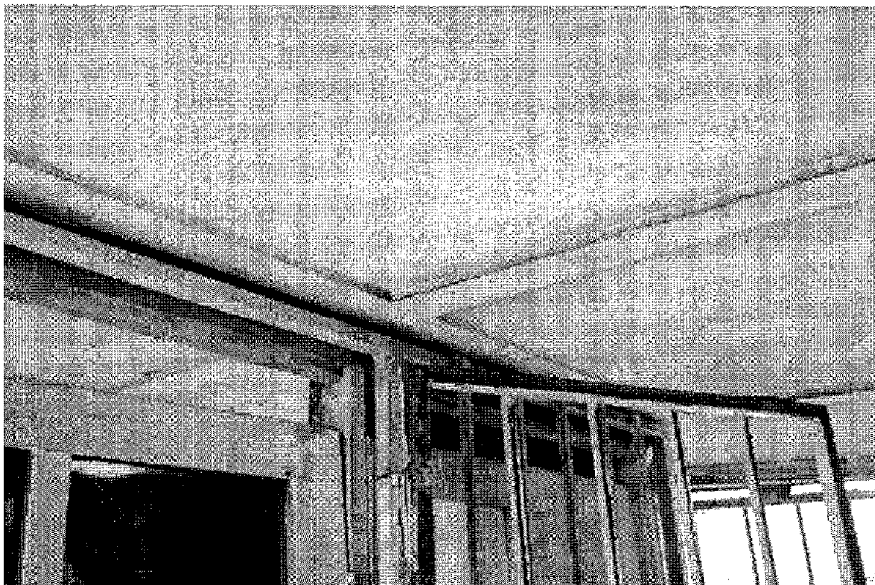
**Photo 6:** Asbestos cement sheeting located on the ceiling of the corner window display and the entrance to 93 Liverpool Road.

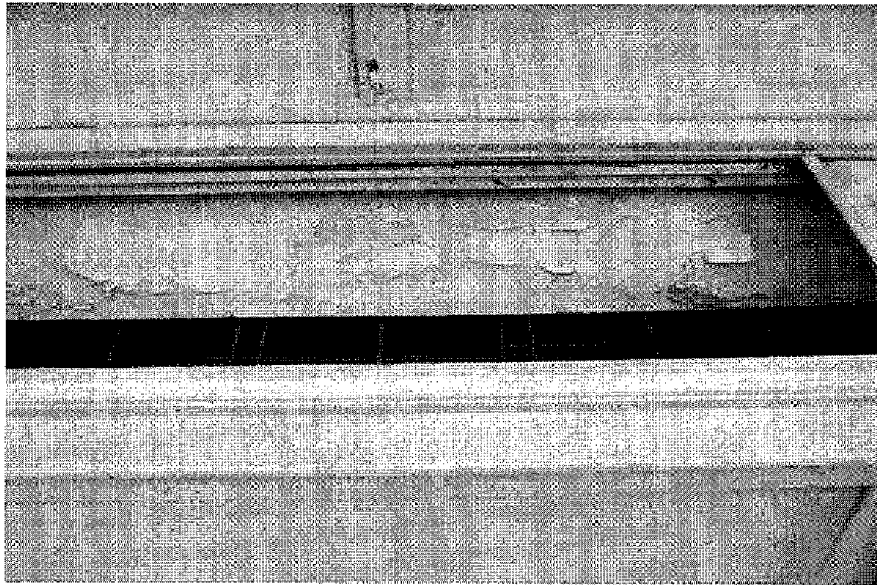
**Photo 7:** White paint with elevated levels of lead on the lintel and ceilings of the commercial tenancy at 89 Liverpool Road.

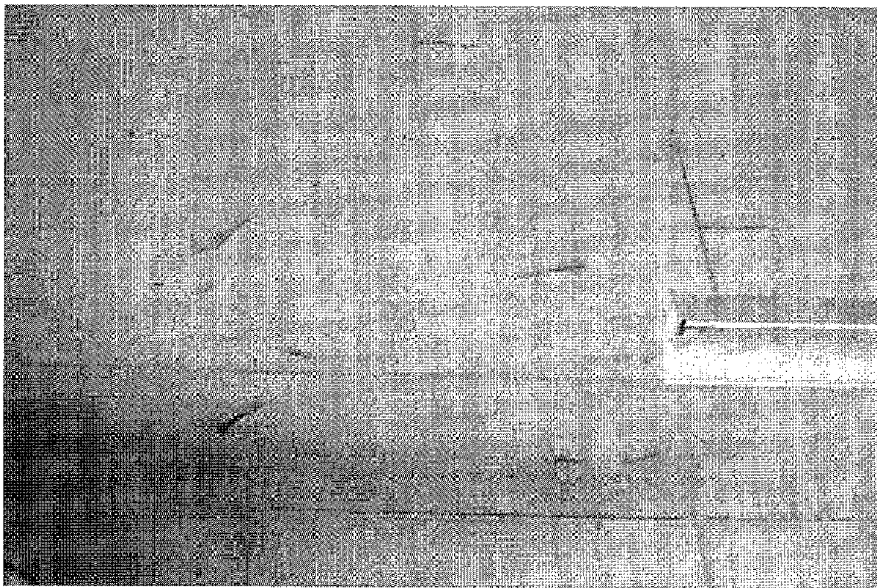
**Photo 8:** Blue paint with elevated levels of lead on the ceiling of the northern room of the commercial tenancy at 91 Liverpool Road.

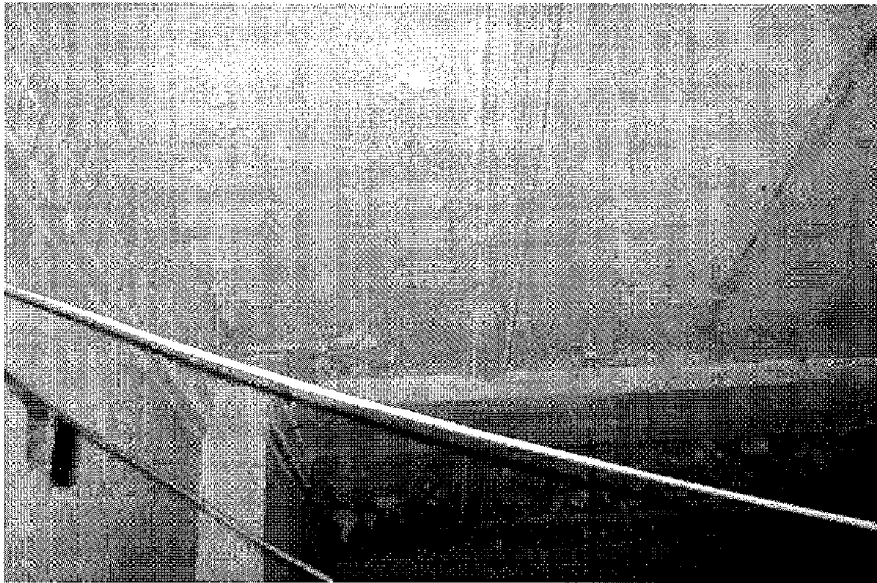
**Photo 9:** White paint with elevated levels of lead on the ceiling of the southern room of the commercial tenancy at 91 Liverpool Road.

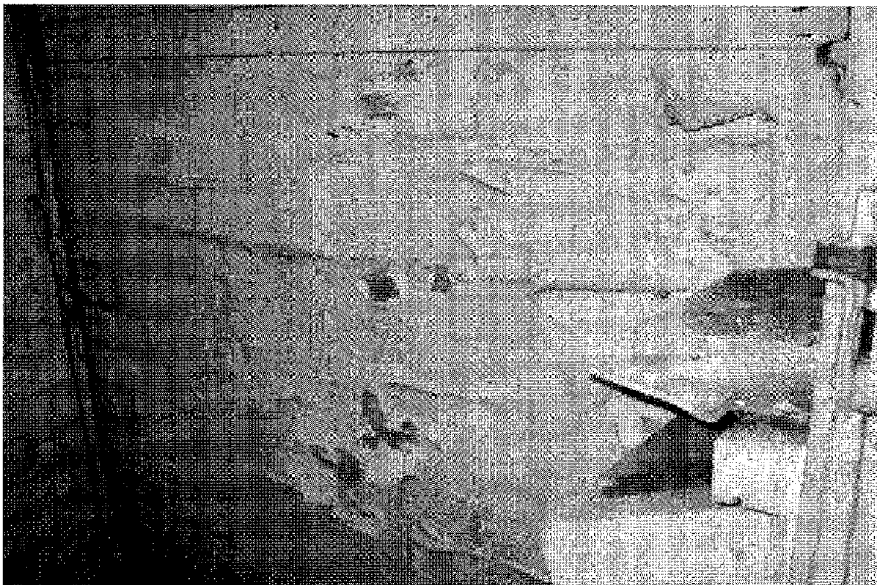
**Photo 10:** Beige paint with elevated levels of lead on the walls of the toilet of the commercial tenancy at 93 Liverpool Road

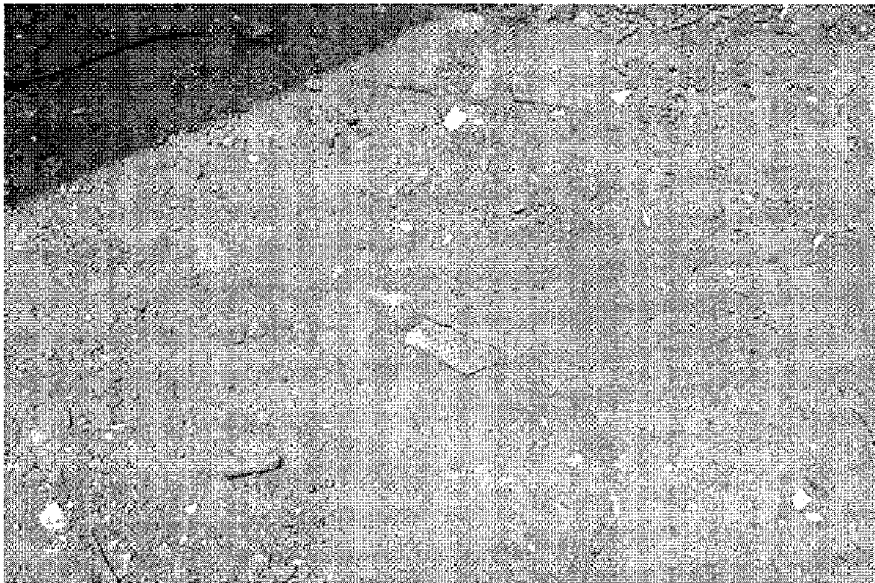
**Photo 11:** Asbestos cement sheet debris on the soil surface of the carpark at the rear of the property.

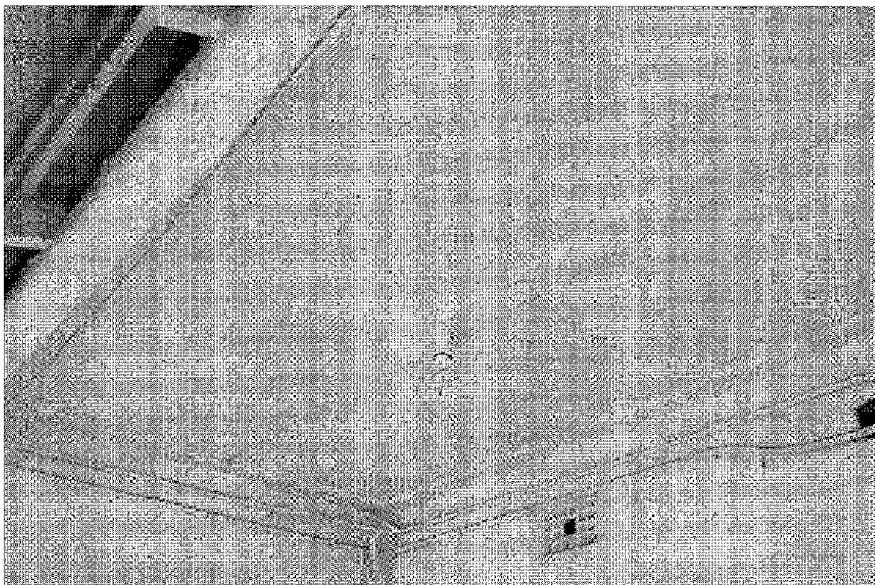
**Photo 12:** Example of asbestos cement sheeting located above the rear entrances to residential tenancies 89A-D and 91A-B.

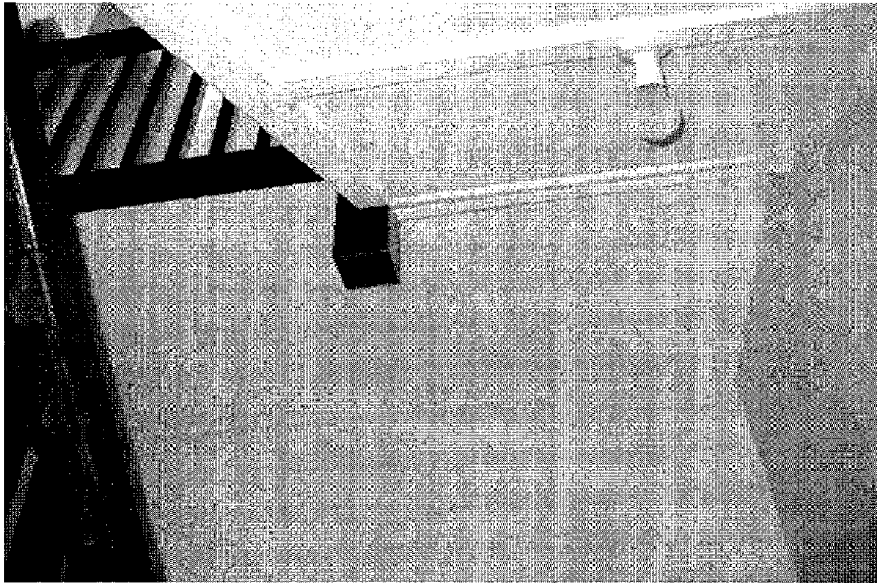
**Photo 13:** Example of asbestos cement sheeting located below the stairs on the ground floors at the rear of residential tenancies 89A-D and 91A-B Liverpool Road.

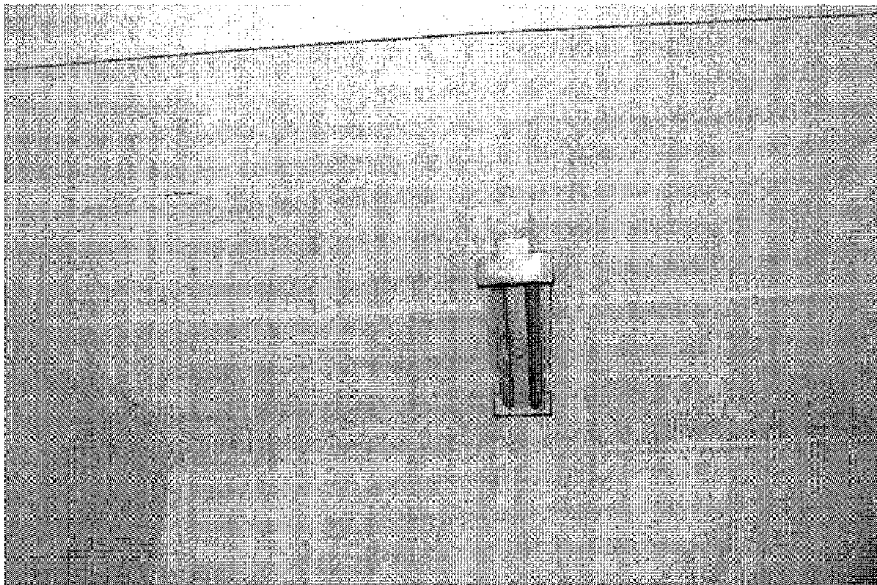
**Photo 14:** Example of asbestos cement sheeting located on the ceilings of the kitchens on the ground floors at the rear of residential tenancies 89A-D and 91A-B Liverpool Road.

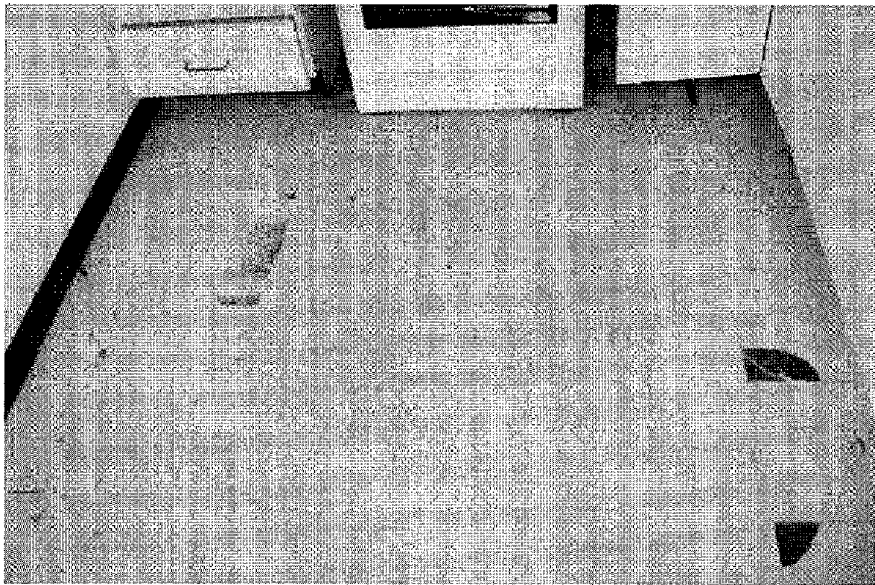
**Photo 15:** Beige vinyl floor tiles containing asbestos located in the kitchen of residential tenancy 89D Liverpool Road.

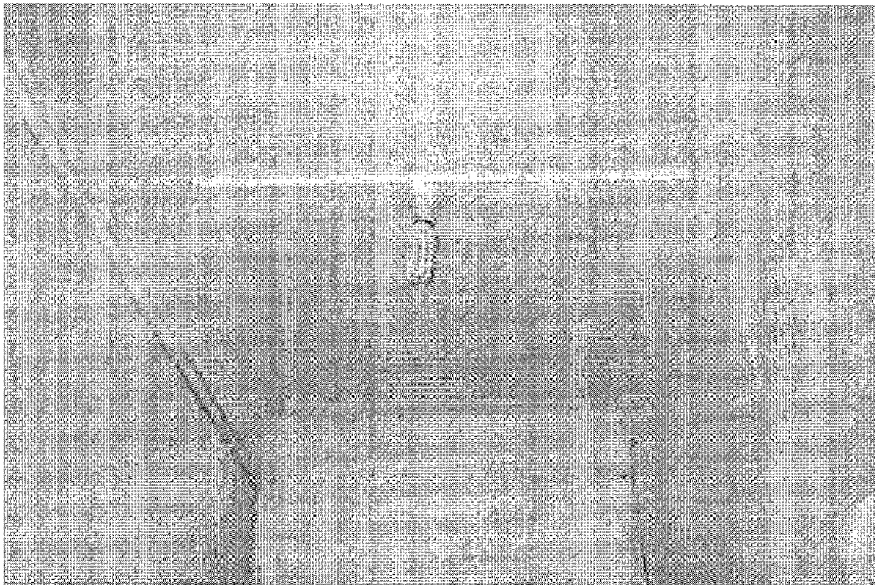
**Photo 16:** Example of asbestos cement sheeting located on the ceilings of the toilets on the ground floors at the rear of residential tenancies 89A-D and 91A-B Liverpool Road.

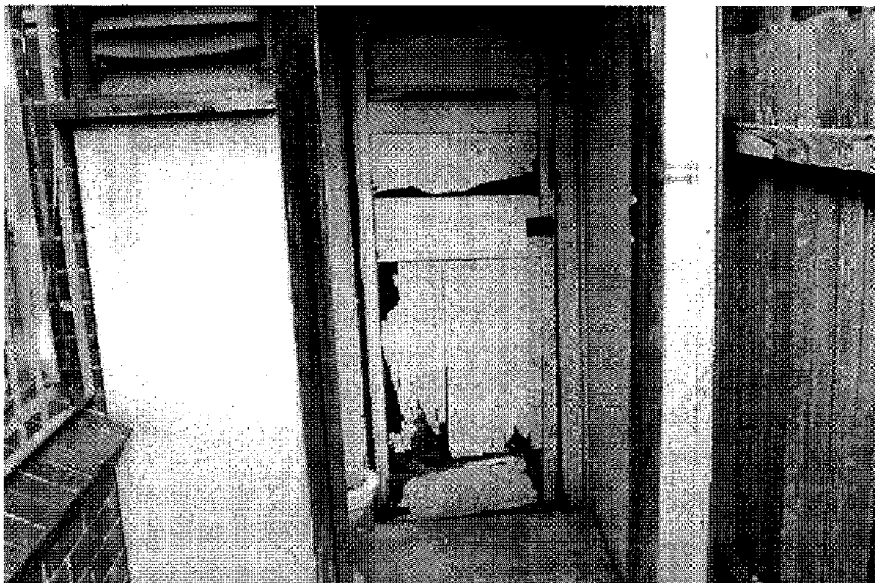
**Photo 17:** Asbestos cement sheeting located in the ceiling and internal and external wall cladding of the outside toilet of residential tenancy at 89C Liverpool Road. Also shown is white paint with elevated levels of lead.

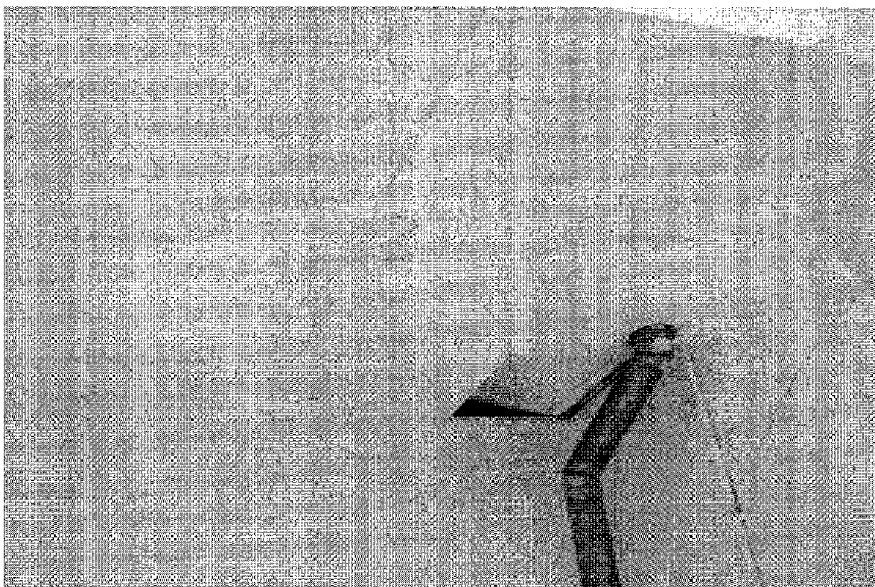
**Photo 18:** Example of asbestos cement sheeting located on the ceilings of the laundry's on the ground floors at the rear of residential tenancies 89A-C and 91A-B Liverpool Road.

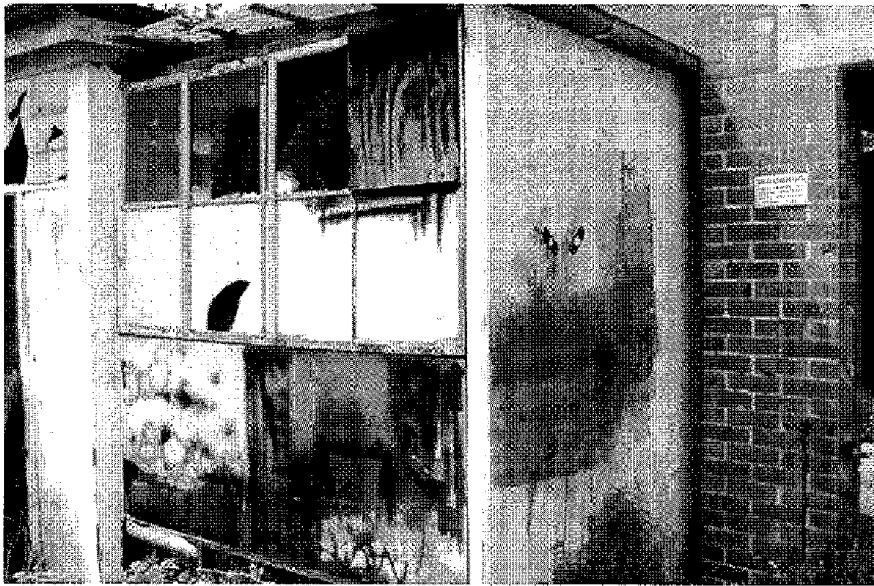
**Photo 19:** Asbestos cement sheeting located on the external wall cladding at the rear of residential tenancy at 89A Liverpool Road.

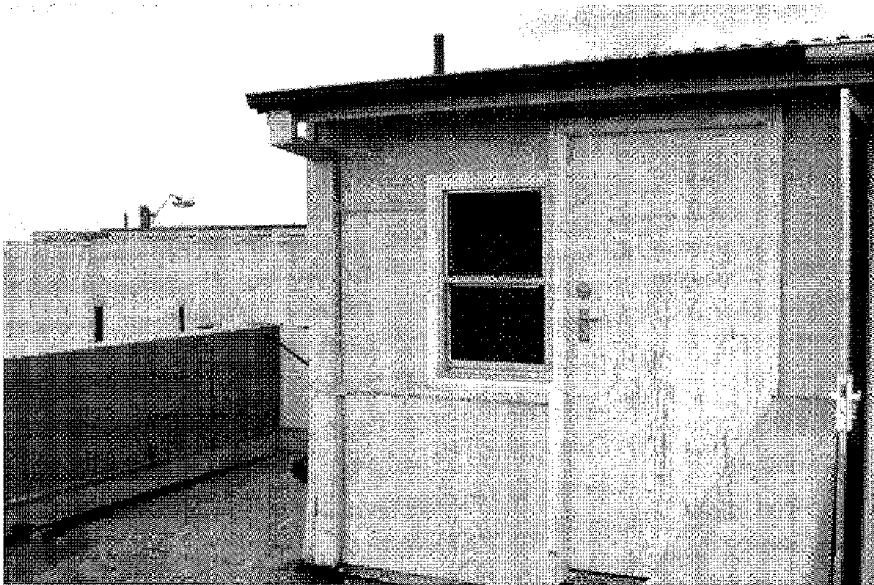
**Photo 20:** Example of asbestos cement sheeting located on the external wall cladding of the roof top laundry's of residential tenancies at 91A-B Liverpool Road.

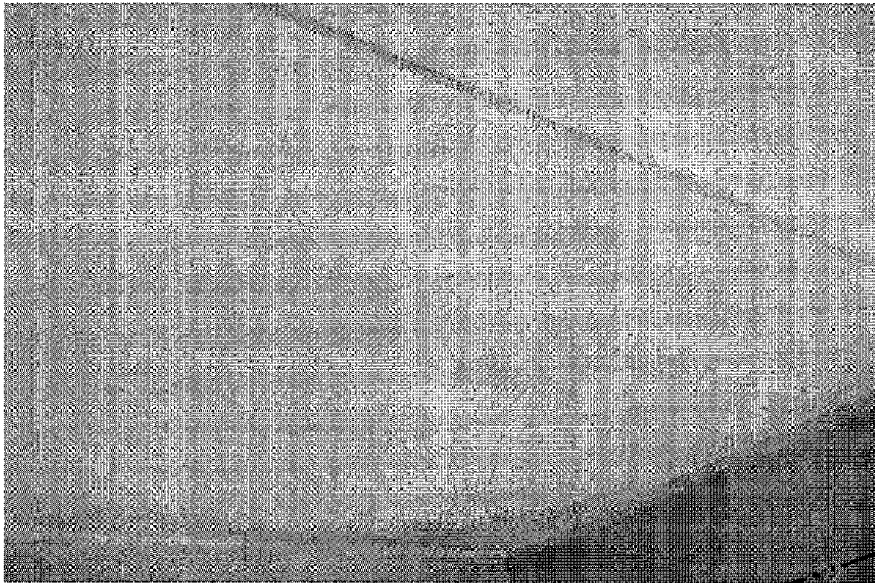
**Photo 21:** Example of asbestos cement sheeting located on the ceiling and internal wall cladding of the roof top laundry's of residential tenancies at 91A-B Liverpool Road.

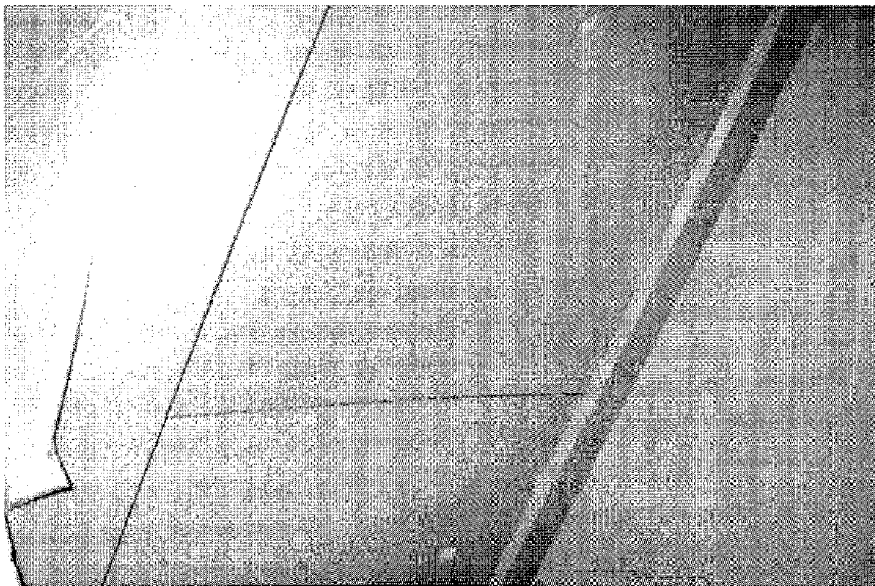
**Photo 22:** Example of asbestos cement sheeting located below the stairs to the roof top laundry's of residential tenancies at 91A-B Liverpool Road.

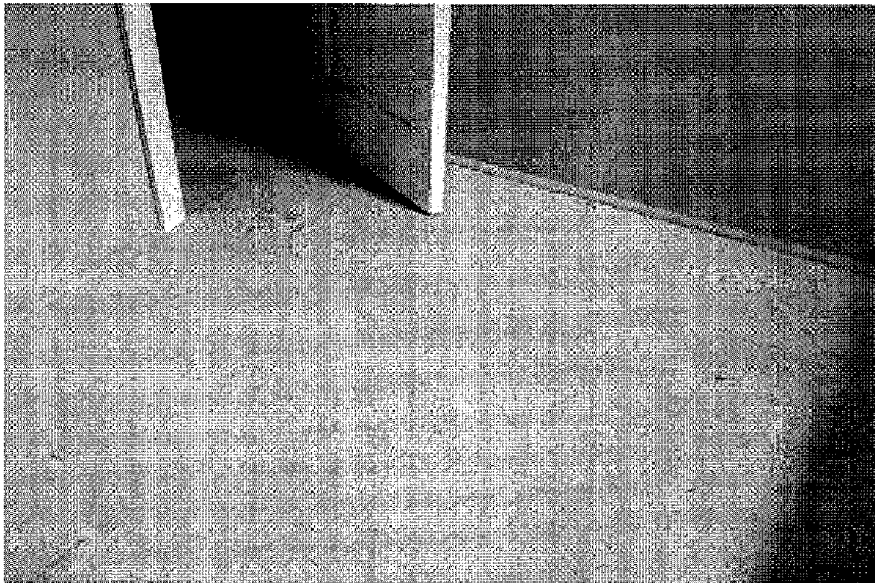
**Photo 23:** Beige vinyl floor tiles containing asbestos located in the kitchen on the first floor of the residential tenancy at 91B Liverpool Road.

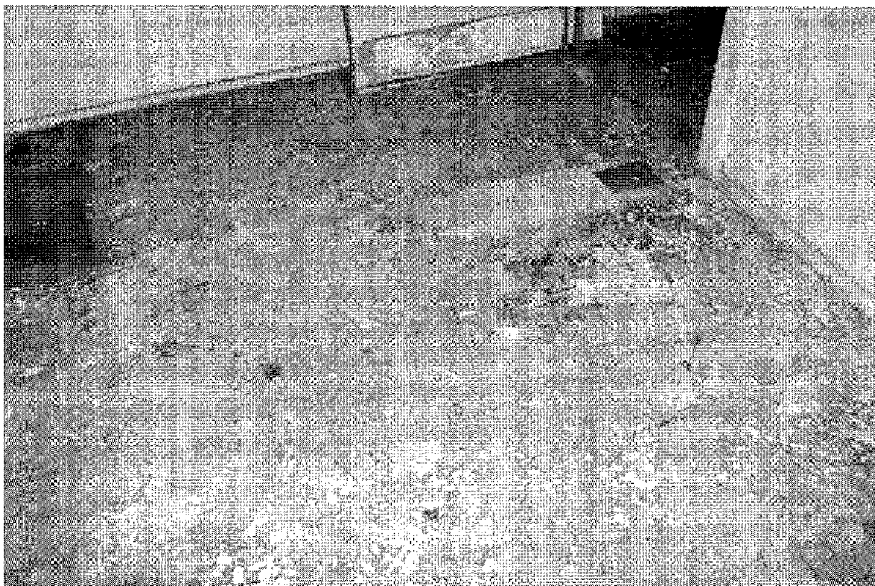
**Photo 24:** Vinyl floor tiles containing asbestos located in the back room of the ground floor residential tenancy at 91A Liverpool Road.

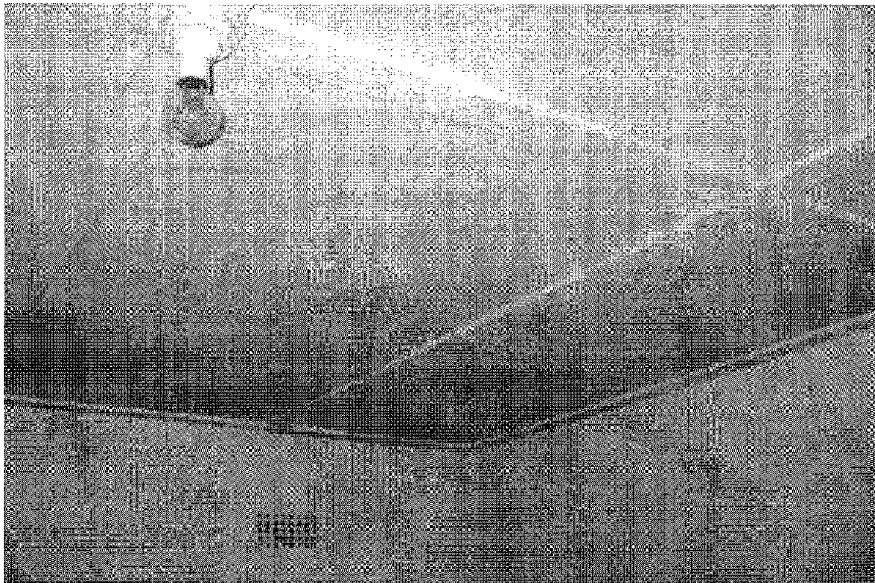
**Photo 25:** Asbestos cement sheeting located on the ceiling of the laundry of the residential tenancy at 16 Bruce Street.

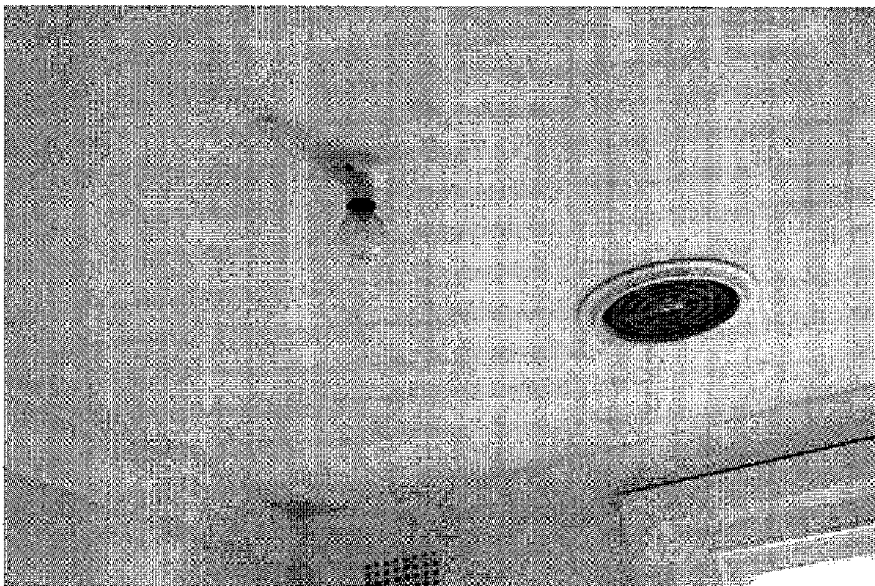
**Photo 26:** Asbestos cement sheeting located on the ceiling of the toilet of the residential tenancy at 16 Bruce Street.

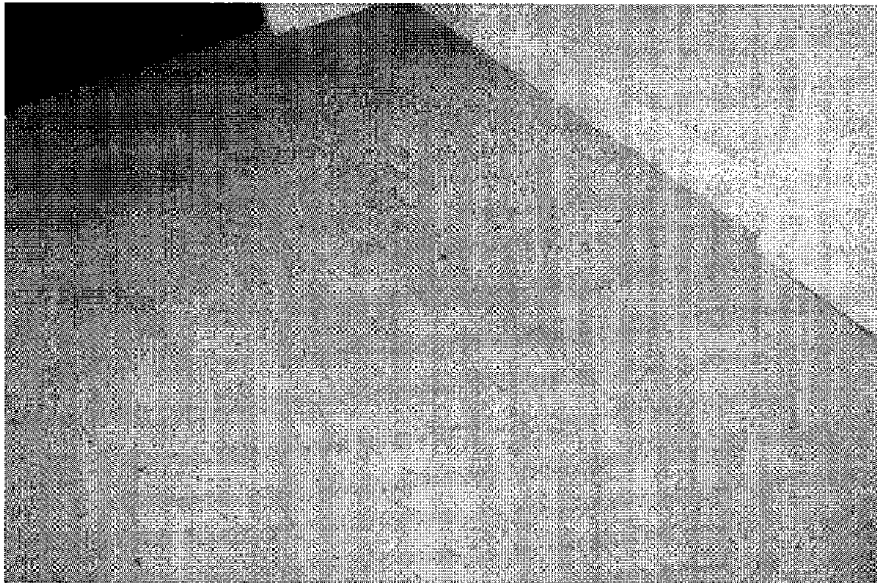
**Photo 27:** Vinyl floor tiles containing asbestos located on the first floor landing and kitchen of the residential tenancy at 16 Bruce Street.

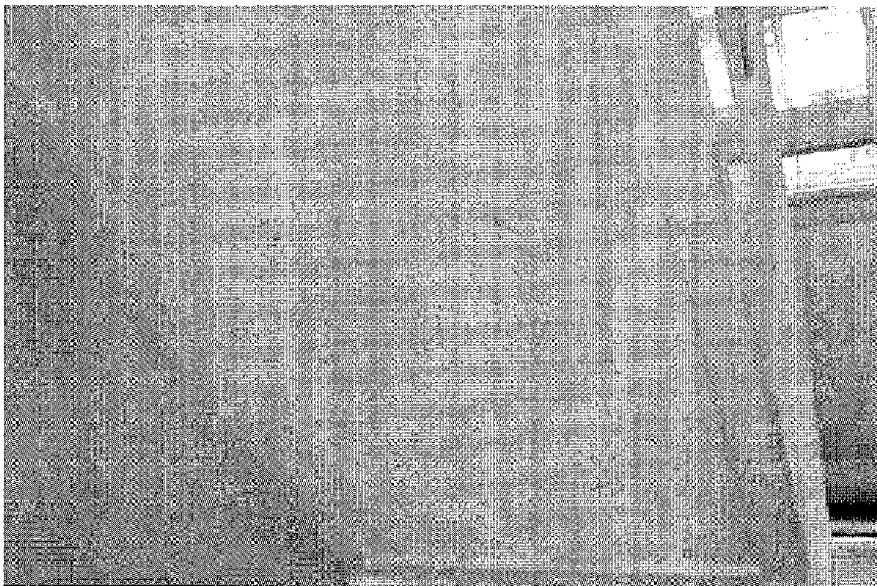
**Photo 28:** Asbestos cement sheeting located under the stairs of residential tenancy 16A Bruce Street.

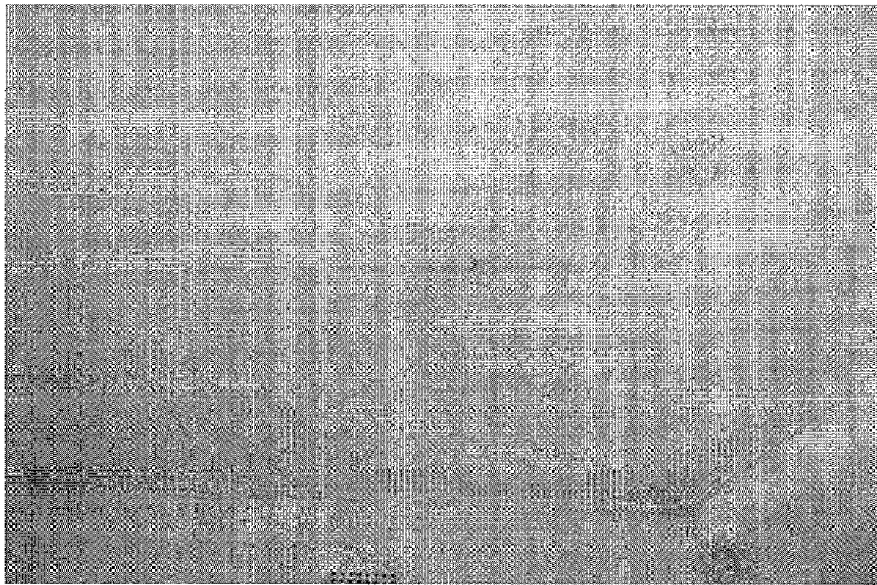
**Photo 29:** White paint with elevated levels of lead located on the ceilings of residential tenancy 89D Liverpool Road.

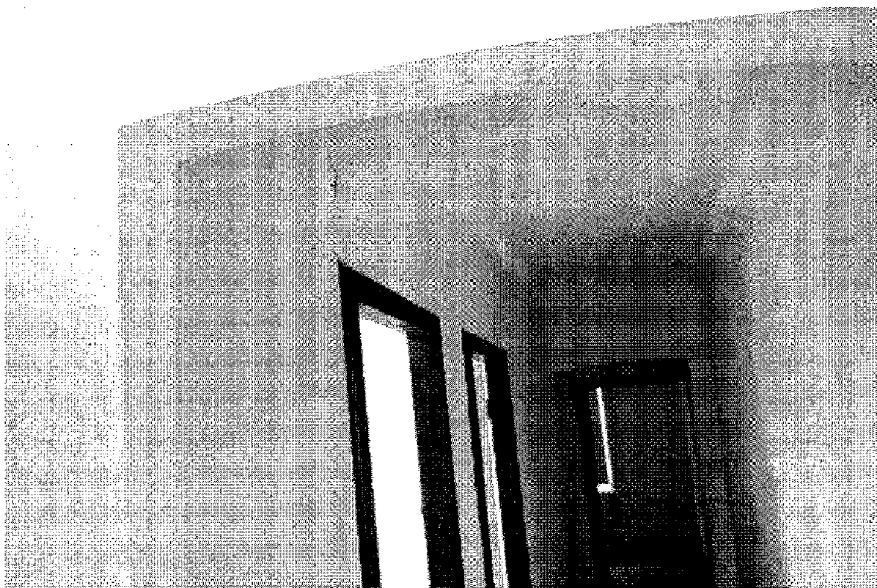
**Photo 30:** Green paint with elevated levels of lead located on the walls of residential tenancy 89D Liverpool Road.

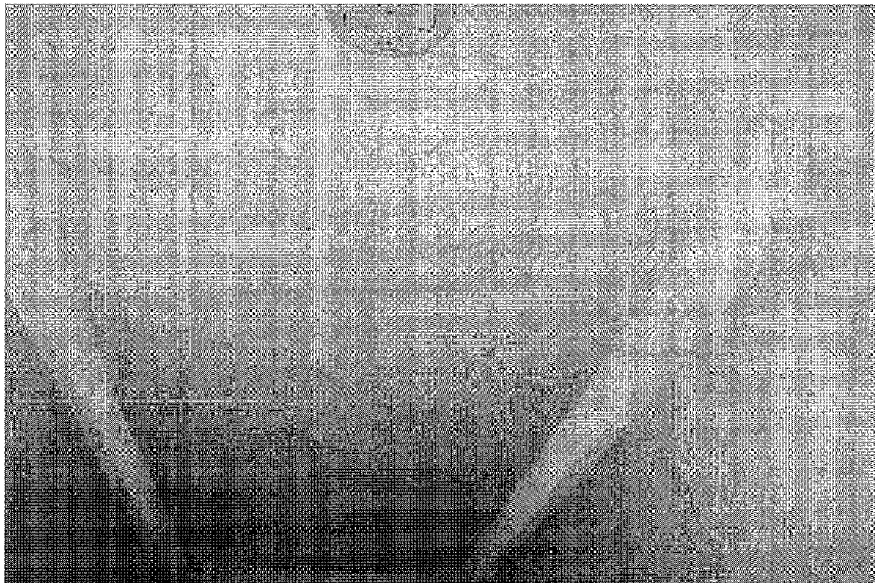
**Photo 31:** White paint with elevated levels of lead located on the ceilings of residential tenancy 89C Liverpool Road.

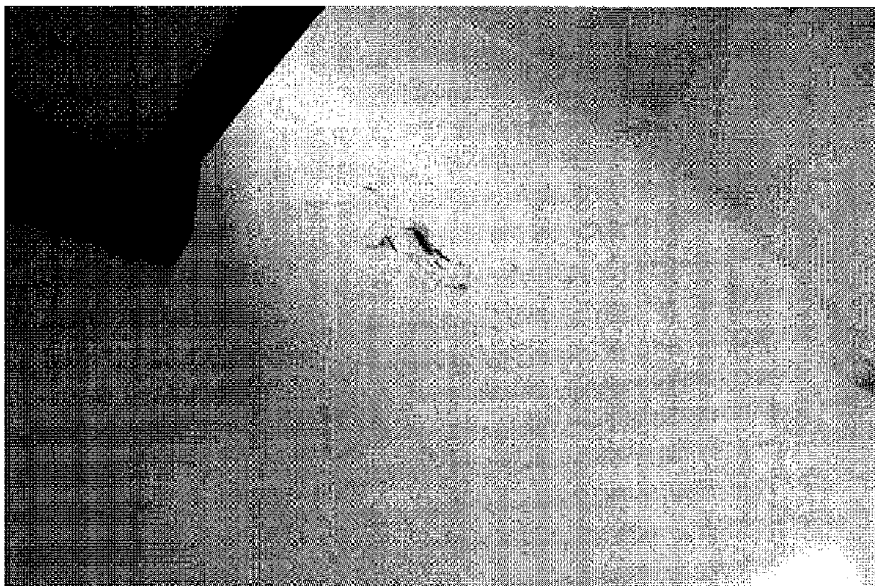
**Photo 32:** Beige paint with elevated levels of lead located on the walls of residential tenancy 89C Liverpool Road.

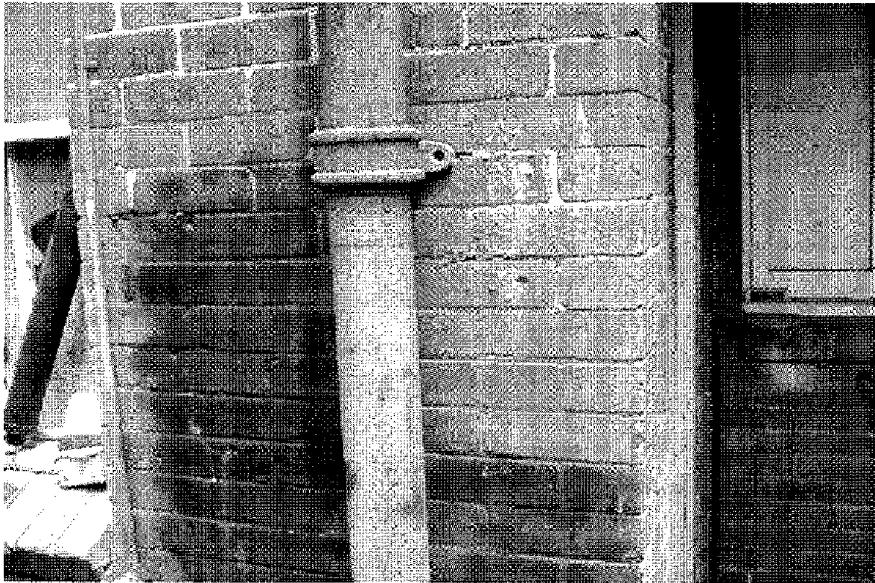
**Photo 33:** Red paint with elevated levels of lead located on the drainpipe at the rear of residential tenancy 91B Liverpool Road.

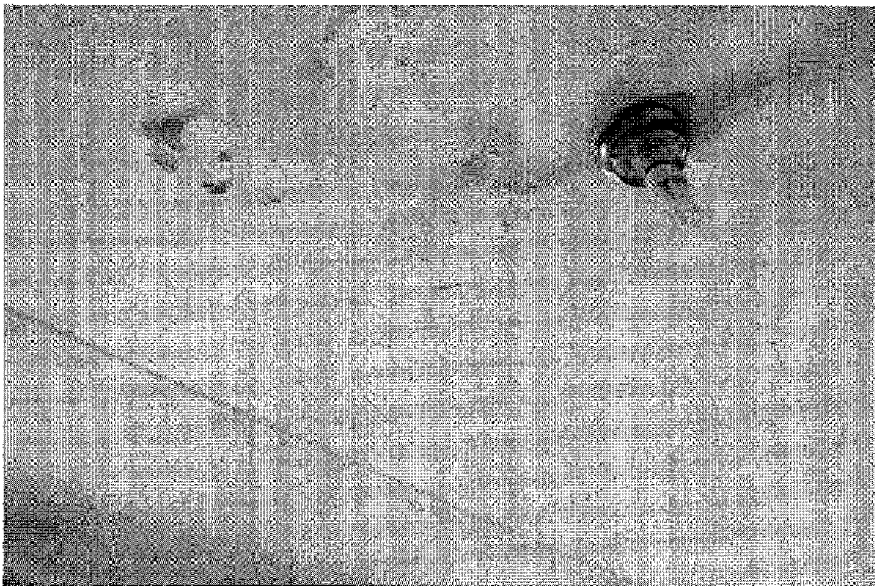
**Photo 34:** White paint with elevated levels of lead located on the ceilings of residential tenancy 91A Liverpool Road.

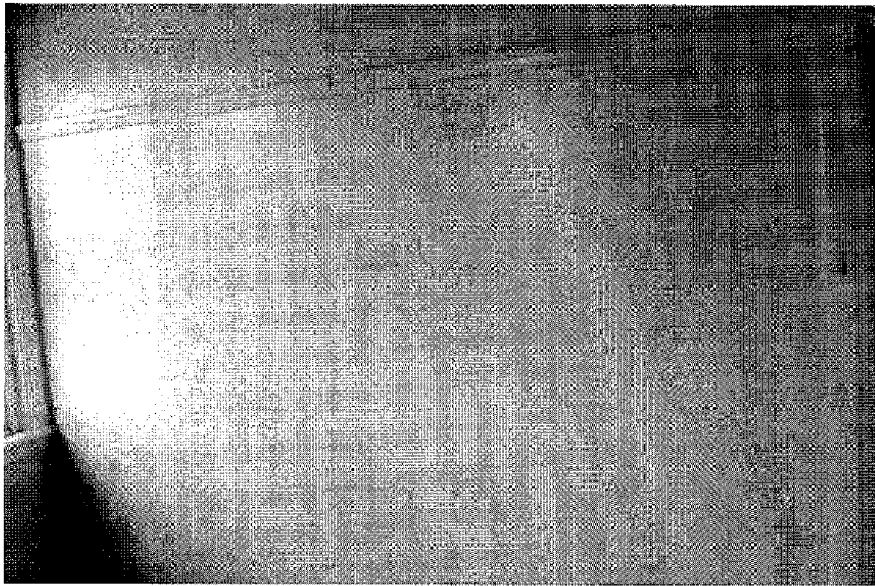
**Photo 35:** Blue paint with elevated levels of lead located on the walls of residential tenancy 91A Liverpool Road.
