Tree Report

Volkswagen Group Australia site
Muir Rd Chullora

For Site Image Pty Ltd

May 2010

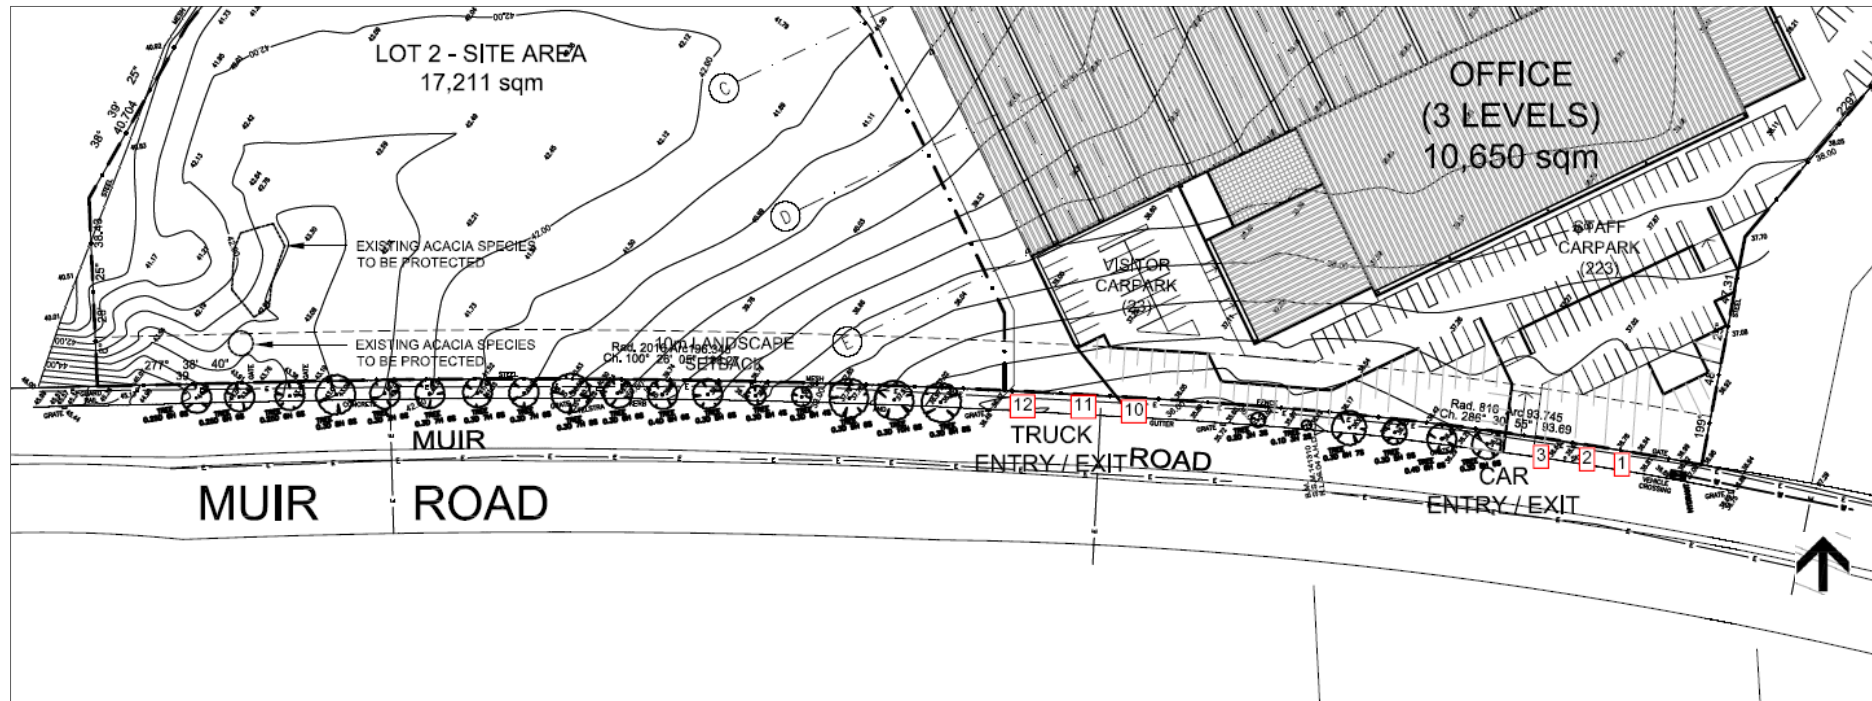
Tree location plan

The site trees proposed for removal are assessed in Table 1 below; trees are numbered from east to west along the row, and tree numbers are noted on the plan attached. Trees were inspected from the ground only and no aerial or subterranean inspections were carried out. The trees are the property of Bankstown City Council.

Six of the row of 29 trees are proposed for removal, in order to accommodate the two entry/exit driveways. The three trees within the easterly carpark driveway are noted as Trees 1, 2 and 3, and the three trees within the westerly truck driveway are numbered 10, 11 and 12. All the other trees in the row would remain unaffected by the proposed development but some in the vicinity of the driveways would need protection during construction.

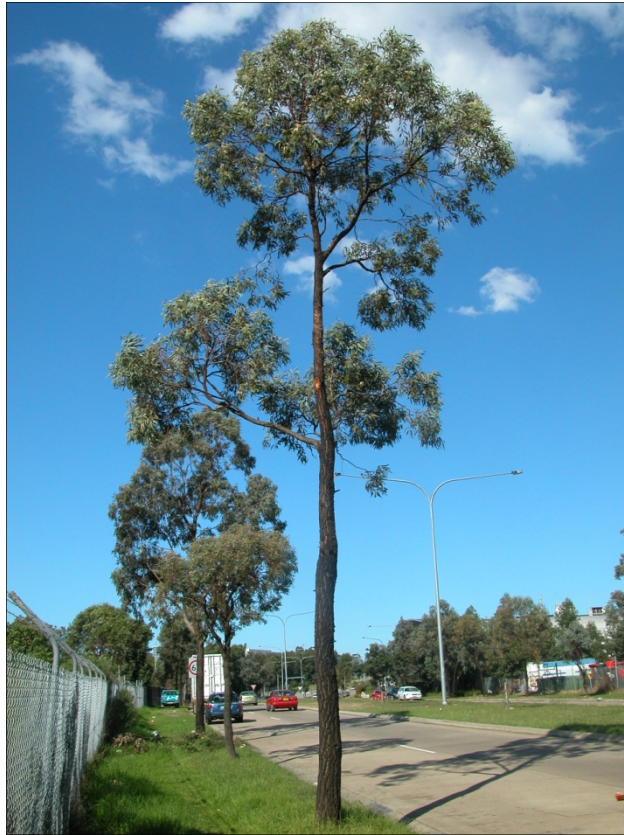
Plate 1: Trees 1, 2 and 3
Eucalyptus sideroxylon (Mugga
Ironbark)

Four of the trees proposed for removal are in fair to good health and condition although some have injuries or minor scaffold defects. Tree 2 is stunted has not grown to the same size as its neighbours. Tree 10 is small and has not become properly established.

Tree no	Species	Approx trunk dbh mm	Approx height m	Approx crown spread m	Health	Condition	SULE	Comment	Effect of proposed development
1	<i>Eucalyptus sideroxylon</i> (Mugga Ironbark)	250	9	5	Good	Good	2D	Branch breakages from vehicle damage	Removal
2	<i>Eucalyptus sideroxylon</i> (Mugga Ironbark)	150	5	3	Fair	Fair	2D	Weak junctions in trunk and branches Small specimen	Removal
3	<i>Eucalyptus sideroxylon</i> (Mugga Ironbark)	250	10	5	Good	Good	2D	Trunk wound	Removal
10	<i>Eucalyptus sideroxylon</i> (Mugga Ironbark)	75	2	2	Good	Poor	3D	Small specimen Loose in ground Poorly established Crown dieback Severe trunk wound at base	Removal
11	<i>Eucalyptus sideroxylon</i> (Mugga Ironbark)	250	9	5	Good	Good	2D	Failed codominant junction at 3m height: possible vehicle damage	Removal
12	<i>Eucalyptus sideroxylon</i> (Mugga Ironbark)	250	7	5	Good	Fair	2D	Poor form with weak junction in trunk at 3m height	Removal

To compensate for the loss of these trees, additional trees of the same species could be planted to fill gaps in the row and possibly to replace poor specimens with better trees.
