# Construction Impact Assessment

Lourdes Retirement Village  
95 Stanhope Road, Killara

**Compiled by**  
George Palmer  
Botanics, Tree Wise People Pty Ltd

**Dated**  
April 2011.

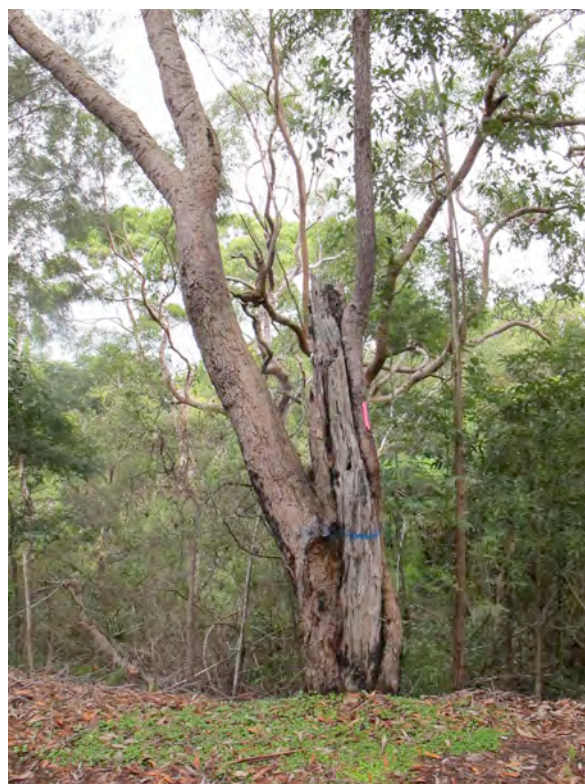
**Figure 3** Shows Tree 227 and the decay at its base.

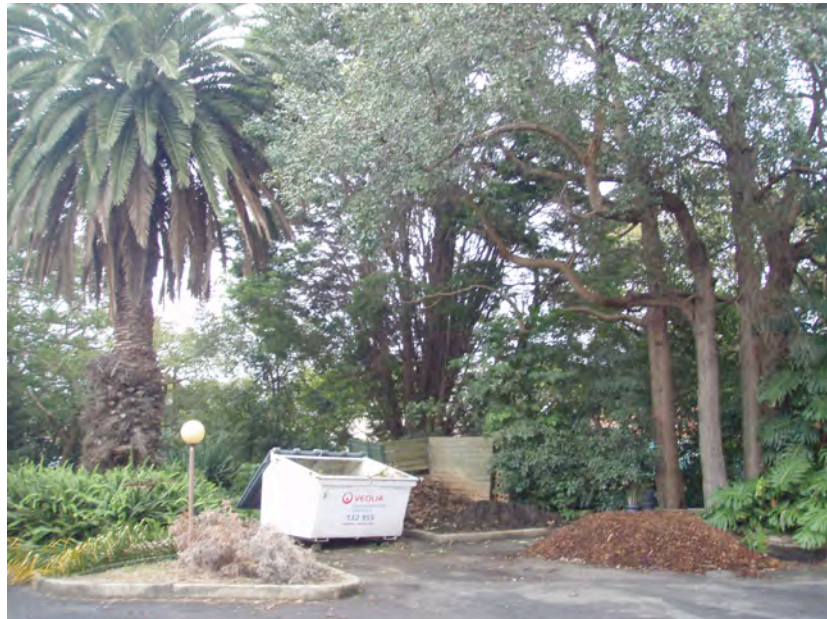
**Figure 4** Shows the trees on the Phoenix to be transplanted and the stand of Turpentine's to be retained with the exception of Tree 21.

3.1.8 Section 4 of the GPR assessment detailed the size and location of roots adjacent to the stand of Turpentine's documented as Trees 21 – 25. These are a significant stand of trees and are part of the remnant plant community.

3.1.9 an assessment of this stand noted that the tree closest the proposed development has been suppressed by the adjacent trees and has developed with a pronounced lean to the south and over the proposed building footprint. The tree has no hope of emerging from this suppression and will always be compromised by the remaining canopy. For this reason it has been recommended that this tree, documented as Tree 21 be removed to allow the adjacent stand of Turpentine's to develop without being compromised by this poorly formed specimen.

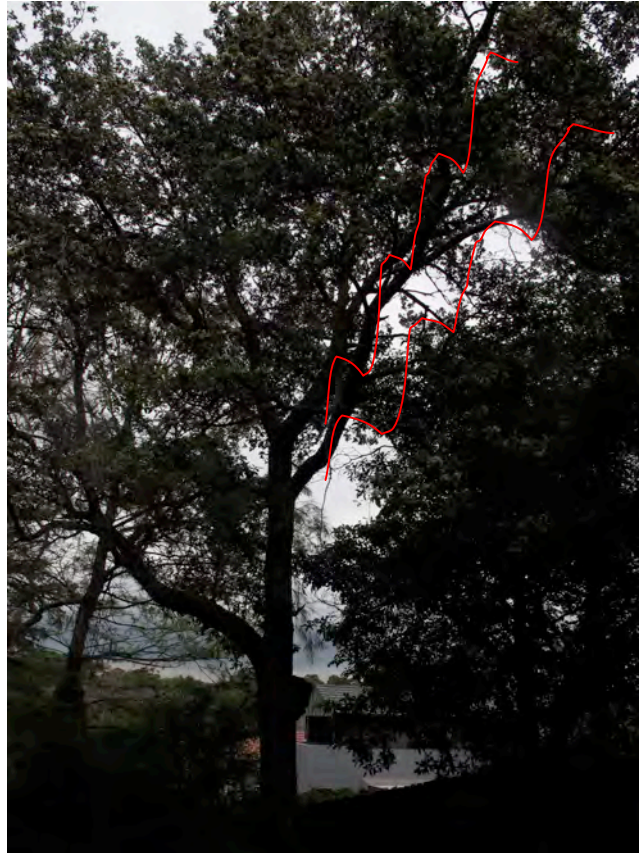
**Figure 5** Shows a portion of the Turpentine, documented as Tree 1 to be pruned to allow for suitable building line clearance.

3.1.11 This tree (Tree 1) is again part of the remnant plant community but is significant being a single tree rather than part of a stand. The tree has however been considered for retention. The GPR information was inconclusive. A visual assessment of the area noted that there is a large concrete sewer access pit has previously been constructed to the east of this tree. It is understood that this pit is at least 700mm below the soil surface and is more likely to be anywhere up to 3 meters below ground.

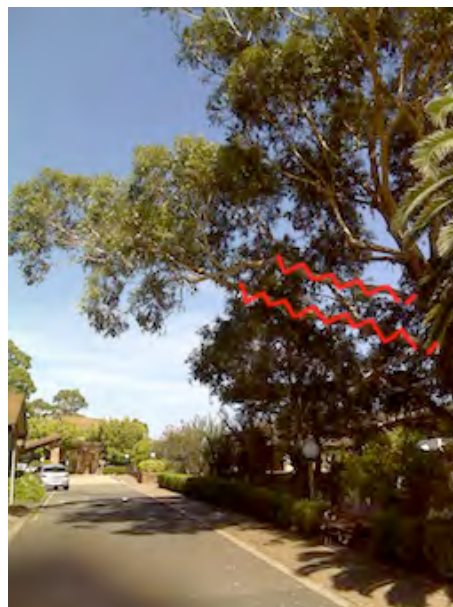
**Figure 6** Shows a portion of the Blackbutt, documented as Tree 54 to be pruned to increase tree life expectancy, improve safety and allow for RFS access.

3.1.6 This proposed pruning will open up 2 pruning wounds, the largest of which will be 175 mm in diameter. This mature specimen has a pronounced lean on a 60 degree angle overhanging the internal road and main pedestrian access way. The impacts of pruning of approximately 25% of the canopy should alleviate overturning forces and therefore increase its length of survival and minimise the safety risk of branch failure.

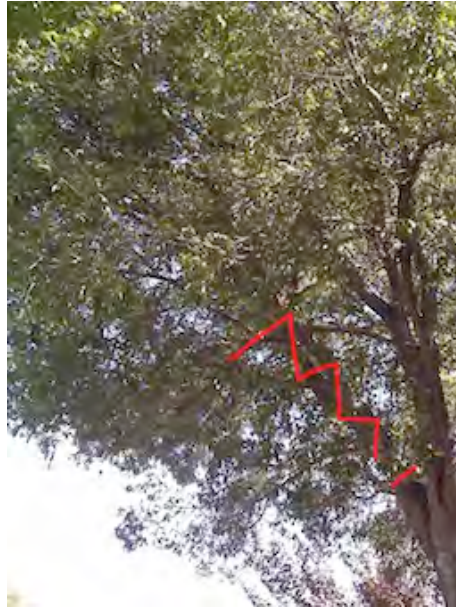
**Figure 7** Shows a portion of the Syzygium, documented as Tree 91 to be pruned (remove: 1x 125mm, 1x75mm branches as shown) to allow for RFS access

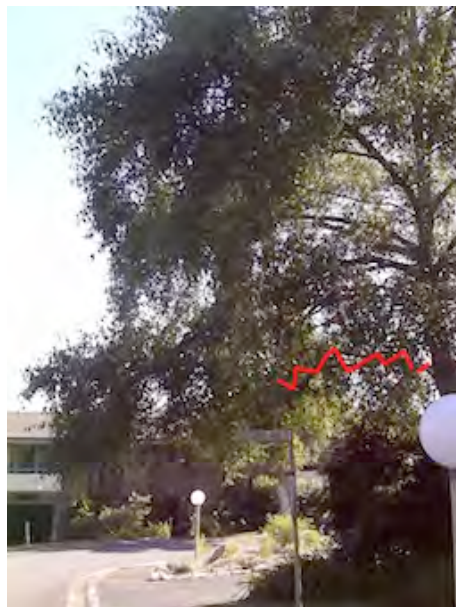
**Figure 8** Shows a portion of the Alder, documented as Tree 92 to be pruned (remove: 1x 100mm as shown) to allow for RFS access

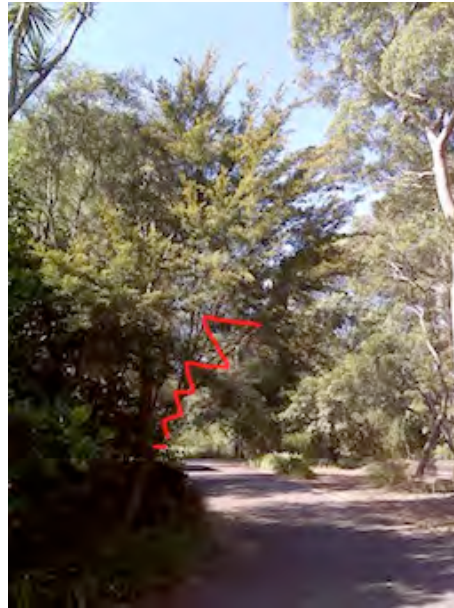
**Figure 9** Shows a portion of the Tee Tree, documented as Tree 93 to be removed to allow for RFS access

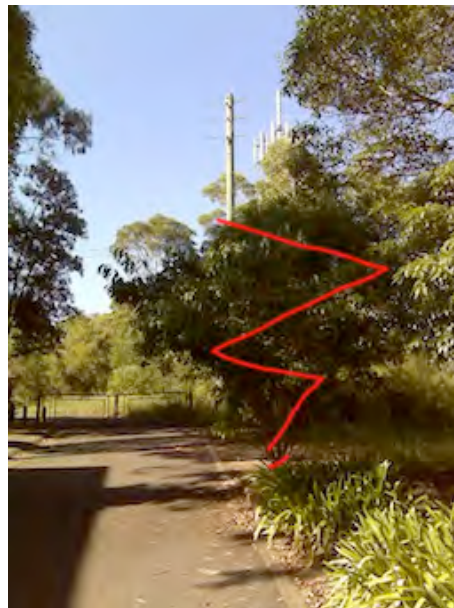
**Figure 10** Shows the Plum, documented as Tree 94 to be removed to allow for RFS access

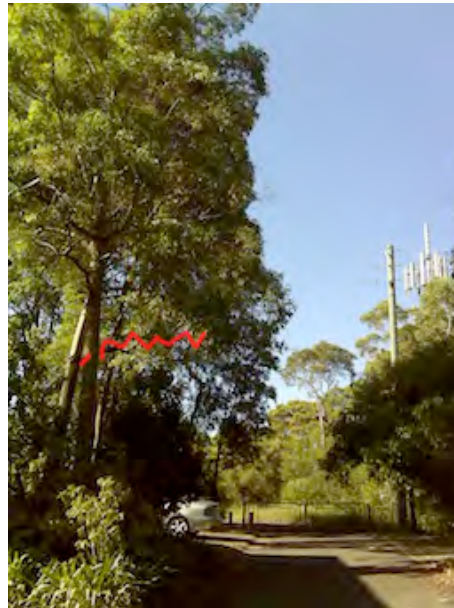
**Figure 11** Shows a portion of the Red Bloodwood, documented as Tree 95 to be pruned (remove: 1x 125mm branch as shown) to allow for RFS access

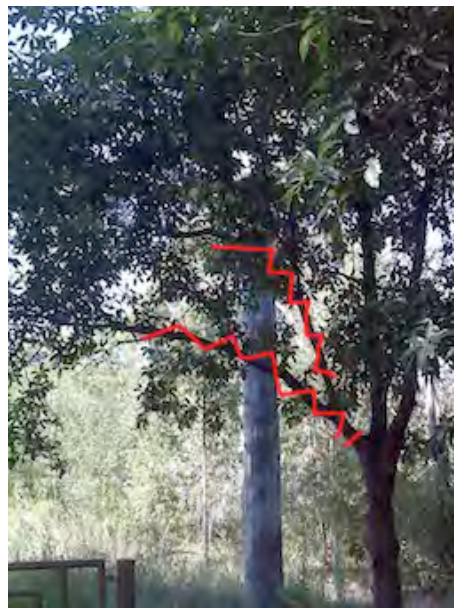
**Figure 12** Shows a portion of the Pittosporum, documented as Tree 96 to be pruned (remove: 2x 75mm branches as shown) to allow for RFS access

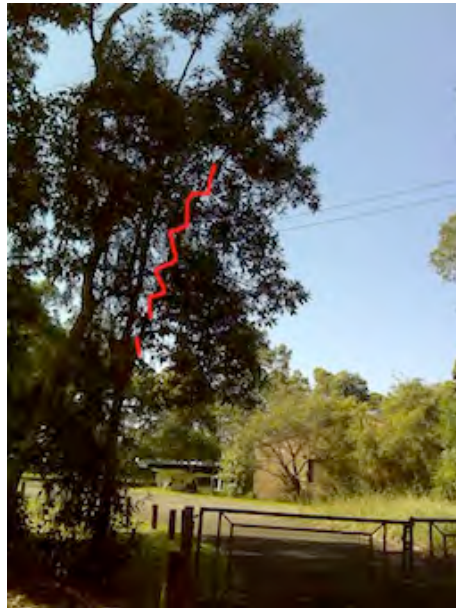
**Figure 13** Shows a portion of the Watergum, documented as Tree 97 to be pruned (remove: 1x 75mm branch as shown) to allow for RFS access

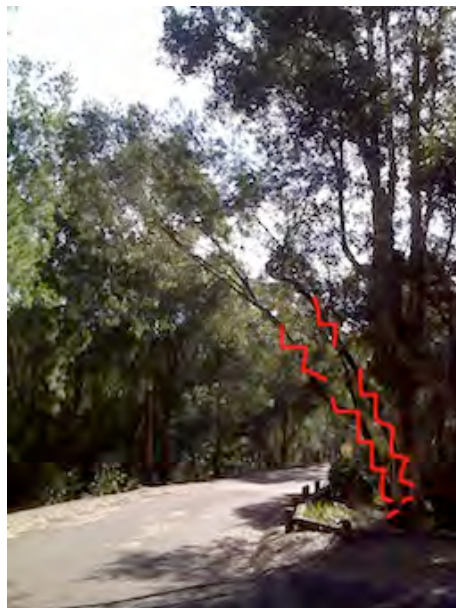
**Figure 14** Shows the 2 Swamp Oaks, documented as Tree 98 & 99 to be removed to allow for RFS access

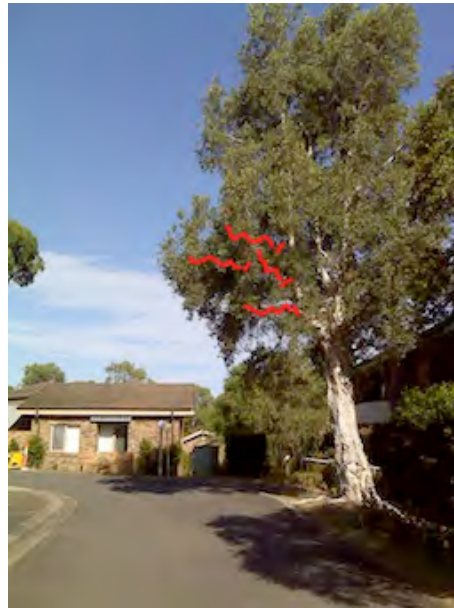
**Figure 15** Shows a portion of the Paperbark, documented as Tree 100 to be pruned (remove: 4x75mm branches as shown) to allow for RFS access

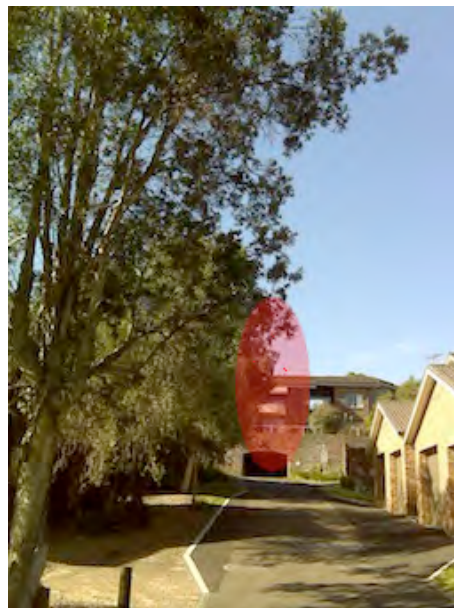
**Figure 16** Shows a portion of the Paperbark, documented as Tree 101 to be pruned (remove: 4x 50mm, branches as shown) to allow for RFS access

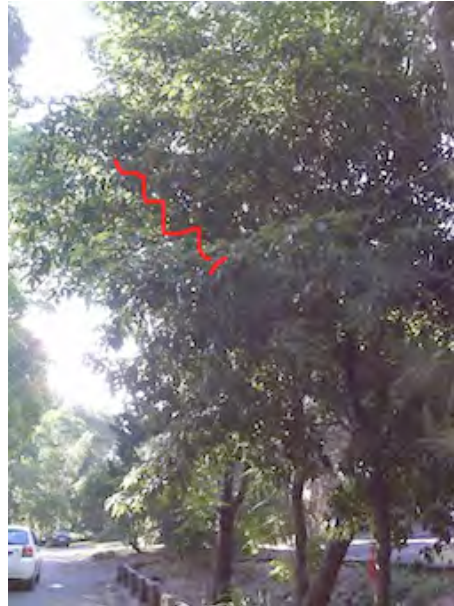
**Figure 17** Shows a portion of the Pittosporum, documented as Tree 102 to be pruned (remove: 4x 50mm, branches as shown) to allow for RFS access

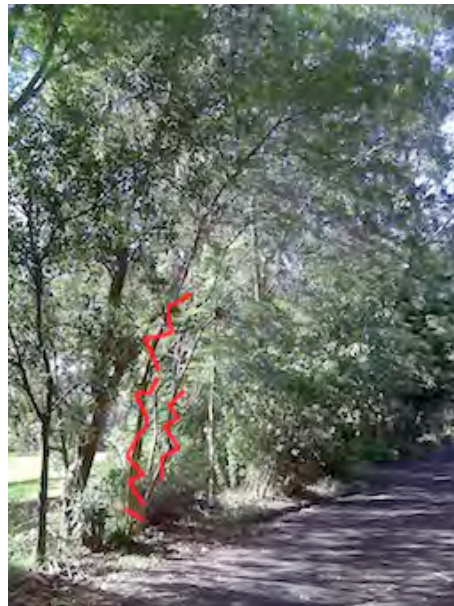
**Figure 18** Shows a portion of the Jacaranda, documented as Tree 103 to be removed to allow for RFS access

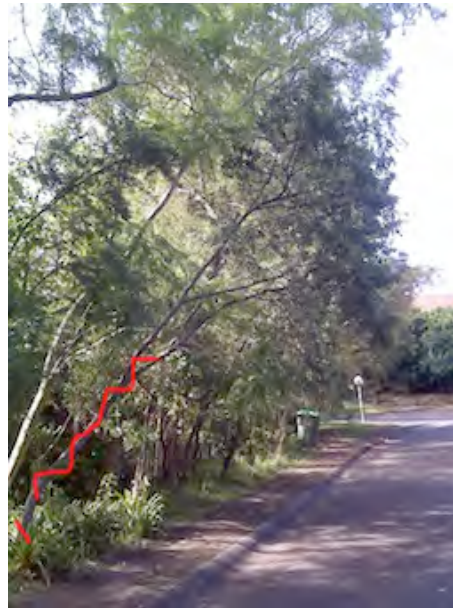
**Figure 19** Shows a portion of the Bottlebrush, documented as Tree 104 to be removed to allow for RFS access

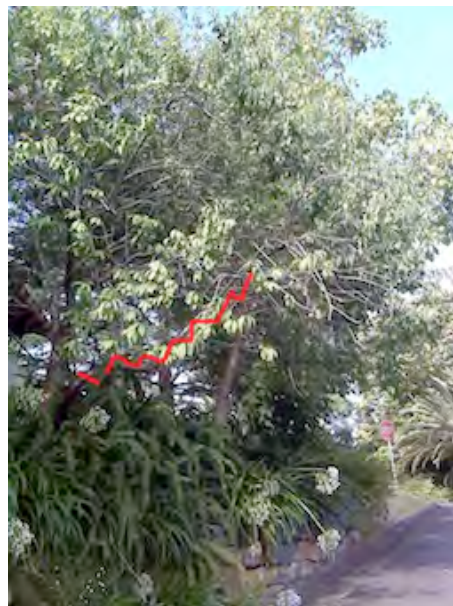
**Figure 20** Shows a portion of the Plum, documented as Tree 105 to be pruned (remove: 2x75mm branches as shown) to allow for RFS access

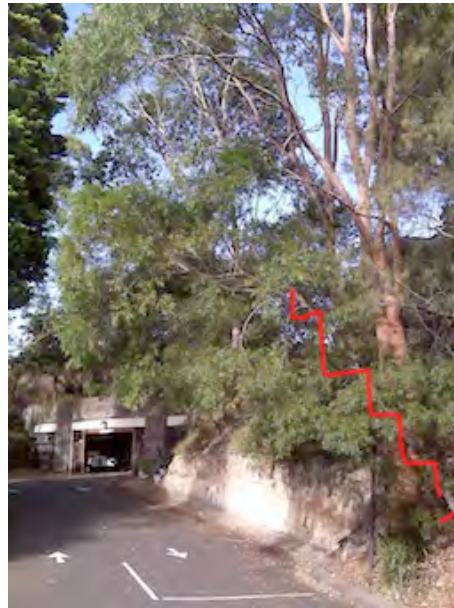
**Figure 21** Shows a portion of the Wattle, documented as Tree 106 to be removed to allow for RFS access

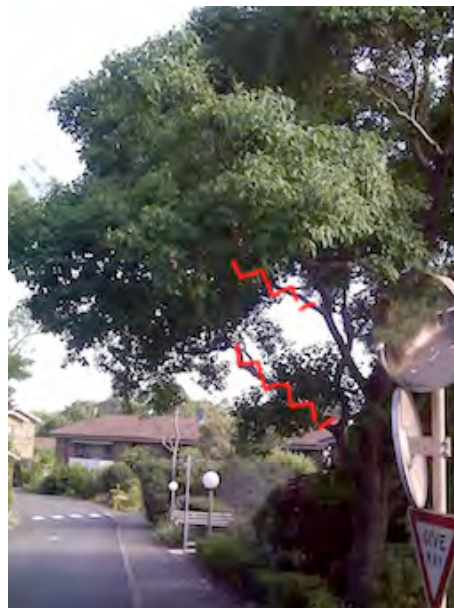
**Figure 22** Shows a portion of the Tallow, documented as Tree 107 to be pruned (remove: 2x 75 branches as shown) to allow for RFS access

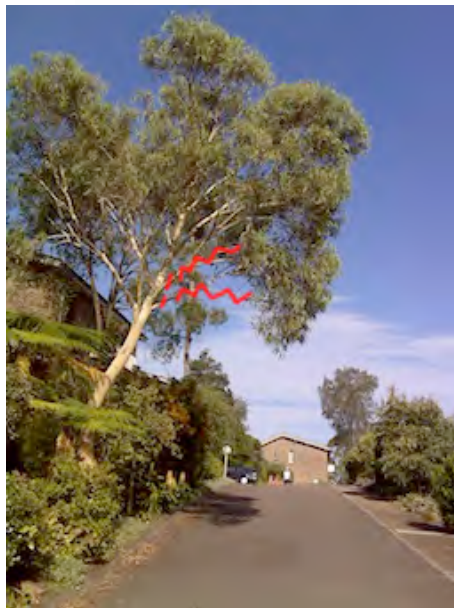
**Figure 23** Shows a portion of the Grey gum, documented as Tree 108 to be pruned (remove: 2x 150mm, branches as shown) to allow for RFS access

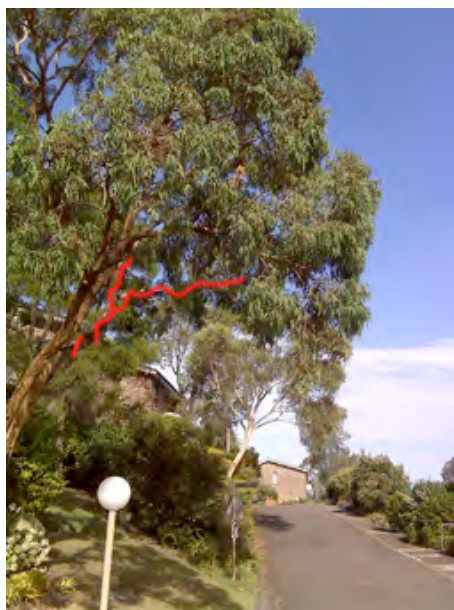
**Figure 24** Shows a portion of the Smooth Bark Apple, documented as Tree 109 to be pruned (remove: 1x 125mm, branch as shown) to allow for RFS access

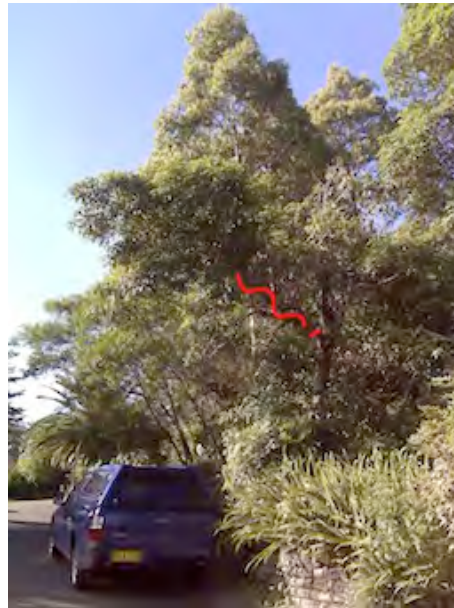
**Figure 25** Shows a portion of the Pittosporum, documented as Tree 110 to be pruned (remove: 1x75mm branch as shown) to allow for RFS access

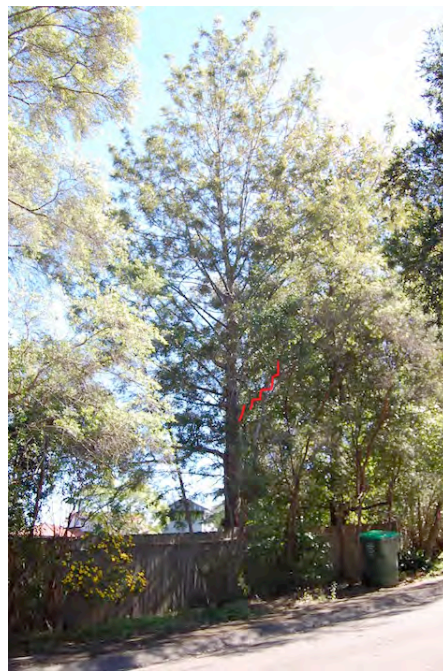
**Figure 26** Shows a portion of the Silky Oak, documented as Tree 119 to be pruned (remove: 1x75mm branch on eastern side as shown) + remove deadwood to allow for RFS Inner Protection Zone

119	Grevillia robusta (Silky Oak)	14 x 4	NA	Moderate	Prune	Remove the lower limb over the fenceline, remove dead wood throughout lower and mid canopy. Prune to create RFS Inner Protection Canopy Separation.
120	Angophora costata (Smooth Barked Apple)	16 x 9	NA	High	Prune	Part of the remnant plant community that provides a significant arboricultural amenity. Prune back to clear canopies and remove dead wood in accordance with RFS Inner Protection Canopy Separation.
123	Olea europa (Olive)	6 x 4		Low	Remove	An exotic weed species recommended for removal.
134	Eucalyptus piperita (Sydney Peppermint)	12 x 6		Moderate	Prune	A mature and significant tree. Remove the lowest limb over the roadway to clear canopies and remove dead wood in accordance with RFS inner Protection Canopy Separation.
144	Casuarina glauca (She Oak)	8 x 4		Low	Remove	Dead. Remove dead wood in accordance with RFS Inner Protection Canopy Separation.

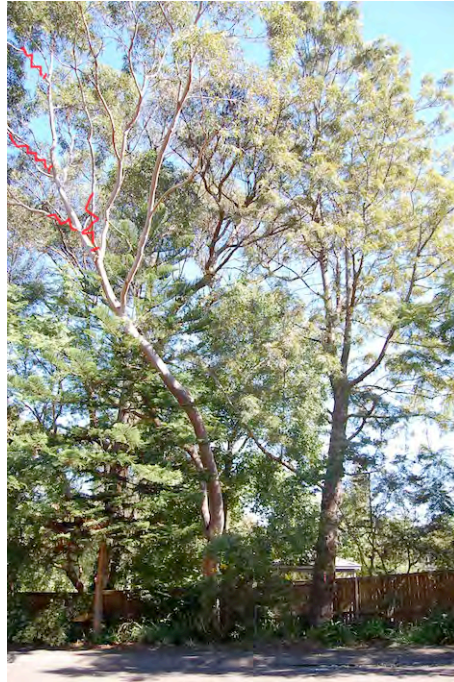
**Figure 27** Shows a portion of the Smooth Barked Apple, documented as Tree 120 to be pruned (remove: 4x75mm branch on eastern side as shown) + remove deadwood to allow for RFS Inner Protection Zone

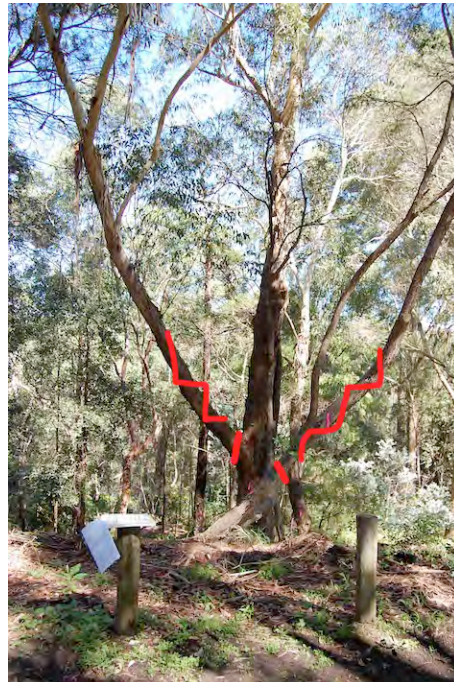
**Figure 28** Shows a portion of the Sydney Peppermint, documented as Tree 134 to be pruned (remove: 2x225mm branch on northern and western side as shown) + remove deadwood to allow for RFS Inner Protection Zone

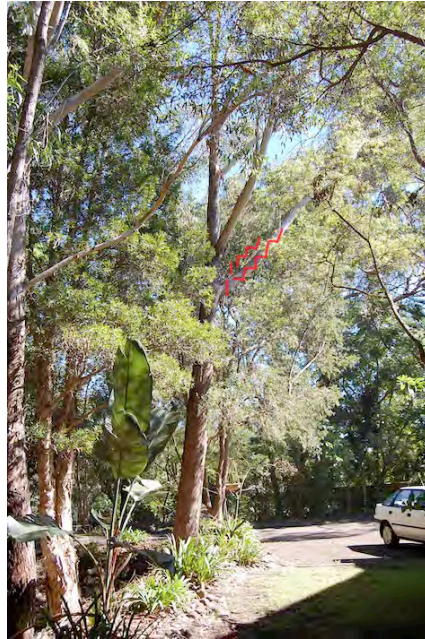
**Figure 29** Shows a portion of the Sydney Peppermint, documented as Tree 152 to be pruned (remove: 2x250mm branches on northern and north-eastern side as shown) + remove deadwood to allow for RFS Inner Protection Zone

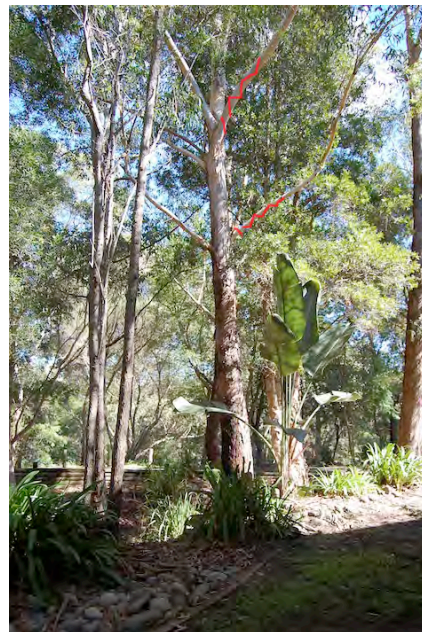
**Figure 30** Shows a portion of the Sydney Peppermint, documented as Tree 154 to be pruned (remove: 1x150,1x200mm branches on northern side as shown) + remove deadwood to allow for RFS Inner Protection Zone

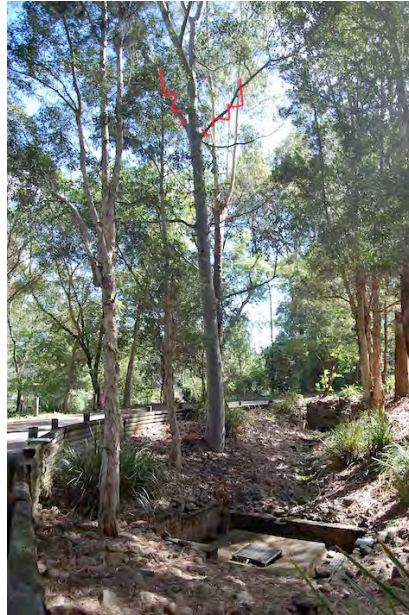
**Figure 31** Shows a portion of the Spotted Gum, documented as Tree 164 to be pruned (remove: 2x150mm branches on north and south side as shown) + remove deadwood to allow for RFS Inner Protection Zone

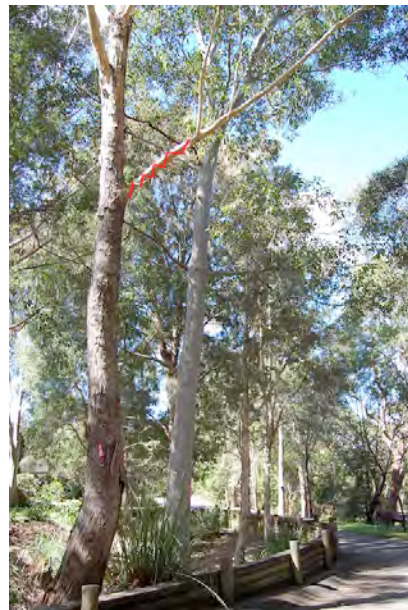
**Figure 32** Shows a portion of the Sydney Peppermint, documented as Tree 165 to be pruned (remove: 1x150mm branches on south side as shown) + remove deadwood to allow for RFS Inner Protection Zone

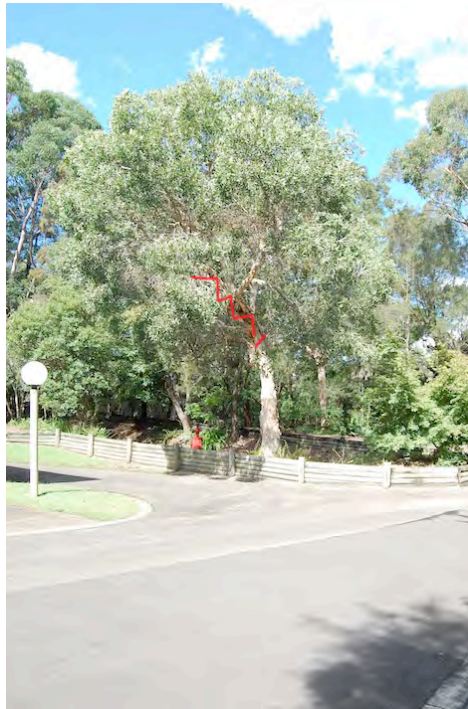
**Figure 33** Shows a Paper Bark, documented as Tree 172 to be pruned (remove: 1x250mm branches on north side as shown) + remove deadwood to allow for RFS Inner Protection Zone

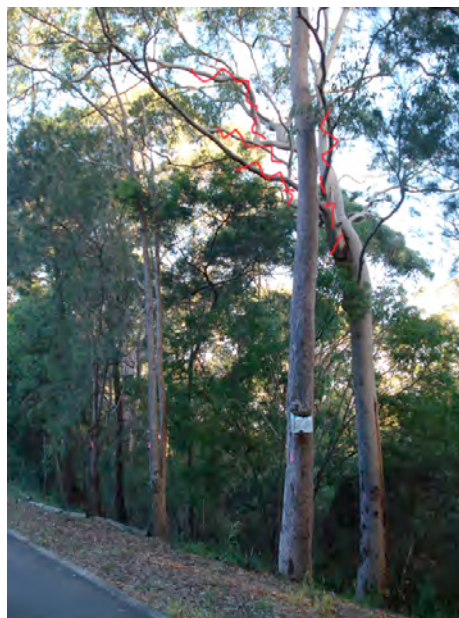
**Figure 34** Shows a portion of the Smooth Barked Apple, documented as Tree 199 to be pruned (remove: 2x150mm branches on northern side as shown) + remove deadwood to allow for RFS Inner Protection Zone

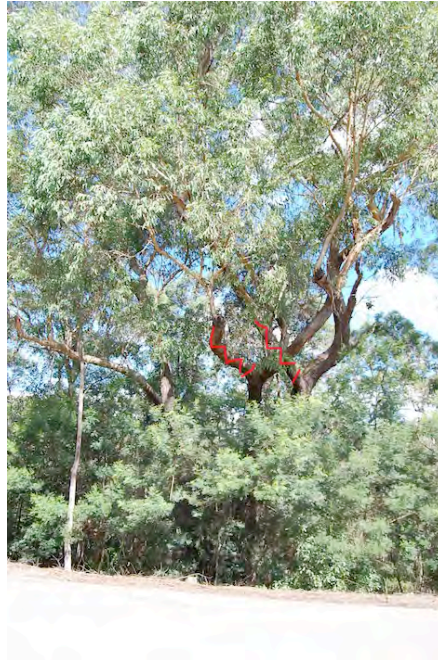
**Figure 35** Shows a portion of the Sydney Peppermint, documented as Tree 209 to be pruned (remove: 2x300mm branches on northern side as shown) + remove deadwood to allow for RFS Inner Protection Zone

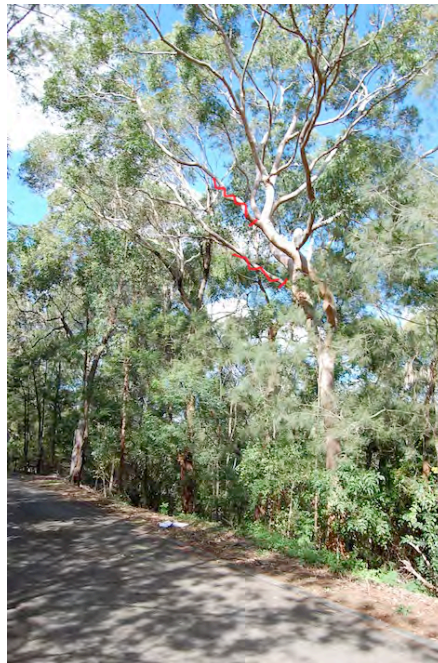
**Figure 36** Shows a portion of the Smooth Barked Apple, documented as Tree 222 to be pruned (remove: 2x200mm branches on northern side as shown) + remove deadwood to allow for RFS Inner Protection Zone

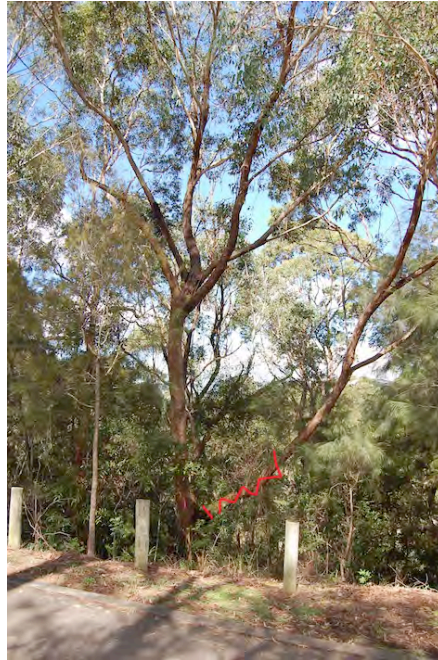
**Figure 37** Shows a portion of the Sydney Peppermint, documented as Tree 234 to be pruned (remove: 1x300mm branches on western side as shown) + remove deadwood to allow for RFS Inner Protection Zone

234	Eucalyptus piperita (Sydney Peppermint)	12 x 9		Moderate	Prune	A semi mature example of the species required to have lowest limb pruned back from road way to allow canopy separation.
244	Eucalyptus piperita (Sydney Peppermint)	12 x 9		Moderate	Remove	A mature and significant tree with a co dominant trunk and decay at the base. Remove in accordance with RFS Inner Protection Canopy Separation.
252	quinquinervia (Paper Bark)	10 x 5		Moderate	Remove	A mature example of the species located directly adjacent to the building within RFS Inner Protection Zone.
262	quinquinervia (Paper Bark)	10 x 5		Moderate	Remove	A mature example of the species located directly adjacent to the building within RFS Inner Protection Zone.
273	Eucalyptus piperita (Sydney Peppermint)	12 x 9		Moderate	Remove	A mature and significant tree with a co dominant trunk and decay at the base. Remove in accordance with RFS Inner Protection Zone Canopy Separation.

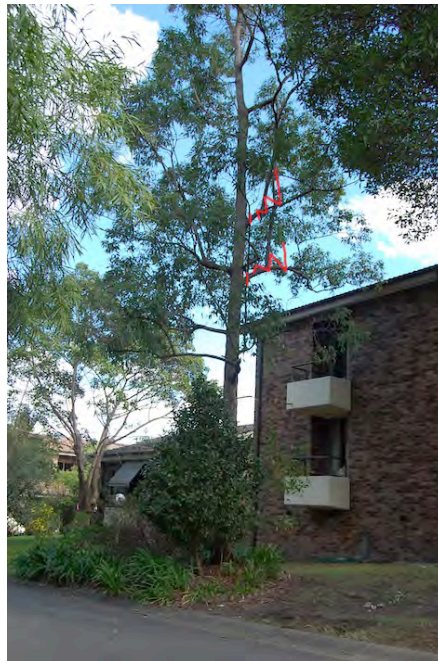
**Figure 38** Shows a portion of the Bloodwood, documented as Tree 350 to be pruned (remove: 2x150mm branches on northern side as shown) + remove deadwood to allow for RFS Inner Protection Zone

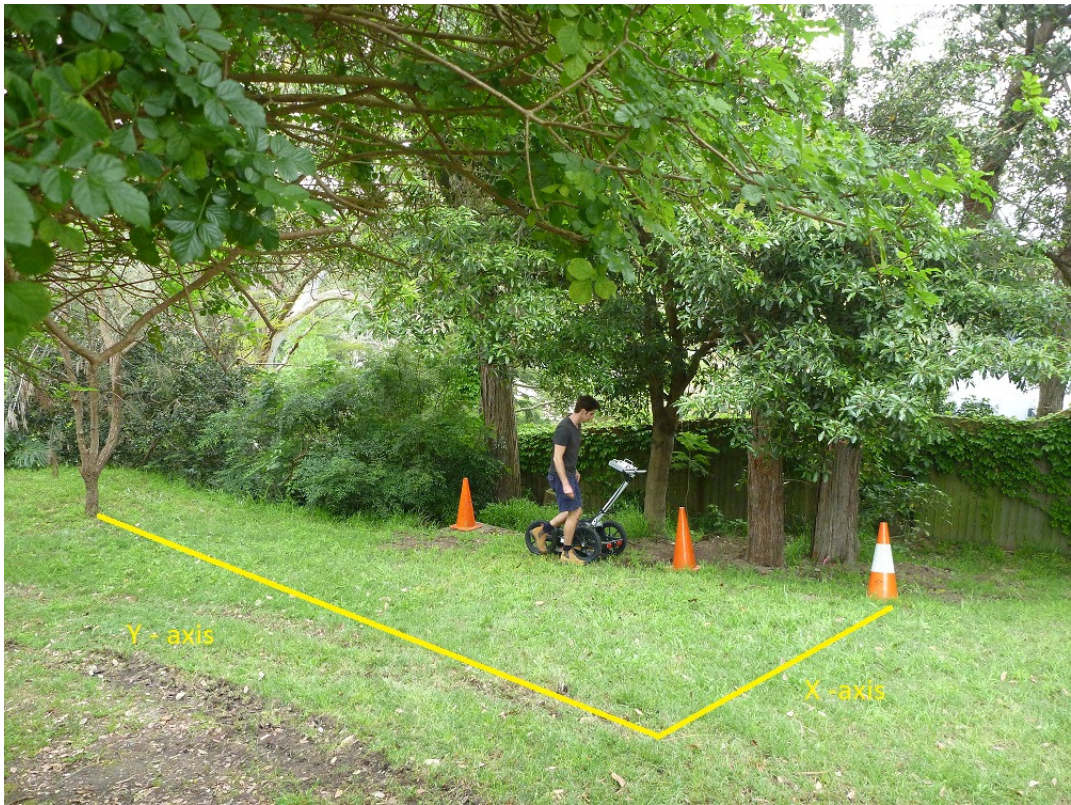
Picture 5 : Section 5

Section 5 returned negative results and unfortunately the creation of a graph was not possible.
