Advanced Treescape Consulting Arboriculturist & Horticulturist

573 – 585 Pacific Highway, Killara

JRPP (Sydney West Region) 13 October 2011 – 2010SYW099 Request for Additional Information on Tree 27 being Root Mapping and Advise on Methods of Driveway Construction for an Acceptable Impact on subject tree

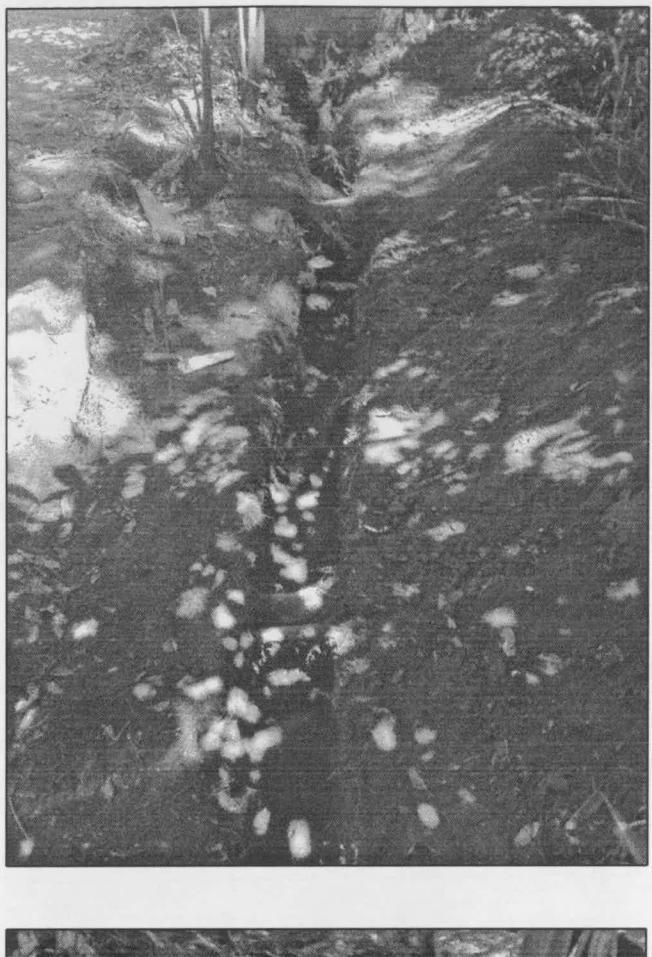
Figure 1 Showing root mapping trench

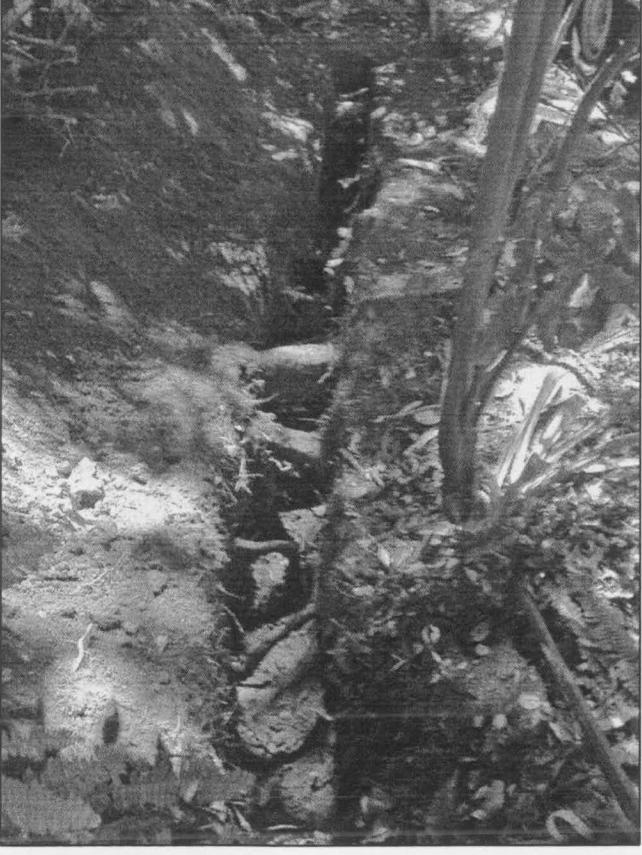
Figure 2 Another view of the root mapping trench

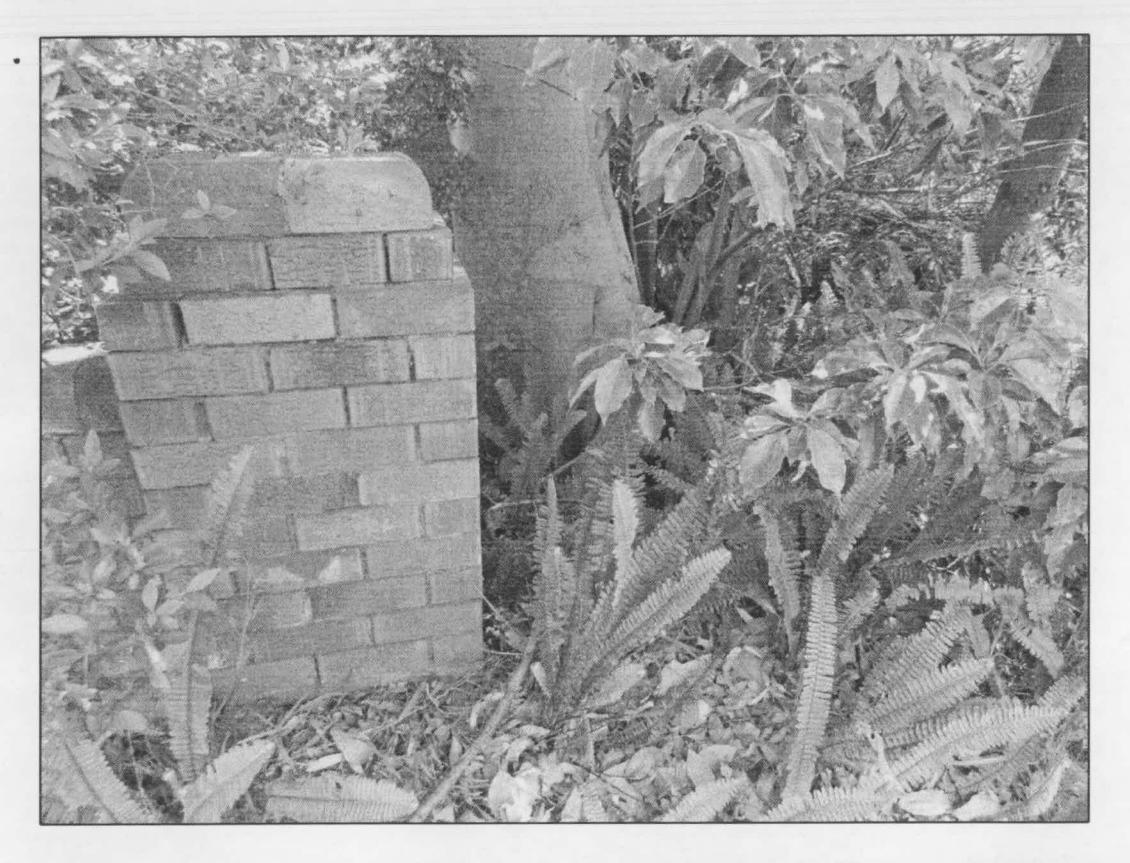
Figure 3 The front fence and trunk of Tree 27 to the north

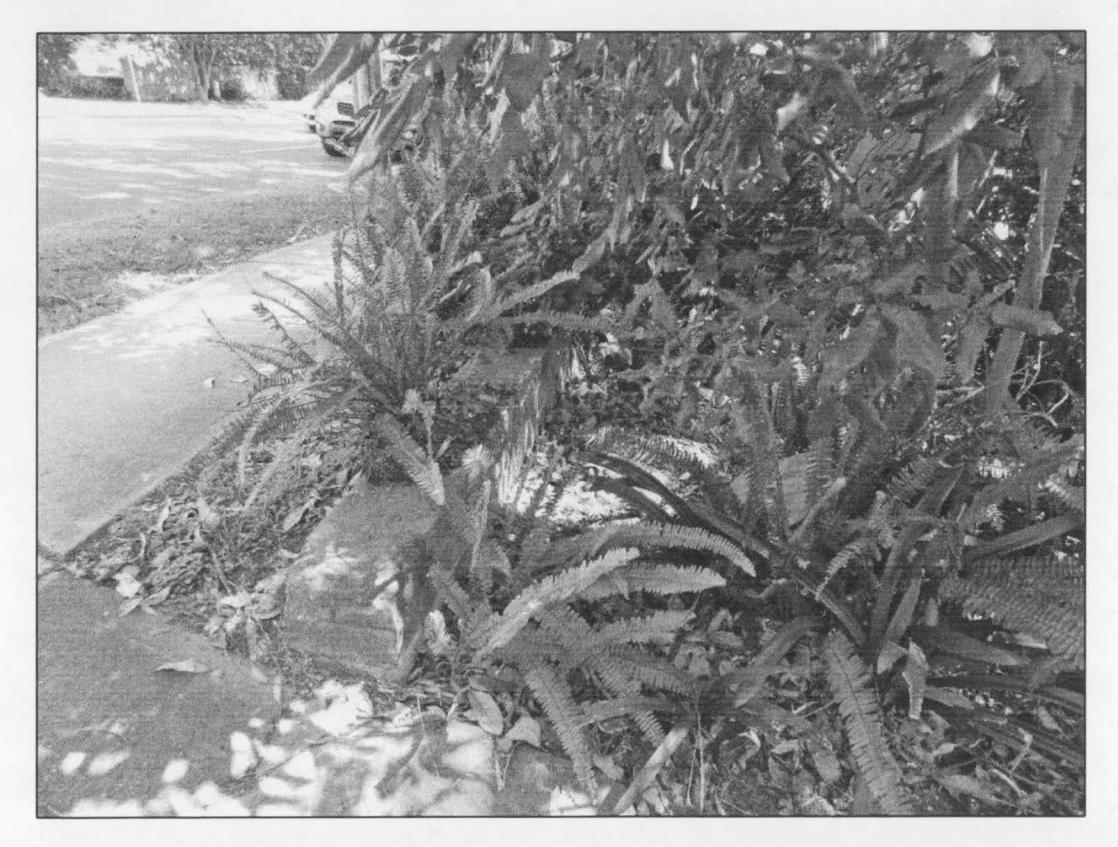
Figure 4 Showing the existing front fence. There are 5 rows of bricks to ground level inside fence and grass clippings

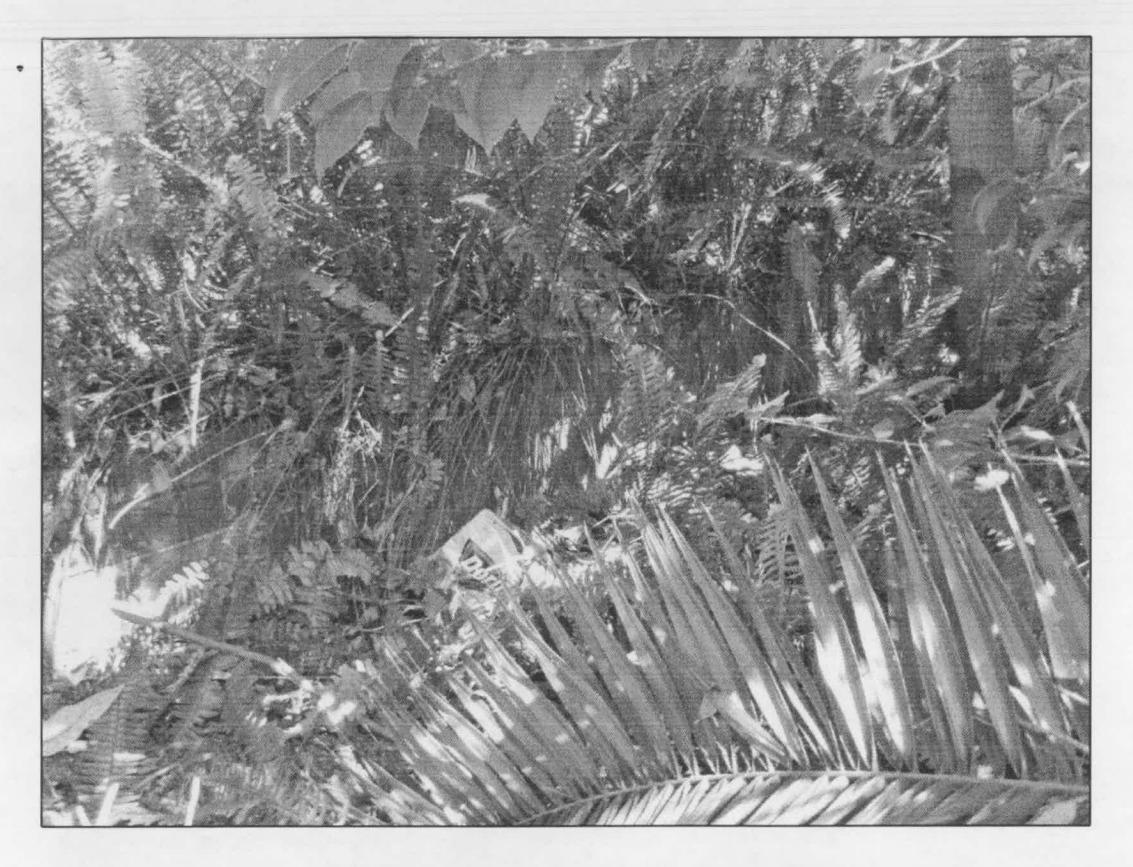
Figure 5 Another view 2 metres from the existing drive

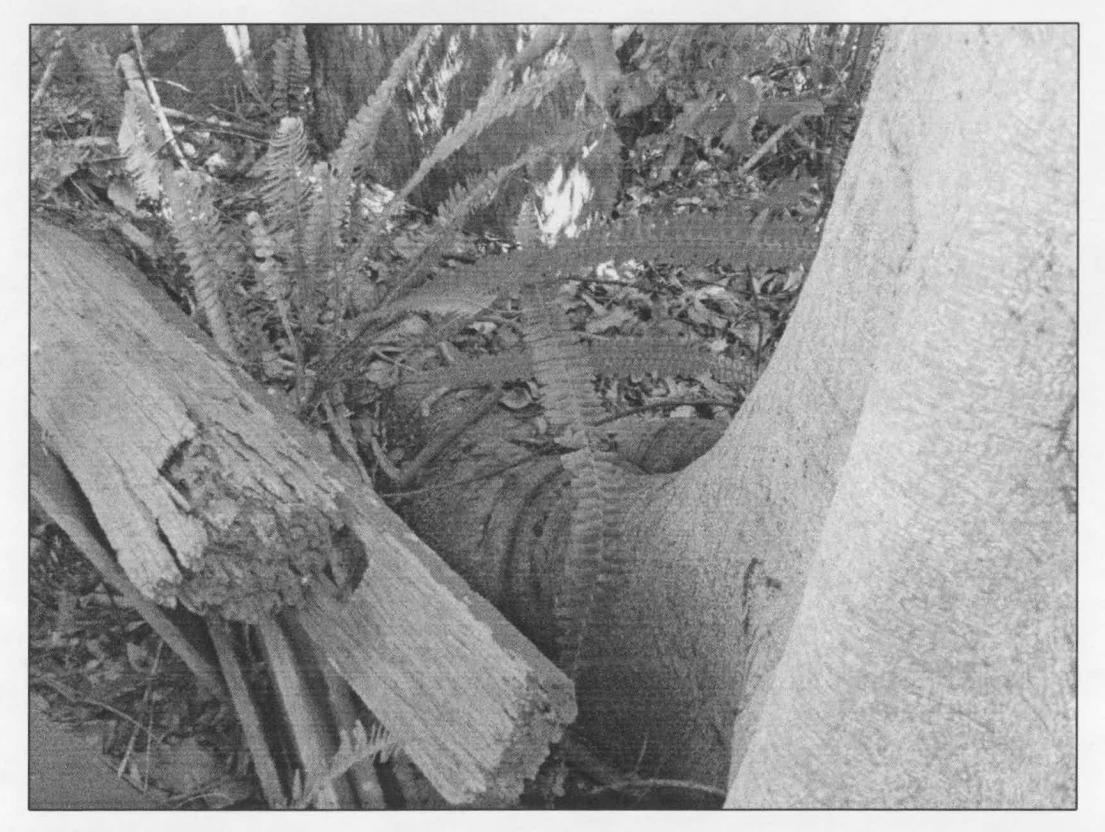
Figure 6 Root buttress of Tree 27 to south with existing fence in background

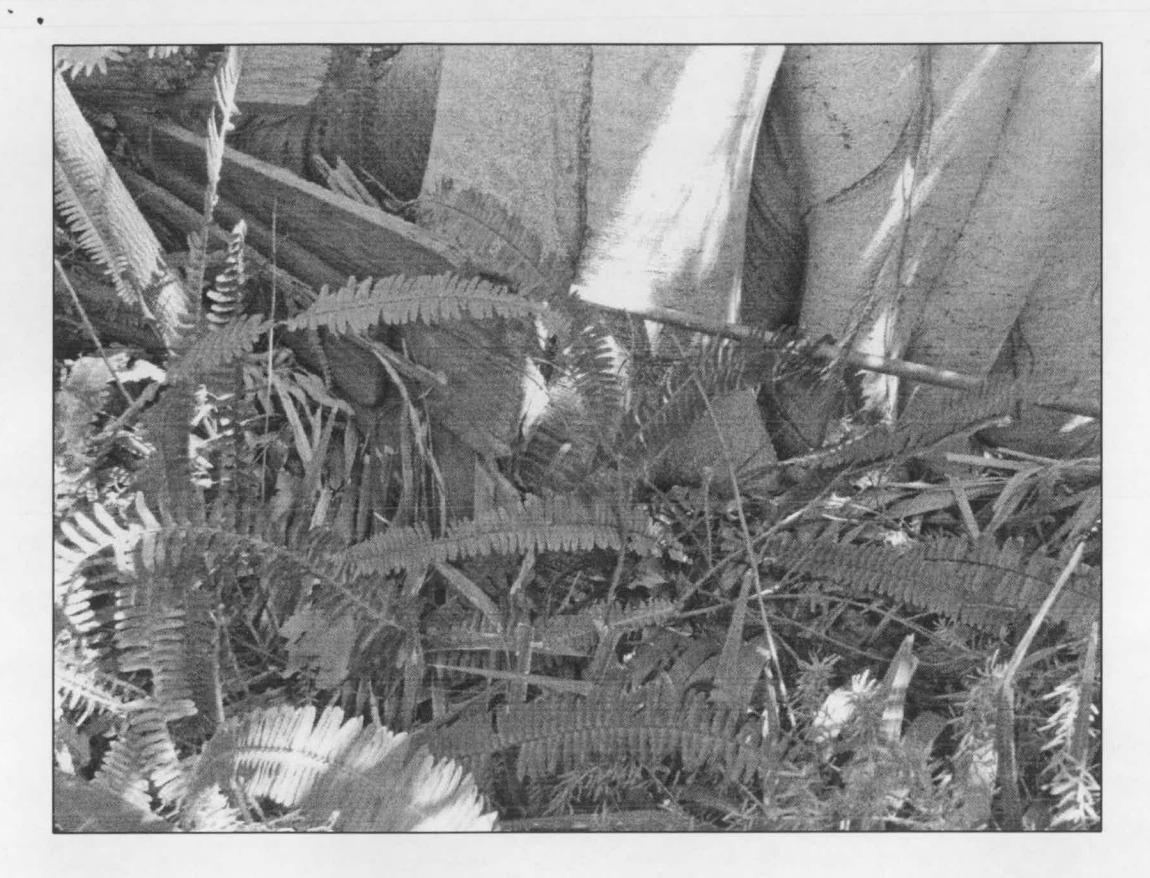
Figure 7 Showing root buttress of Tree 27 to the east, failed wooden fence in the foreground - only 1 root to the east which is supported by the root mapping

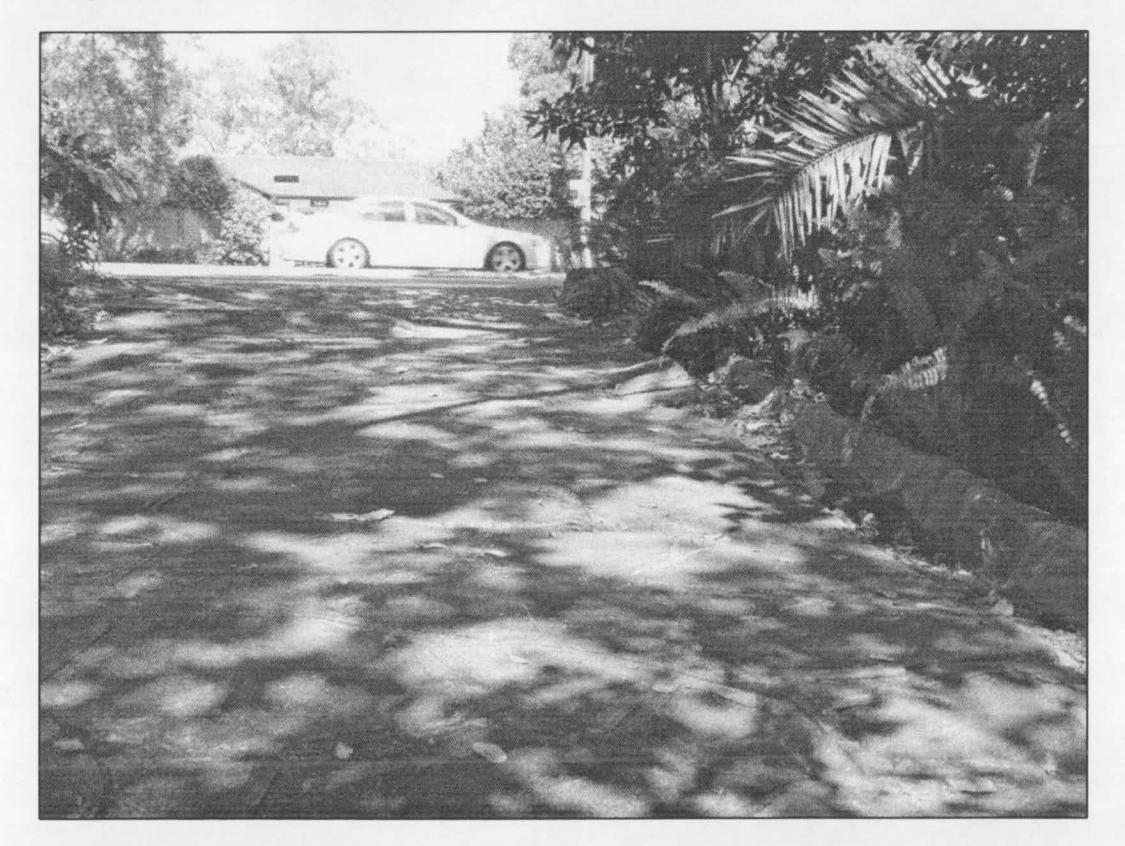
Figure 8 View of fall of existing drive. There is plenty of space for the concrete slab to bridge the root buttress

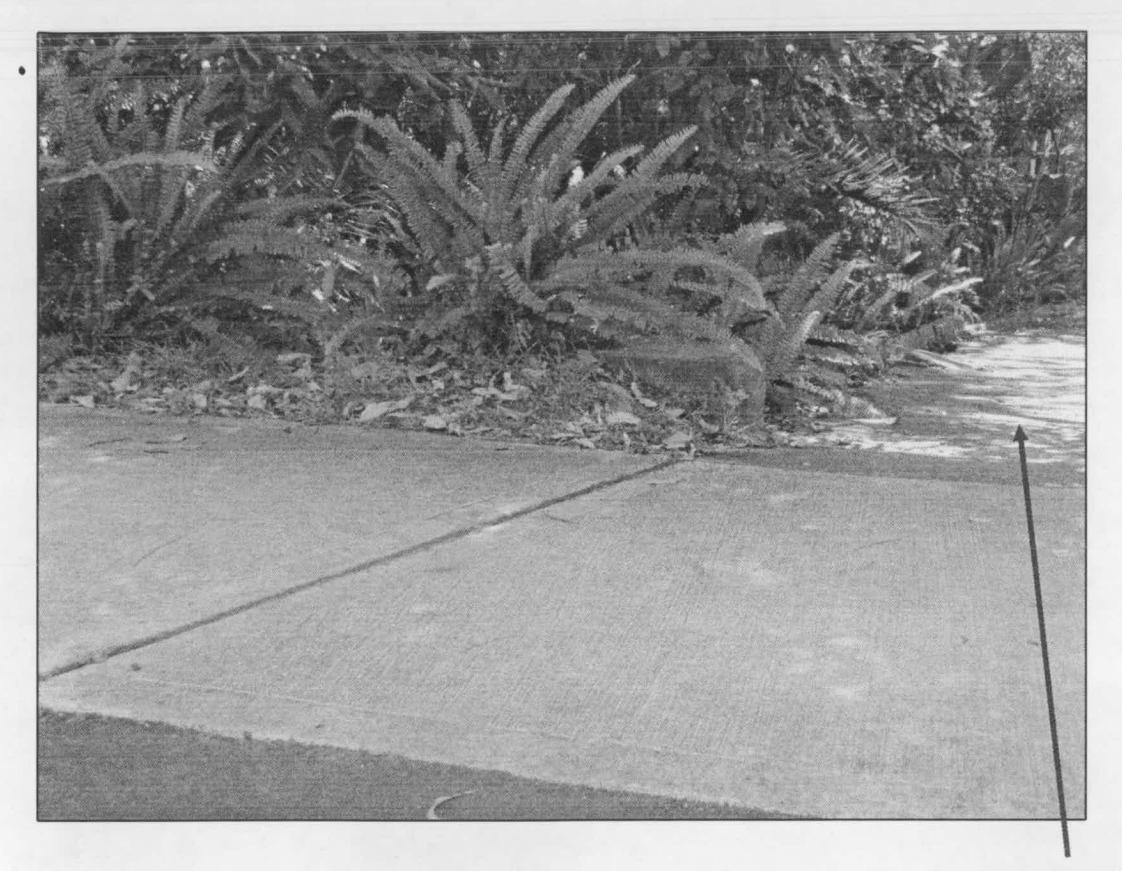
Figure 9 View from the road of footpath and crossover and then the existing drive dropping off to the north

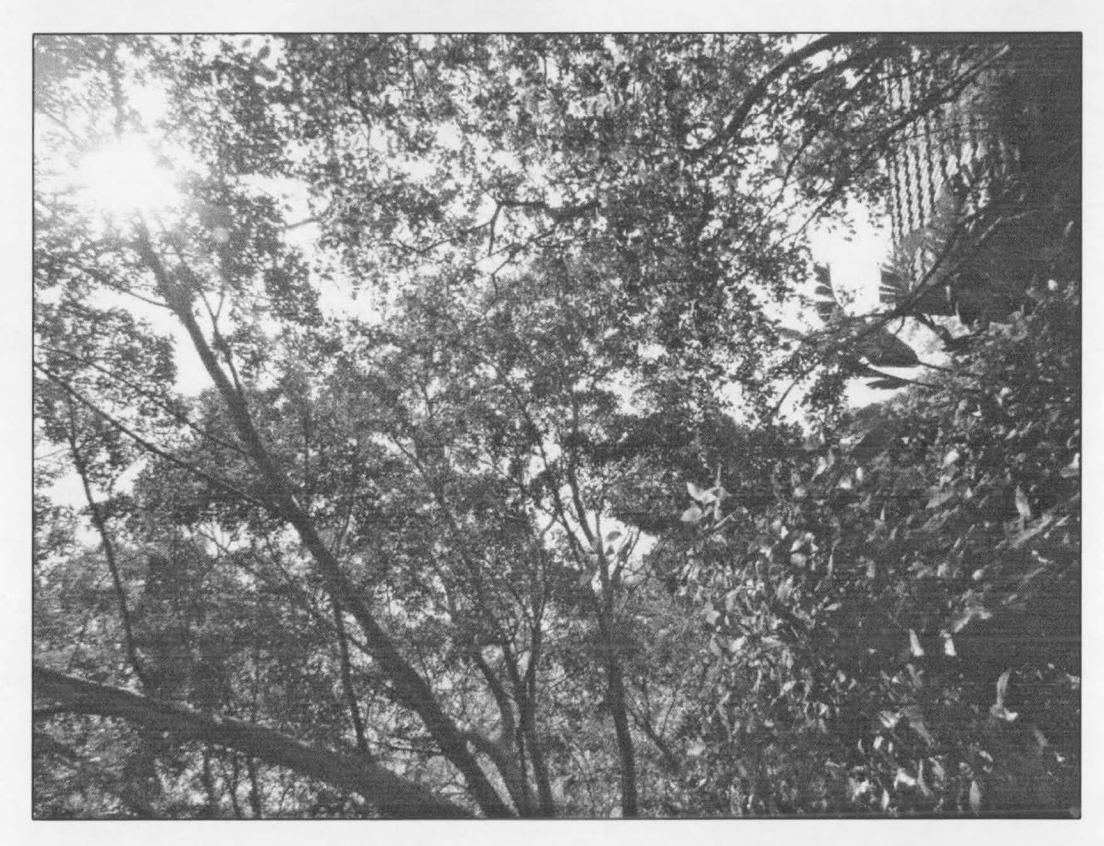
Figure 10 Shows crown/branches over existing residence. This may need to be trimmed for the new building - minor tip pruning

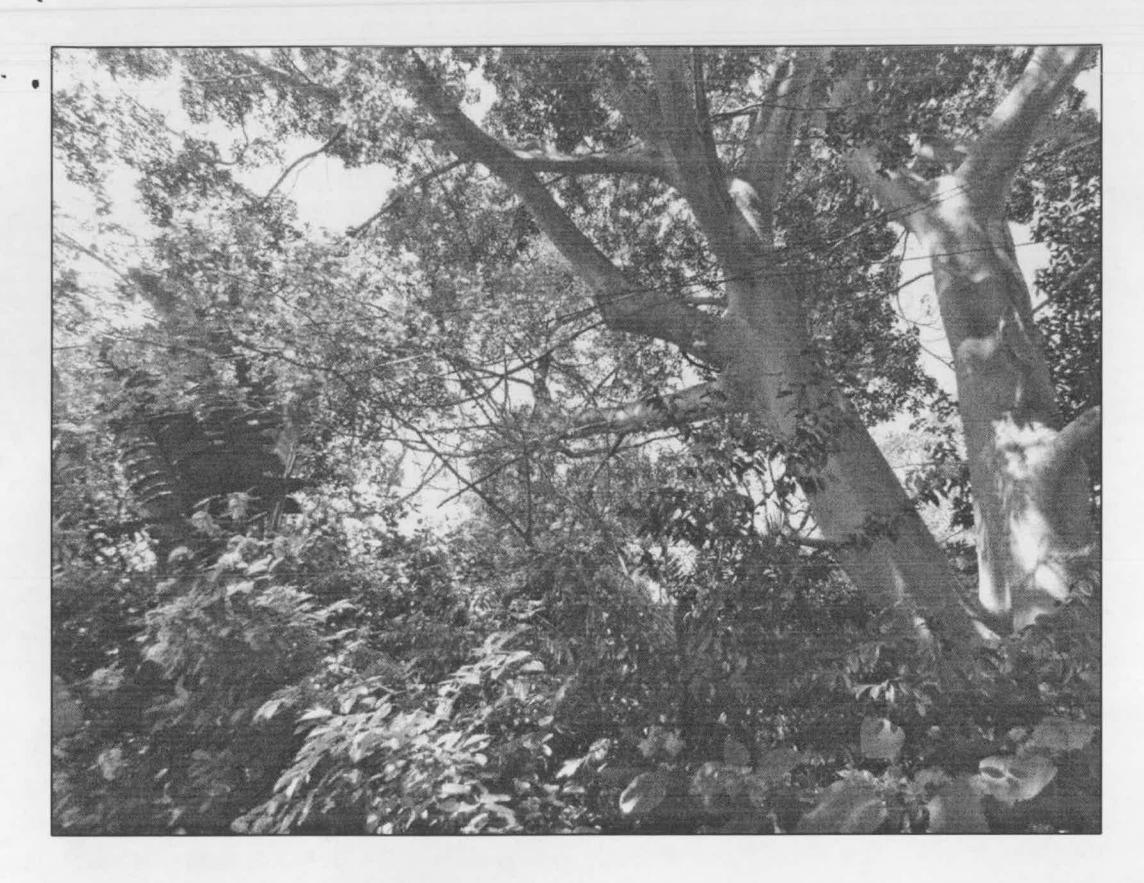
There is a series of digital images showing the main scaffold branch that runs to the north-east of the trunk of the tree. This does not actually pass directly over the driveway but it is clear to be seen that the scaffold branch is at least 6 metres from ground level. It would clearly not require any crown management for the proposed driveway. The only crown that will need to be managed will probably be 2 metres on the northern dripline of the tree as this would touch the proposed building. We must take 2 metres from the proposed edge of the building back to accommodate the scaffolding for the construction of the building. The removal of these branches will be able to be conducted in compliance with AS4373:2007 *Pruning of amenity trees* as the small branches extend for at least 3 metres from the main scaffold branch. There will be an acceptable impact on the tree and the branches will regenerate very quickly from the pruning. The amenity provided by this tree will not be impacted by these works as they cannot be seen from the roadway and the regrowth will completely cover any wounds on the branches caused by the canopy reduction. The impact on the tree is acceptable and considered to be minimal.

Figure 11 Showing northern scaffold branch of Tree 27 from front yard of 585 Pacific Highway
