## Windale Creek Restoration Plan

Prepared for  
**Masters**

October 24 2014

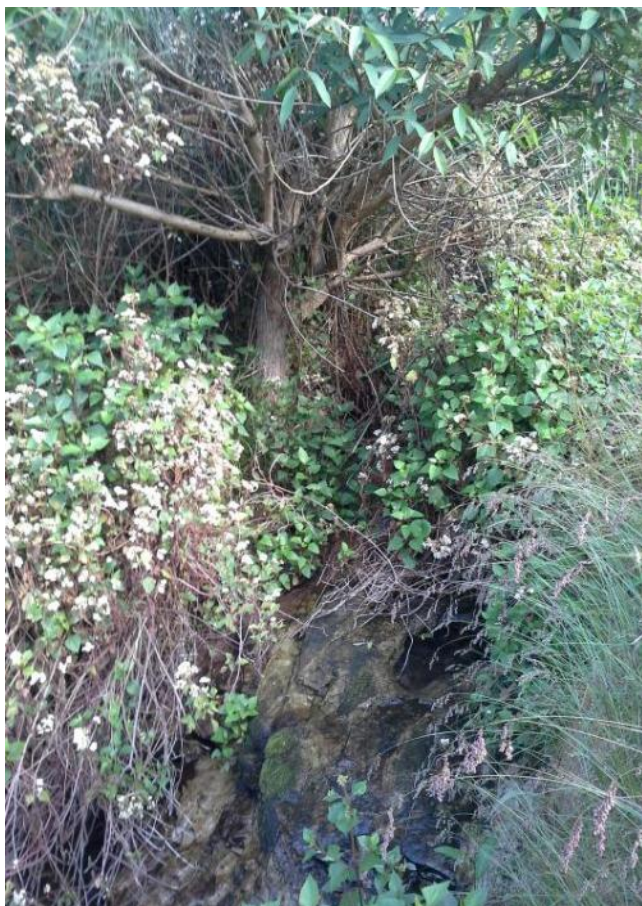
### Point 115

| Site Issue | Priority | Works needed |
|---|---|---|
| Erosion | H | <p>The section is moderately incised (~1.0 m) but appears quite stable due to the surrounding native vegetation, although where vegetation may be removed by weed control works some stabilisation such as jute matting or coir logs may need to be incorporated.</p> <p>Due to the location just upstream from the deeply eroded section (Point 113) it is recommended that the section require some woody debris to be implanted into and across the stream bed to help naturally reduce water flow and trap sediment. This in conjunction with other such methods further upstream in zone 1 to reduce flow rates will help stabilise the existing stream banks.</p> |
| Rubbish | L | Rubbish comprises scattered general litter only. |

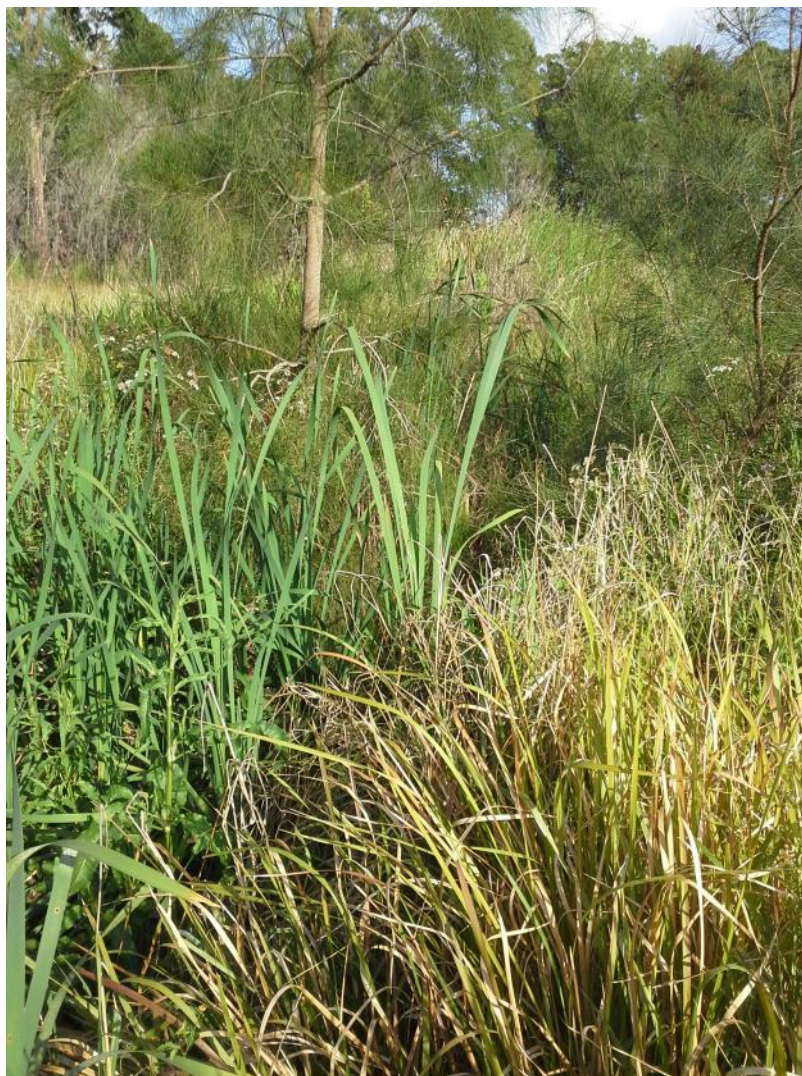
## Point 116

| Site Issue | Priority | Works needed |
|---|---|---|
| Erosion | M | As for adjacent areas the section is moderately incised (~1.0 m) but appears quite stable due to the surrounding native vegetation, although where vegetation may be removed by weed control works some stabilisation such as jute matting or coir logs may need to be incorporated. |
| Rubbish | L | No rubbish observed. |

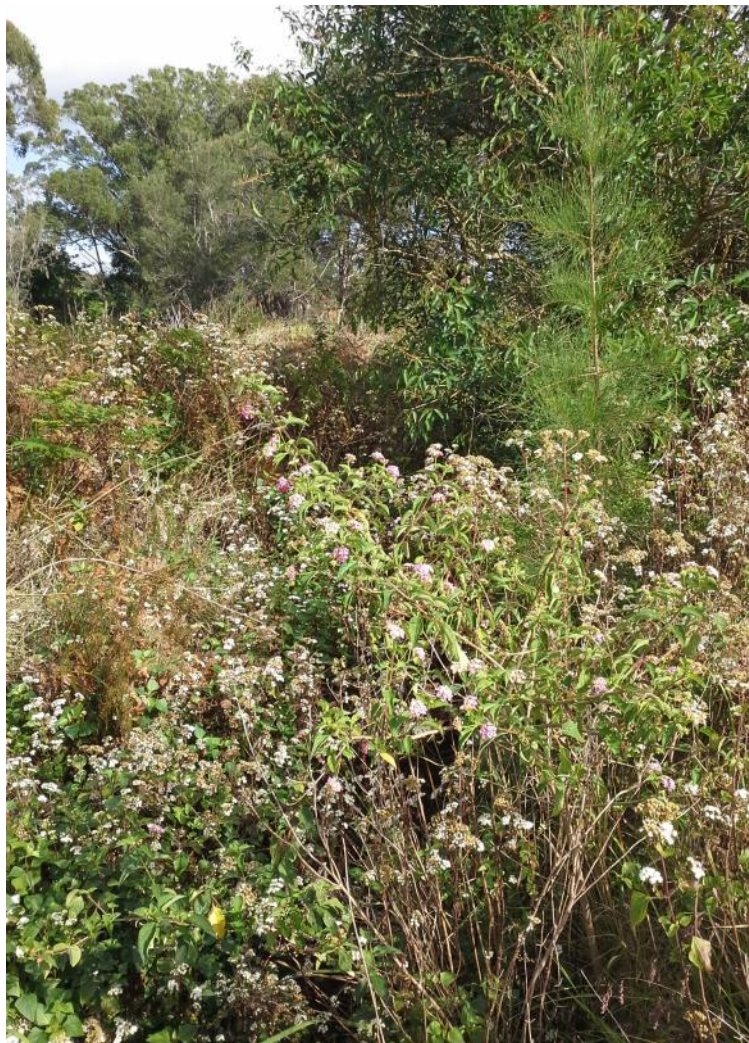
## Point 117

| Site Issue | Priority | Works needed |
|---|---|---|
| Erosion | H | The section is moderately incised (~1.0 m) but appears quite stable due to the surrounding native vegetation, although where vegetation may be removed by weed control works some stabilisation such as jute matting or coir logs may need to be incorporated. |
| Rubbish | L | Rubbish comprises scattered general litter only. |

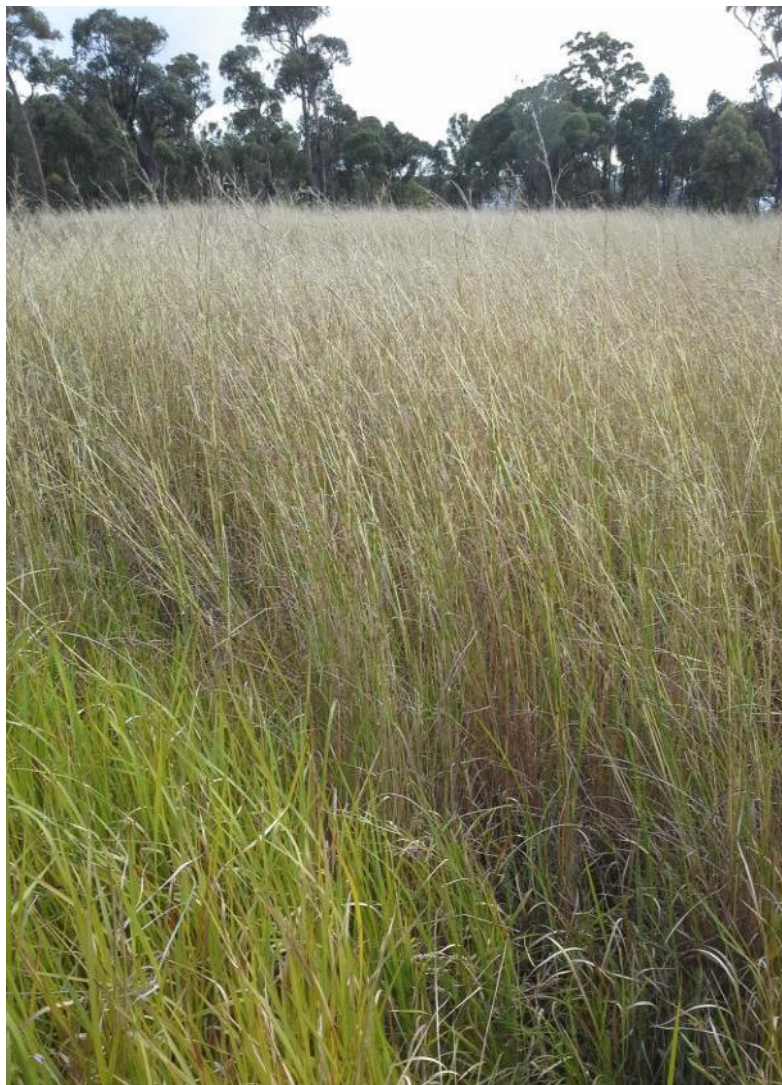
## Point 118 – dense introduced grassland area adjacent to creek

| Site Issue | Priority | Works needed |
|---|---|---|
| Erosion | L | This area is located adjacent to the creek and contains a large proportion of introduced grass species. No erosion issues. |
| Rubbish | L | Rubbish comprises scattered general litter only. |

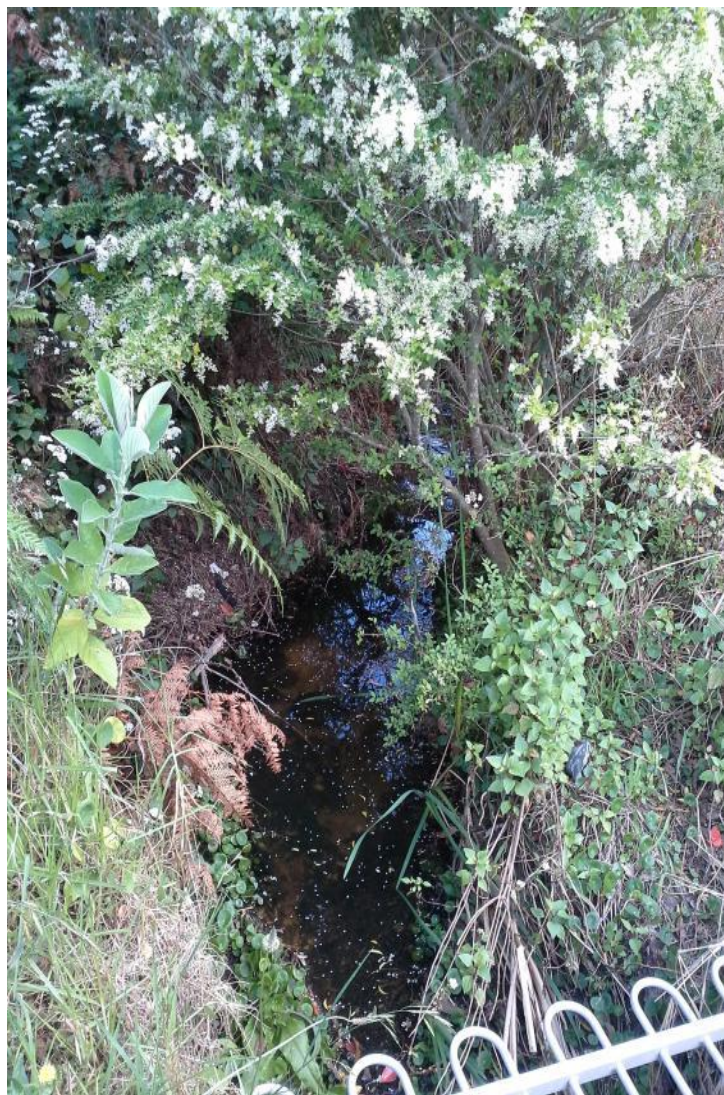
## Point 119 (creek crossing site)

| Site Issue | Priority | Works needed |
|---|---|---|
| Erosion | H | <p>As for adjacent areas the section is moderately incised (~1.0 m), but appears quite stable due to the surrounding native vegetation, although where vegetation may be removed by weed control works some stabilisation such as jute matting or coir logs may need to be incorporated.</p> <p>This location would also be a potential area for the installation of in stream flow controls to reduce the impacts further downstream. This section may require some woody debris or rocky structures (e.g. rock armour) to be implanted into and across the stream bed to help naturally reduce water flow and trap sediment. This in conjunction with other such methods further upstream to reduce flow rates will help stabilise the existing stream banks.</p> |
| Rubbish | L | <p>Rubbish comprises scattered general litter, as well as building waste (fencing) as this is currently an existing makeshift bridge / creek crossing.</p> |

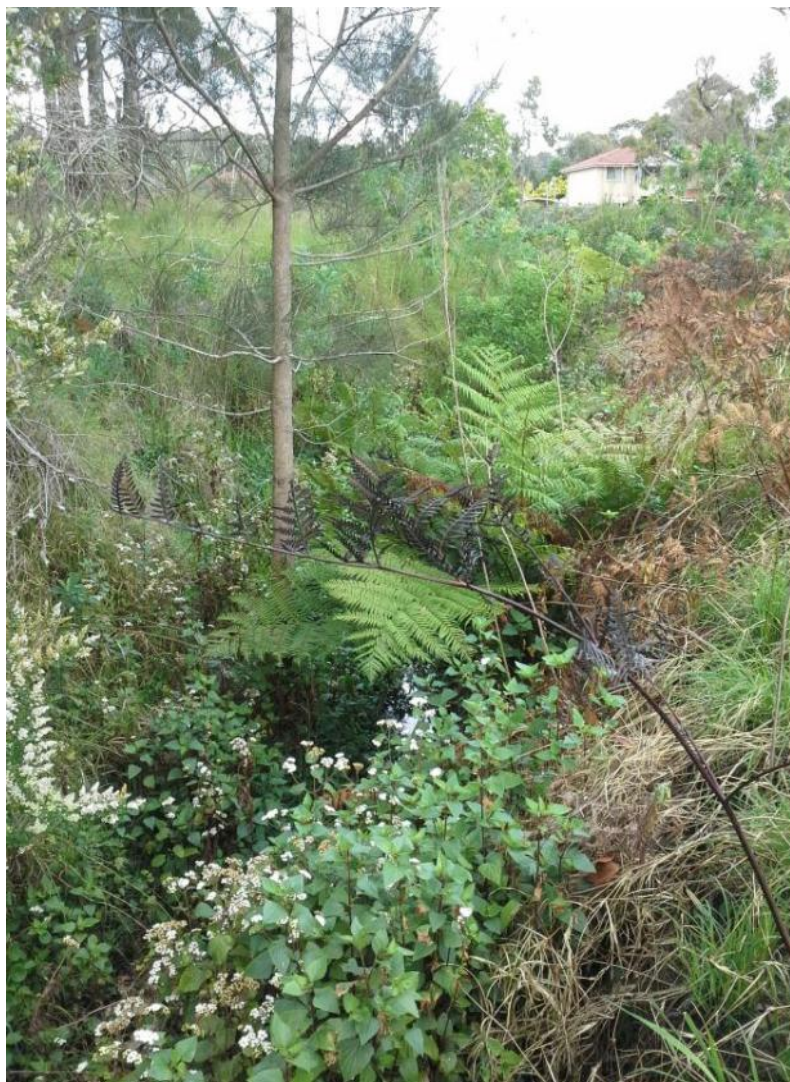
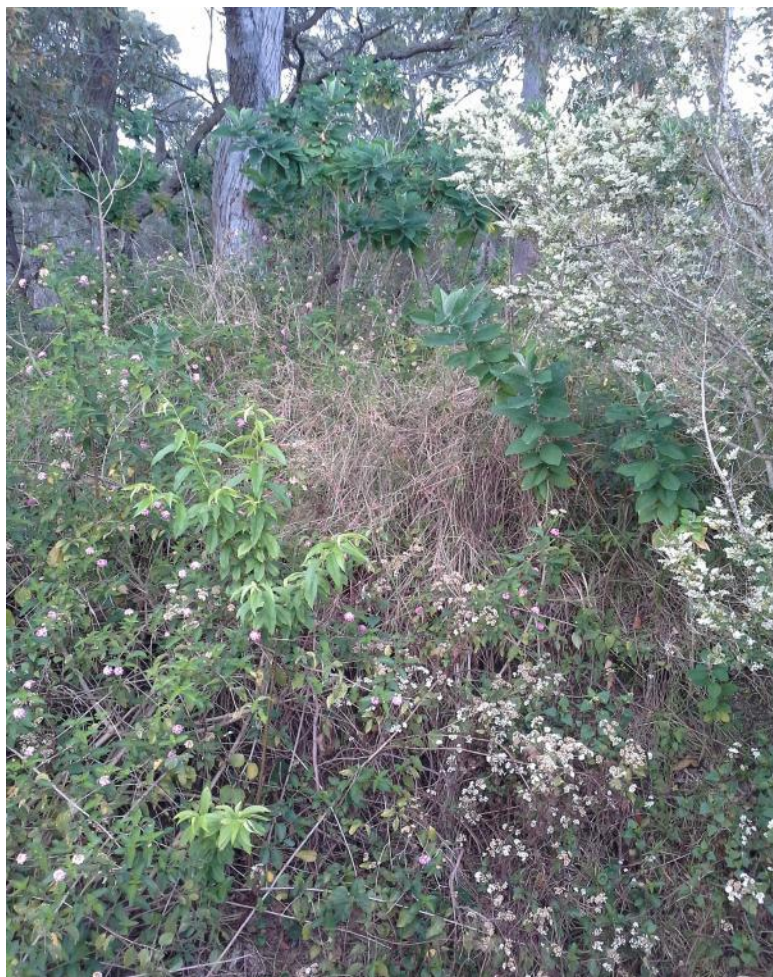
## Point 120

| Site Issue | Priority | Works needed |
|---|---|---|
| Erosion | H | <p>This area is moderately incised to a depth of ~1.5 m with banks that appear to contain less compact sediments (possibly dumped on the top of the southern bank of the watercourse during a past sediment removal practice, likely undertaken by machinery). As a result this section will require the installation of erosion controls, such as jute matting and / or coir logs, for stabilisation purposes along the upper banks once the primarily weed dominated adjacent vegetation is removed.</p> <p>Due to previous disturbances at this location, it would also be a potential area for the installation of in stream flow controls to reduce the impacts further downstream. This section may require some woody debris or rocky structures (e.g. rock armour) to be implanted into and across the stream bed to help naturally reduce water flow and trap sediment. This in conjunction with other such devices further upstream to reduce flow rates will help stabilise the existing stream.</p> |
| Weed control | M | <p>The area has dense infestations of weed species on both creek banks and in surrounding areas that will require removal and control. Clear removal of existing weed dominated vegetation, installation of weed matting and planting is recommended for a large proportion this location. Main dominant weed species at this location include: Small-leaf Privet, Lantana, Crofton Weed and <i>Crotalaria lunata</i>. Other common weedy species are primarily herbaceous and grass species including Guinea Grass, Cobblers Pegs, Purple Top and Fleabane. Spraying weed dominated grassy areas (away from the stream) with herbicide will likely be necessary.</p> |
| Revegetation | M-H | <p>Moderate to extensive planting of suitable native species after weed control, should be carried out to help in stabilisation of the upper bank and adjacent areas where Privet and <i>Crotalaria</i> have been removed</p> |

| | | as well as areas covered in dense grassy and herbaceous weeds. Suitable species would include: <i>Lomandra longifolia</i> , <i>Themeda australis</i> , <i>Pratia purpurescens</i> , <i>Cymbopogon refractus</i> , <i>Carex appressa</i> , <i>Gahnia clarkei</i> , <i>Dianella caerulea</i> , <i>Ficus coronata</i> , <i>Melaleuca styphelioides</i> , <i>Melaleuca lineariifolia</i> and <i>Glochidion ferdinandi</i> . In adjacent areas <i>Corymbia maculata</i> , <i>Eucalyptus siderophloia</i> , as well as <i>Angophora costata</i> , <i>Angophora floribunda</i> and <i>Eucalyptus piperita</i> . Additional species for revegetation are present in Schedule 1. |
| Rubbish | L | Rubbish comprises scattered general litter only. |

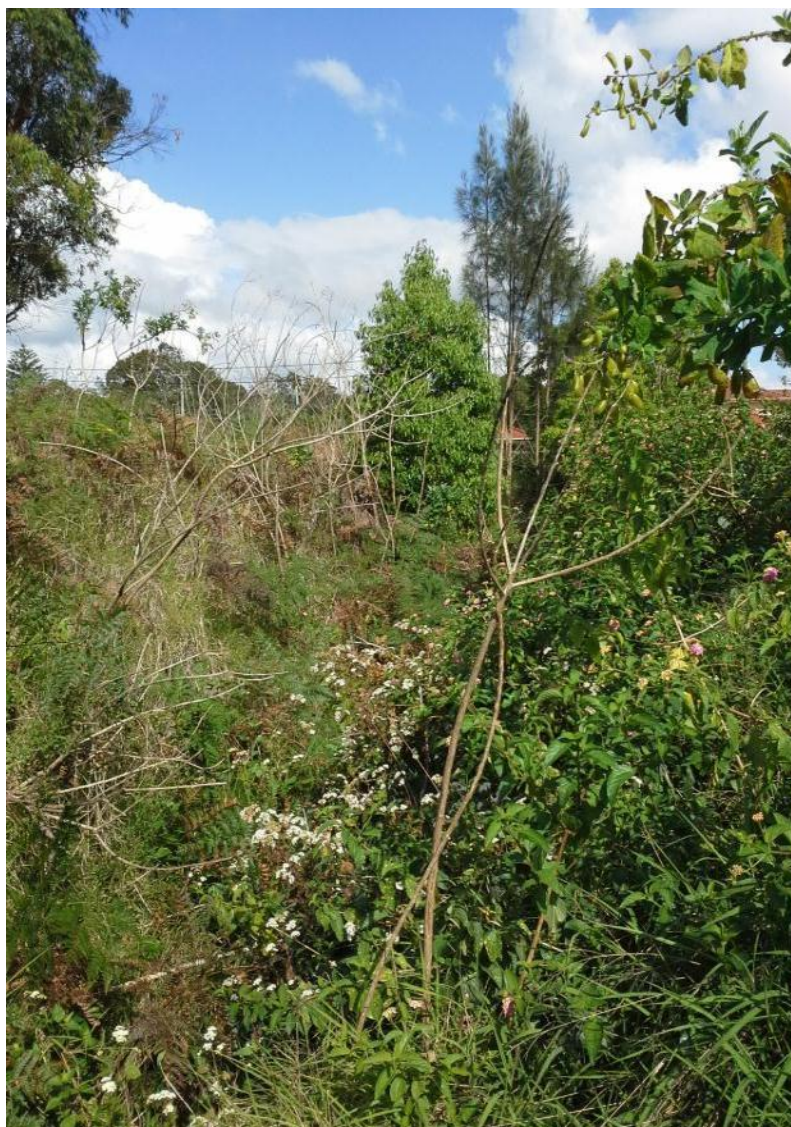
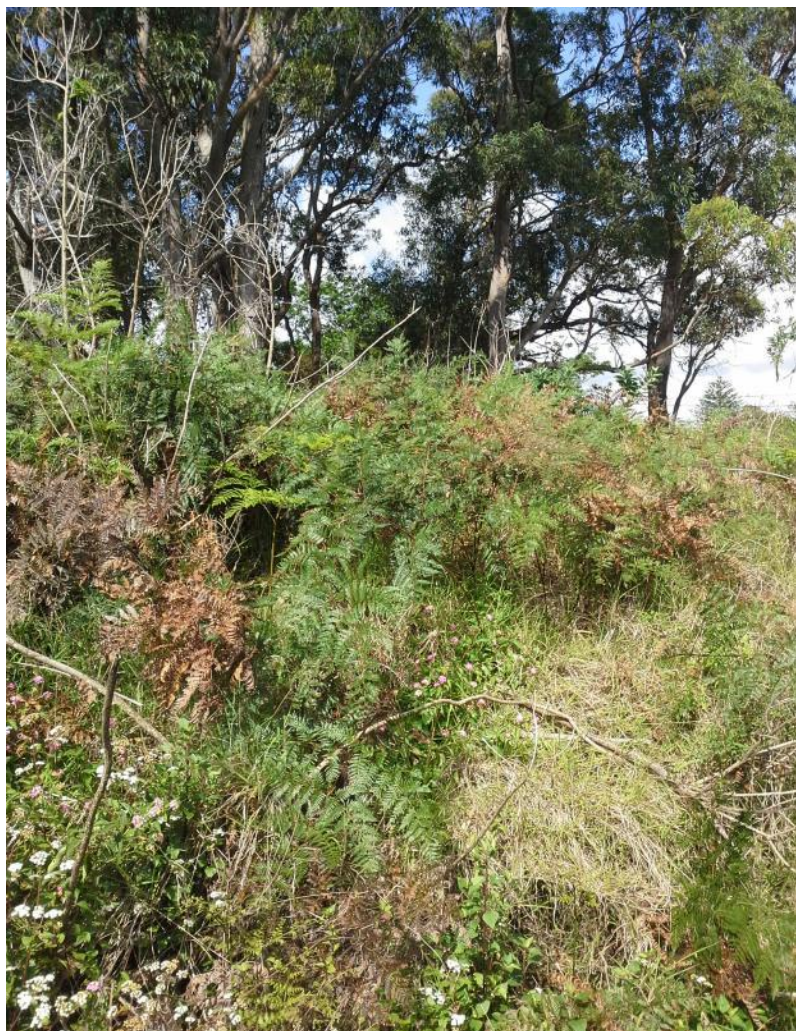
## Point 121

This section is similar in most respects to Point 120

| Site Issue | Priority | Works needed |
|---|---|---|
| Erosion | H | <p>This area is moderately incised to a depth of ~1.2 m with banks that appear to contain less compact sediments (possibly dumped on the top of the southern bank of the watercourse during a past sediment removal practice, likely undertaken by machinery). As a result this section will require the installation of erosion controls, such as jute matting and / or coir logs, for stabilisation purposes along the upper banks once the primarily weed dominated vegetation is removed.</p> <p>Due to previous disturbances at this location, it would also be a potential area for the installation of in stream flow controls in conjunction with the works at Point 120 to reduce erosion impacts further downstream. This section may require some woody debris or rocky structures (e.g. rock armour, gabions, etc.) to be implanted into and across the stream bed to help naturally reduce water flow and trap sediment. This in conjunction with other such devices further upstream to reduce flow rates will help stabilise the existing stream and improved areas.</p> |
| Weed control | M | <p>The area has dense infestations of weed species on both creek banks and in surrounding areas that will require removal and control. The process would involve detailed removal of existing weed dominated vegetation; installation of weed matting; planting is recommended for a large proportion this location. Dominant weed species at this location include: Camphor Laurel, Small-leaf Privet, Lantana, Crofton Weed and <i>Crotalaria lunata</i>. Other common weedy species are primarily herbaceous and grass species including Guinea Grass, Cobblers Pegs, Purple Top and Fleabane. Spraying weed dominated grassy areas (away from the stream) with herbicide will likely be necessary.</p> |

| Revegetation | M-H | Moderate to extensive planting of suitable native species after weed control, should be carried out to help in stabilisation of the upper bank and adjacent areas where Privet and Crotalaria have been removed, as well as areas covered in dense grassy and herbaceous weeds. Suitable species would include: <i>Lomandra longifolia</i> , <i>Themeda australis</i> , <i>Pratia purpurescens</i> , <i>Cymbopogon refractus</i> , <i>Carex appressa</i> , <i>Gahnia clarkei</i> , <i>Dianella caerulea</i> , <i>Ficus coronata</i> , <i>Melaleuca styphelioides</i> , <i>Melaleuca lineariifolia</i> and <i>Glochidion ferdinandi</i> . In adjacent areas <i>Corymbia maculata</i> , <i>Eucalyptus siderophloia</i> , as well as <i>Angophora costata</i> , <i>Angophora floribunda</i> and <i>Eucalyptus piperita</i> . Additional species for revegetation are present in Schedule 1. |
| Rubbish | L | Rubbish comprises scattered general litter only. |

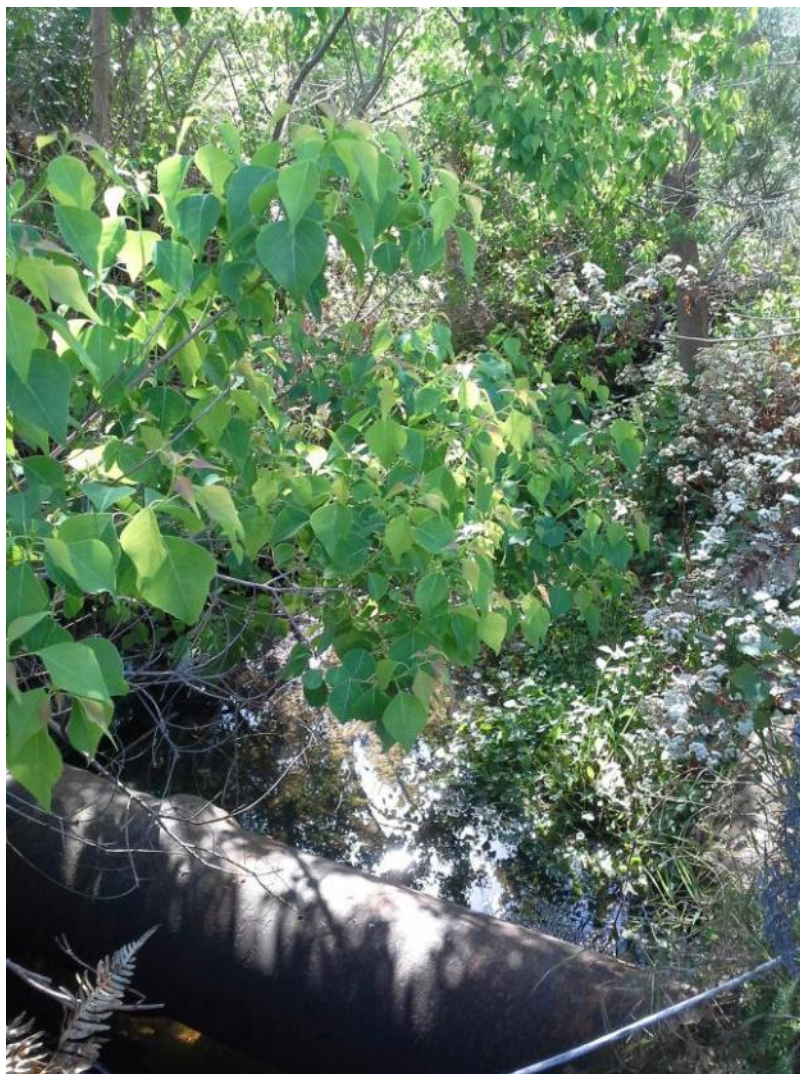
## Point 122 – Stormwater entry

| Site issue | Priority | Works needed |
|---|---|---|
| Erosion | H | <p>This area contains the piped stormwater feed for the creek which crosses South Street from the west. The section contains a concrete sill below the pipe, beyond the concrete sill there is little by way of water flow reduction structures. This stormwater entry area would be an ideal location to commence the creek water flow reduction by the installation of dissipaters and / or a retention basin.</p> <p>In addition to the water flow controls this section will require the installation of bank erosion controls, such as jute matting and / or coir logs, for stabilisation purposes along the upper banks once the primarily weed dominated adjacent vegetation is removed.</p> |
| Weed control | M | <p>The area has dense infestations of weed species on both creek banks and in surrounding areas that will require removal and control. The process would involve detailed removal of existing weed dominated vegetation; installation of weed matting; planting is recommended for a large proportion this location. Main dominant weed species at this location include: Chinese Tallow, Lantana, Crofton Weed and <i>Crotalaria lunata</i>. Other common weedy species are primarily herbaceous and grass species including Guinea Grass, Cobblers Pegs, Purple Top and Fleabane. Spraying weed dominated grassy areas (away from the stream) with herbicide will likely be necessary.</p> |

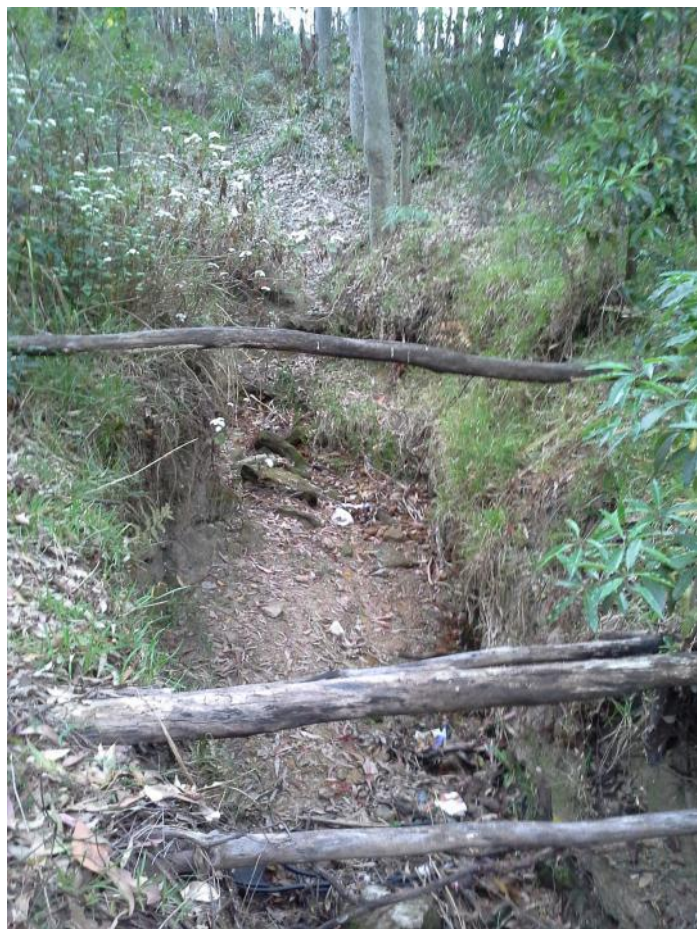
### Point 109

| Site Issue | Priority | Works needed |
|---|---|---|
| Erosion | H | <p>The section is deeply incised (~1.5 m) but appears quite stable due to the surrounding native vegetation, in particular the trees <i>Corymbia maculata</i> (Spotted Gum). The lower bank and stream bed are considered stable due to the presence of sandstone bedrock.</p> <p>This section may require some woody debris to be implanted into and across the stream bed to help naturally reduce water flow and trap sediment. This in conjunction with other such methods further upstream to reduce flow rates will help stabilise the existing stream banks.</p> |
| Rubbish | L | <p>Rubbish comprises scattered general litter only.</p> |

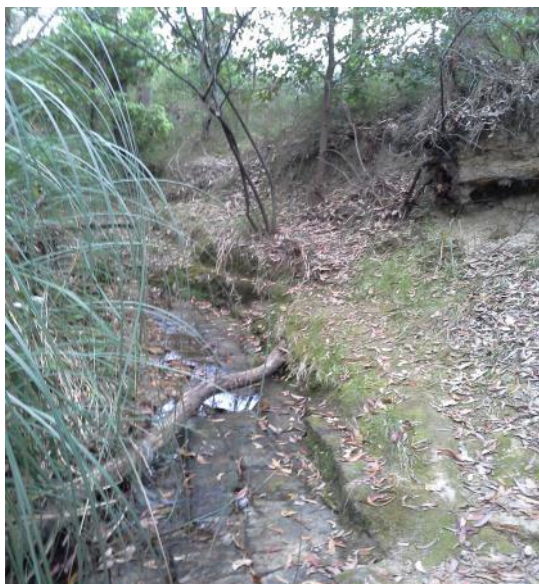
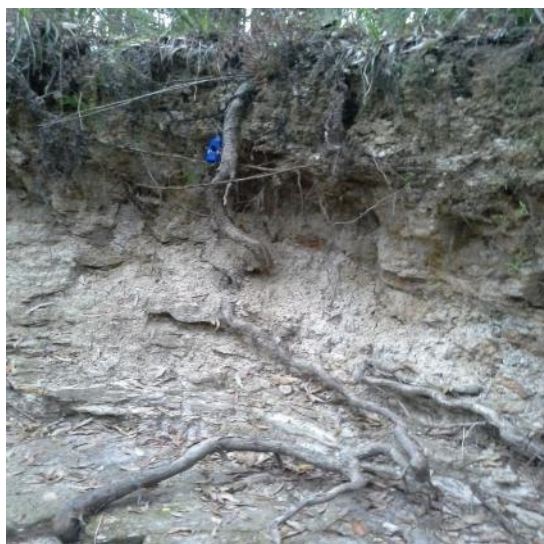
## Point 110

| Site Issue | Priority | Works needed |
|---|---|---|
| Erosion | H | <p>The section is located on a bend and is deeply eroded and incised (~1.5 to 1.8 m) via bank scour. The internal bend appears to be stable although the external bend is quite unstable with obvious recent erosion of siltstone material and exposed tree roots. This area is likely to erode further without works at this location. The adjacent native vegetation is relatively intact and keeping these areas stable. The extreme lower bank and stream bed are considered stable due to the presence of sandstone bedrock.</p> <p>This section may require some woody debris or rocky structures (e.g. rock armour) to be implanted into and across the stream bed to help naturally reduce water flow and trap sediment. This in conjunction with other such methods further upstream to reduce flow rates will help stabilise the existing stream banks.</p> |
| Rubbish | L | Rubbish comprises scattered general litter only. |

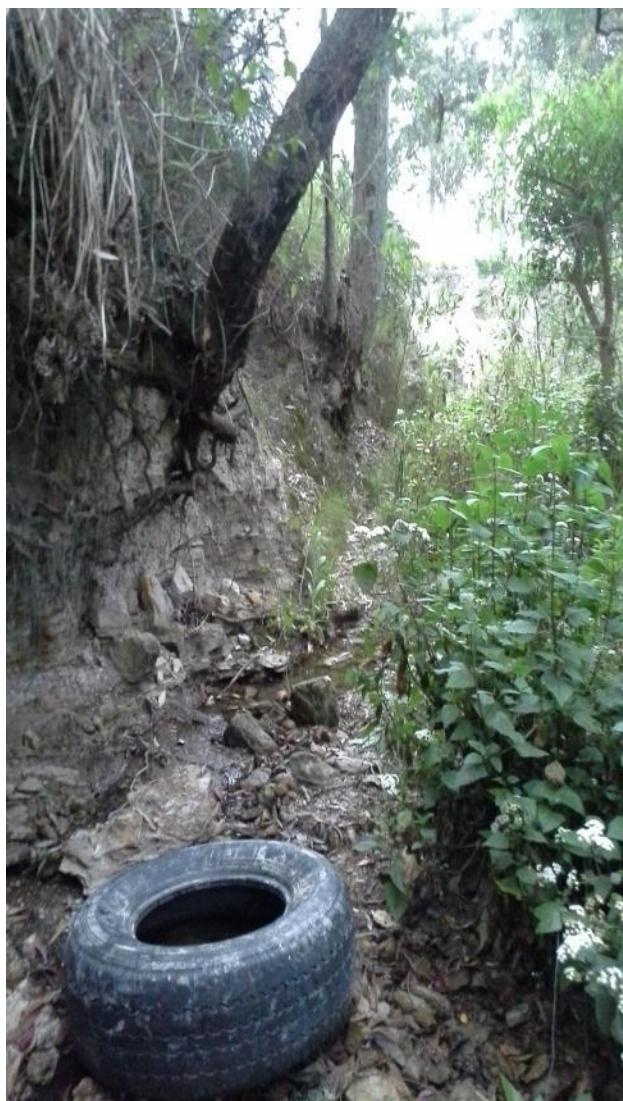
## Point 111

| Site Issue | Priority | Works needed |
|---|---|---|
| Erosion | H | <p>The section is located on a bend and is severely eroded and undercut up to 2.5 m via bank scour. Both the internal and external bend appear to be unstable with obvious recent erosion of siltstone material and exposed tree roots. This area is likely to erode further without works at this location. The adjacent native vegetation is relatively intact and keeping these areas stable. The extreme lower bank and stream bed are considered stable due to the presence of larger rocky material and sandstone bedrock.</p> <p>This section may require some woody debris or rocky structures (e.g. rock armour) to be implanted into and across the stream bed to help naturally reduce water flow and trap sediment. This in conjunction with other such methods further upstream to reduce flow rates will help stabilise the existing stream banks.</p> |
| Rubbish | L | Rubbish comprises primarily scattered general litter only and a few bulky items (e.g. vehicle tyres) |

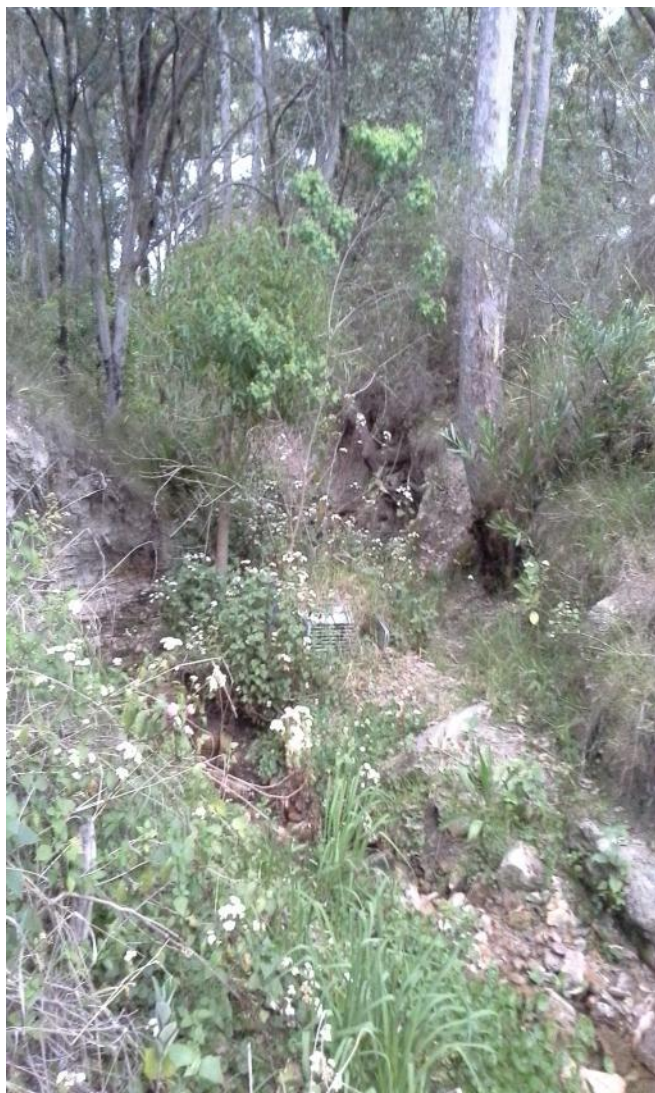
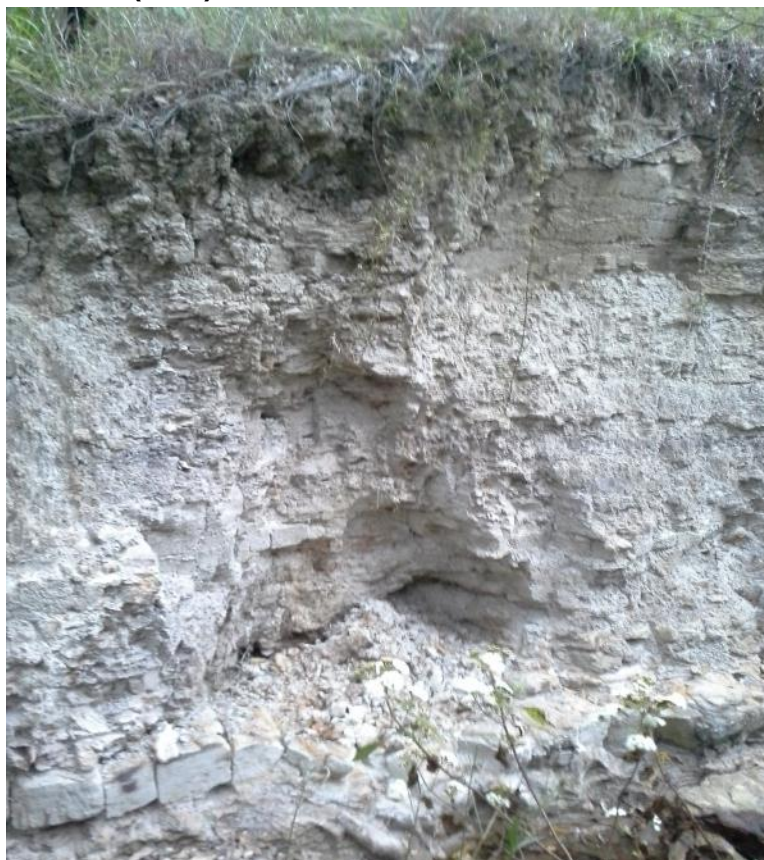
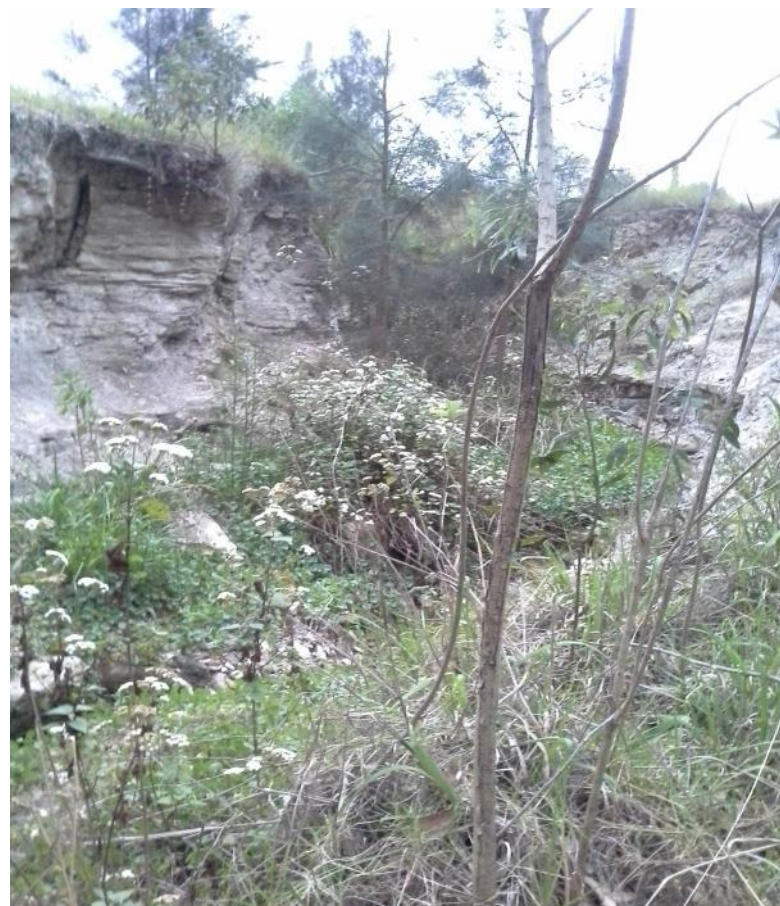
## Point 112

| Site Issue | Priority | Works needed |
|---|---|---|
| Erosion | H | <p>The section is located on a bend and is severely eroded and undercut up to 3 m via bank scour and evidence of some slumping. Both the internal and external bend appear to be unstable with obvious recent erosion of siltstone material and exposed tree roots. This area is likely to erode further without works at this location. The adjacent native vegetation is relatively intact and keeping these areas stable. The extreme lower bank and stream bed are considered stable due to the presence of larger rocky material and sandstone bedrock.</p> <p>This section will require some woody debris or rocky structures (e.g. rock armour) to be implanted into and across the stream bed to help naturally reduce water flow and trap sediment. This in conjunction with other such methods further upstream to reduce flow rates will help stabilise the existing stream banks.</p> <p>Bank stabilisation may also require the use of jute or other erosion control matting as well as installation of coir logs or similar.</p> |

| Rubbish | L | Rubbish comprises primarily scattered general litter only and a few bulky items (e.g. shopping trolley, vehicle tyres) |

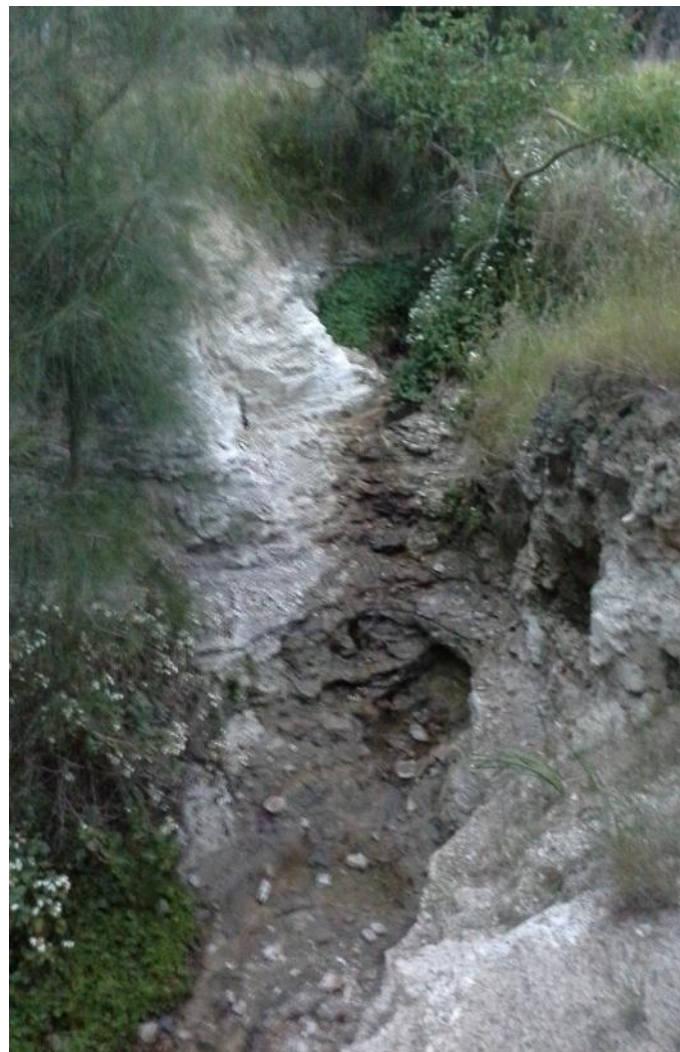
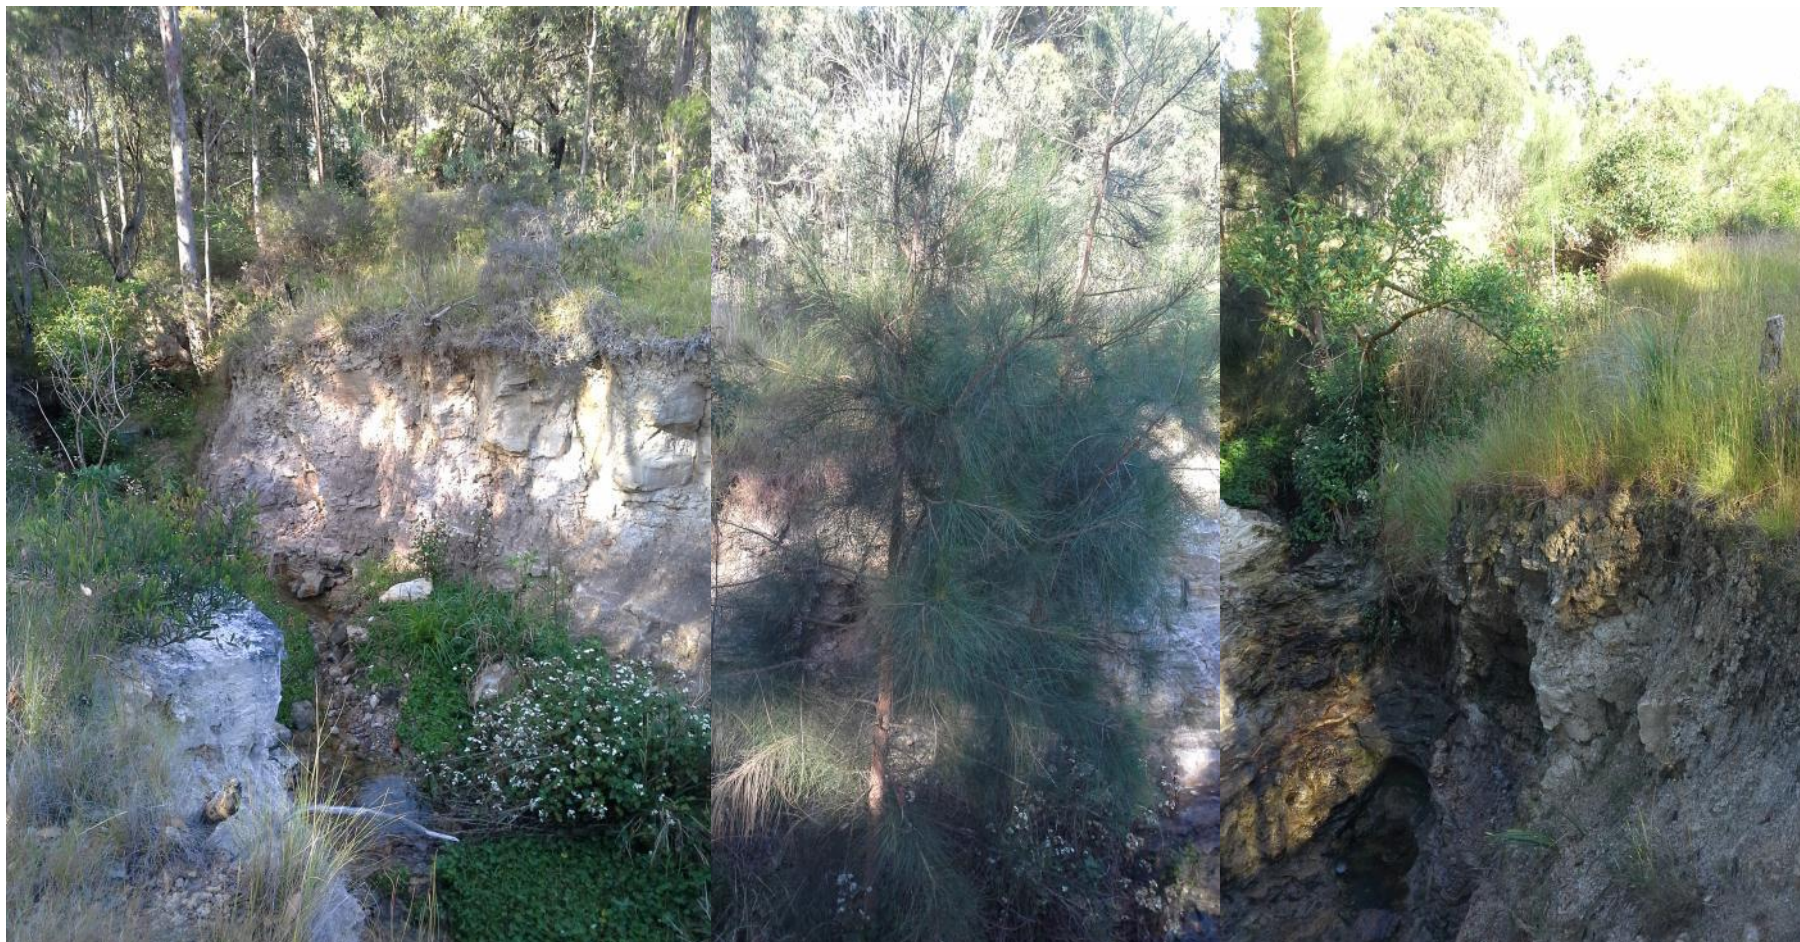
## Point 113

| Site Issue | Priority | Works needed |
|---|---|---|
| Erosion | H | <p>This section consists of the most severe erosion along the creek with undercutting of exposed banks up to 4.5 m high. Bank scour and slumping is evident. Both the internal and external bend appear to be unstable with obvious recent erosion of siltstone material and exposed tree roots. This area is likely to erode further without works at this location. The adjacent native vegetation is relatively intact and keeping these areas stable. The extreme lower bank and stream bed are considered stable due to the presence of larger rocky material and sandstone bedrock.</p> <p>This area will require significant work to stabilise the section, including the potential creation of a retention basin, rock wall armour, gabion installation, woody debris or rocky structures be implanted into and across the stream bed or a combination. This in conjunction with other such methods further upstream to reduce flow rates will help stabilise the existing stream banks.</p> <p>Bank stabilisation will also require the use of jute or other erosion control matting as well as installation of coir logs or similar.</p> |

| Rubbish | L | Rubbish comprises primarily scattered general litter only |

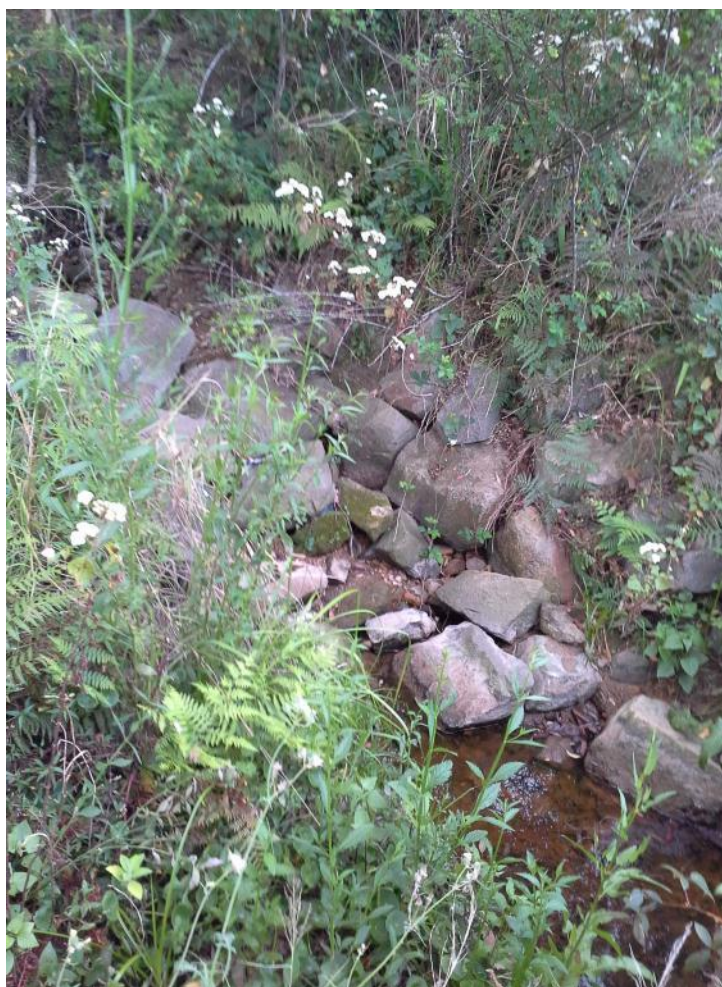
### Point 103 - Southern exit point for the watercourse

| Site Issue | Priority | Works needed |
|---|---|---|
| Erosion | M | Very minor at this location. There is a constructed rock reinforced stream bank section which extends for approximately 3 m in this location upstream from the Pacific Highway drainage culvert. The rock reinforcement will need to be maintained and will likely need additional / extra rock material. |
| Rubbish | L | Rubbish comprises scattered general litter only. |

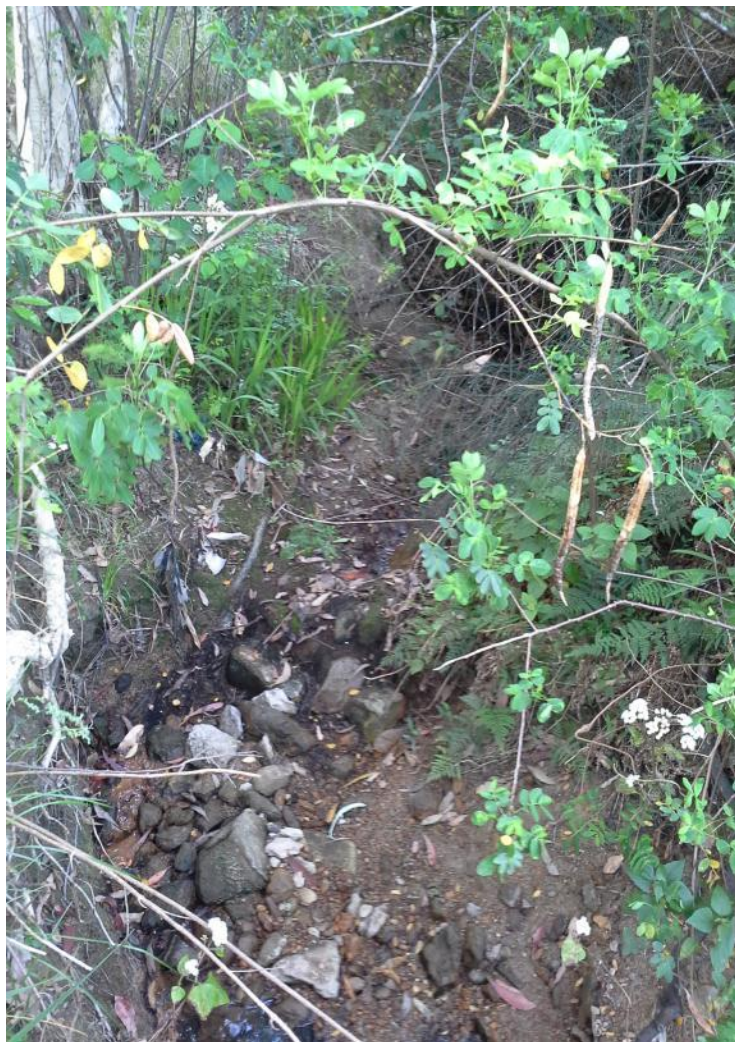
## Point 104

| Site Issue | Priority | Works needed |
|---|---|---|
| Erosion | L | Very minor at this location. No works are anticipated at this time |
| Rubbish | L | Rubbish comprises scattered general litter only. |

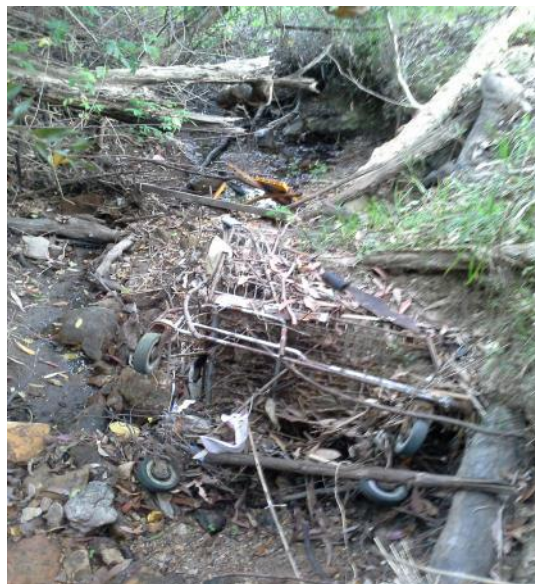
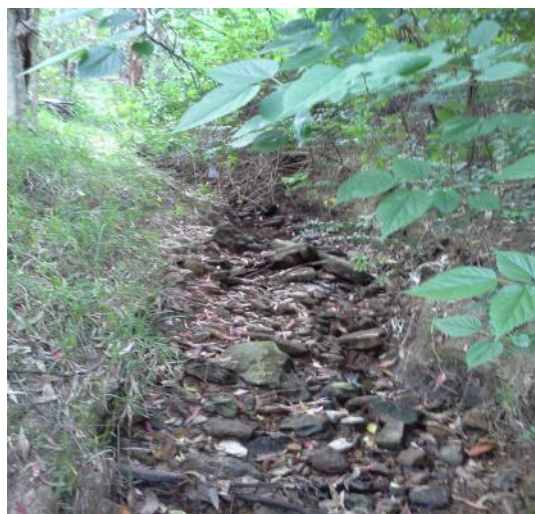
## Point 105

| Site Issue | Priority | Works needed |
|---|---|---|
| Erosion | L | Minor at this location. No works are anticipated at this time. Existing logs and debris to be retained. |
| Rubbish | M | Rubbish comprises a combination of scattered general litter, but also contains larger items such as a shopping trolley and road barriers. |

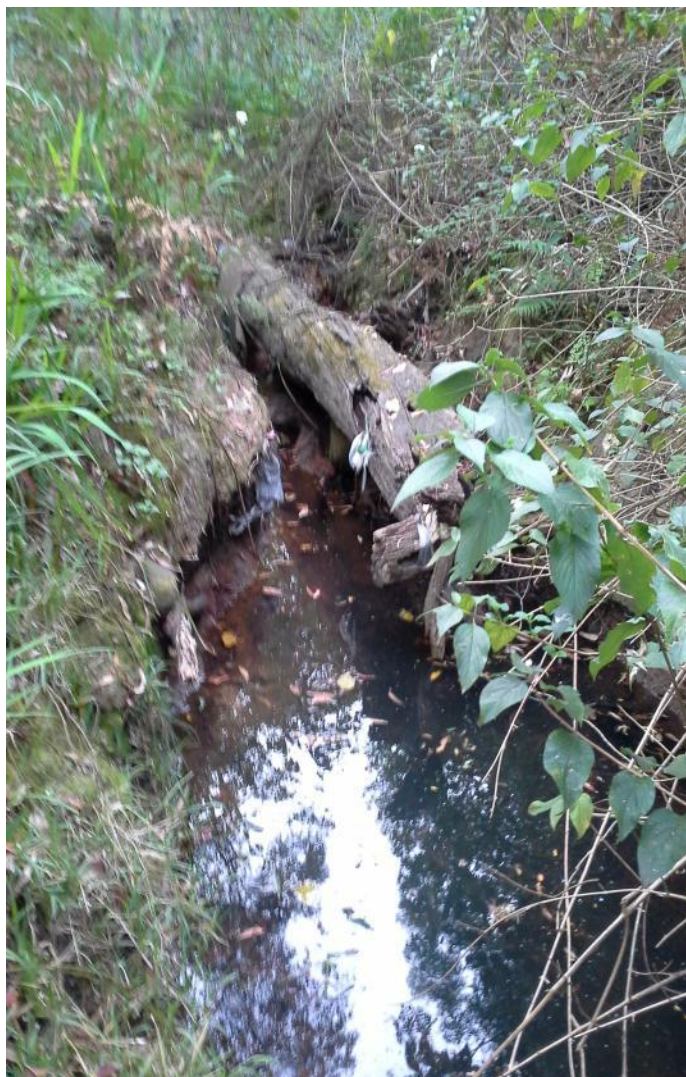
## Point 106

| Site Issue | Priority | Works needed |
|---|---|---|
| Erosion | L | The section of creek bank is relatively stable at this location due to the presence of large in-stream debris (i.e. large log) and the presence of a semi-permanent pool. |
| Rubbish | L | Rubbish comprises scattered general litter only. |

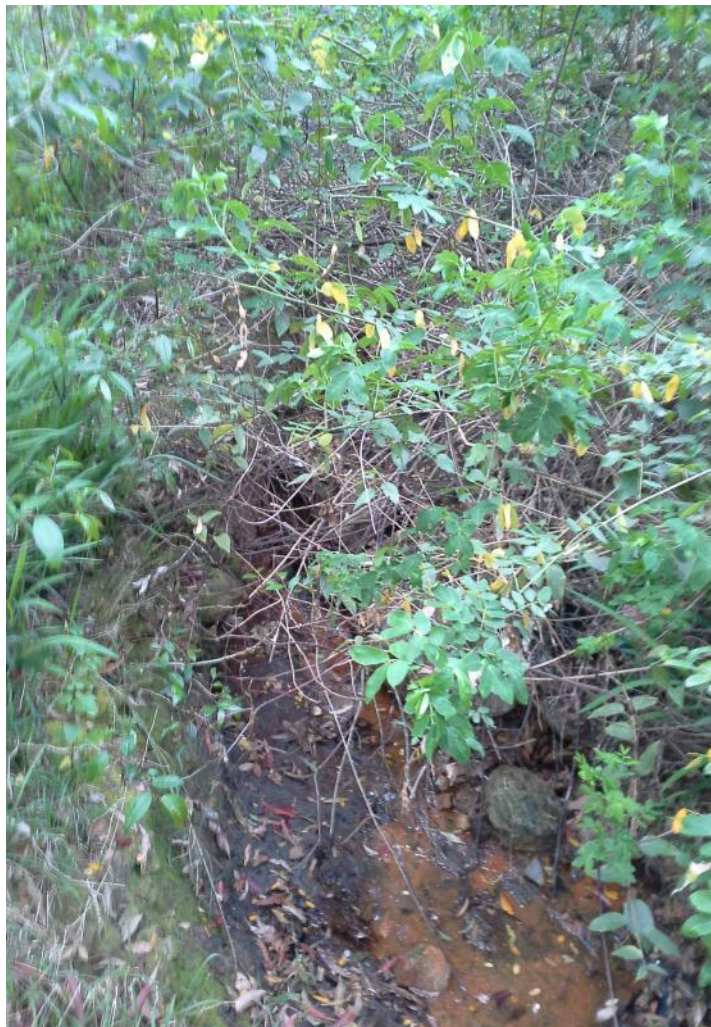
## Point 107

| Site Issue | Priority | Works needed |
|---|---|---|
| Erosion | L | The section of creek bank is relatively stable at this location. |
| Rubbish | L | Rubbish comprises scattered general litter only. |
