## Windale Creek Restoration Plan

Prepared for  
**Masters**

October 24 2014

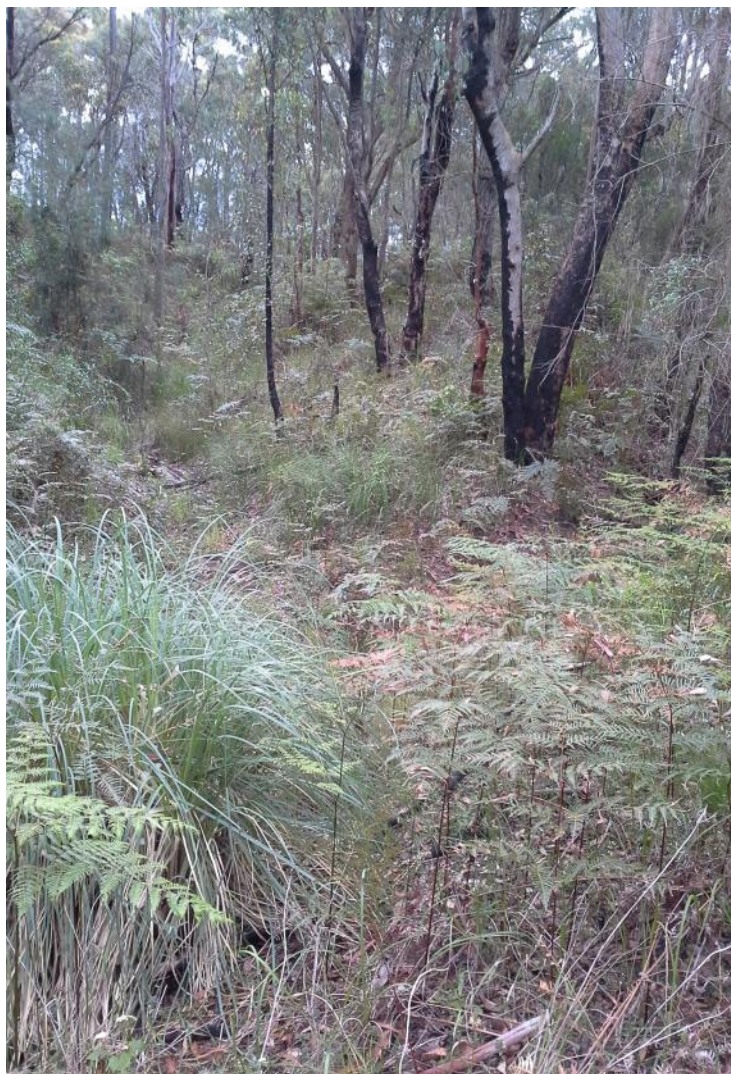
## Point 108 – small tributary watercourses to the west

| Site Issue | Priority | Works needed |
|---|---|---|
| Erosion | L | This tributary section is stable and will not require any erosion control works. |
