4 June 2014

RE: DA 1892/2013 – 40-48 BURTON ROAD, MOUNT HUTTON

Arborist Report

Eleebana Shores Retirement Village

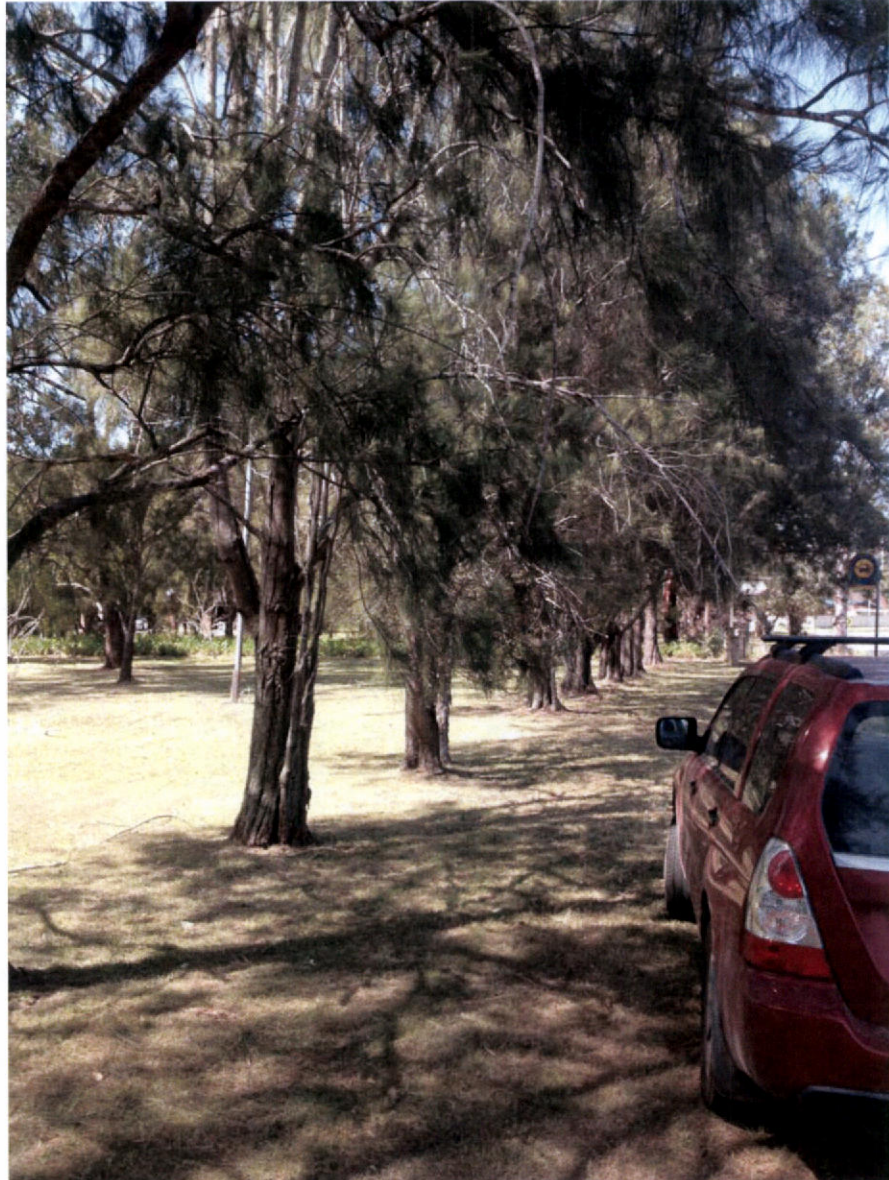
Tree 2 *Casuarina cunninghamiana* River She Oak ULE Rating 2A Tree AZ Rating A2
Tree's 2 through to 15 form a row along the western boundary of Lot 11. Tree 2 is of average health with some minor issues such as dead wood, stubs and hanging branches present.

Figure 2: Trees 2 to 15 along the Burton Road frontage.

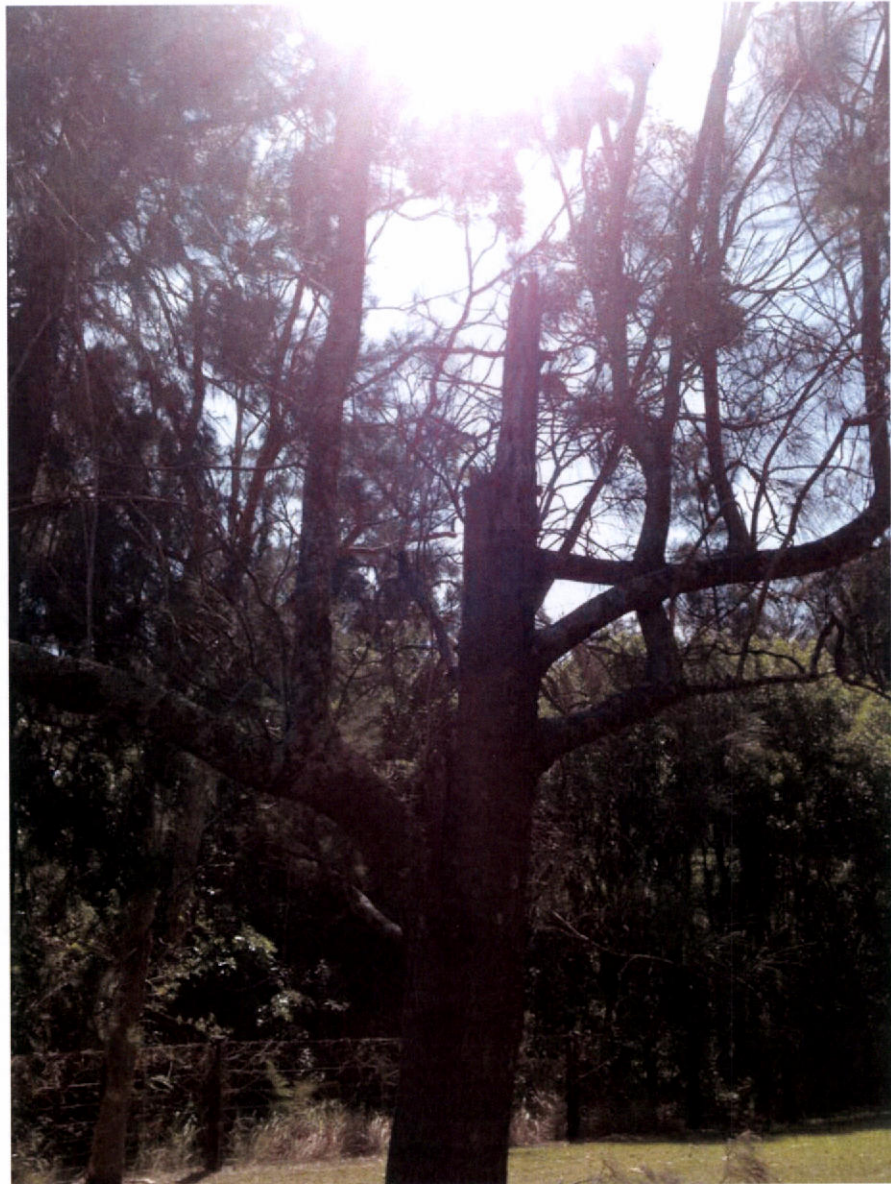
Tree 3 *Casuarina cunninghamiana* River She Oak ULE Rating 4B Tree AZ Rating Z4
Main trunk failure at 3m. This has led to poor form.

Figure 3: Tree 3 with trunk failure.

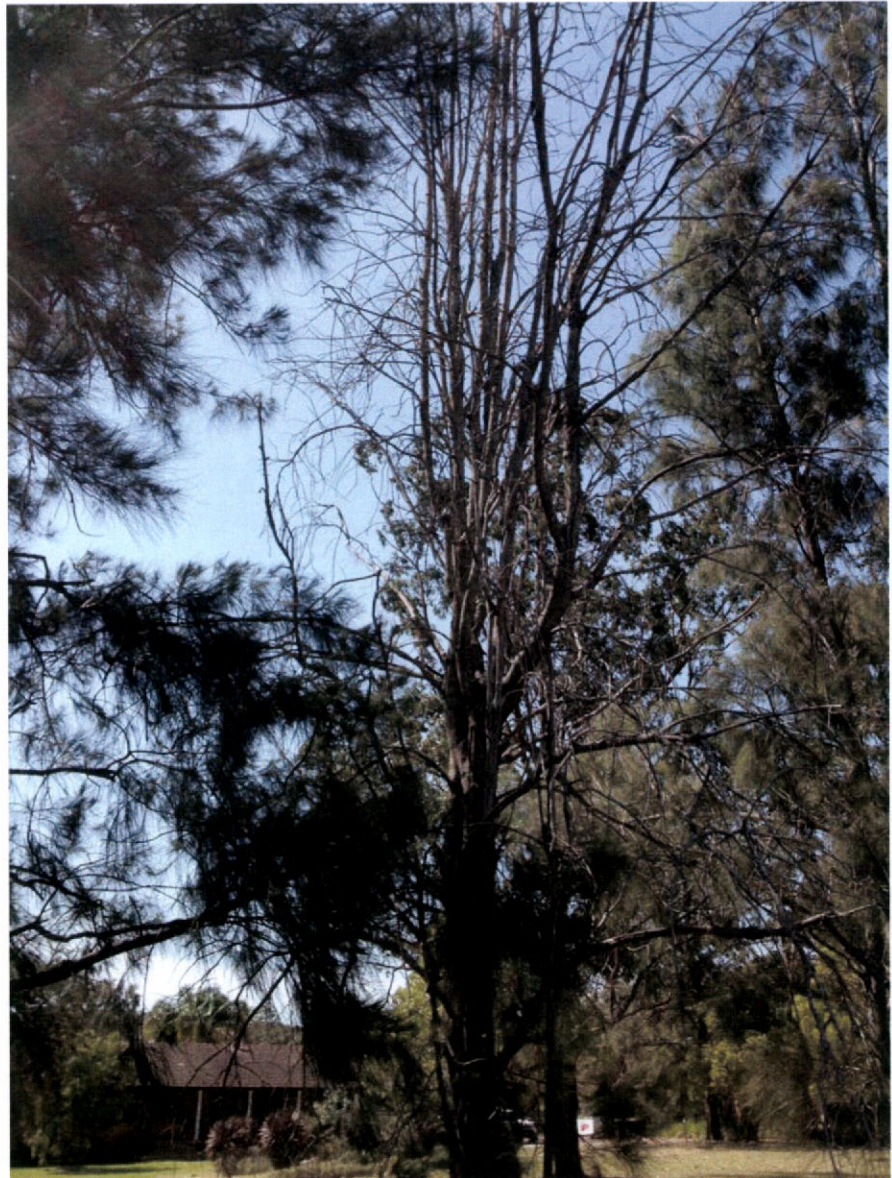
Figure 4: Tree 7

Tree 7 *Casuarina cunninghamiana* River She Oak ULE Rating 4A Tree AZ Rating Z4
Dead tree. Tree should be removed and replaced.

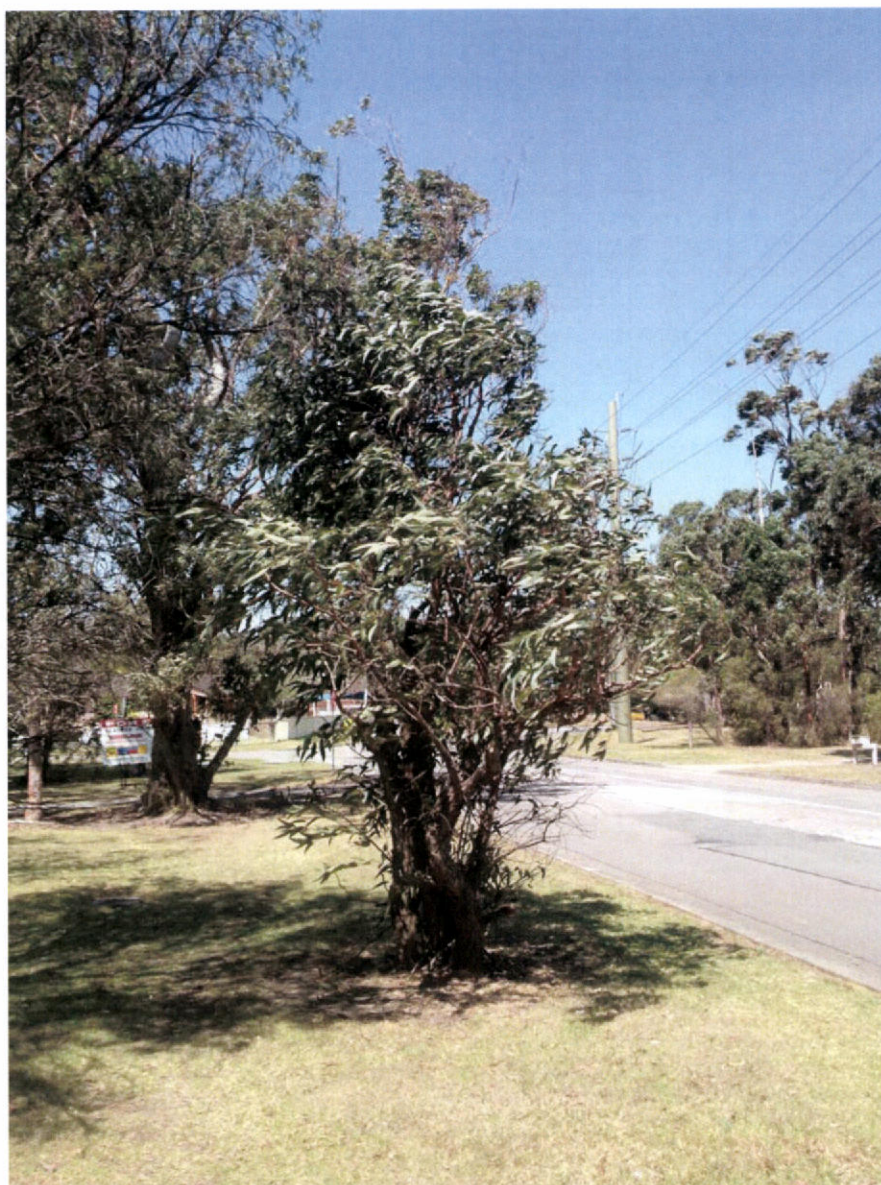
Figure 5: Tree 23

Tree 23 *Eucalyptus umbra* Broad Leaved White Mahogany ULE Rating 4B Tree AZ Rating Z10

Located in street verge. Small stunted tree of very poor form.

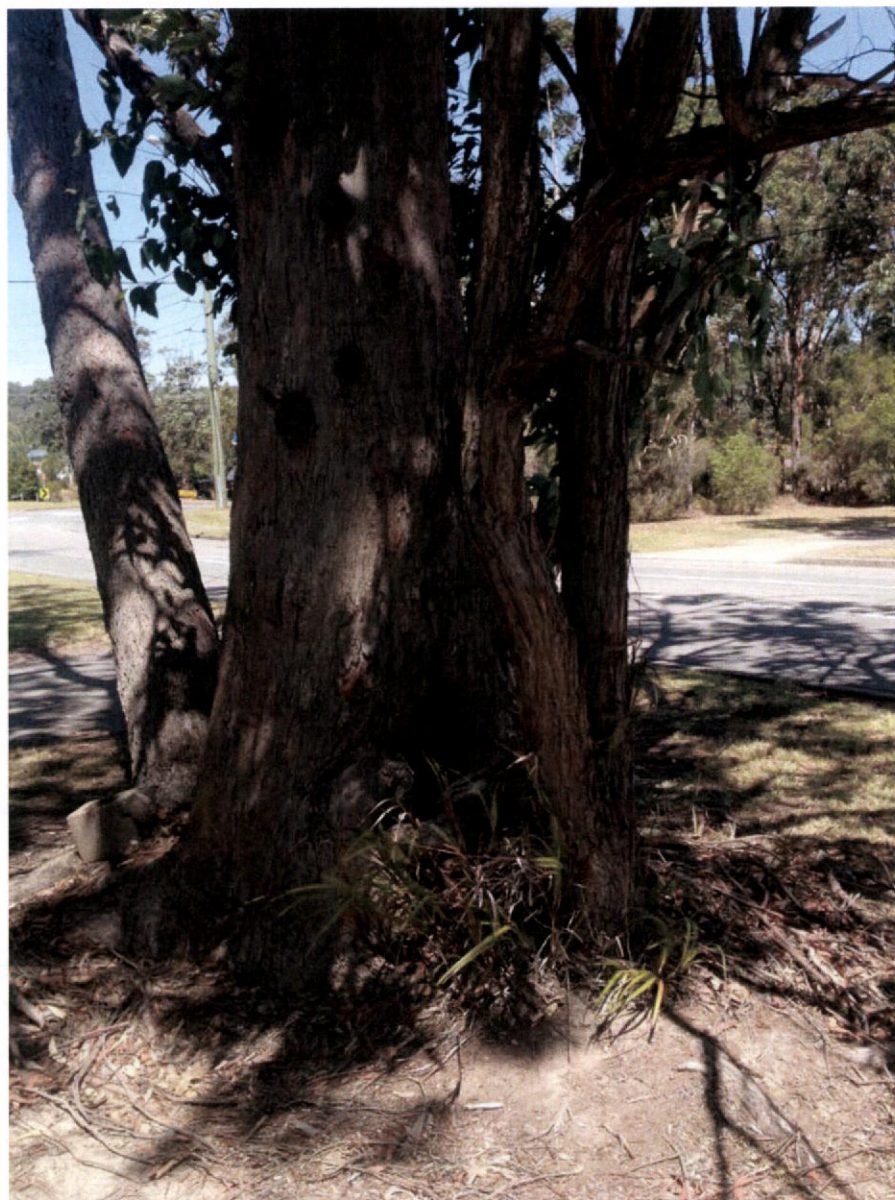
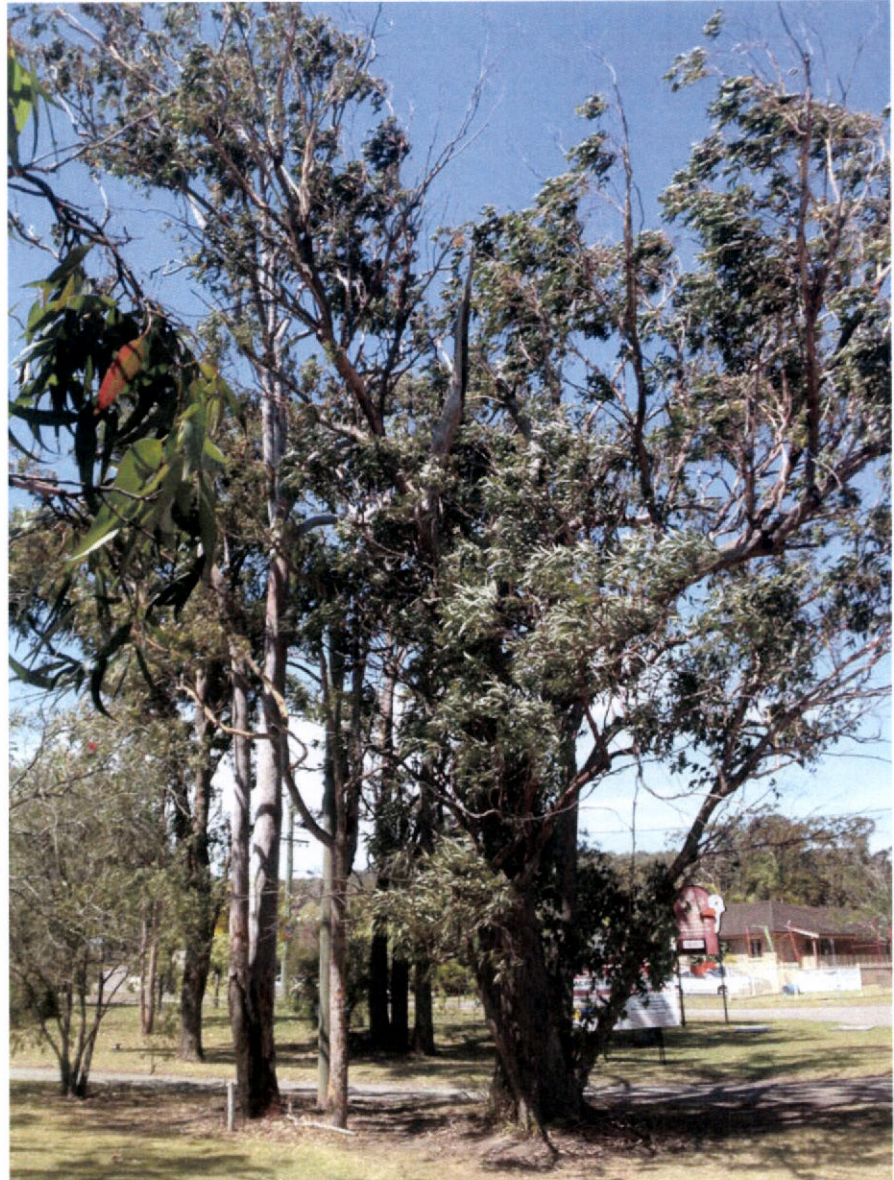
Trees 24, 25 and 26 are growing against each other. All 3 trees require removal. Tree 24 is suppressed and has a poor structural form.

Figure 6: Trees 24, 25 and 26 all growing in nvery close proximity.

Over mature tree in decline. Large amount of decay throughout the tree. Many past branch failures evident. Hollow present in branch failure wound. This tree should be removed.

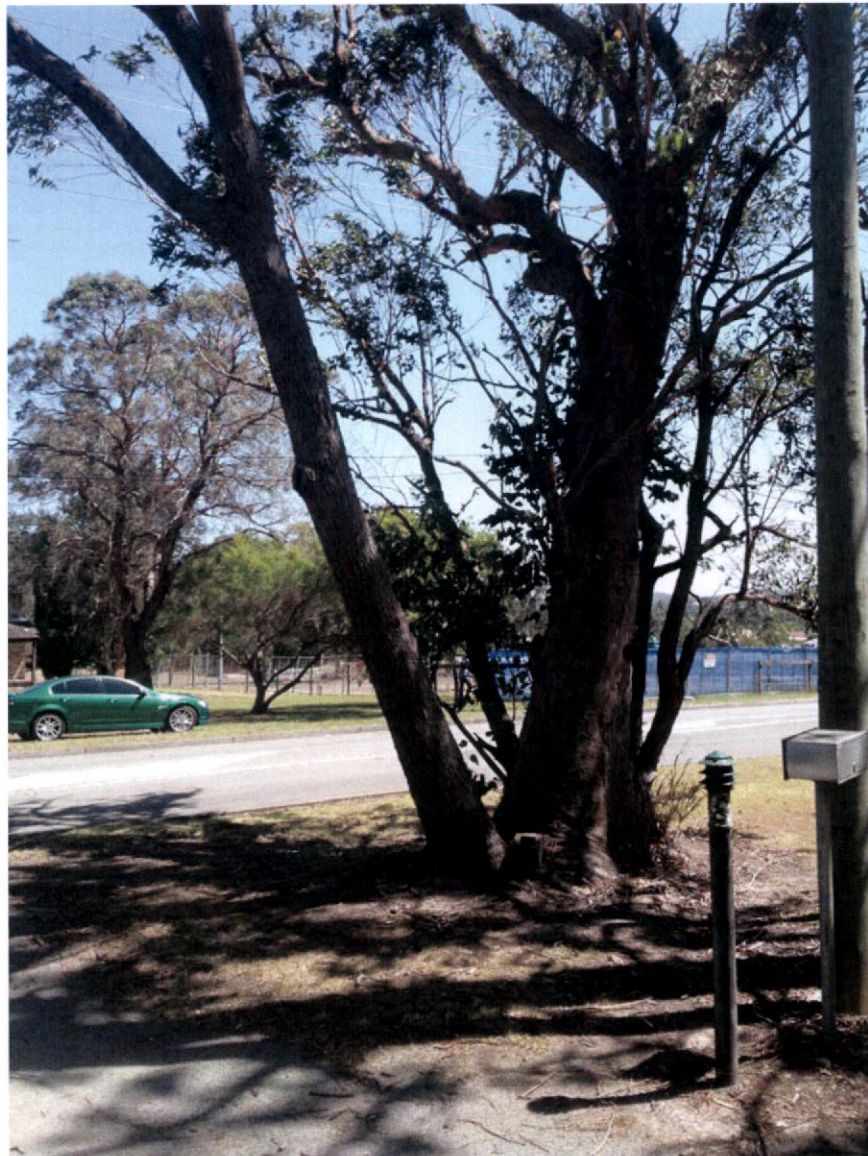
Growing against tree 25, has a severe lean to the south developed through phototropism. Lean overhangs residential power supply lines. Tree should be removed.

Figure 8: Tree 26 leaning to the south over powerlines.

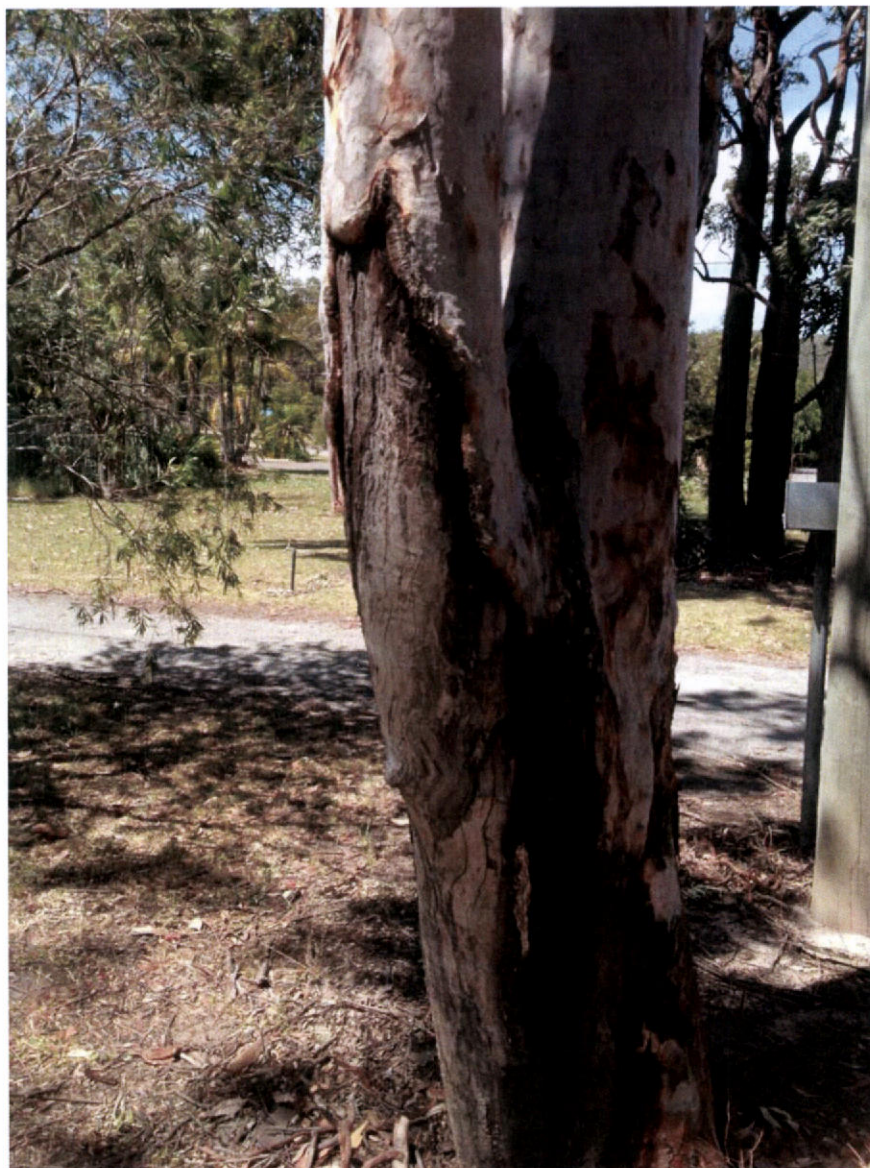
Tree 28 *Angophora costata* Smooth Barked Apple ULE Rating 3D Tree AZ Rating Z10
Large wound located at the base of the trunk. Co-dominant leaders.

Figure 9: Tree 28 large wound to lower trunk.
