Traffic Impact Assessment

Darryl McCarthy Constructions Pty Ltd.
PO Box 246
Tenterfield NSW 2372

July 2014

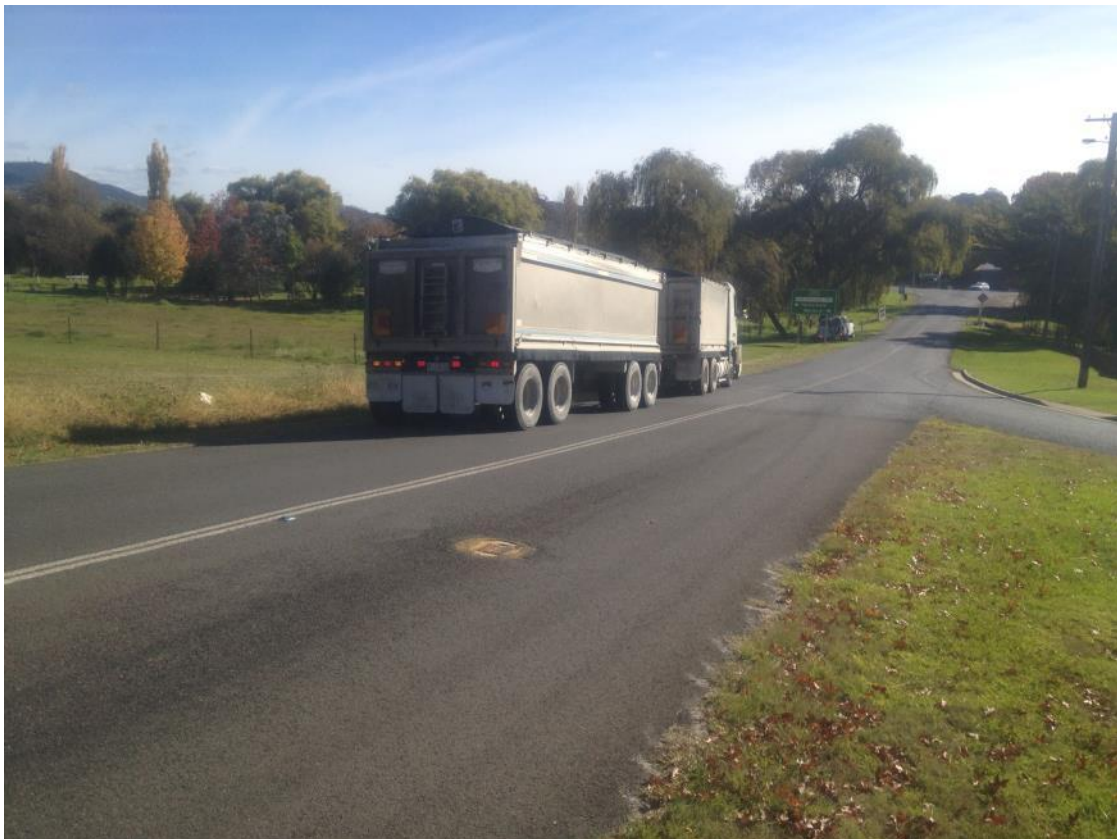
Naas Street, between Logan Street and the New England Highway is a Regional Road which links the Mount Lindesay Road to the New England Highway. This section of Naas Street is approximately 7m wide although it narrows over the culvert structure which has non conforming guardrail. Centreline marking is provided, although it is worn in sections. The seal and associated pavement is in reasonable condition as shown in **Plate 1**. There is some outer wheel path rutting near the intersection with the New England Highway.

Plate 1 Naas Street between Logan Street and New England Highway

The section of Naas Street utilised for laden trucks from the quarry is generally considered suitable for the continuation of truck transportation. The minor pavement defects at the western end of this section close to the New England Highway will require some repairs however intervention is not required at present and future repairs should be covered as part of the s94 contribution.

The existing rail barriers over the culvert are non-conforming, however this is a pre-existing issue and exists in a low speed environment. Short of providing conforming barriers, improved delineation on approach to the existing barriers are recommended.

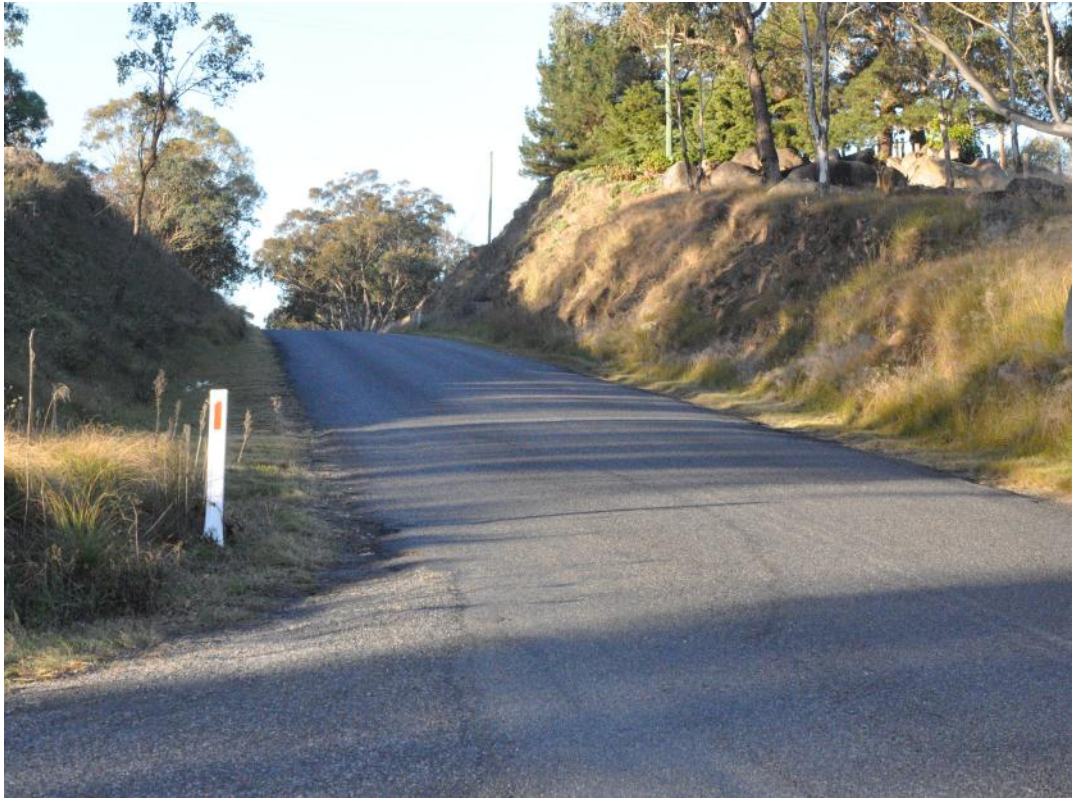
Plate 2 Poor sight distance due to crest looking north at Leechs Gully Road Intersection

The two intersections with Mount Lindesay Road are Leechs Gully Road and Bryans Gap Road which have limited sight distances of 220m and 110m respectively in the direction of the crest (see Plates 2 and 3). There are also numerous private accesses along the route that are either concealed or have limited sight distance. This is a pre-existing issue that is not necessarily exacerbated by the Proposal however it is recommended that the trucks operate at a self-imposed speed limit of 80km/hr to improve the reaction time of vehicles approaching the intersections and accesses along this section of road.

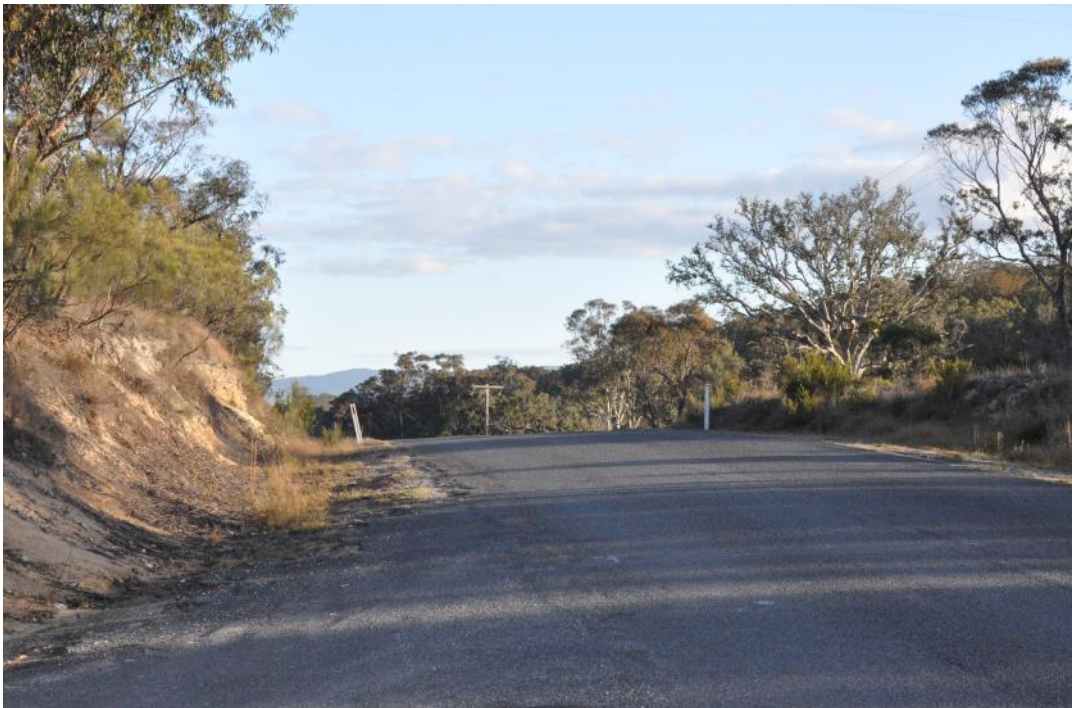
Plate 3 Poor sight distance due to crest looking south at Bryans Gap Road

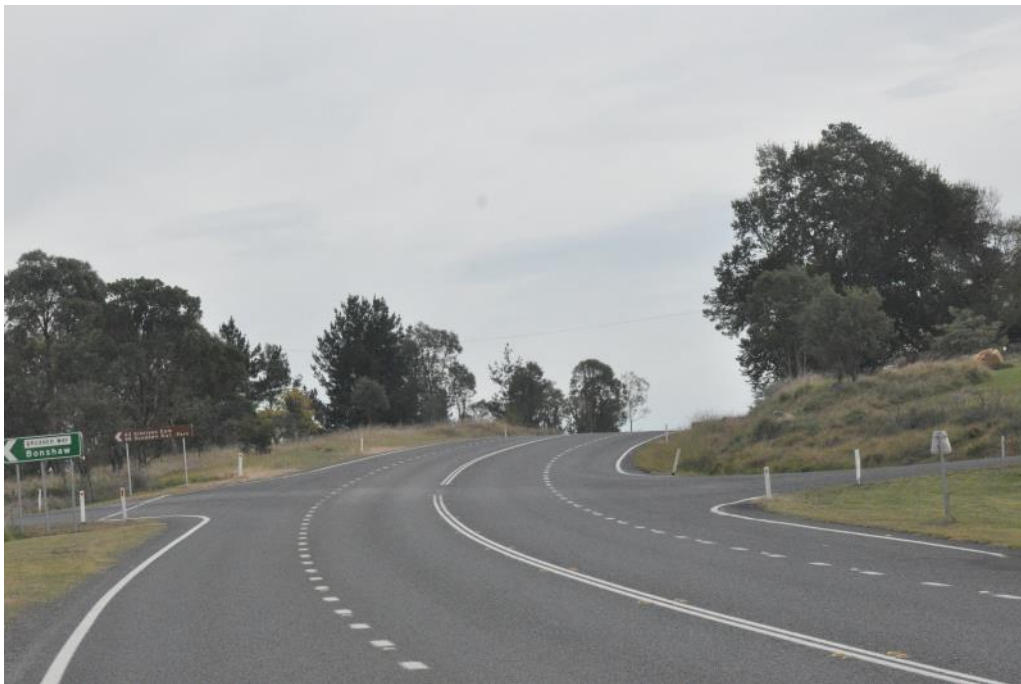
The sight distance in either direction along the New England Highway is limited to the north at 110m and very good to the south at greater than 500m. Safe intersection sight distance (SISD) for 100km/hr is 248m therefore sight distance to the north in this speed environment is considered to be deficient. **Plate 4** shows the crest limiting sight distance to the north.

Plate 4 Poor Sight Distance due to crest looking north along the New England Highway

Regardless of the destination it is recommended that the current practice of trucks not travelling westward on Old Ballandean Road should continue. That would avoid the need for trucks to make a right turn manoeuvre from Old Ballandean Road or continuation onto the Bruxner Way at this intersection. Rather, it is recommended that the current safer practice of travelling to the Naas Street / New England Highway intersection continue.

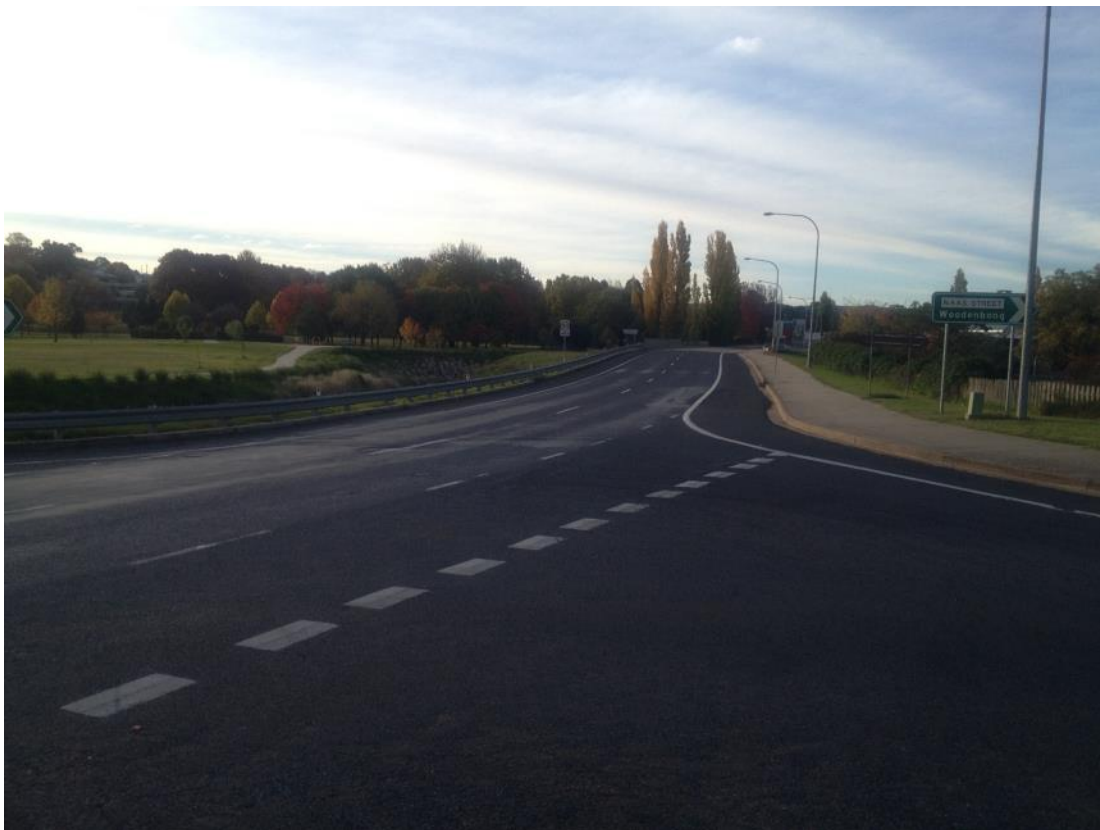
W beam guardrail is provided along the western side of the highway to the north along the highway extending around the corner into Naas Street heading west. The sight distance in either direction along the New England Highway is good to the north at 350m and reasonable to the south at 190m. Safe intersection sight distance (SISD) for 50km/hr is 97m therefore the available sight distance is more than adequate. Plates 5 and 6 below show the sight distance in either direction.

Plate 5 Sight Distance looking north along the New England Highway

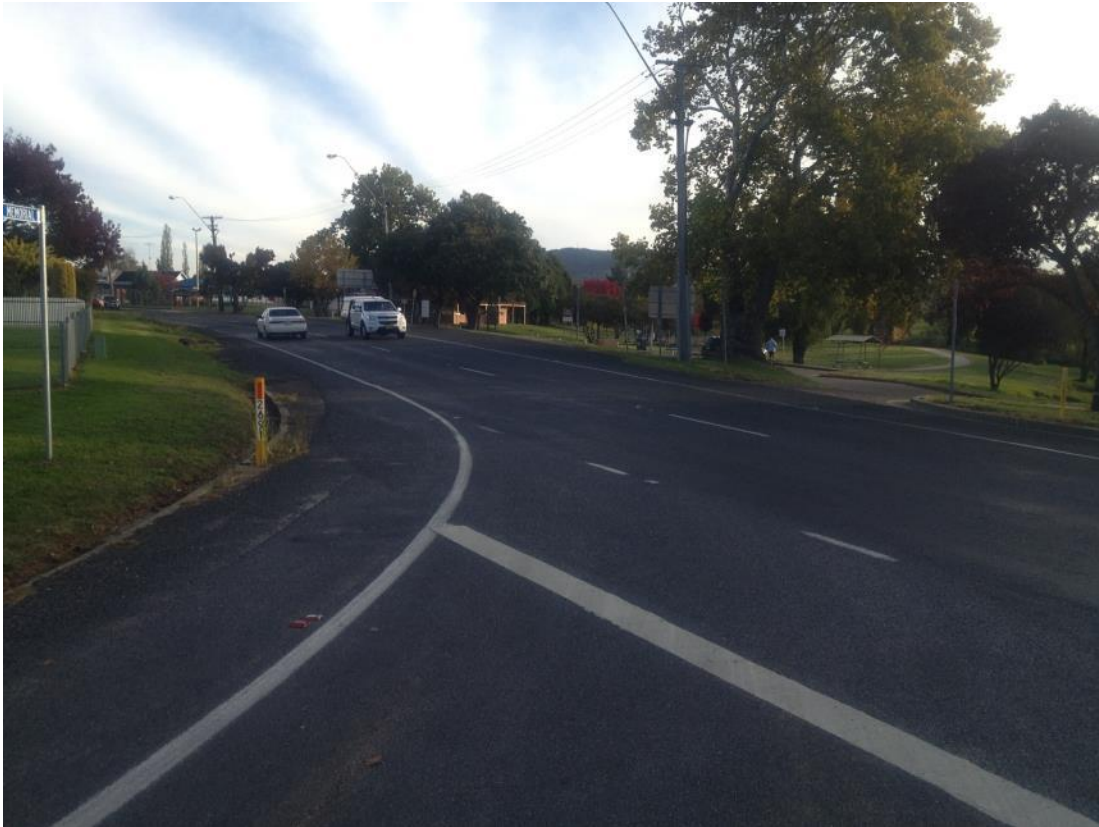
Plate 6 Sight Distance looking south along the New England Highway

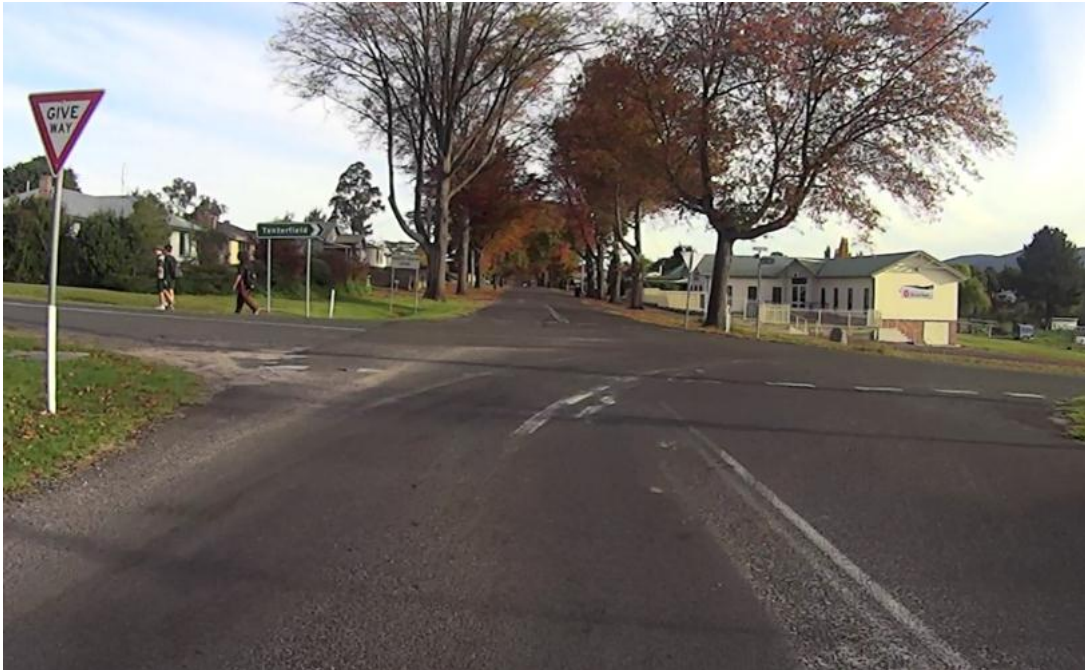
The pavement is in average condition with rutting prevalent however thin asphaltic concrete surfacing has been applied and is likely assisting in avoiding excessive pavement defects as a result of screwing. Plate 7 shows the layout of the four way intersection.

Plate 7 Logan Street intersection with Naas Street approaching from north

Although sight distance is good to the east and reasonable to the west, it is recommended that the northern approach is controlled by a stop sign instead of give way. This would force the drivers to be more cognisant of other traffic and pedestrians within the vicinity of the intersection before turning right across the opposing traffic lane.

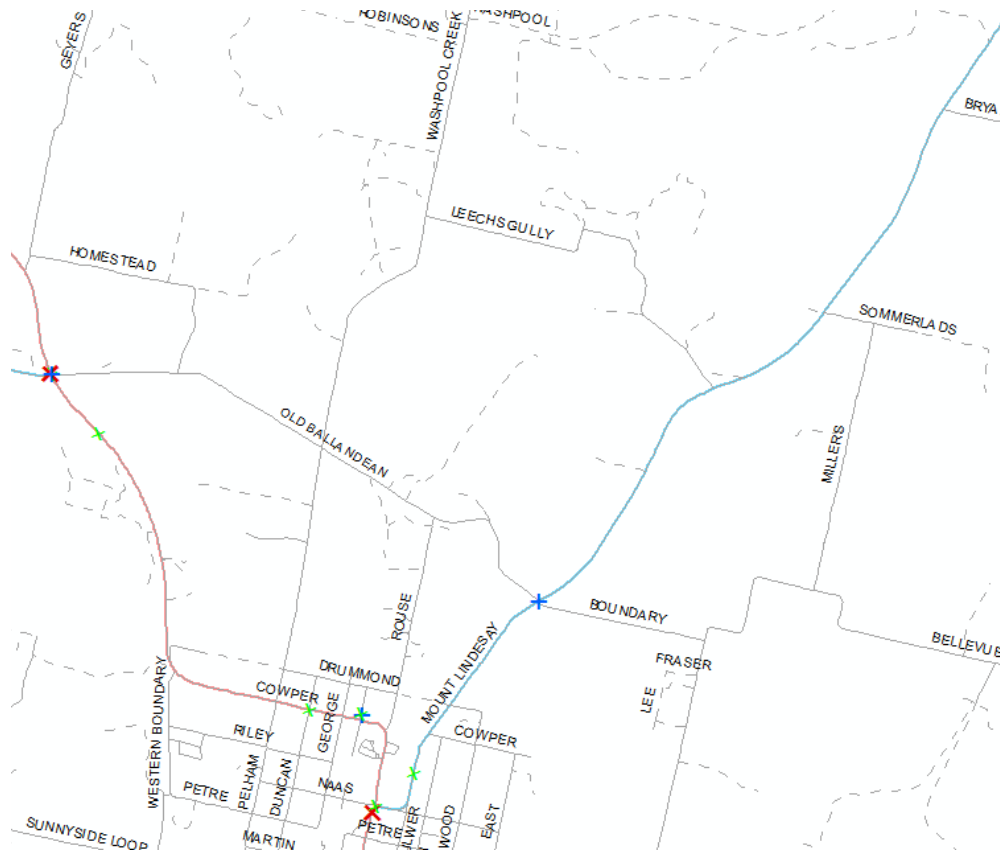
Figure 3 Crash locations over the past 5 years (source RMS 2014)

The majority of incidents that have occurred appear to be associated with vehicles failing to give way and / or stop at the respective intersections. Sight distance is reasonable at the Old Ballandean Road intersection with the Mount Lindesay Road therefore is not believed to have contributed to the incident at this location. It is difficult to determine from the data provided whether the lack of sight distance to the north at the Old Ballandean Road intersection with the New England Highway contributed to this accident.
