## Tree Assessment

Residential Aged Care Facility

158 Macquarie Road,  
CARDIFF

November 2016  
REF: (A15069T)

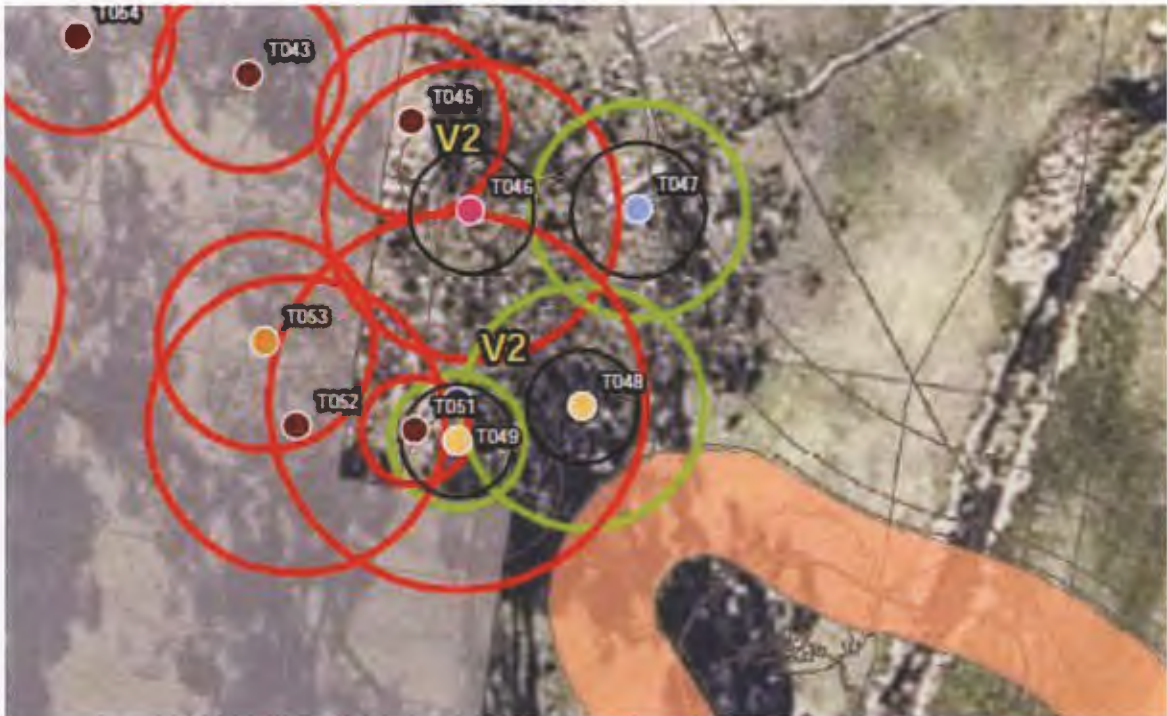
Figure 2 - Map of T048 & T049 (Travers Ecology)

Below is a map showing the TPZ's and SRZ of Trees T048 & T049.

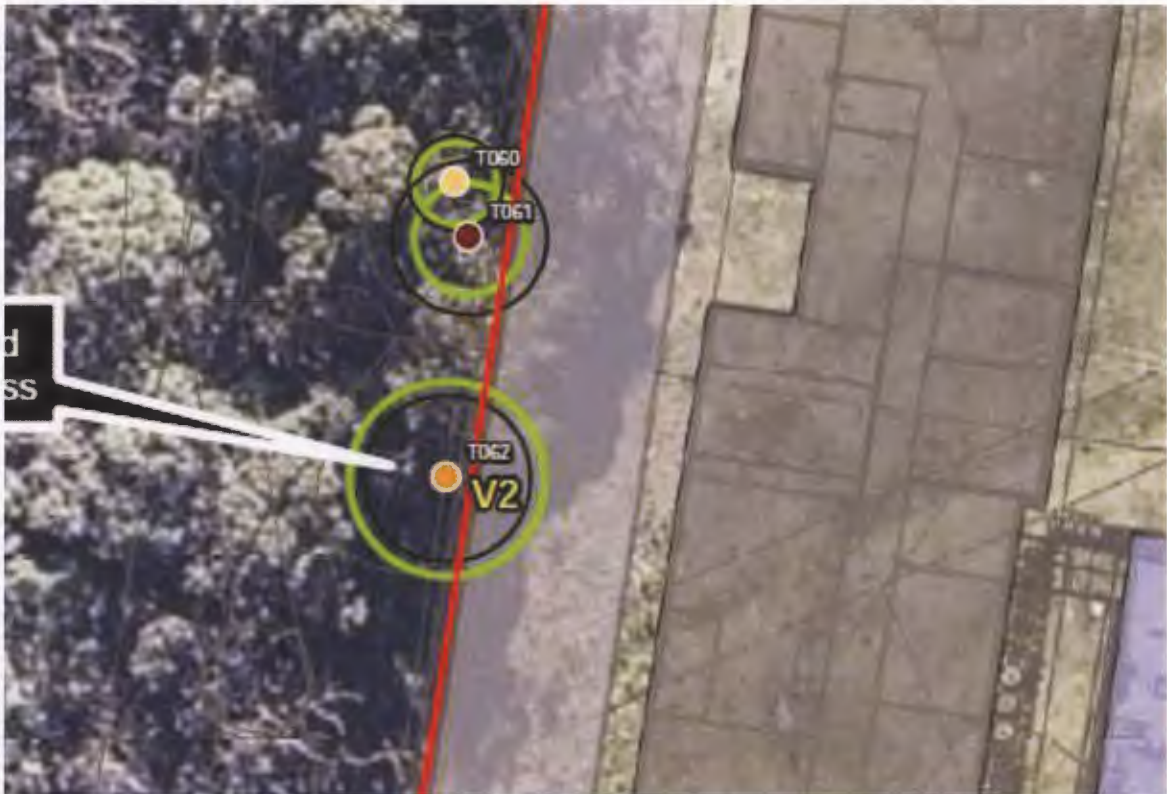
Figure 3 - Map of T061 & T062 (Travers Ecology)

Below is a map showing the possible major encroachment of SRZ of T061 and T062.
