Arborist Report

**Client: Hunter New England Local
Health District**

Address: 1a (Lot 10) Dudley Road
Charlestown N.S.W 2290

Date: 4 January 2016

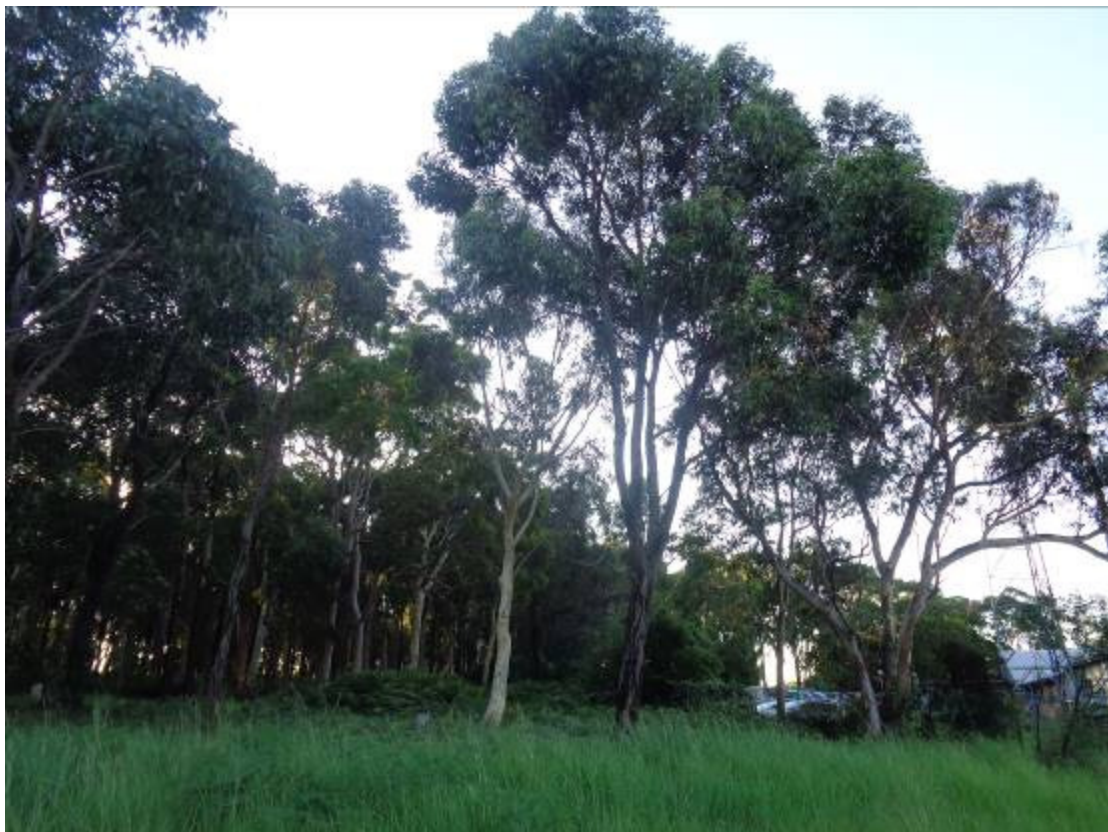
Figure 4 – showing the north western part of the site & the location of the proposed facility. This will require the removal of Trees 1 – 6 & 12 – 14 that will be within the proposed facility & will therefore require removal to construct the dwelling.

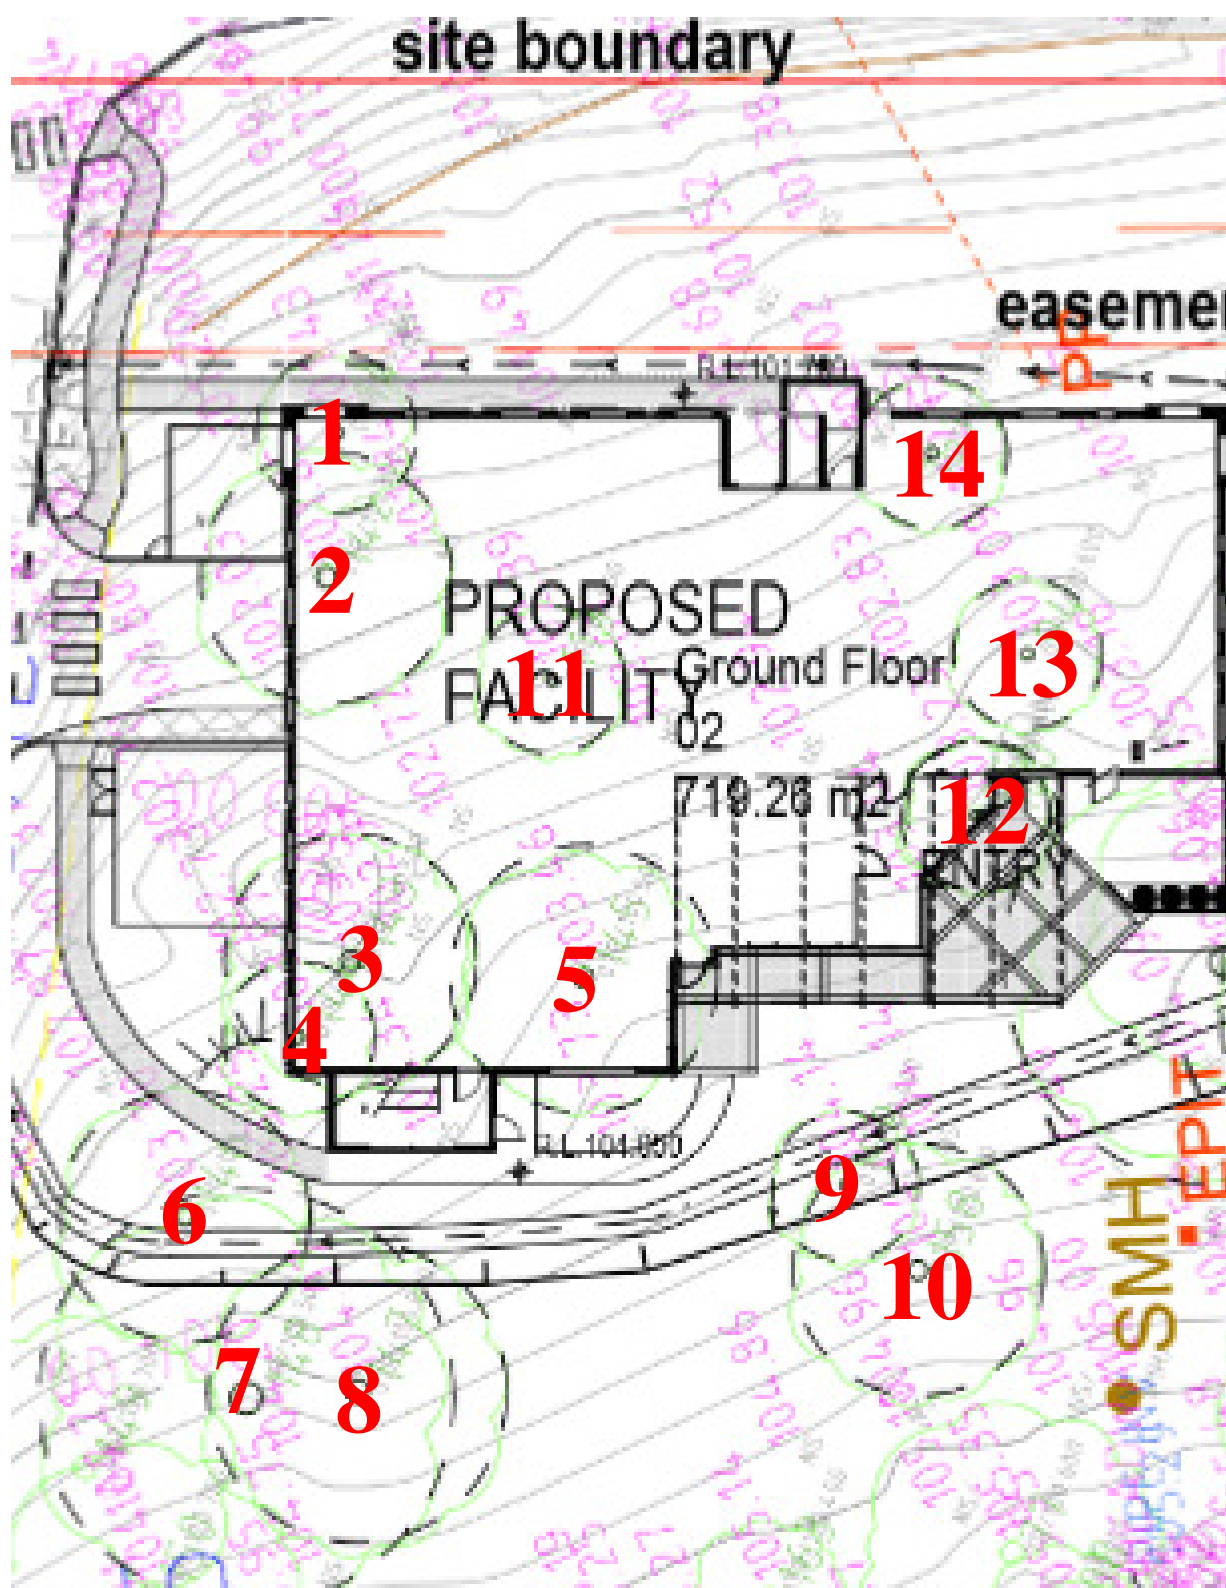
Figure 7 – showing the location of Trees 1 – 14 in relation to the proposed building
