arboricultural impact assessment, proposed development 124 – 128 killeaton street, st ives

13th October 2014

prepared by Melanie Howden - Ass. Dip. Hort. (Haw. Ag. C.), SoA. Arb. MAIH, MIACA

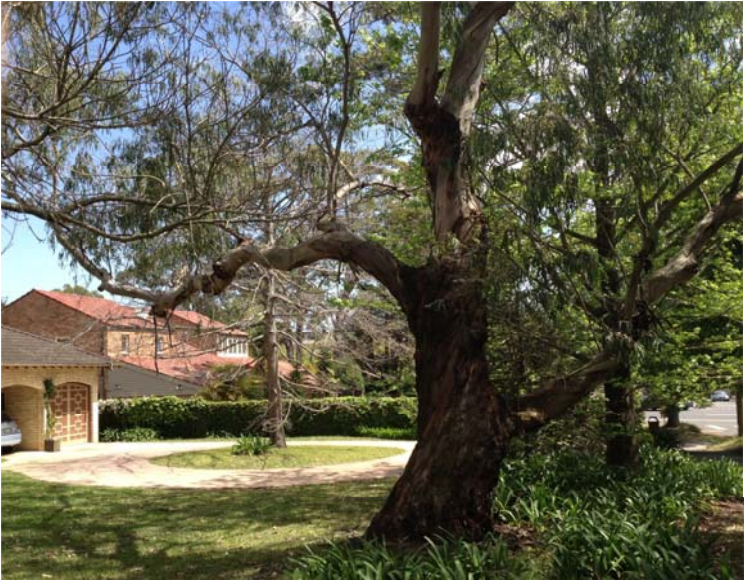
Figure 7.1 - Tree No.312 looking west will require pruning of the low branch on the western (left) side

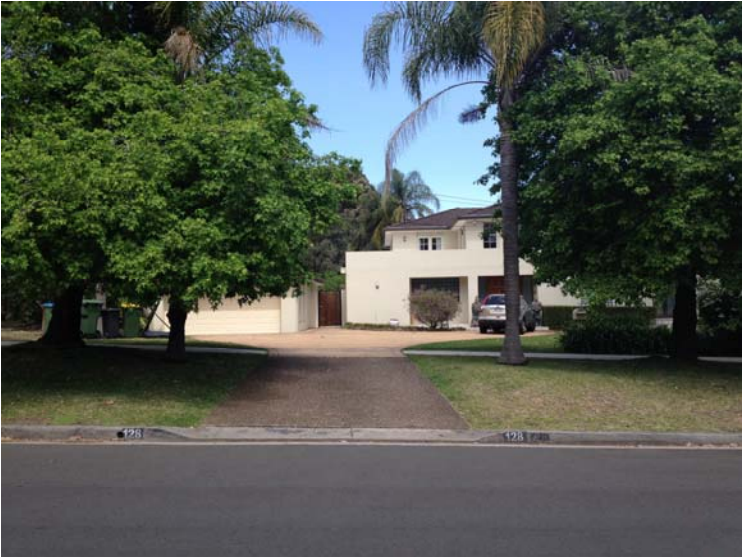
Figure 7.2 – Tree No.192 (left) will require branch pruning to provide vehicular access for the proposed driveway crossover.

192	<i>Liquidambar formosana</i>	500	700	1	Moderate L/scape Sig.	6.00	113.10	4.20	2.80	The proposed driveway crossing is within 2.8m (west) of the tree.	No significant impact with appropriate Tree Protection Measures.	Retained with Designed Tree Protection Measures	Within road reserve
195	<i>Liquidambar formosana</i>	400	500	1	Moderate L/scape Sig.	4.80	72.40	3.40	2.50	The proposed driveway crossing is within 3.4m (east) of the tree.	No significant impact with appropriate Tree Protection Measures.	Retained with Designed Tree Protection Measures	Within road reserve
196	<i>Hakea sp.</i>	1*180, 3*120	550	Unstable	Low L/scape Sig.	3.30	34.20	2.30	2.60	No proposed works within the tree's Tree Protection Zone.	No significant impact however, the tree is dead.	To be Removed	Within road reserve
197	<i>Liquidambar formosana</i>	480	650	1	Moderate L/scape Sig.	5.80	104.30	4.00	2.80	The front boundary palisade fence is within 3.8m (south) of the tree.	No significant impact with appropriate Tree Protection Measures.	Retained with General Tree Protection Measures	Within road reserve
