# ARBORICULTURAL ASSESSMENT AND IMPACT REPORT

## PROPOSED RESIDENTIAL REDEVELOPMENT

**5 TO 17 BYRON AVENUE  
CAMPBELLTOWN, NSW.**

11th November 2014

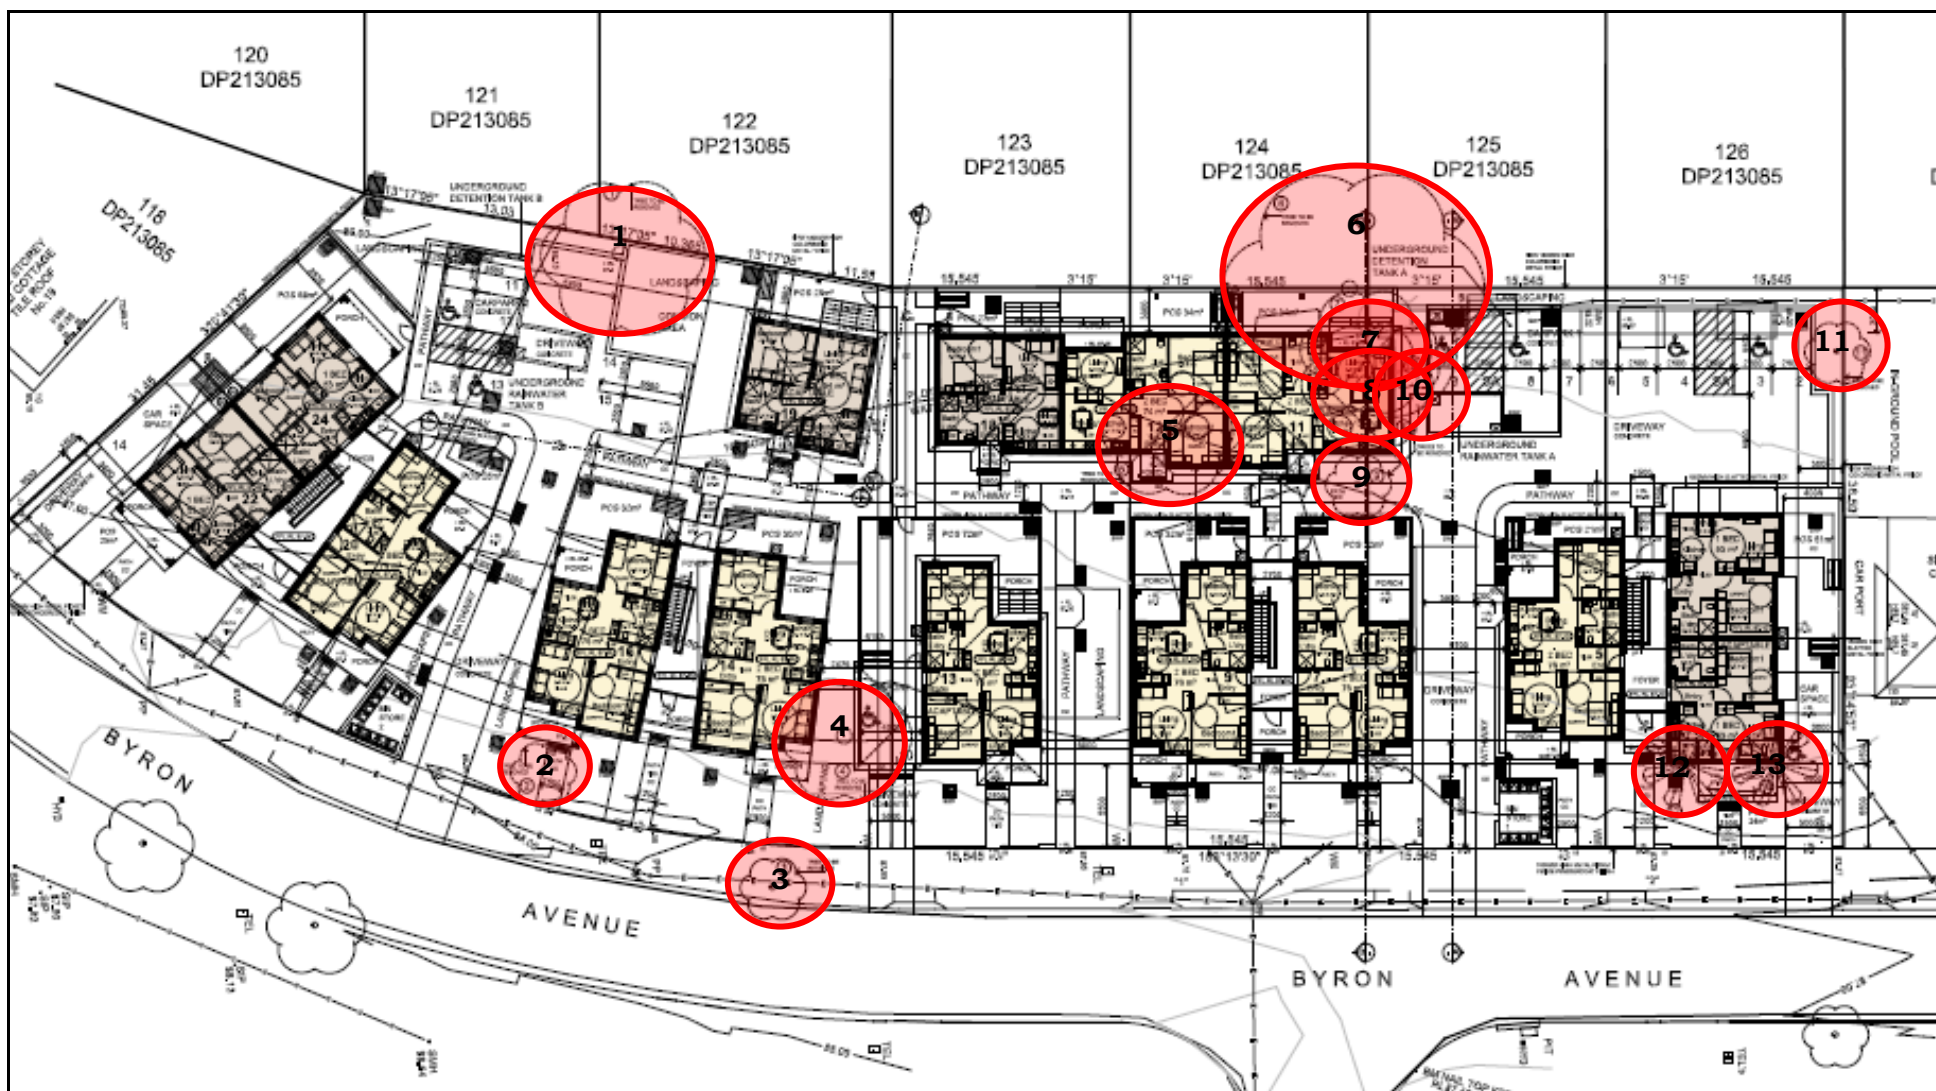
Figure 6 Show's the trees to be retained or removed.

Subject to Council or equivalent process, approval is recommended for the removal of all site trees/shrubs tabled including minor shrubs based on the plans provided. Many of the site species are species known to be nuisance, weed species or exempt due to height requirements under Councils TPO.

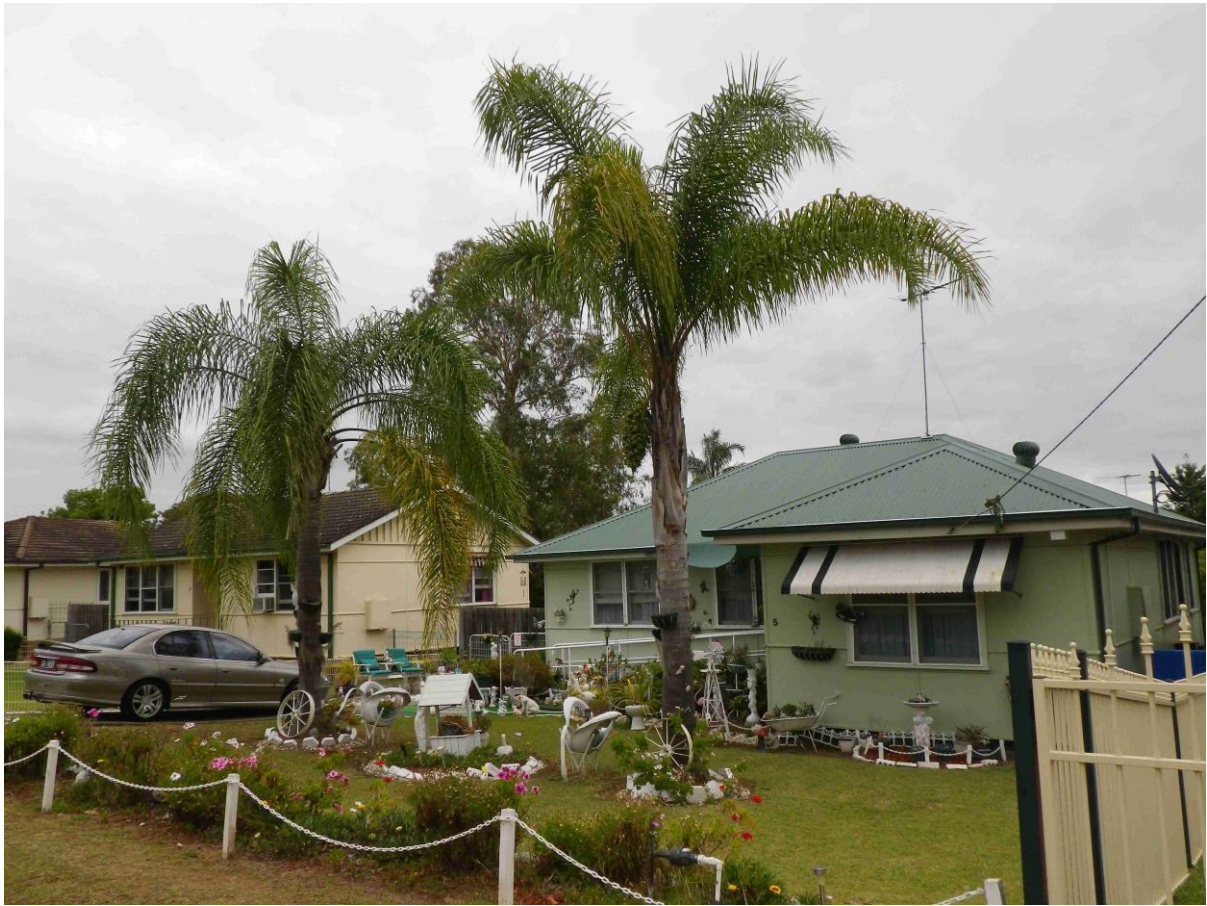
**Figure 7 Shows looking at the front of Number 5 and Cocos Palms**

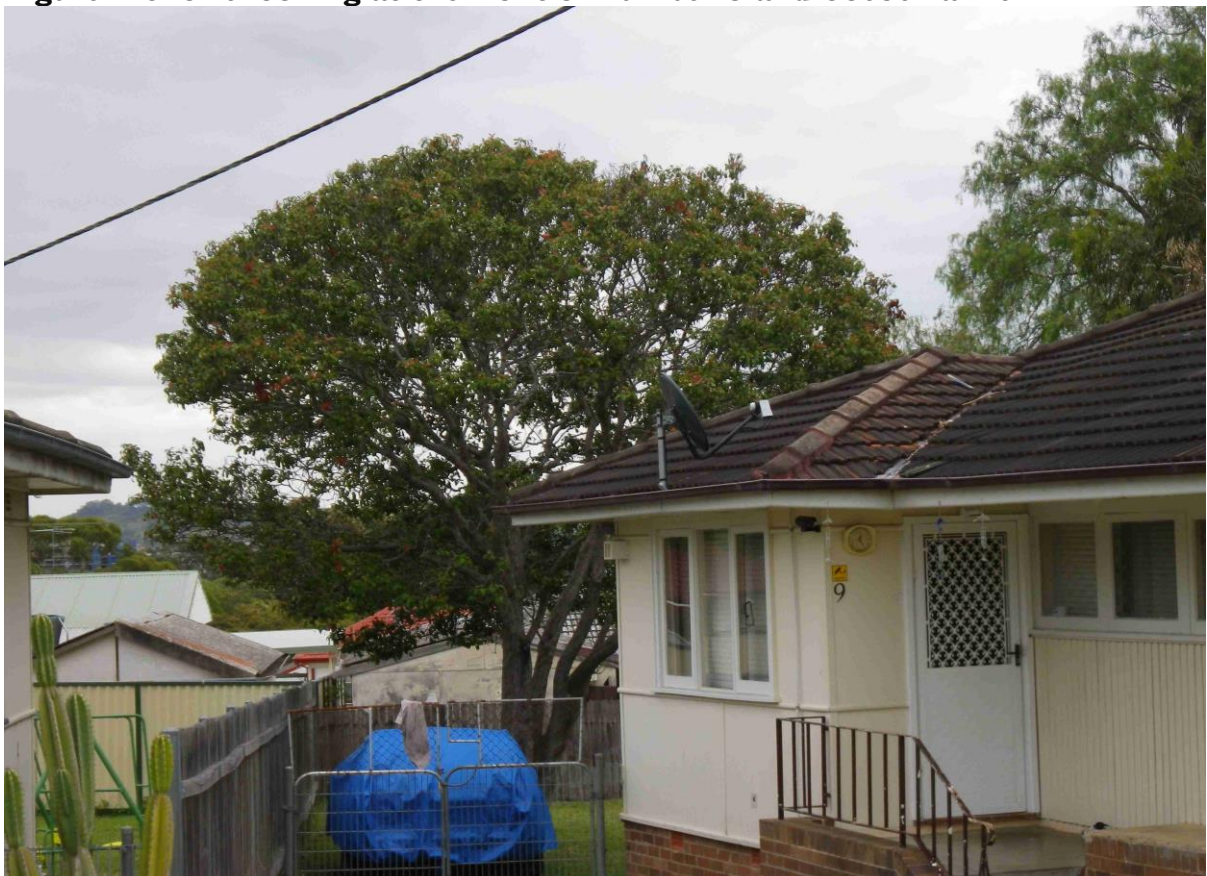
**Figure 8 Shows looking at Tree 5 located in the rear yard.**

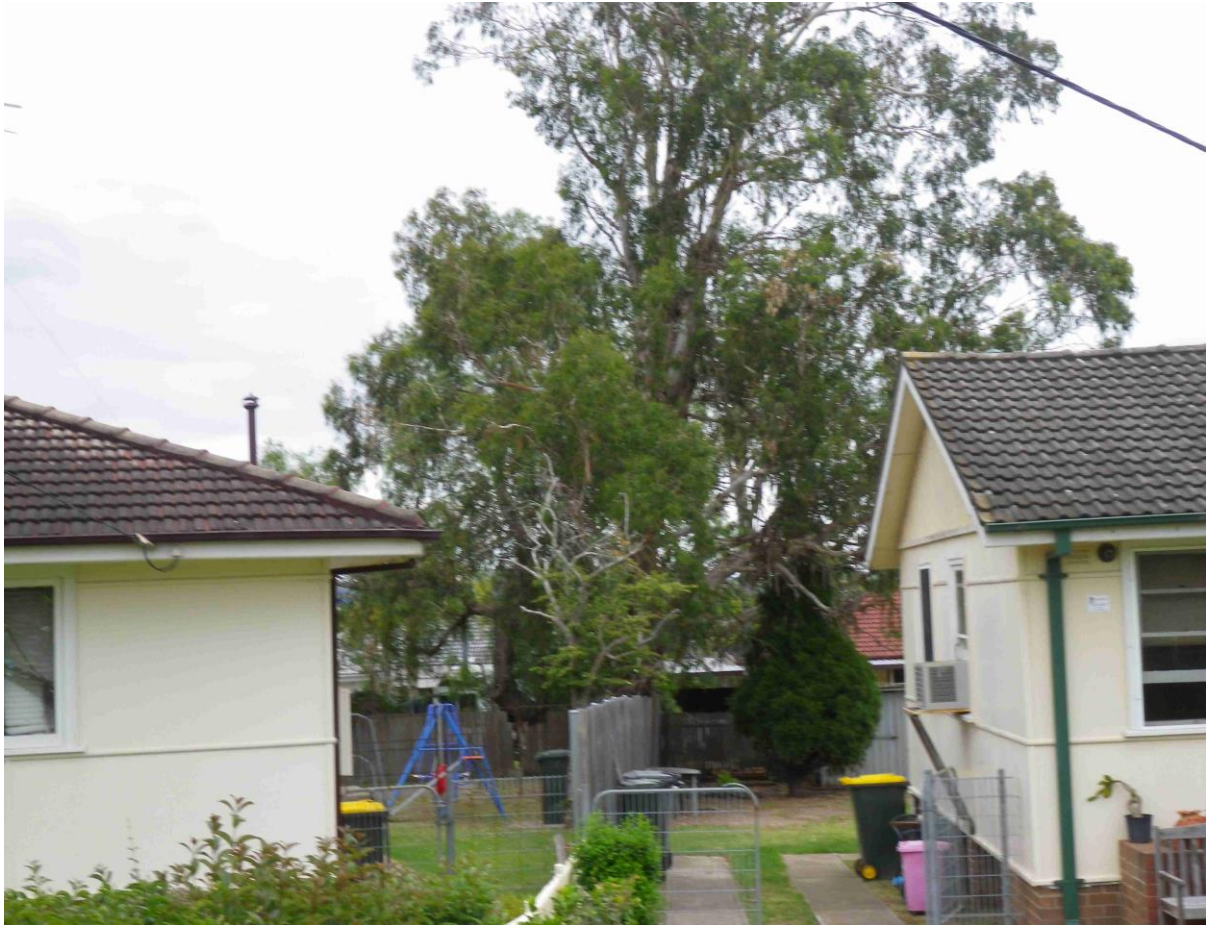
**Figure 9 Shows trees located on top of the sewer main.**

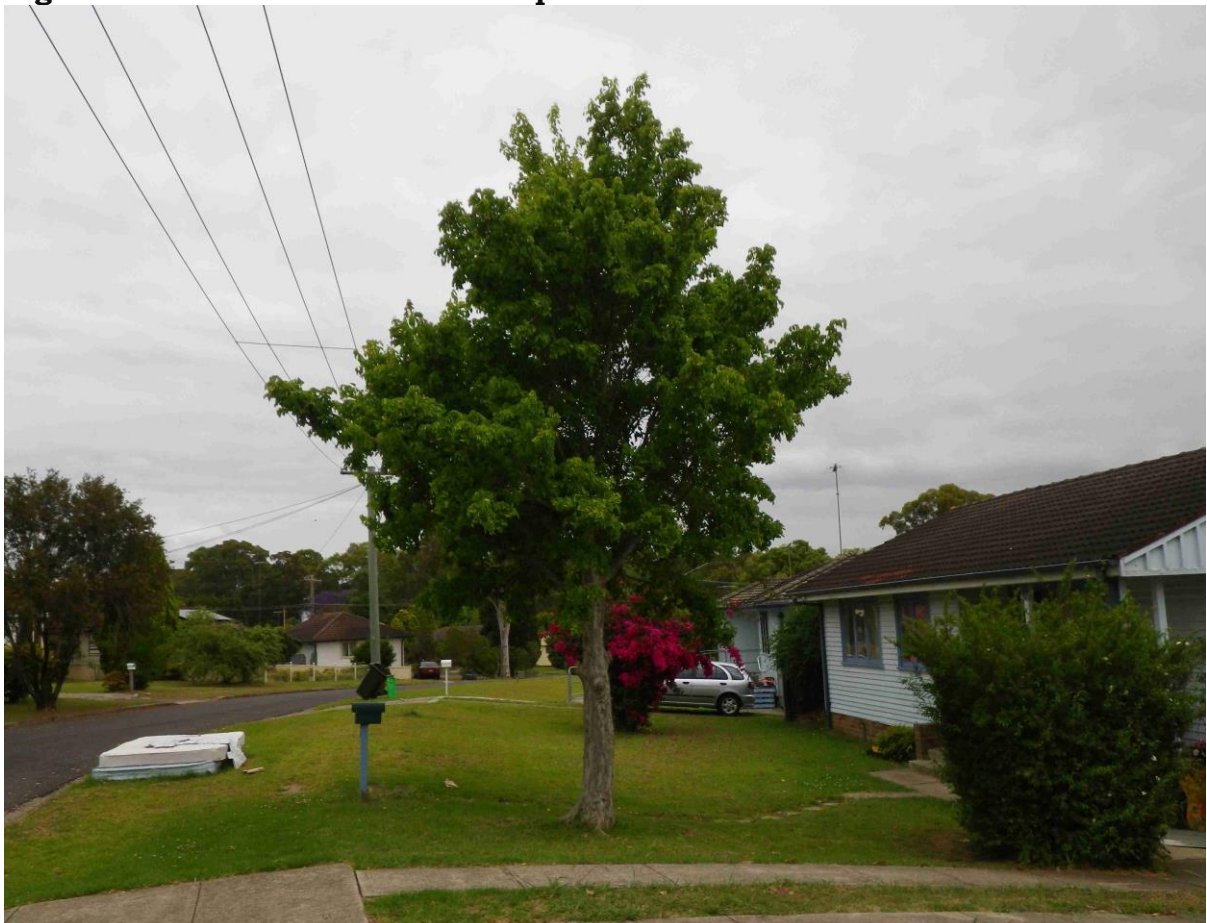
**Figure 10 Shows Tree Number 2 in the front lawn.**

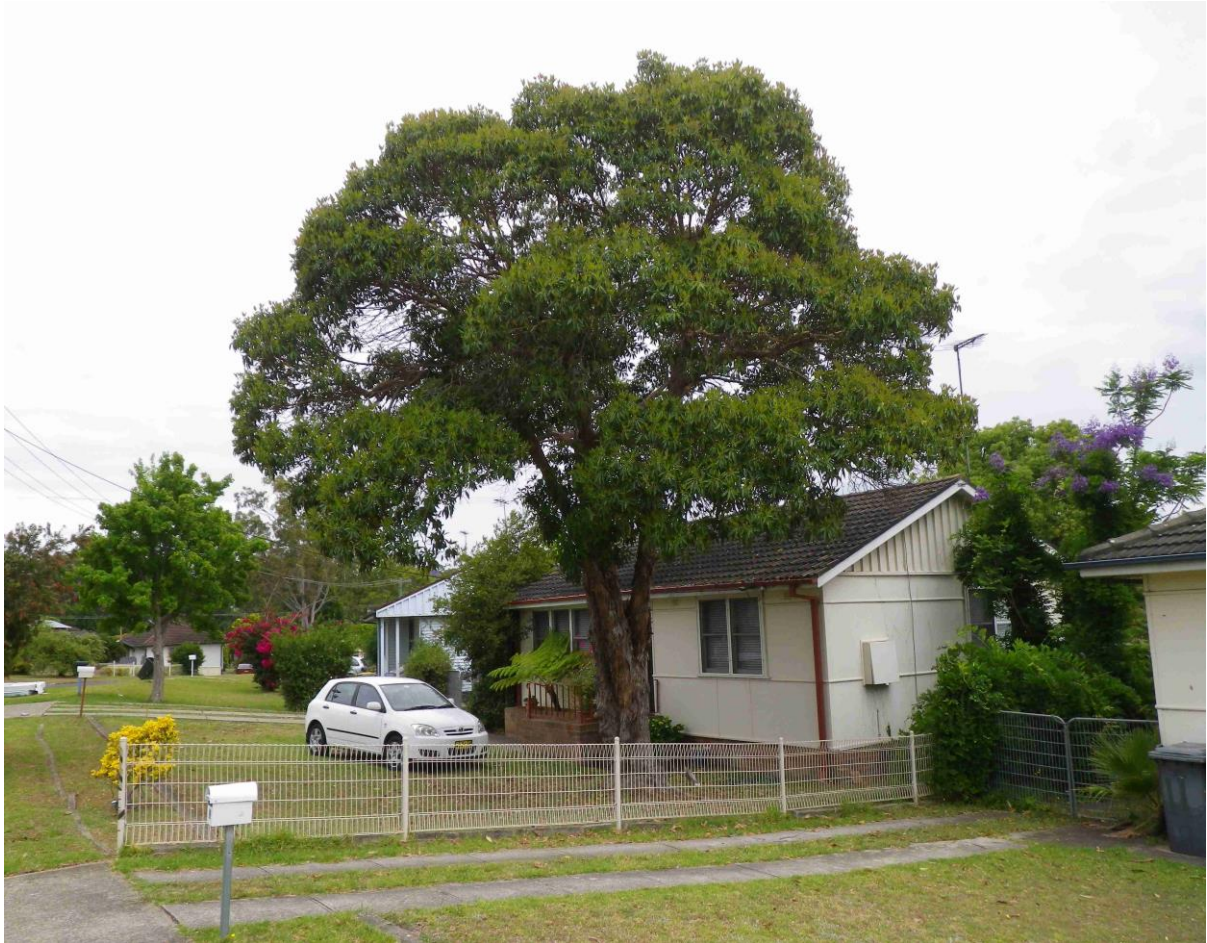
**Figure 11 Shows the brush box from a distance.**

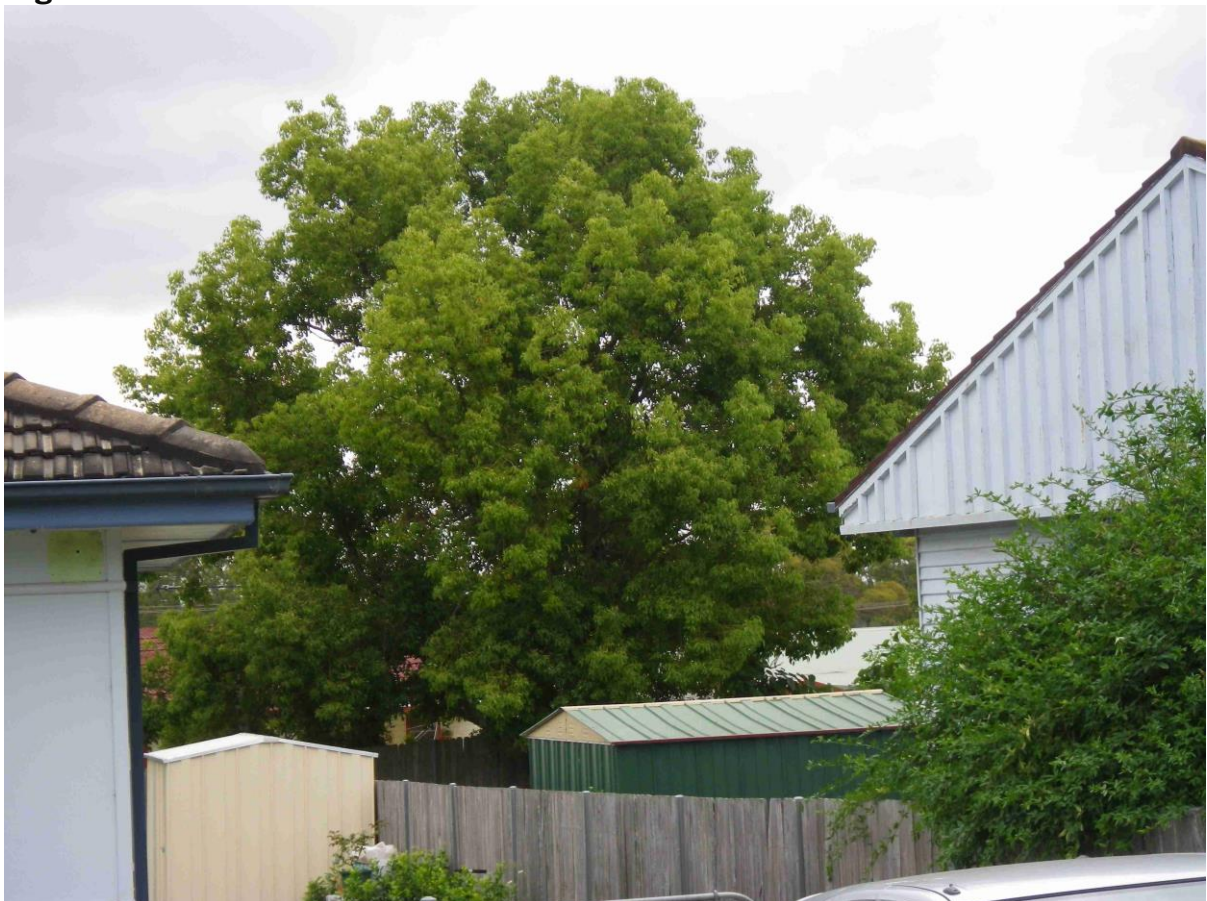
**Figure 12 Shows Camphor laurel located in the rear of the property.**
