Report on Geotechnical Investigation

Proposed Junior School Building St Philip's Christian College, Gosford Campus 20 Narara Creek Road, Narara

> > Project 75957 September 2015

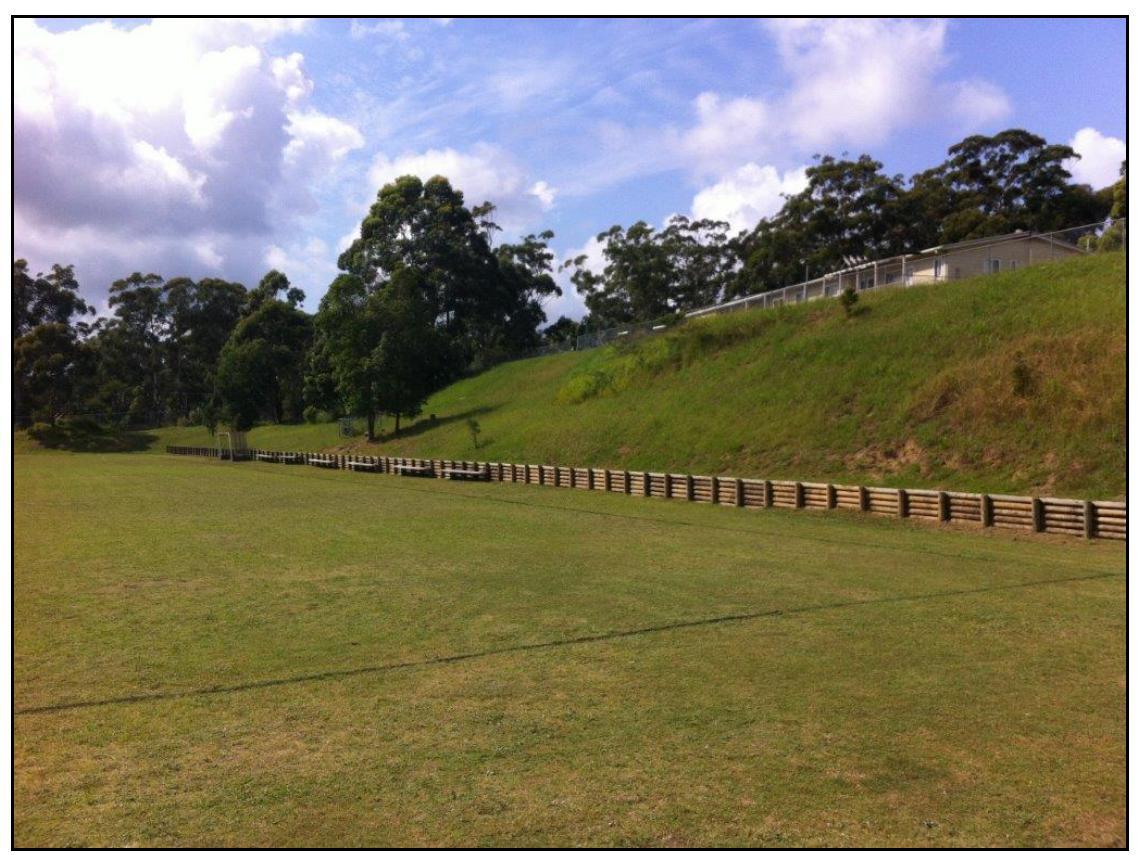
Figure 2: Area of the proposed Junior School Building looking from the north-west of the site.

- The footprint of the proposed junior school building straddles over a batter slope that is about 7 8 m high. The batter falls down to the north at slopes of between 25° and 40°, with the steepest section towards the western end of the batter. The lower third or the eastern half of the batter is significantly flatter and slopes at about 10°- 15°. There was no slumping or significant creep observed in this slope.

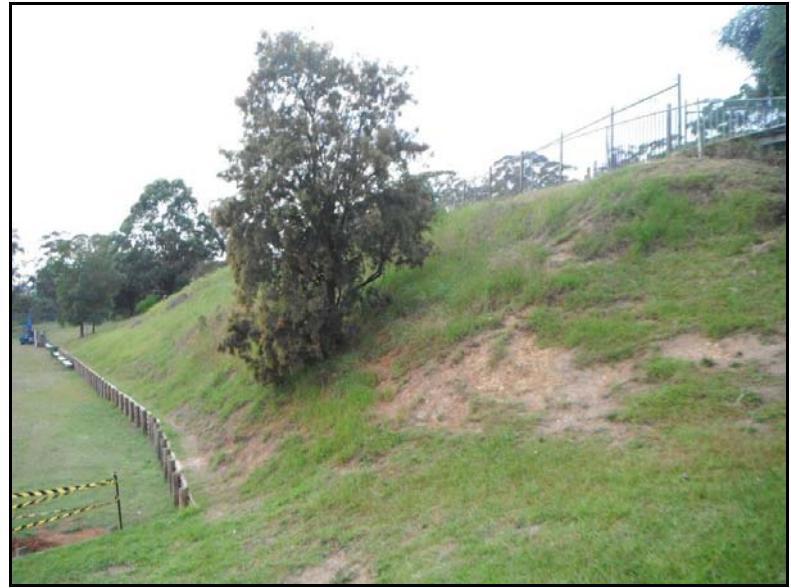
- A 0.8 m high timber retaining wall was located at the toe of the batter. No rotation, leaning or displacement was observed in the wall.
- Several patches of bare soil were present at the western end of the batter and were observed to expose mainly sandy clay filling (refer to Figure 3).

Figure 3: Photo showing the western end of the batter with filling exposed.

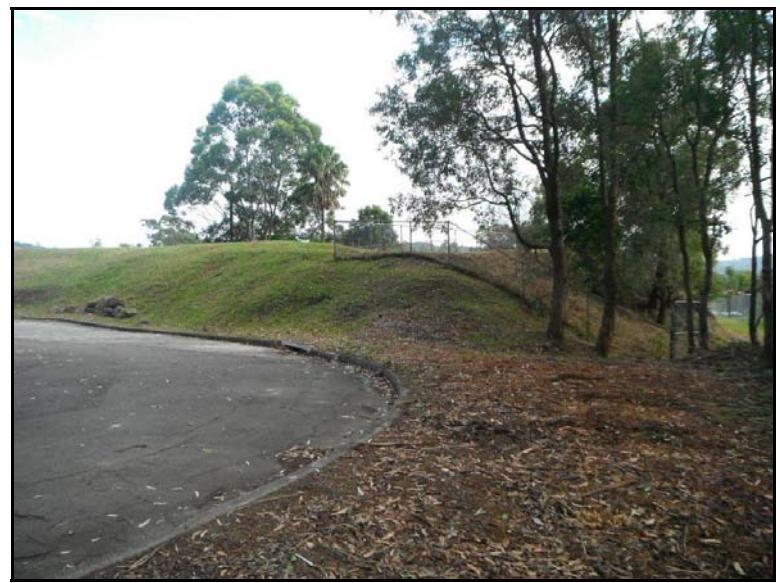
- A demountable classroom block is present slightly beyond the crest of the batter. No cracking or evidence of settlement was observed within the building or concrete pavements that surrounded the building.
- The school hall is located to the south-west of the development area, and approximately 10 15 m to the south of the batter. No cracking or evidence of settlement was observed in this building.
- Based on comparison of the surface topography with that of the hillside further beyond the development area, it appeared that much of the area to the east of the existing demountable classroom block comprised extensive filling that was estimated to be about 3 – 5 m deep (refer to Figure 4).

Figure 4: Photo showing the western end of the filled area.

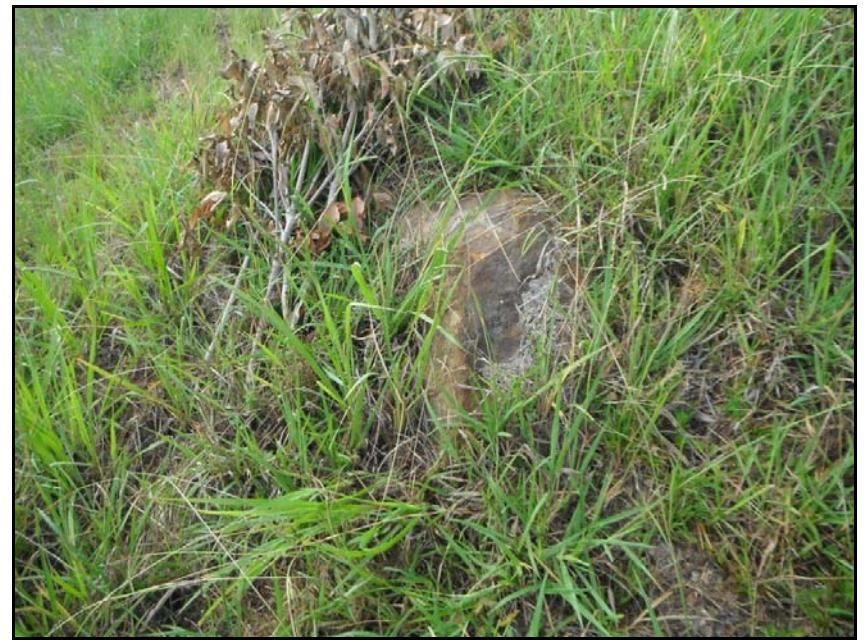
- Areas further upslope of the development area had been terraced to accommodate school buildings, roads and footpaths. No signs of settlement or hillside instability were observed in the vicinity of the proposed junior school building.
- Occasional sandstone boulders were protruding from areas of existing filling (refer to Figure 5).

Figure 5: Sandstone boulder exposed within the development area.

Given the subsurface conditions encountered in the boreholes, it is expected that uncased concrete bored piers would be a suitable footing system for this project. A few sandstone boulders were observed protruding from the ground surface, and other civil work at the school has encountered buried boulders and other large objects in the filling; whilst no large objects were encountered in the test pits and boreholes, it is possible that some may be present within the fill batter and, if struck during drilling, would present difficulty with installing the piers. Such potential obstructions should be removed during the reworking of the existing filling.

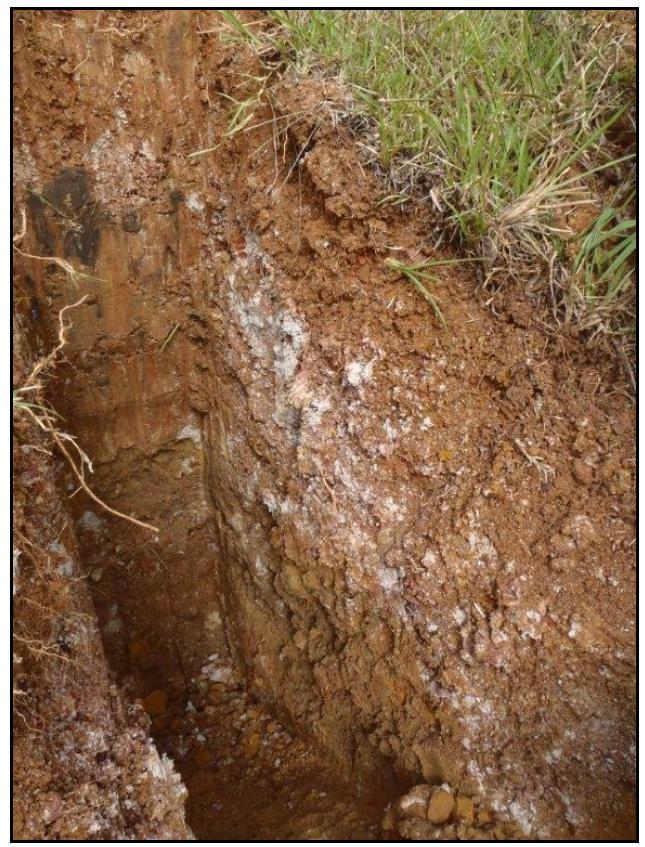
Figure 6: Filling encountered at Pit 6.

From the conditions encountered, it appears that the majority of the slope has been constructed by the placement of filling onto the side of the hill rather than cutting into the hillside. SPT blow counts were relatively low ('N' values generally less than 5) within the filling indicating that it is poorly compacted.
