## Vertical Transportation Design Statement – Marrickville Community Hub Development

# **ARBORICULTURAL IMPACT ASSESSMENT**

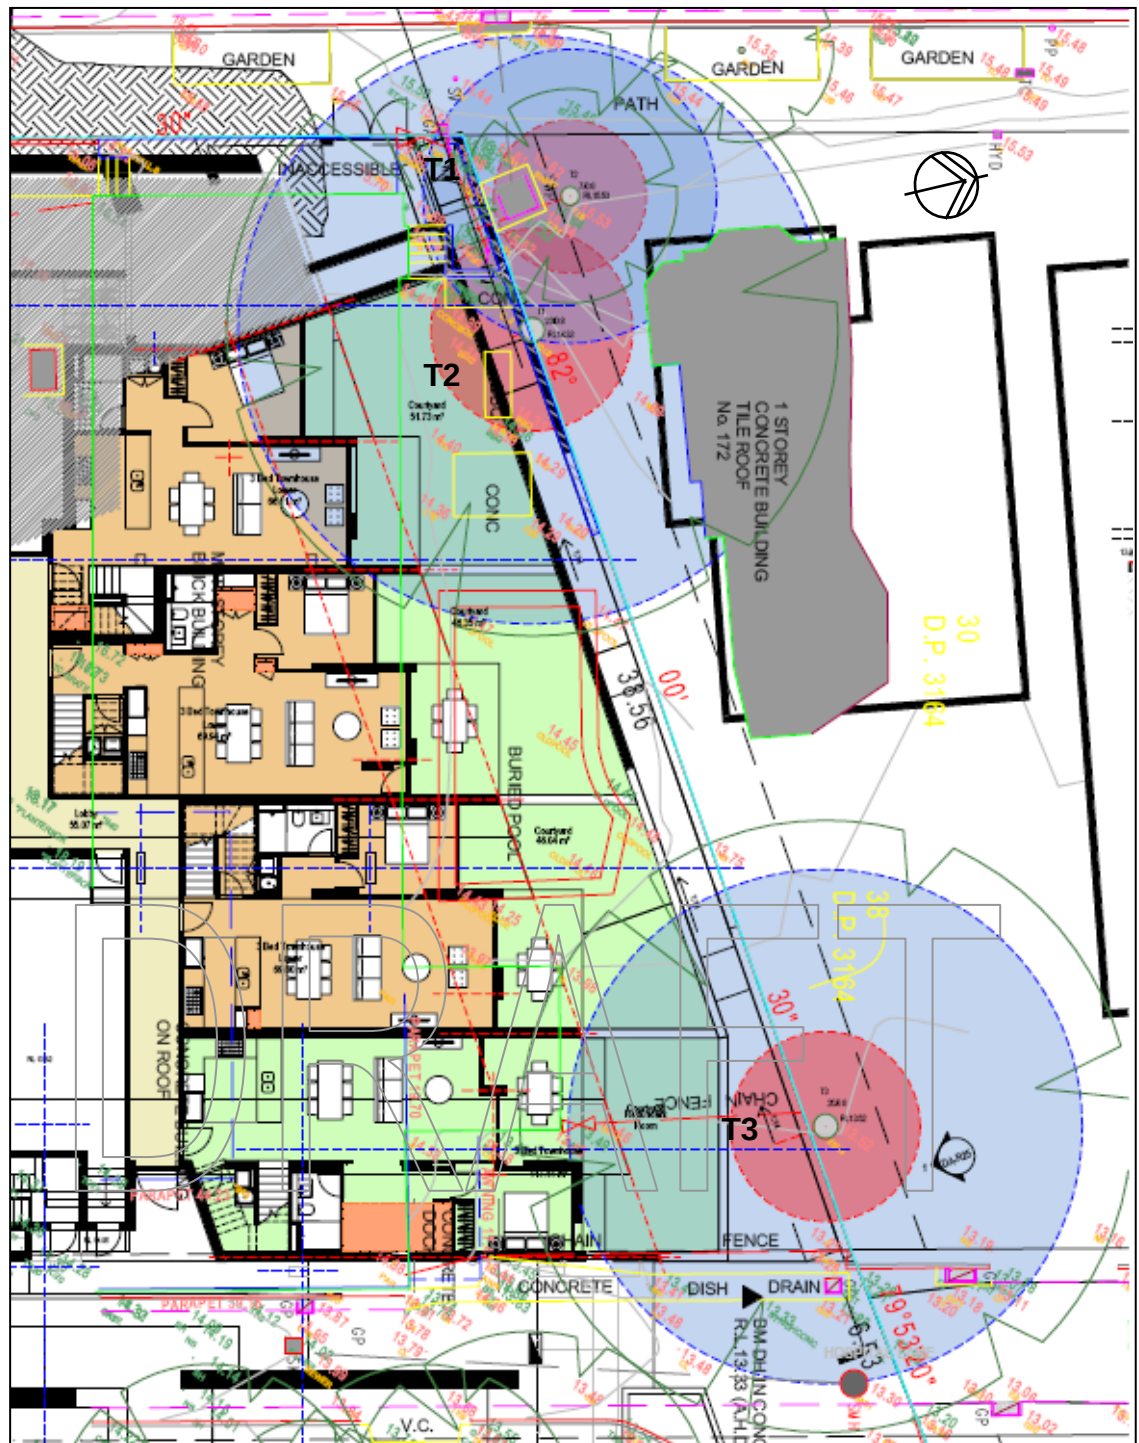
**Figure 1**

Shows the approximate location of Trees 1, 2 and 3 in relation to the proposed development, adjacent to the proposed north walkway. The trees notional SRZ's (red, inner circles), TPZ (blue, outer circles) are shown to illustrate potential impact areas. Not to scale.

- Root mapping to determine the impact on the SRZ of both trees.
  - Close arboricultural supervision of works within the TPZ of the adjoining trees 1—3 is required to minimise any possible damage to the trees occurring during demolition, excavation and construction works.

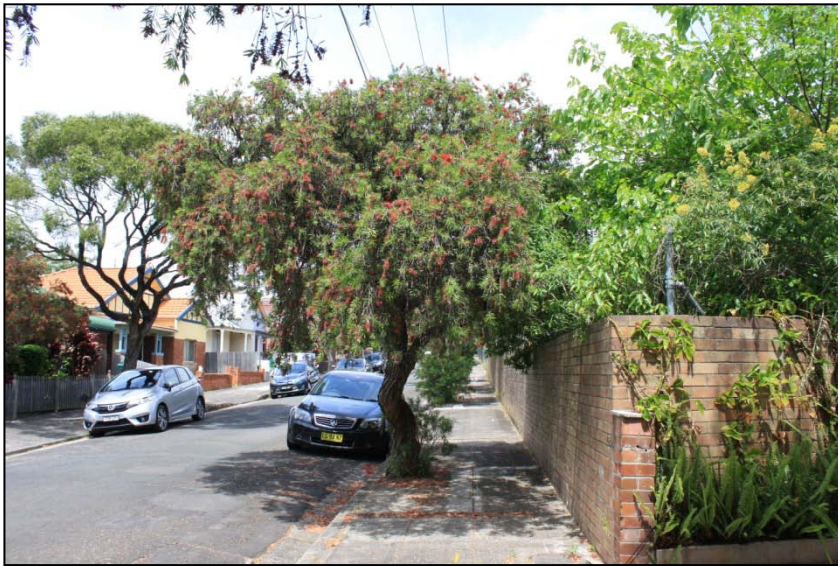
**Plate 1 (left)**  
Looking south towards Tree 14. Illustrating the proximity of trees to the adjoining, future Marrickville Community Hub site.

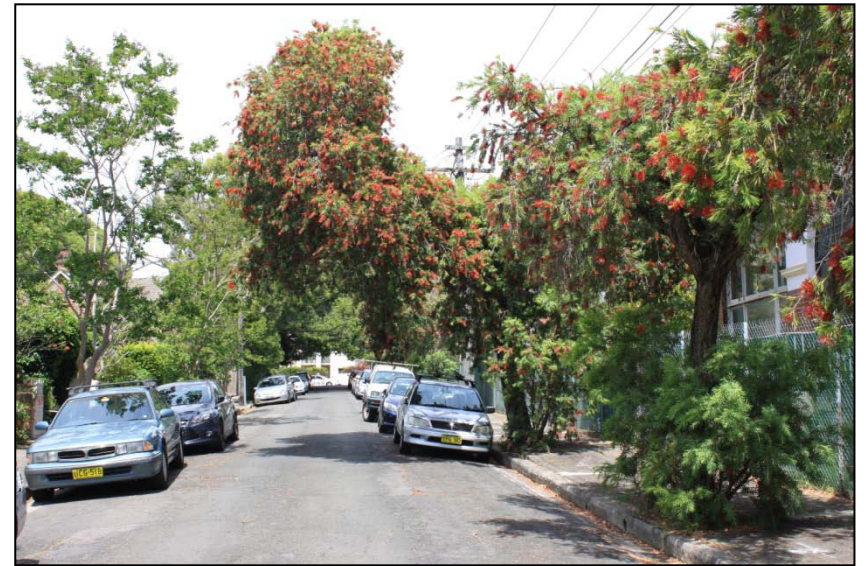
**Plate 2 (right)**  
Substantial pruning to clear power lines has resulted in prolific growth, potential branch end-weight issues, and encouraged basal shoots, which affects visibility from the footpath to the road.

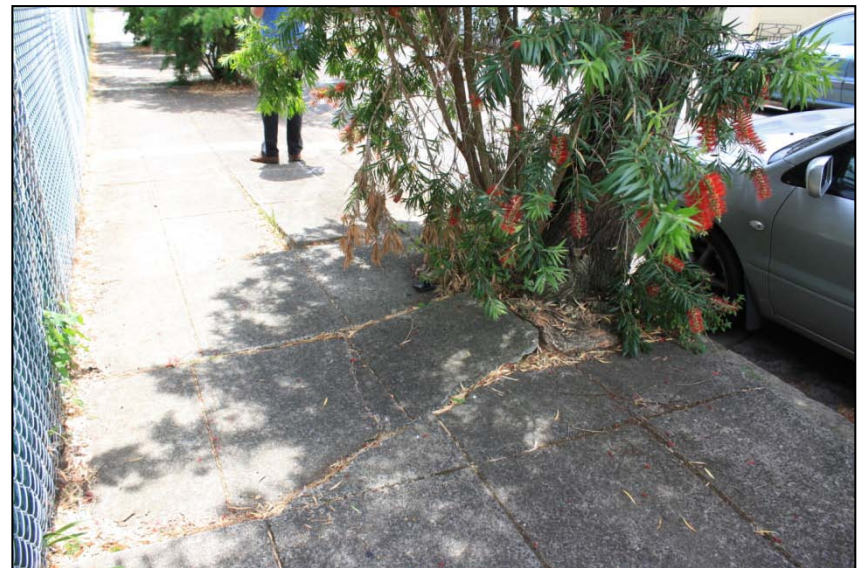
**Plate 4 (right)**  
The base of Tree 8, showing the substantial cracking and lifting of the pavement.
