ARBORICULTURAL ASSESSMENT REPORT

Clancy Catholic College 201 Carmichael Drive West Hoxton

Fulton Trotter Architects

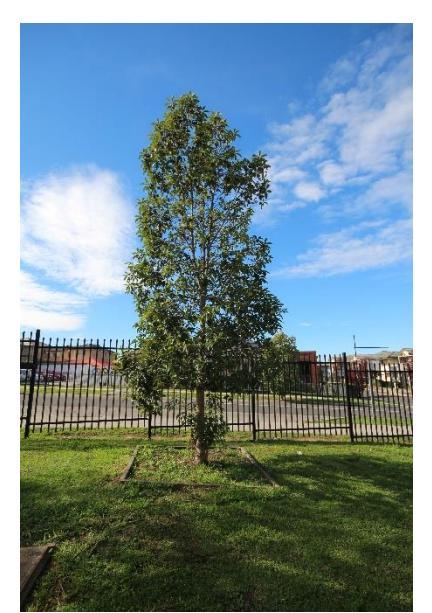
2. Trees 2A, 2, 3, 4, 5, 6A, 6C, 7 & 8 *Lophostemon confertus* all have good vitality and form except for tree 6A (multiple trunks). Tree 2A & 4 is outside the proposed building works and can be retained and protected in the Tree Management Plan (TMP). All of the other trees are located within the building and will, need to be removed to construct Block M and the new entry Courtyard. Trees 2, 3, 4 & 5 are mature trees with good vitality and form – refer plate 1. It is possible to transplant these trees for reuse on site as they respond readily to the shock of transplanting. The site soil is a clay which is a benefit when transplanting these trees – the root plate will be stable and easily prepared for transplanting. Removal of trees 2, 3, 5, 6A, 6C, 7 & 8 is supported with the reuse of trees 2, 3 & 5;

Photo of tree 3 showing the form and condition of this specimen

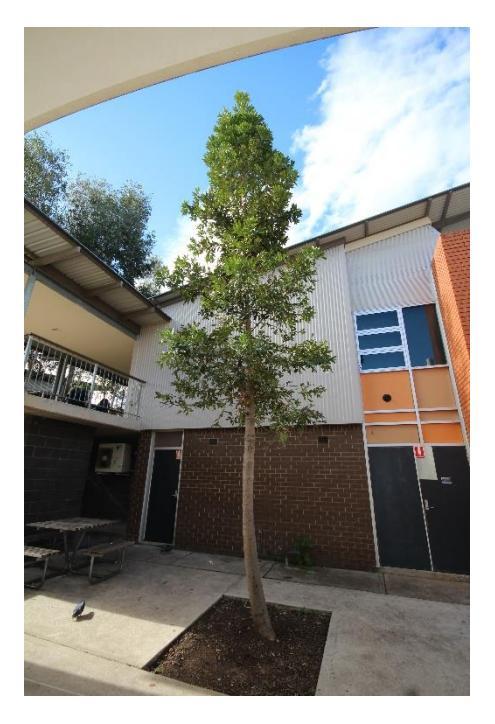
Plate 2

5. Trees 9 - 15, 17 - 20, 24 - 34 *Agathis robusta* (on the whole good vitality and form) – refer plate 2. The Kauri Pine is a long lived hansom tree in maturity, able to adapt to the climate and soils at West Hoxton. These trees will be impacted by the building works associated with Block L, M and the associated open courtyards. However all these trees are of an ideal size and health and can be easily transplanted on site. Transplanting of these trees is recommended;

Photo of tree 20 – typical of the Kauri Pines for transplanting

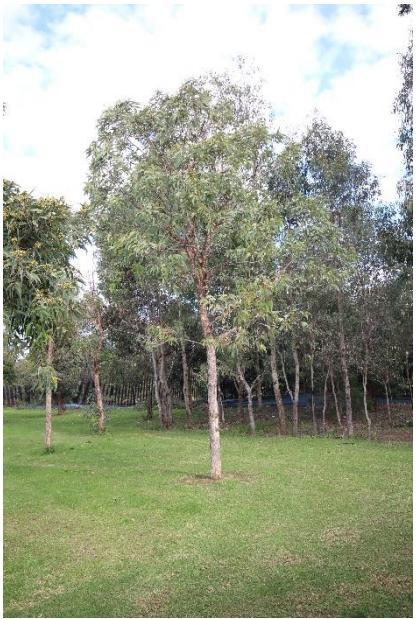
7. Trees 35A *Lophostemon confertus*, 35, 36, 37 *Eucalyptus eximia* all show good vitality except for tree 35A (Average vitality from being in a permanent bog). All these trees are within the southern end of Block L and the proposed playing courts – removal supported due to relatively small development – refer plate 3 Plate 3

Photo of tree 37 showing semi-mature size

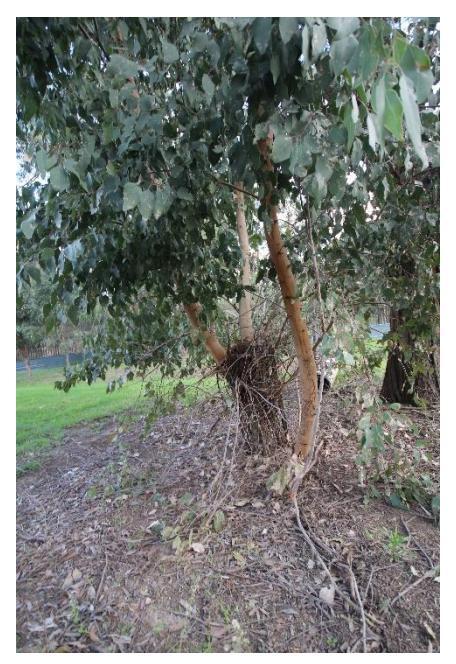
12. Tree 44 *Eucalyptus amplifolia* has previously been lopped at 600mm with the entire canopy being epicormic regrowth branches – refer plate 4. This tree should be removed regardless of any development works; Plate 4

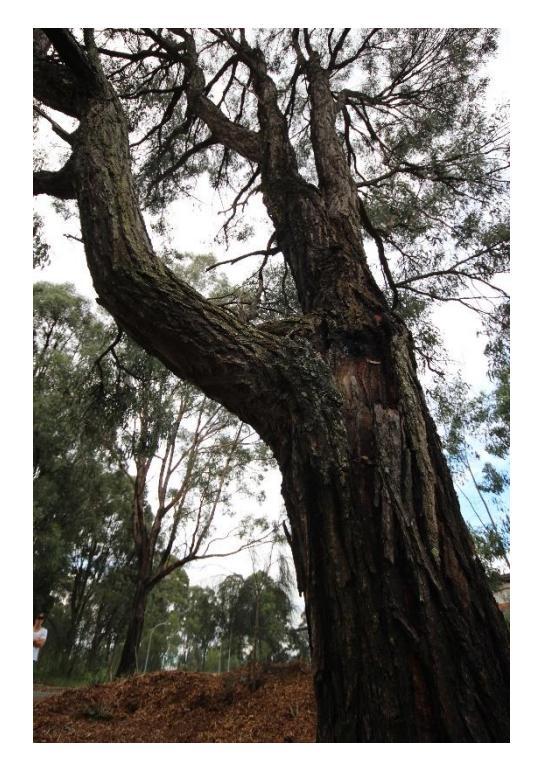
17. Tree 51 *Eucalyptus fibrosa* shows fair vitality but suspect structural stability due a recent large stem failure, in all probability due to bark inclusion – refer plate 5. The structural integrity of this tree has been lost due to the recent branch failure as the failure is at the junction of the two remaining large stems. This tree must be considered a hazard and poses a danger to any user of this site. Removal is supported regardless of the development works;

Photo of the large branch failure from tree 51

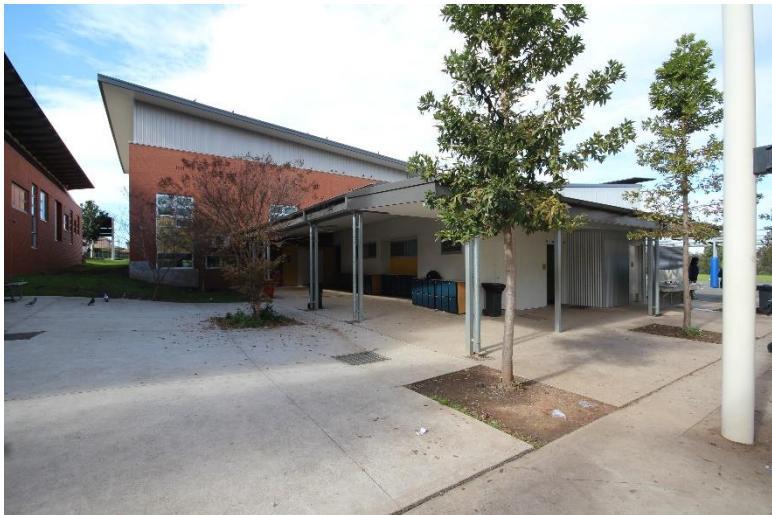
19. Tree 53 *Eucalyptus eugenioides* has a large termite mound at the base of the trunk (active termites were seen). The structural integrity of this tree has been compromised by the action of the termites. Therefore it is recommended for removal to ensure the ongoing safety of the staff and students at this college. Removal supported; 20. Tree 54, 54A, 56 & 59A *Eucalyptus paniculata*, tree 55, 59 & 60 *Eucalyptus eugenioides* and tree 59B *Casuarina glauca* have on the whole good to fair vitality. Trees 55 & 60 have genetic structural defects (included bark) that warrant their removal for safety reasons with this areas increased use. To remain; 21. Trees 61, 62 & 63 *Lagerstroemia indica* all show good vitality and typical form for this species – refer plate 6. These trees are within the building footprint and associated courtyard of the works for Block M and will need to be removed. These trees are of a size and species that can be easily transplanted for reuse on site. Plate 6
