# **Limited Geotechnical Investigation**

No 176 Salamander Way, Salamander Bay

St Philip's Christian College

25 October 2017 5QS Ref: 7209

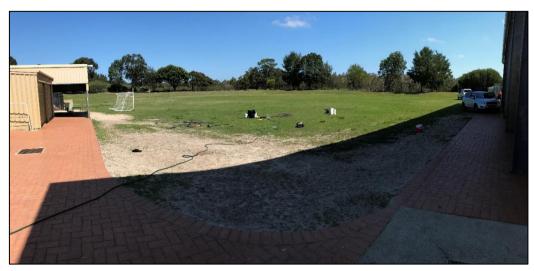
Photograph P1 – View south-east through south-west, taken from near the eastern corner of the basketball courts

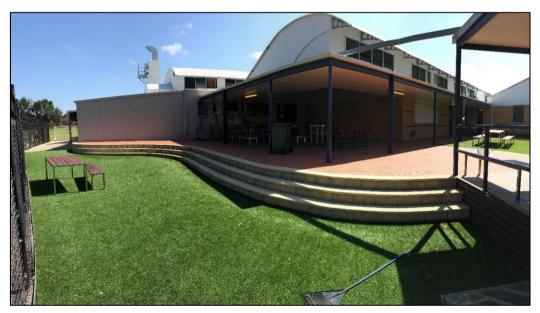
**Photograph P2** – View south-west through north-west, taken from near the eastern corner of the Senior School Building (to be demolished)

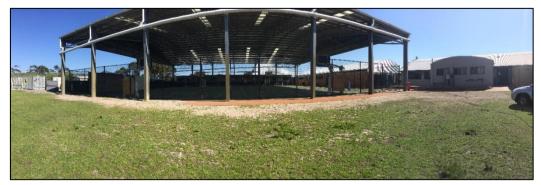
**Photograph P3** – View west through north, taken from existing sporting field to the south-east of the basketball courts
