Arboricultural Development Assessment Report

1-3 Thomas Street Lewisham NSW 2049 Lot 22 DP 827632

> FINAL April 2017 (Updated August 2017)

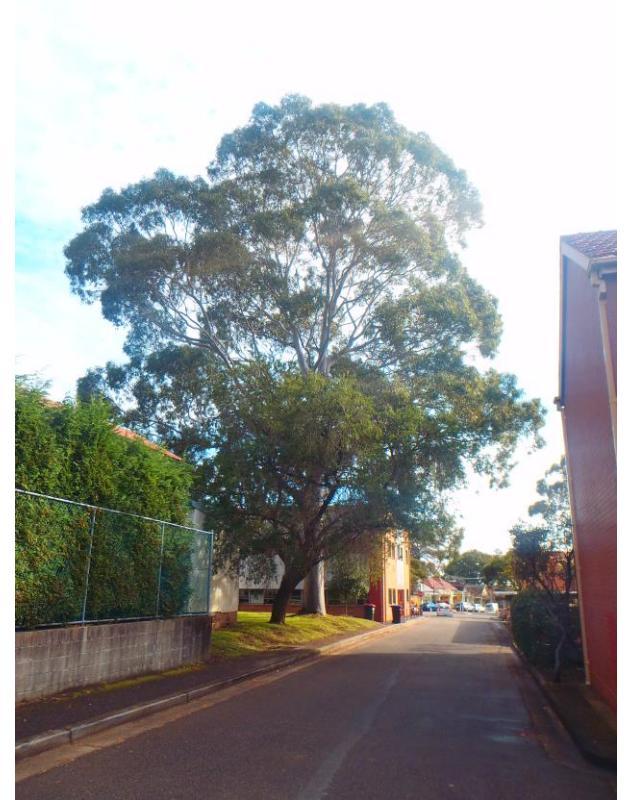
Tree 32 is a large, grand specimen of Lemon-scented Gum Tree (*Corymbia citridora*) located between Buildings 4 and 5. This tree is in excellent health and condition and appears free of any cracks, splits or fruiting bodies. Due to the existing curtilage surrounding this tree, pruning has been minimal resulting in a broad spreading canopy. The base of the tree consists of a lawn area that has had minimal compaction over the years and, as such, has helped to provide one of the best specimen trees on site. Car parking is proposed below this tree that will be within the calculated TPZ.

Plate 1: Image showing Trees 32 and 33 to be retained. P. Vezgoff.

- **4.5** The root zones of **Trees 32, 33 73, 74 and Tree Group 83** will require protection from compaction. Compaction of the root zone reduces oxygen and moisture exchange of the roots. This will lead to premature death of the tree. To reduce compaction of the root zone mulch is recommended to be spread around the base of the tree to the extent of the TPZ fencing.

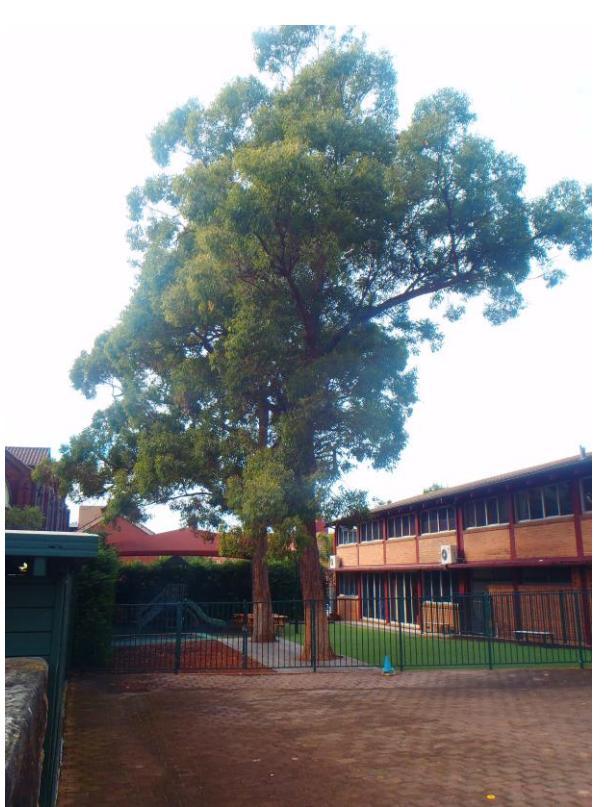
Trees 73 and 74 are mature Tallowwood trees (*Eucalyptus microcorys*) that are in good health and condition. These trees are growing in a playground area and should be regularly checked (annually) for deadwood due to the target area below them. Extensive landscape works are proposed below these trees (Plate 2).

Plate 2: Image showing Trees 73 and 74. P. Vezgoff.

4.7 The removal of the concrete below Tree group 83 and the existing artificial turf below Trees 73 and 74 shall be undertaken so as to pull the concrete away from the trees. A flat bucket excavator is recommended. A spotter shall be present to ensure overhanging branches are not damaged. These works below Tree group 83 should be supervised by the Project Arborist. Once the concrete is removed the project Arborist may recommend remedial actions such as drip irrigation or addition ground protection until the final surface finish can be completed.

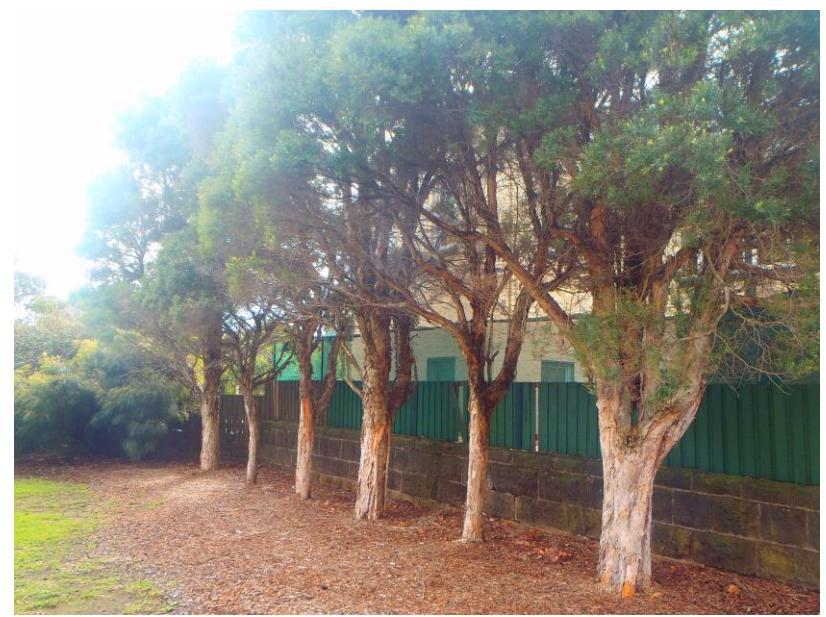
Plate 3: Image showing Trees 78-81. P. Vezgoff.

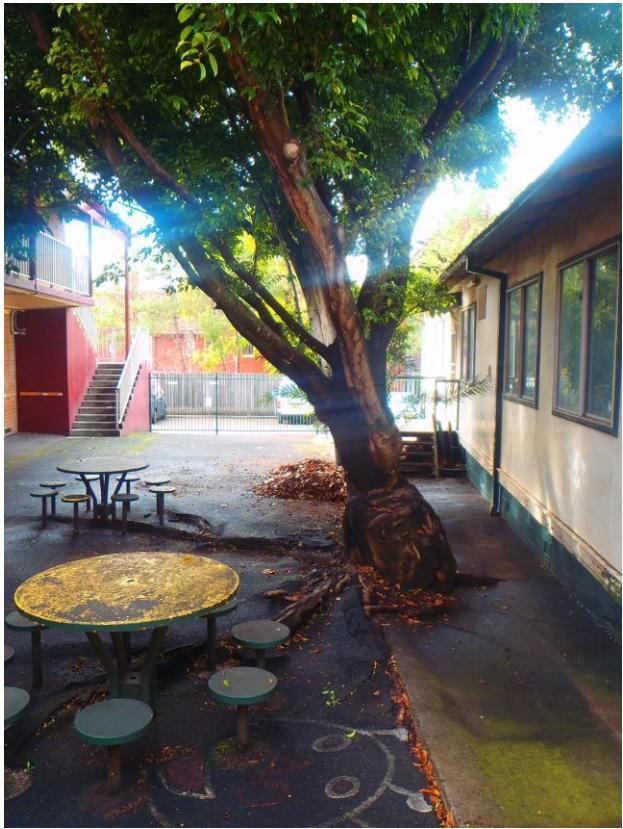
Tree 75 is proposed to be removed to allow for the school extension. This tree is a mature Weeping fig (*Ficus benjamina*) and in most Council areas has been previously listed as an exempt species that is not highly valued. As seen in Plate 4 the building next to this tree has now been removed. This structure was within the SRZ area of this tree and it is likely woody roots were damaged during the demolition process. A low value tree for the site this tree is recommended for removal.

Plate 4: Image showing Tree 75. P. Vezgoff.

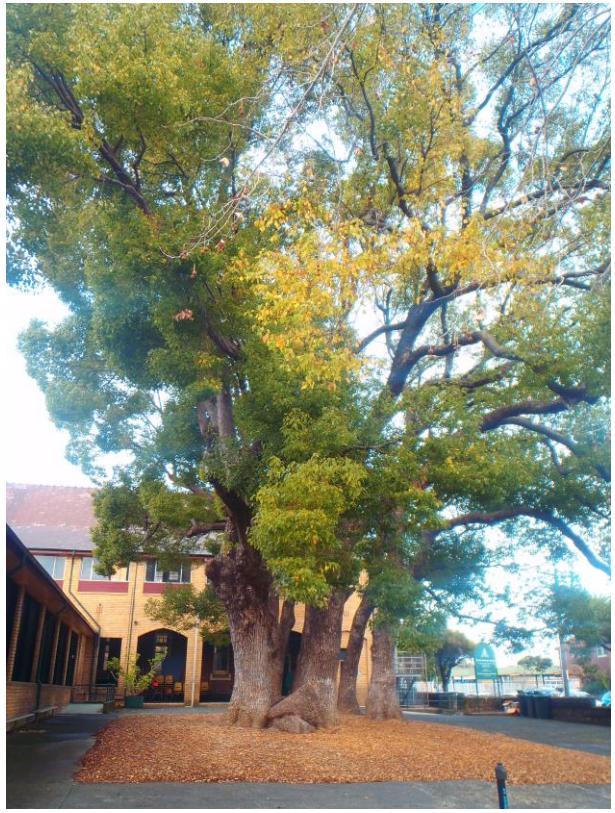
Plate 5: Image showing Tree group 83. P. Vezgoff.

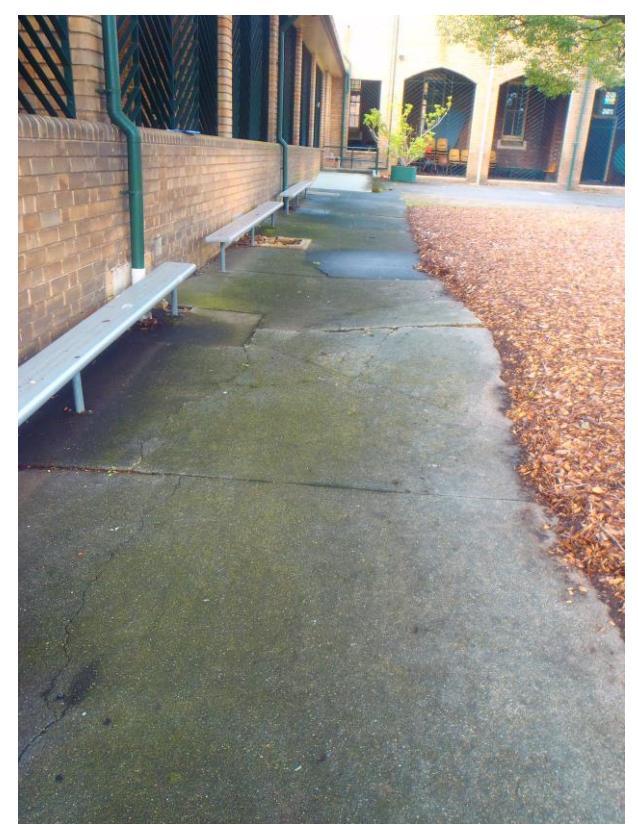
Plate 6: Image showing the condition of the concrete around Tree group 83. P. Vezgoff.

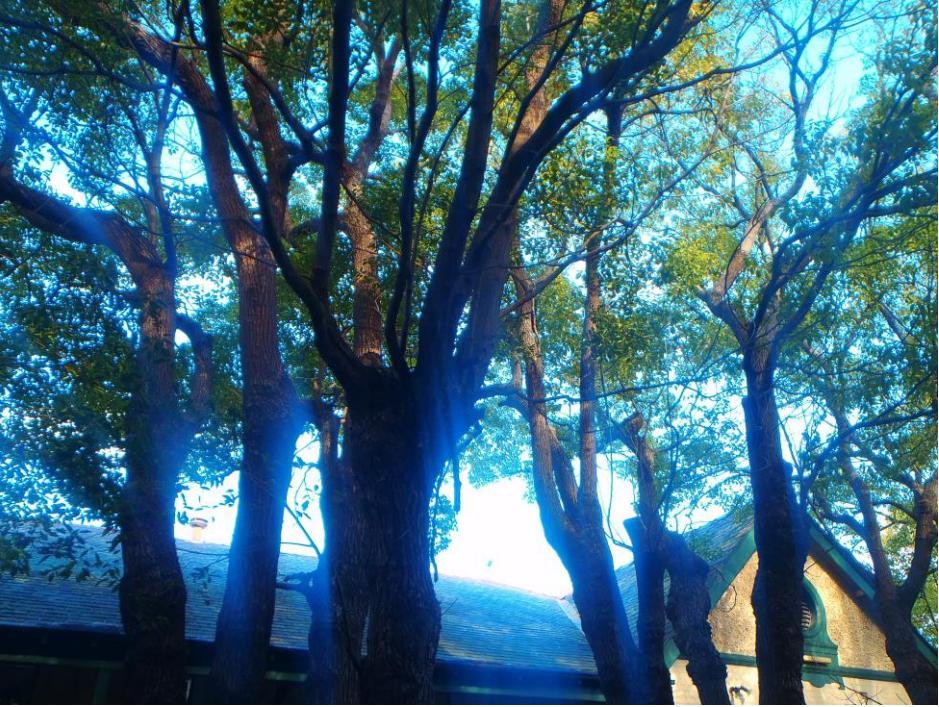
Plate 7: Image showing the dense canopies of Tree group 83 P. Vezgoff.

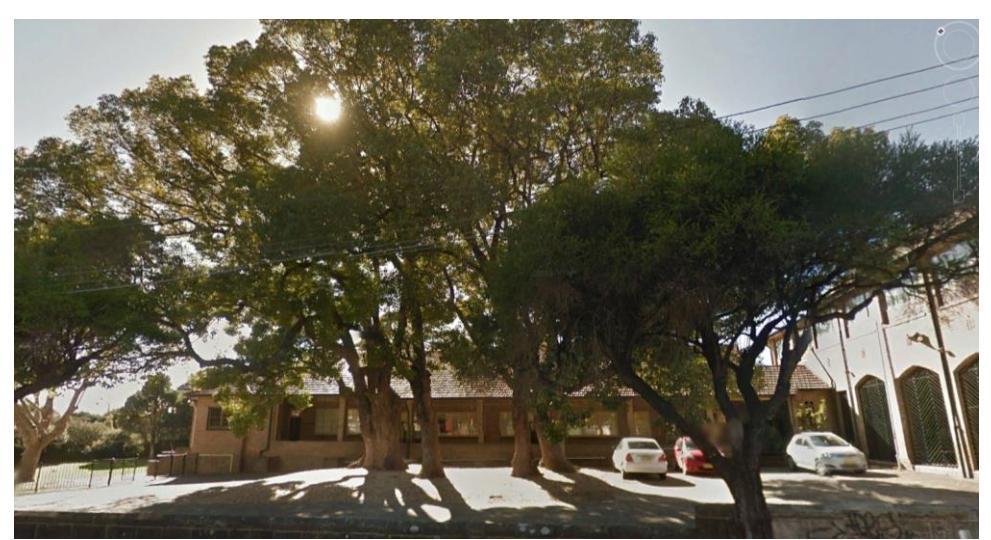
The largest group of trees on site is a group of six (6) Camphor Laurel (*Cinnamomum camphora*) located south west of Building 3 numbered as Tree Group 83 (Plate 8). As previously mentioned, it appears these trees were at a mature height in 1943 so they are potentially over eighty years old. This group of trees has grown as one and will have grafted root zones providing much stability. This grouping of canopies has also grown close together and formed a large single dome of canopy, visually apparent from the streetscape (Plate 7). Extensive woody roots will be present as noted by the lifted paving, shown in Plate 6. Although not native, I would still consider this group of trees as the next most significant group, aside of Tree 32. It is possible Council would request the retention of this group of trees due to visual amenity it provides from the

Plate 8: Image showing Tree group 83

4.6 The area over the TPZ of Tree group 83 is proposed to be used for car parking and vehicle access. It is recommended that this area has a surface that is permeable to water and oxygen. The suspended slab system below Tree group 83 will be permeable to water and oxygen to a degree and the addition of a watering system will also help the trees with any anticipated change in hydrology.

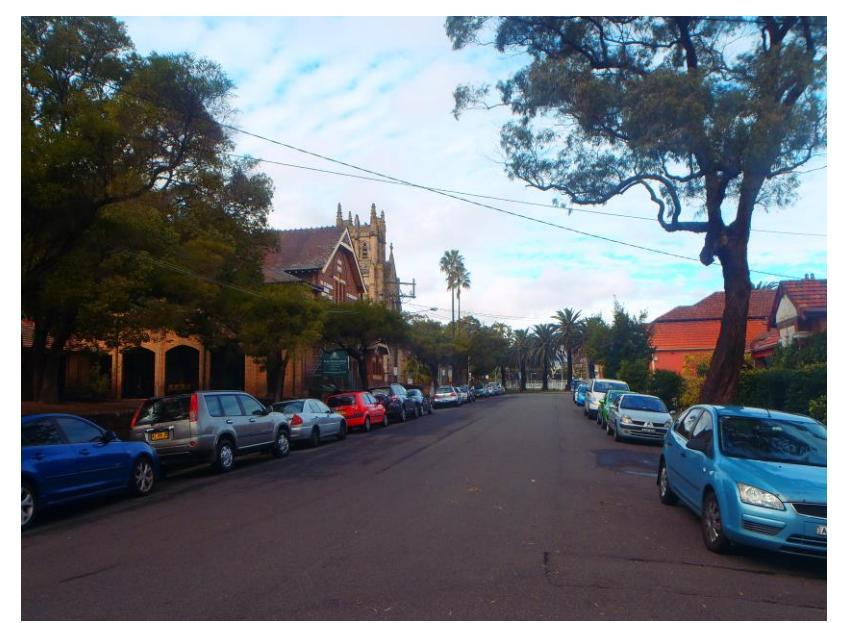
Plate 9: Image showing street trees along Thomas Street. P. Vezgoff.

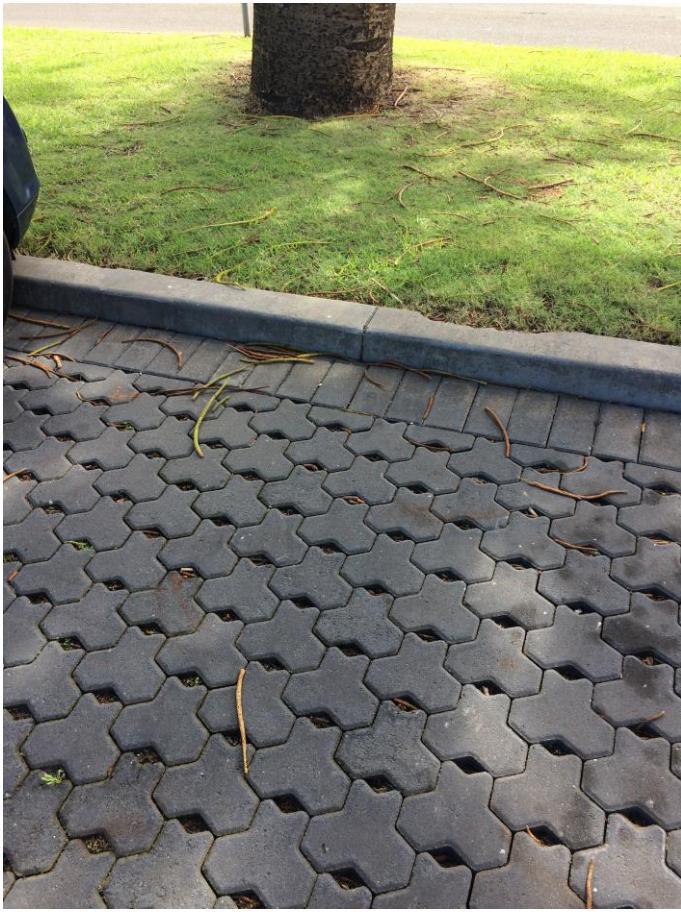
Plate 10: Image showing porous paving recommended below Tree 32. P. Vezgoff.

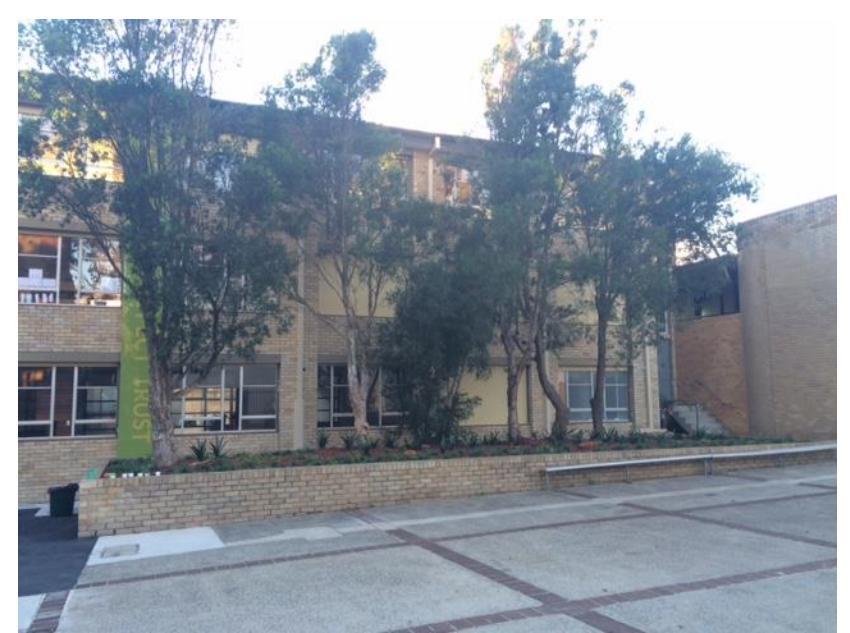
Trees 59-68 are all small trees or large shrubs that are growing in raised garden beds. Most of these raised garden beds are damaged to some extent, therefore long term retention of these trees and shrubs is not a long-term option but they could be retained for the short term. Trees 69 and 70 are both Weeping bottle brush (*Callistemon viminalis*) in small brick raised planter beds (Plate 11). These trees are in a similar situation to Trees 59-68.

Plate 11: Image showing Trees 60-68 in a small brick raised planter bed. P. Vezgoff.

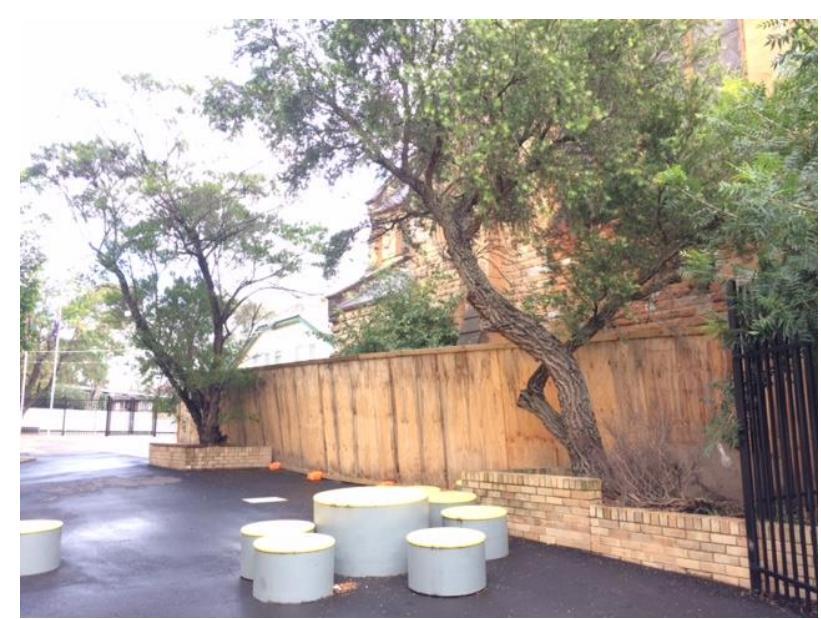
Plate 12: Image showing Trees 69 and 70 in small brick raised planter beds. P. Vezgoff.

| | | | | | Live | | | | | | TPZ | SRZ |
|---|---|---|---|---|---|---|---|---|---|---|---|---|
| | Weeping bottle brush | | | Multi | | visual | 3c Removed for a | | | Cracking brick planter | | |
| 69 | (Callistemon viminalis) | 7 | 4 | stemmed | 90 | defects | better specimen. | Poor | Mature | bed. | | |
