# Arborist Impact Assessment 2018

Prepared for  
**Residential Aged Care  
Facility**

C/o Adam Fahey  
11-15 Lang Road, 76-80 Marsh  
Parade & 542-536 Hume Highway  
Casula, NSW 2170  
**23<sup>rd</sup> May 2018**

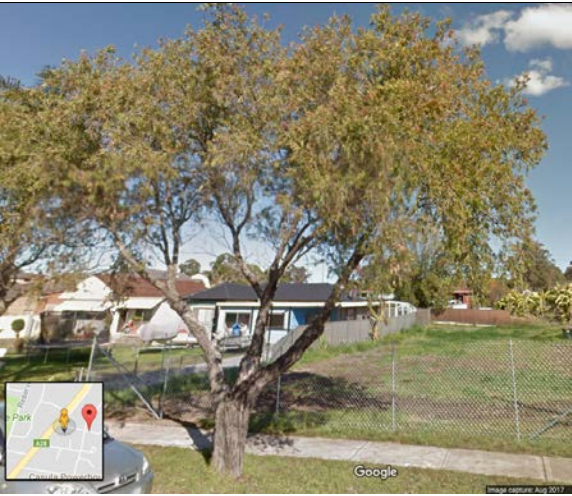
| <p>Plate 2. Street Tree 83 impacted by access to the development. Moderate value. (Courtesy Google Maps).</p> | <p>Plate 3. Tree 83 existing to be removed for access. Site Plan GSA 2017.</p> |

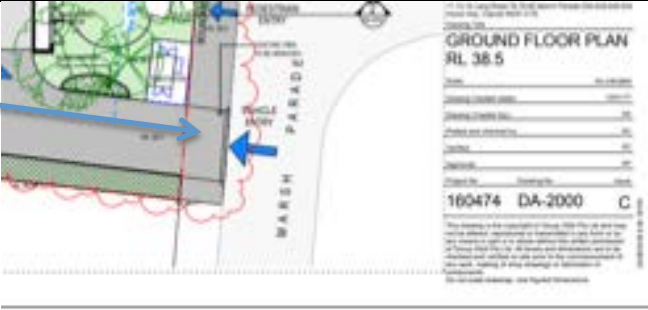
| <p>Plate 4. Indicates the revised plan access where tree 83 will be removed. Blue arrow.</p> | |
