# arboricultural impact assessment report

## AIA-01

Revision B, Issued for Development Application  
9 March, 2018

**Adventist Aged Care –  
RACF Extension and New ILU's  
54-56 Elsom Street, Kings Langley**

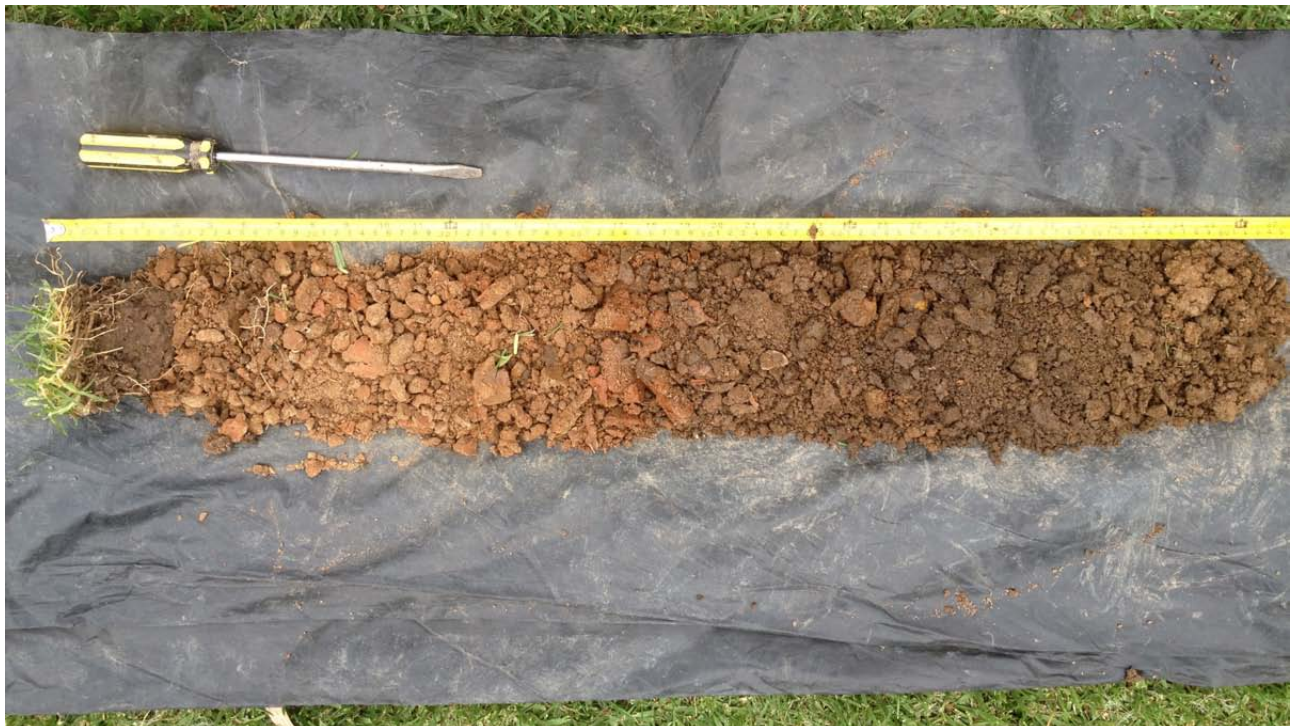
The sample results are summarised as follows. The top soil (A Horizon) is likely an imported sandy loam with an apedal structure and shallow to only 100mm deep. The next layer from 100mm-500mm is a medium to heavy clay soil more consistent with the subsoils found on the site naturally. The pH of this material was very slightly acidic at 6.5. Its structure is a coarse to medium blocky pedal structure.

This profile arrangement is probably as a result of previously excavated subsoil material being placed as a fill layer over the pre-existing topsoil profiles to level and raise the area where the sample was taken. This would be consistent with the use and character of the site. The bottom half of the profile is then more consistent with what would be expected from the naturally occurring soil profiles described for the Luddenham soil association. The material from 500-800mm is a dark brown clay loam with a medium to coarse sub angular blocky structure with a pH of 7.0.

*Figure 2 – Typical Soil Profile to a depth of 1m. Note the soil profile appears to be altered and inverted. This is probably as a result of excavated subsoil material previously being placed as a fill layer over the existing topsoil profile to level and raise the area where the sample was taken. The bottom half of the profile is more consistent with what would be expected from the natural soil profiles. The fill material was then topped with 100mm of imported sandy loam topsoil to apply the grass. (Photo: Arterra)*

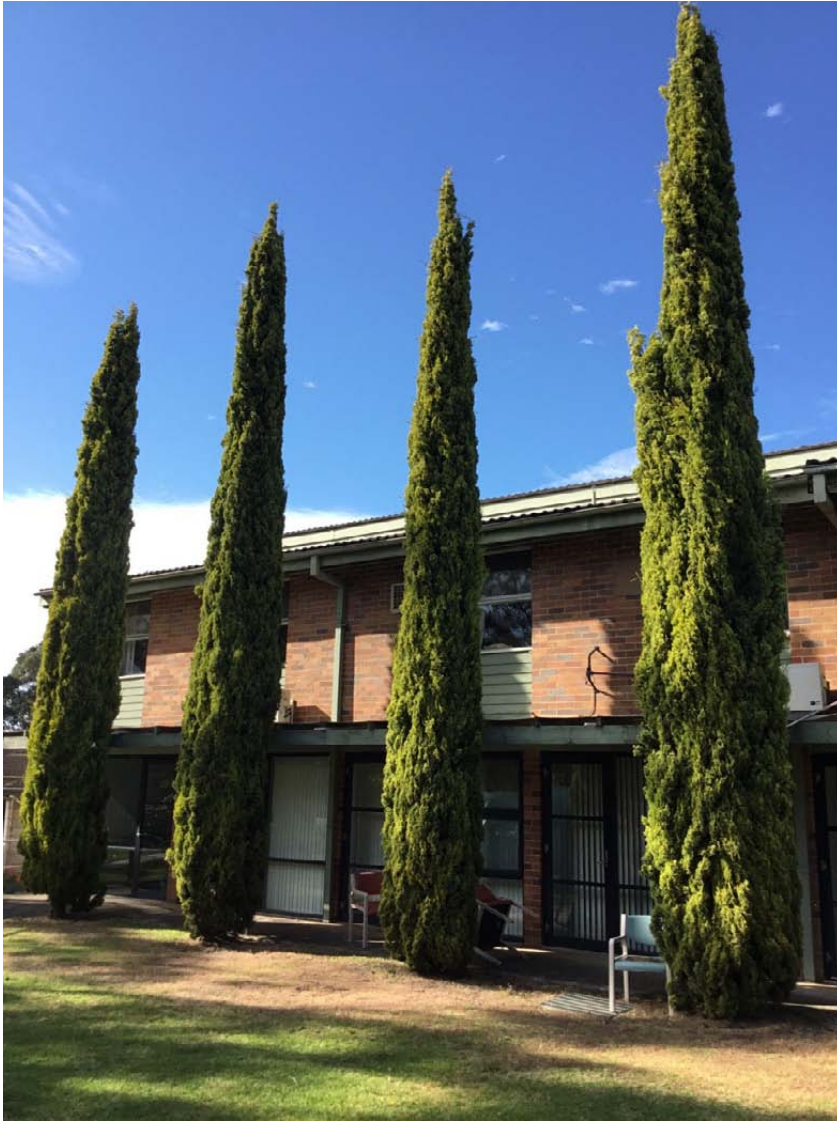
*Figure 5 – The site contains numerous Swanes Golden Pencil Pines. These trees are located in very close proximity to the buildings to be demolished and cannot realistically be retained or adequately protected during the construction operations.*

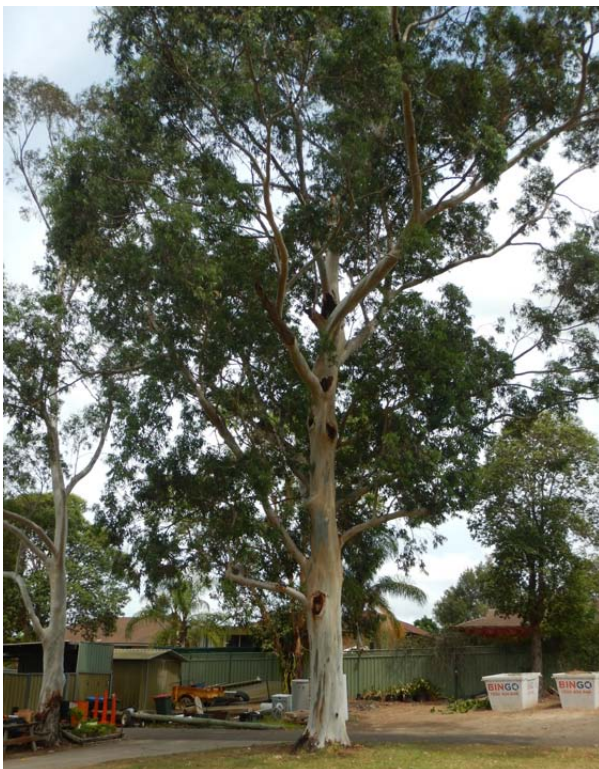
**T69**, although currently displaying good vitality, is a large Sydney Blue Gum with significant cavities and defects at 8.5m, 11m & 12m height. There is also a history of previous significant branch failures throughout the tree canopy. It has significant structural weakness within the major body of the trunk due to the extensive Cockatoo damage and subsequent decay at most of the major branch junctions. Although the tree has compensated, to various degrees, for these weaknesses, by putting on additional wood around the cavities, there are still very major structural deficiencies within this tree that cannot be realistically rectified or catered for in the site planning. In our opinion this tree would represent too great a risk if left in close proximity to underlying residences or within actively used roadways or car parking areas. In its current condition it is also unlikely to tolerate any significant disturbance around its base. It is extremely likely to continue to periodically shed very sizeable branches from its canopy. In the author's opinion, there is a very significant risk that major parts of the upper canopy of this tree could fail in a moderate storm or wind event.

Figure 7 –T69 showing structural issues including decay and historic limb failures.

Both T68 and T69 are, in the author's opinion, unsuitable to be retained within the context of an aged care development and accordingly are recommended for removal.

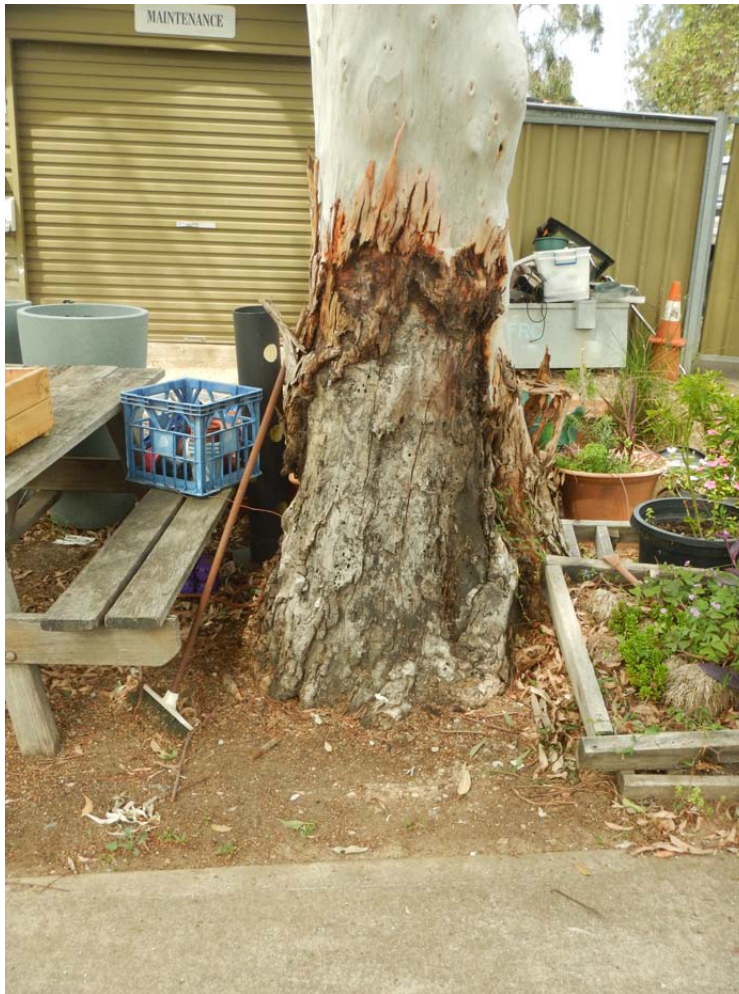
**T68** is relatively poor quality tree immediately adjacent to T69. It has a very asymmetrical canopy to the east and extensive wounding via borer damage to its base. This wounding is on the side of the tree under the most structural stress as the tree has a slight lean towards the east. The basal area affected is in excess of 50% of the trunk circumference at its base. This tree should not be retained as part of the development. Its condition is unlikely to improve as the area around it has been extensively compacted due to frequent trafficking and use.

Figure 8 –T68 showing extensive borer wounding and soil compaction at the base.

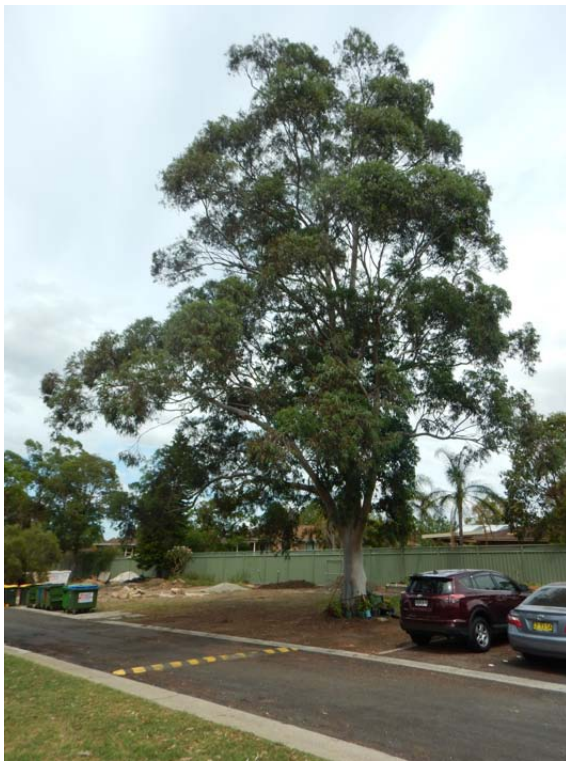
T60 – *Eucalyptus saligna* (Sydney Blue Gum)

T60, T106, T105 and T104 are all good quality, but large trees. They are all worthy of retention. T60 has a small defect on its south-western side which could be rectified with judicious and appropriate pruning, although if the area is left largely un-developed this could also be left without pruning. This would be the preferred outcome.

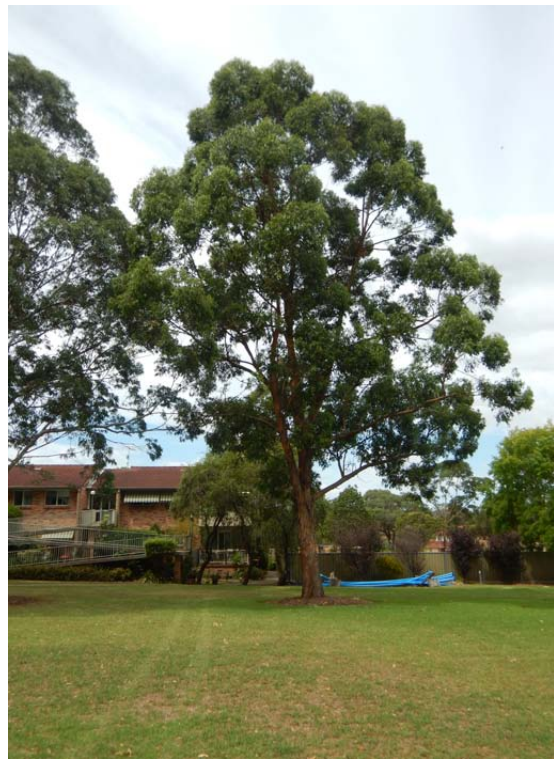
T104 – *Eucalyptus microcorys* (Tallowood)

**T104** a *Eucalyptus microcorys* (Tallowood) and **T105, T106** both *Eucalyptus saligna* (Sydney Blue Gum) are now to be retained following the deletion of previously submitted units 26/27 and 24/25. The proposed pedestrian paths have been kept mostly clear of the trees and those passing into the TPZ are to be constructed at or above existing ground level to minimise tree impacts. All three trees will experience some minor incursions (10% or less) as a result of the excavations for the detention basin, car parking and road construction occurring to their west. Given the healthy condition of the trees and the very minor nature of the incursions, it is the author's opinion that the trees may be successfully retained and protected for the duration of the project. All new services shall be kept clear of the remaining nominal TPZ.
