Douglas Partners

ADDITIONAL URBAN CAPABILITY ASSESSMENT

“KINGSHILL”

PACIFIC HIGHWAY, NORTH RAYMOND TERRACE

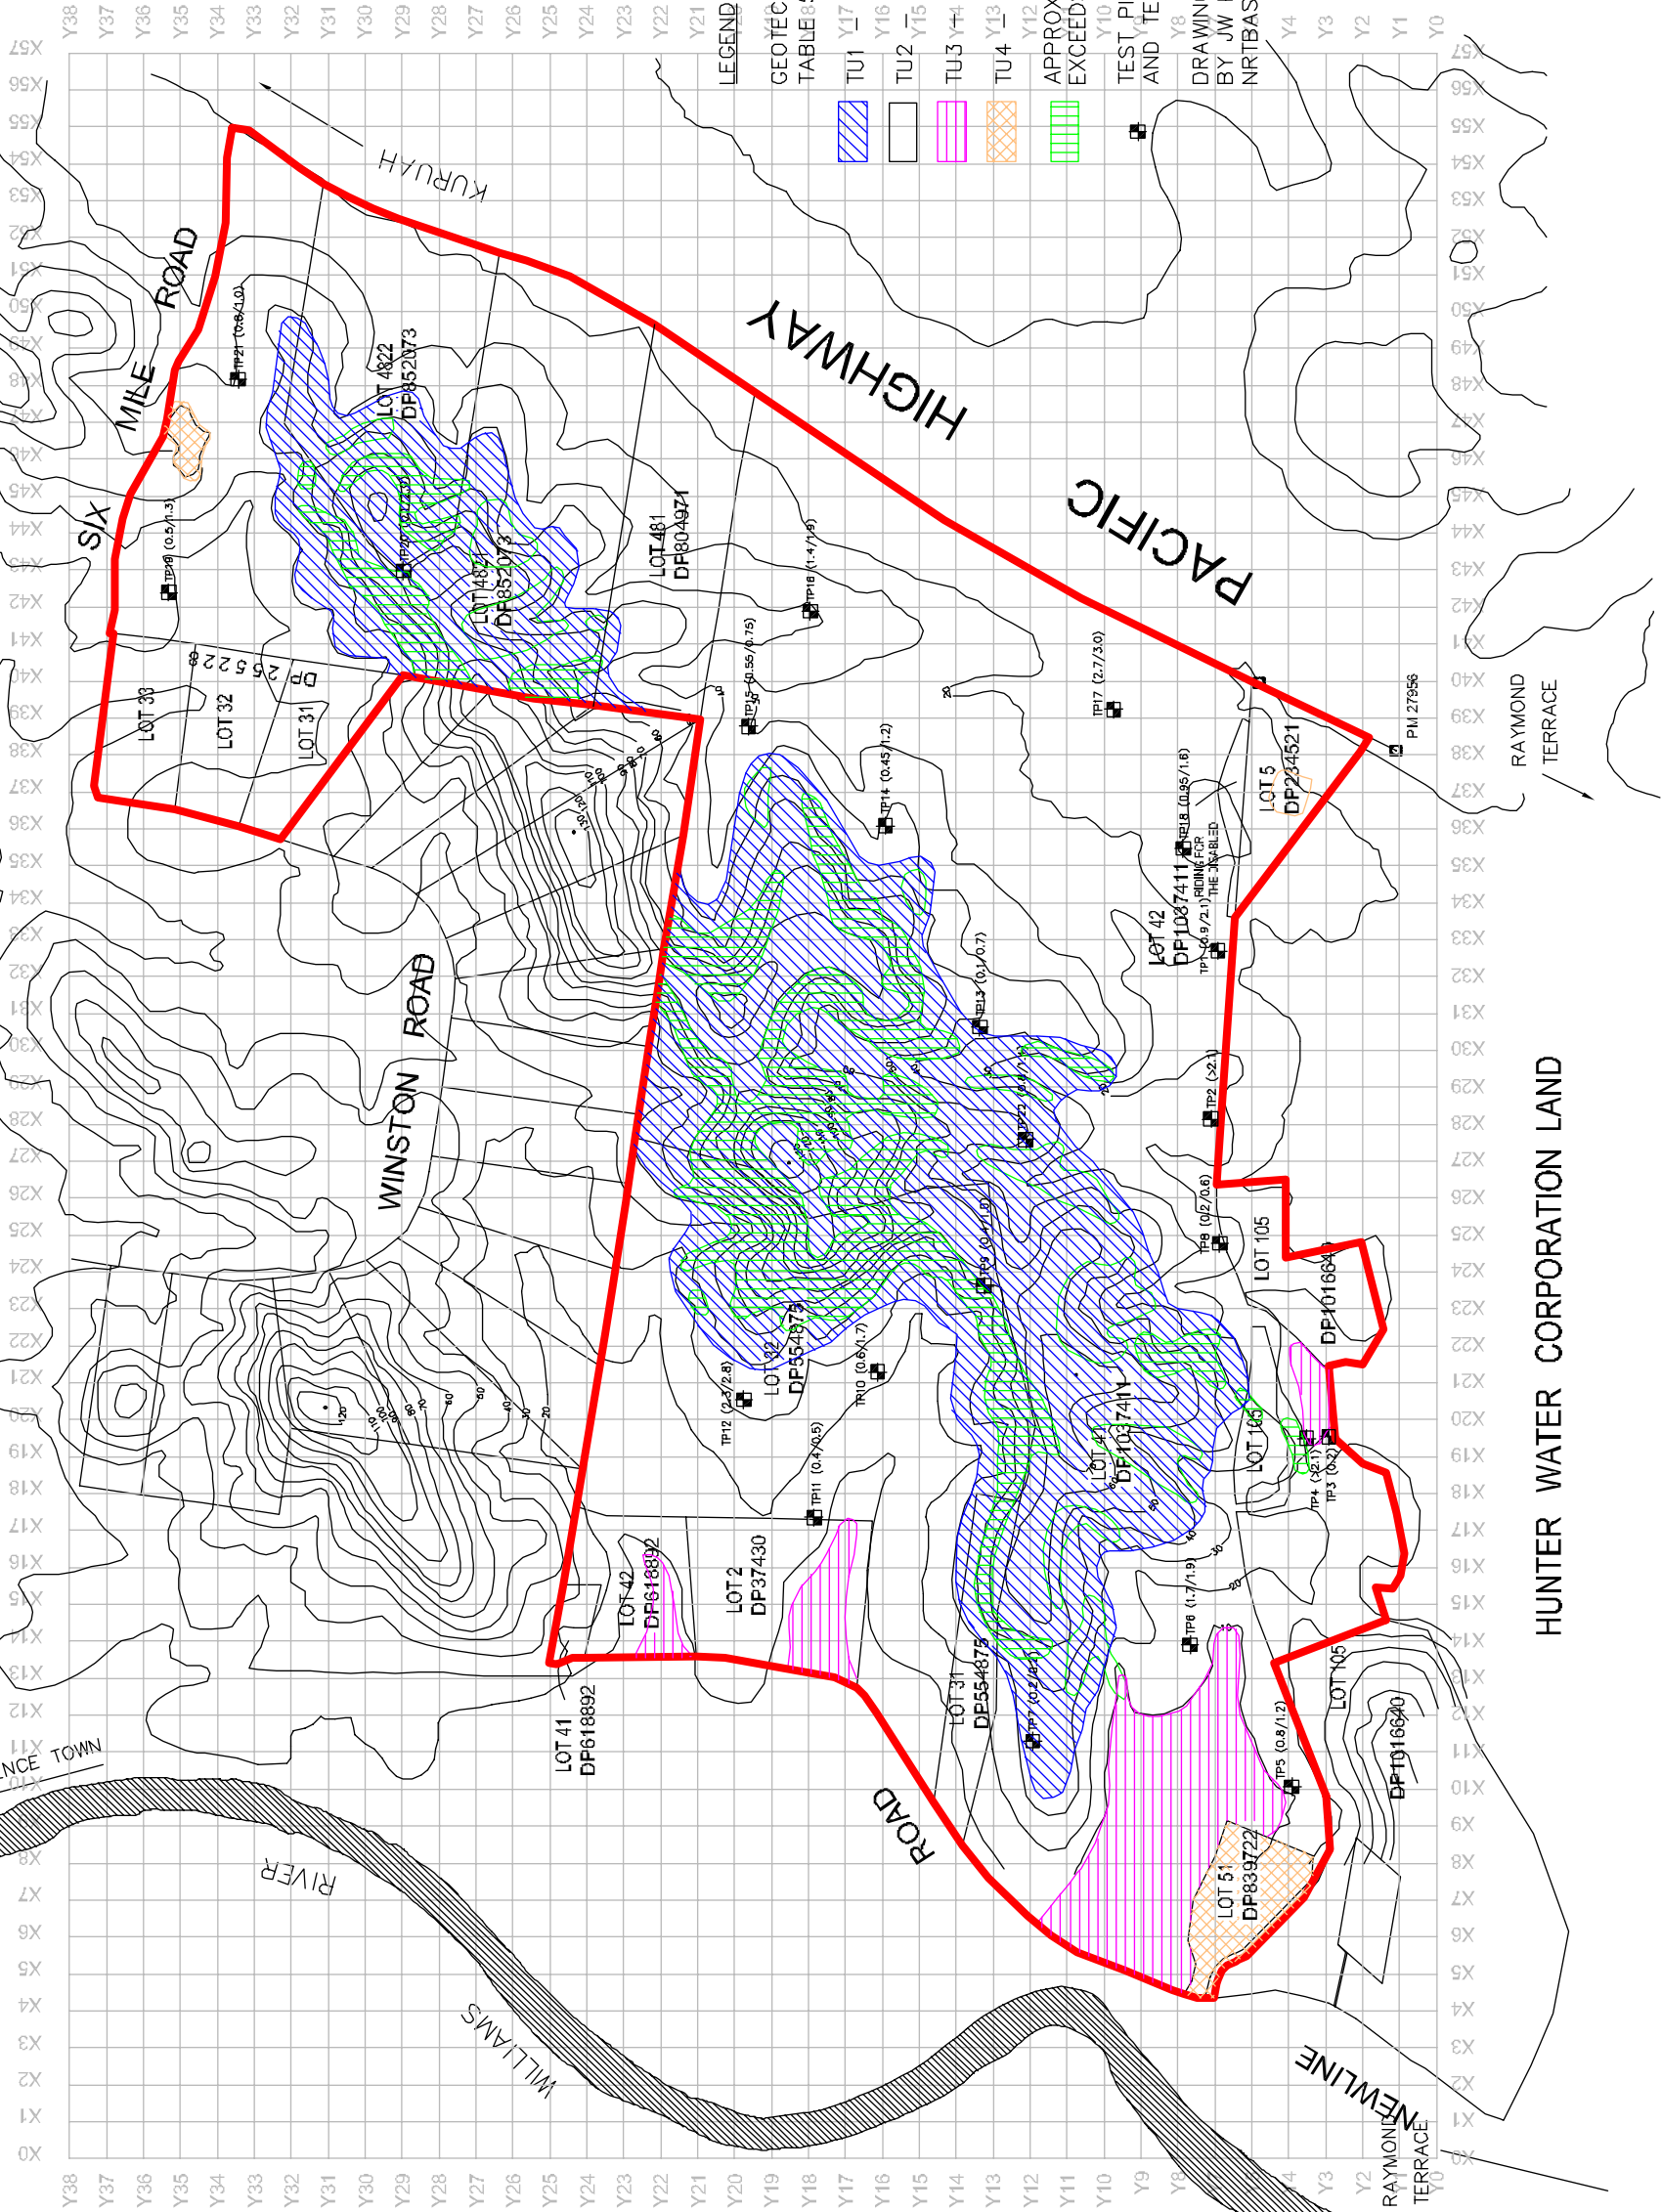
Terrain Unit	Description	Features	Geotechnical Constraints
TU1	Upper hill slopes, gully flanks, hill crests and spur lines (see also 4H:1V slope drawing)	<ul style="list-style-type: none"> including steep slopes in excess of 4H:1V typically shallow rock, <1 m deep common rock outcrop includes cliff lines 	<ul style="list-style-type: none"> potential stability issues associated with loose boulders and cliff lines, impacting on downslope areas, specific stability assessment recommended where slope in excess of 4H:1V difficult excavation, possible heavy ripping or drill and blast required in some areas high potential for erosion caused by development contains major limitations to on-site effluent disposal
TU2	Lower slopes, base of gullies	<ul style="list-style-type: none"> slopes generally less than 4H:1V variable depth to rock (0 m to >2 m) variable soil types, predominantly high plasticity clays gully erosion on some parts of site, where clearing has been undertaken presence of earth dams in some gullies variable vegetation cover 	<ul style="list-style-type: none"> potential stability issues associated where upslope boulders could impact on development difficult excavation in some areas high potential for erosion caused by development waterlogging of soils in some areas, particularly gully bases and low elevation potential reactive soils, site classification required remediation or removal of dams required on-site effluent subject to detailed investigation and design

TU3	Low lying areas	<ul style="list-style-type: none"> low lying areas and wetlands below about RL 10 	<ul style="list-style-type: none"> existing wetlands poorly drained prone to inundation, 1 in 100 yr flood level at about RL 5 potential acid sulphate soils below RL 5 low wet strength, potentially compressible foundation soil conditions sensitive to upstream development
TU4	Altered terrains	<ul style="list-style-type: none"> disturbed soils quarries landfill 	<ul style="list-style-type: none"> stability issues in and around quarries, remediation of quarries may be required uncontrolled filling settlement of landfill
