**82-90 Christie Street, St. Leonards**

Please find herein a review of the Windtech report entitled 'Pedestrian wind environment study 88 Christie Street, St. Leonards' dated 13 December 2017, ('the Report').

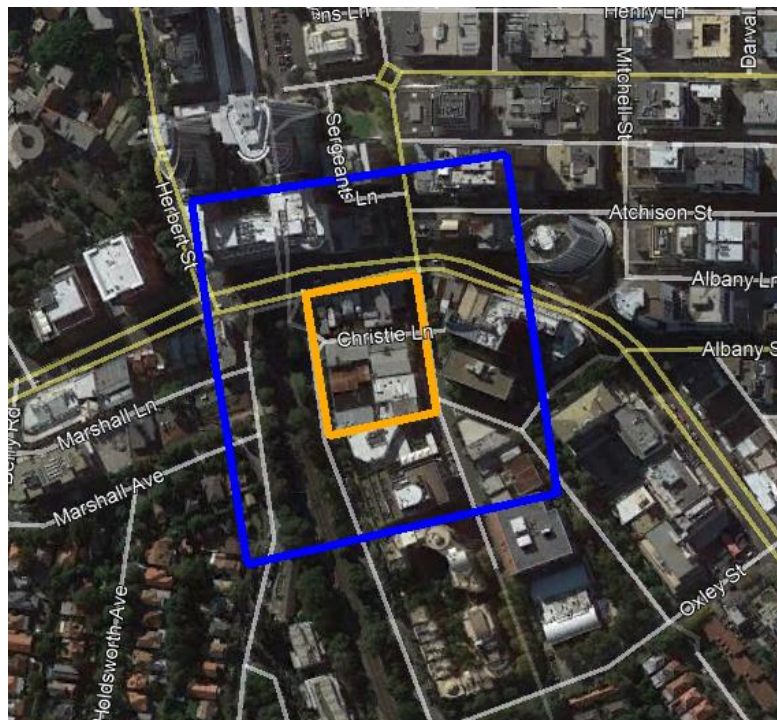
Figure 1: Recommended test area from AWES (2104)

The test area considered for the assessment is not considered great enough to capture the impact of the proposed development. The recommended assessment zone is shown in Figure 1. Such a large development would be expected to have a greater impact on the surrounding environment further from the site than the area tested, particularly on the south-west corner of the intersection of Christie Street and the Pacific Highway. Figure 5k in the report showing the location of the remote test locations on an aerial photograph is poor to get an appreciate of the exact test location.

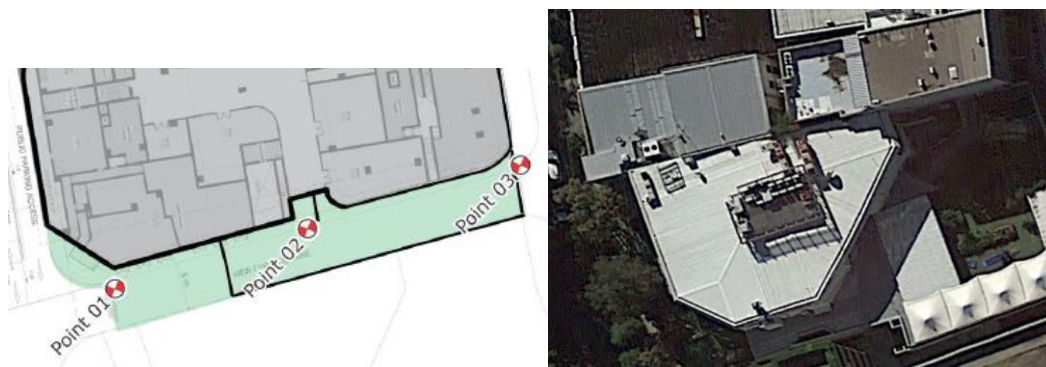
Figure 2: Test Locations 1 and 2 (L), and aerial image (R)

Locations 1 and 2 in the existing configuration would appear to be inside buildings, Figure 2. As there is no data for the existing configuration in the Report, it is impossible to check.

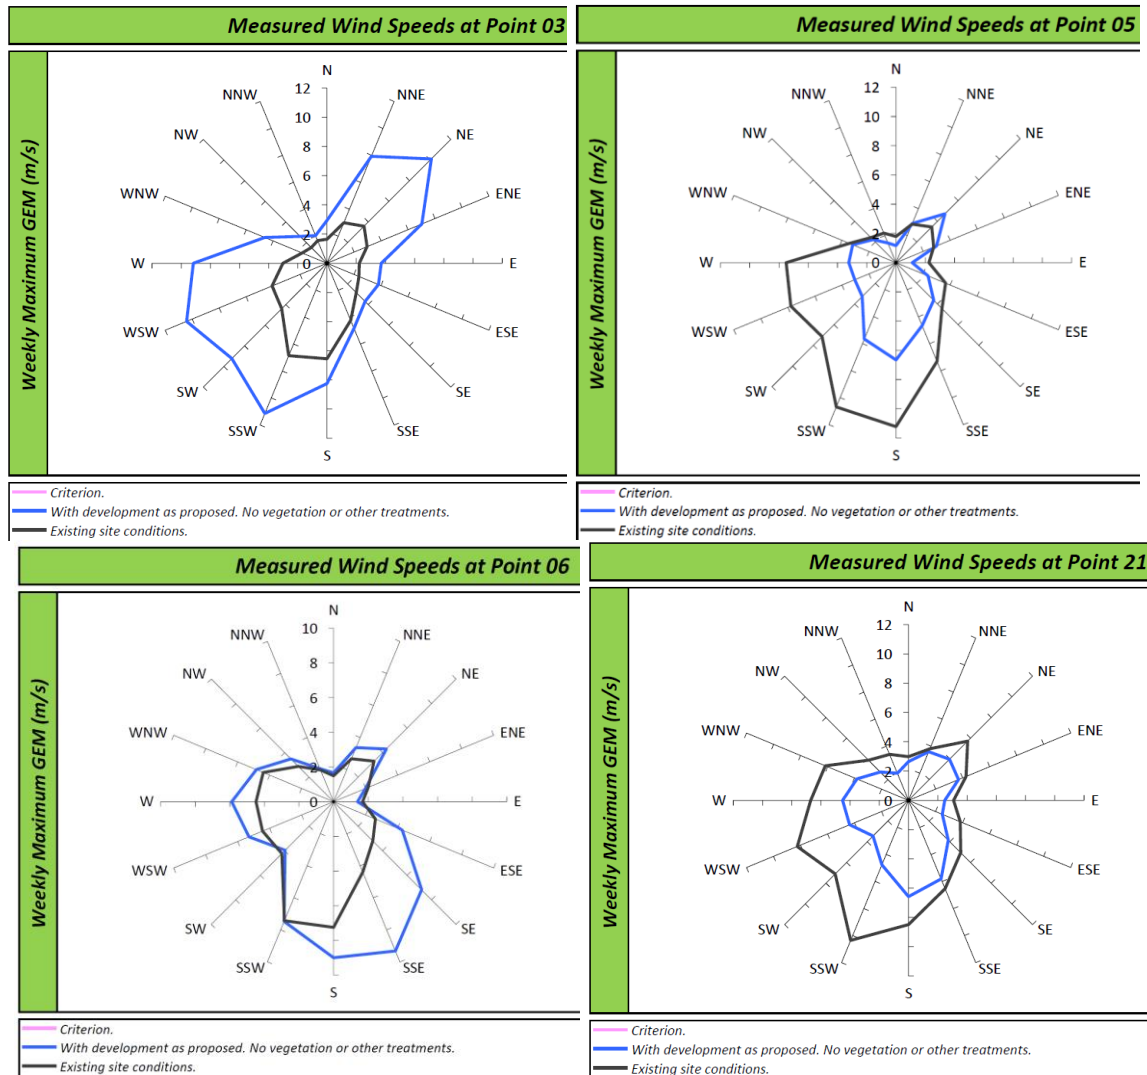
Figure 3: Comfort results from the Report for various positions on the ground plane

As there is insufficient detail in the report and no discussion around the results, there are some uncertainties as to the cause for some of the trends in the results. The inclusion of such large buildings on the fringe of a built-up area would be expected to have a significant impact on the local wind climate, particularly around the corners, such as Location 3, Figure 2, where the impact of the development has a significant impact on the wind conditions Figure 3. However, for example Locations 5, and 21, Figure 4, illustrate that the

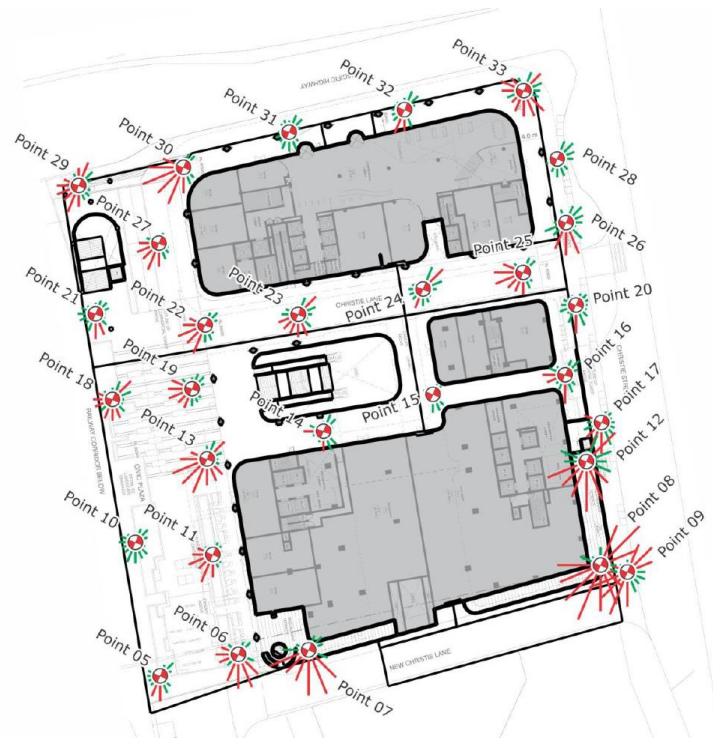
Figure 4: Ground floor test point layout from the Report

proposed development offers significant protection from all wind directions. The change in measured mean wind speed between Locations 5 and 6 in the existing configuration for winds from the south goes from 7 to 11 m/s. This gradient of wind speed in a relatively benign area requires some level of explanation.

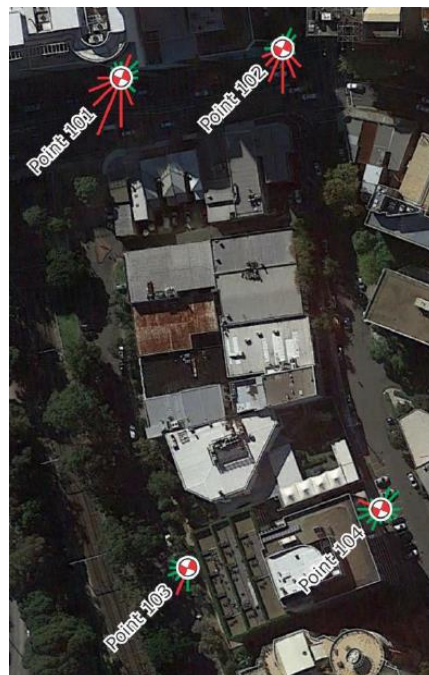
Figure 5: Remote test Locations

Wind conditions remote from the building have been measured at only four locations, Figure 5. The results presented in the Report, surprisingly show the large development to have a minimal impact on the wind conditions remote from the site, for virtually all wind directions. The site is windy, with 3 of the 4 locations exceeding the Lane Cove comfort criterion, and Location 102 exceeding the Melbourne safety criterion. The only major changes are at Location 103 and 104. At Location 103, for winds from the south-south-west, the proposed development, downwind of the test location, increases the wind speed to above the Lane Cove Council criterion of 16 m/s: this exceedance has not been captured in Table 9 of the Report. At Location 104, the proposed development offers shielding to winds from the north-west quadrant.
