ARBORICULTURAL IMPACT ASSESSMENT REPORT MILPERRA VILLAGE: VERSION 2

22nd January 2019 Rev. B PROJECT: 1841

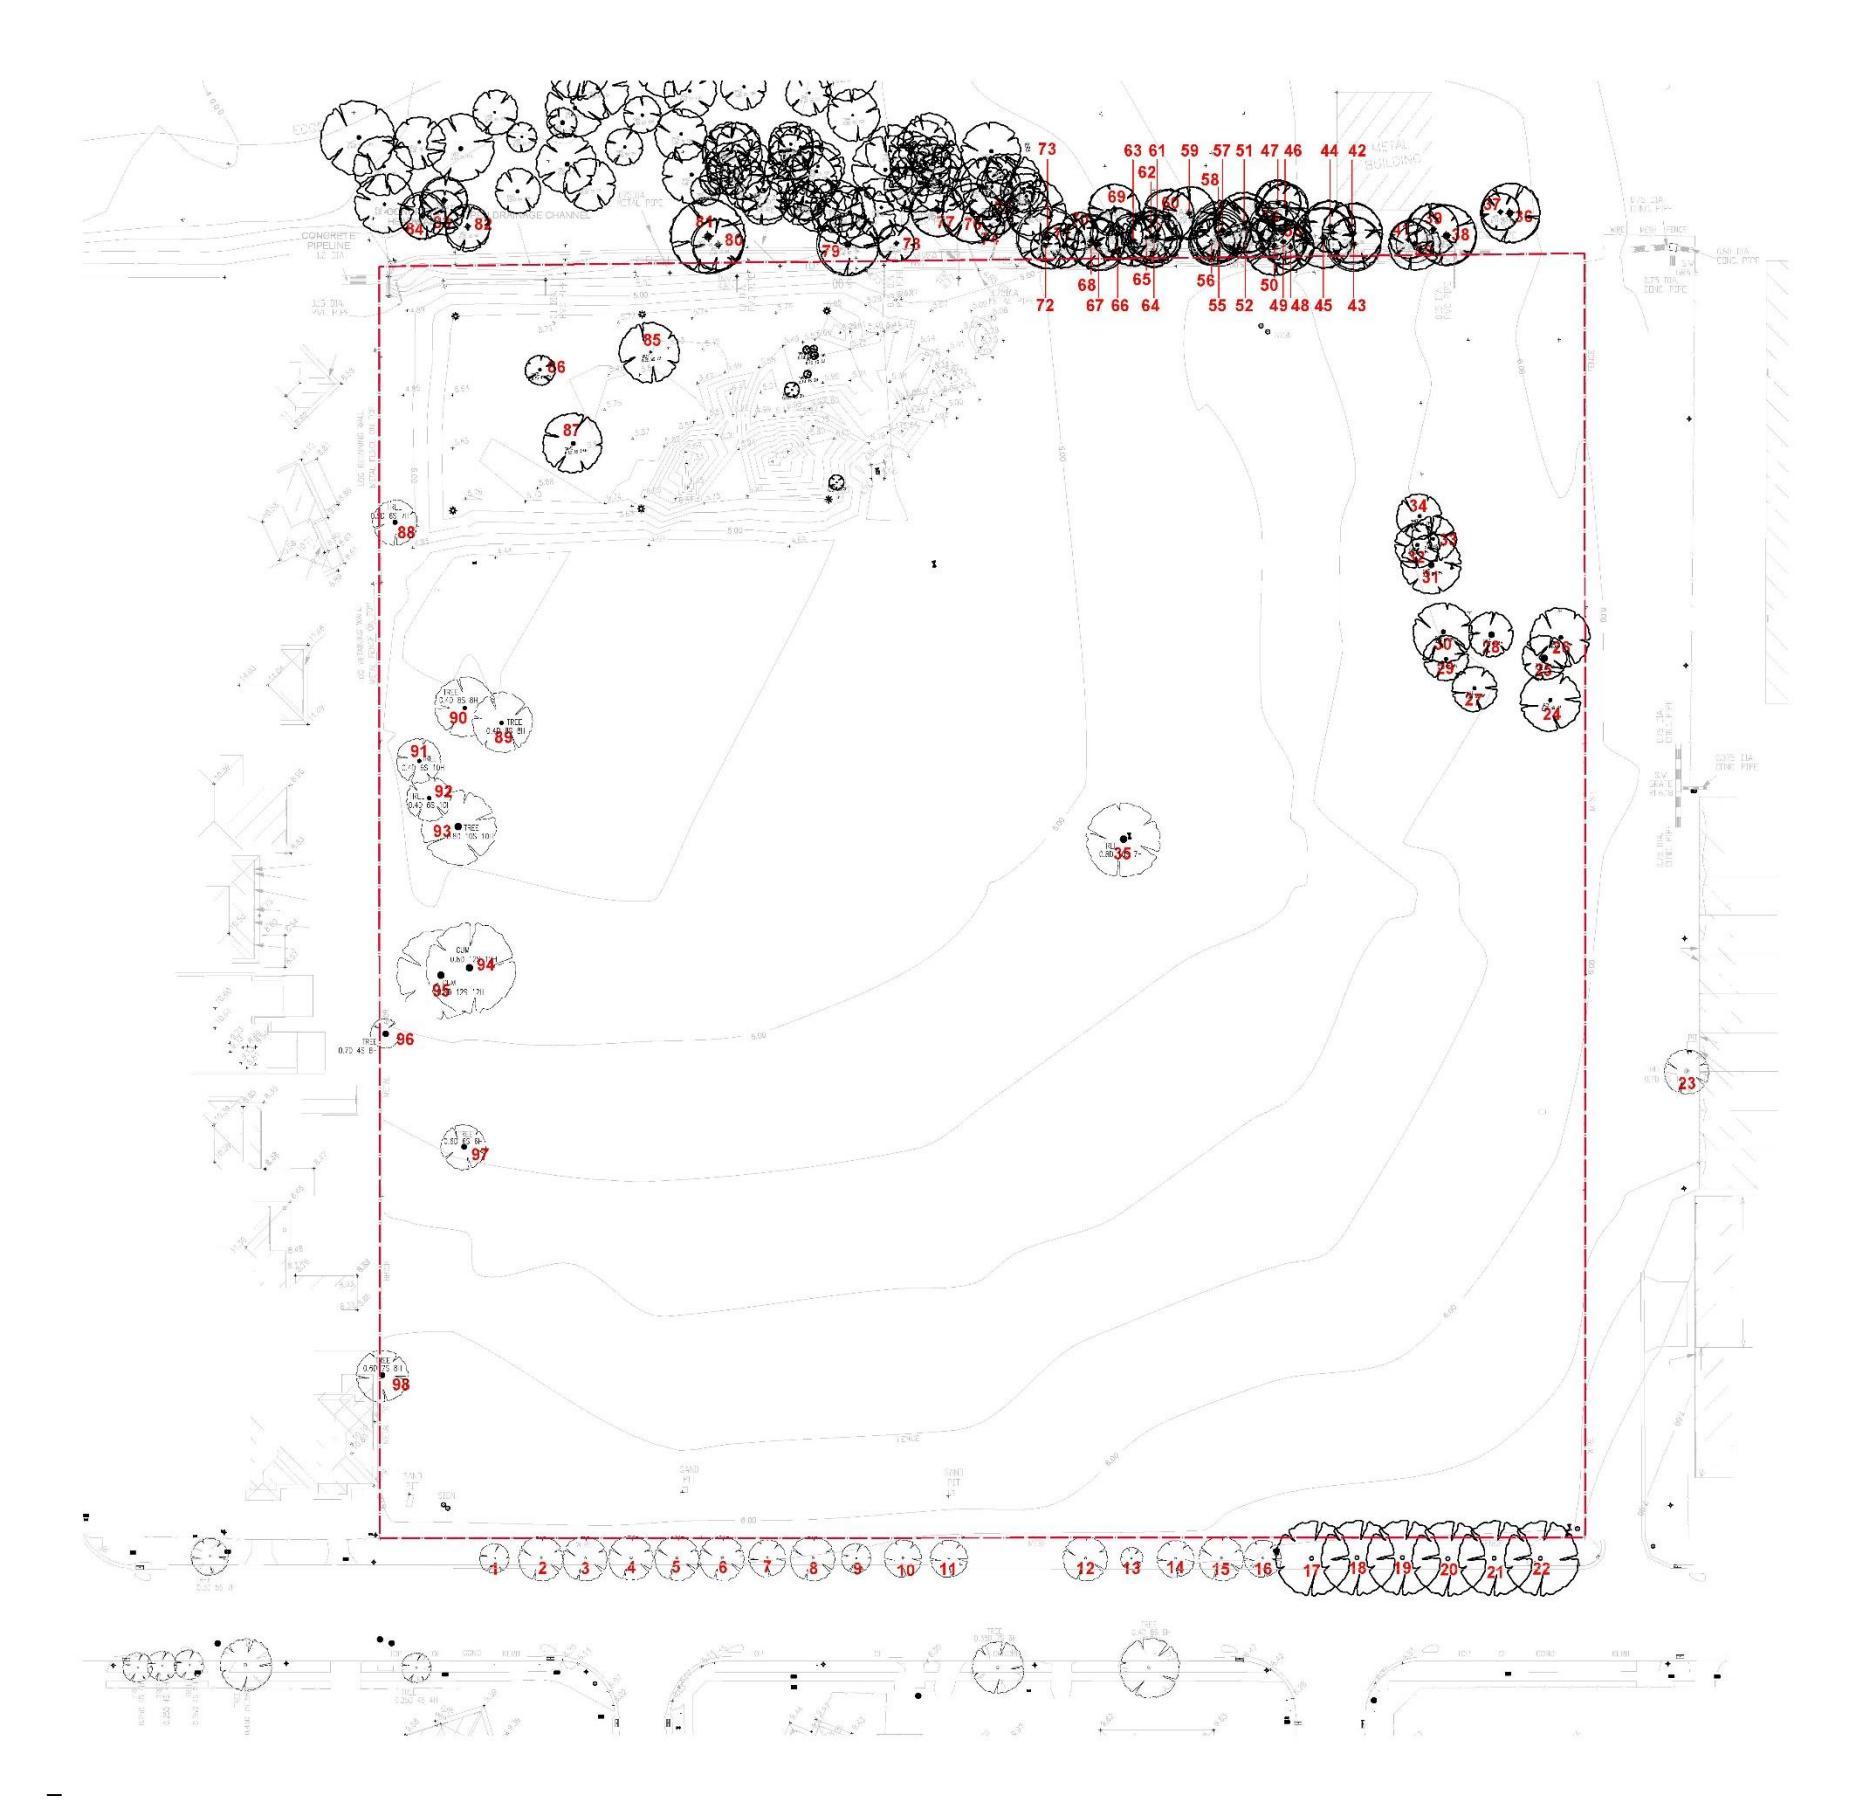
Figure 2: Existing Trees

All trees identified on the site are Australian native trees. Figure 2 indicates the tree locations.

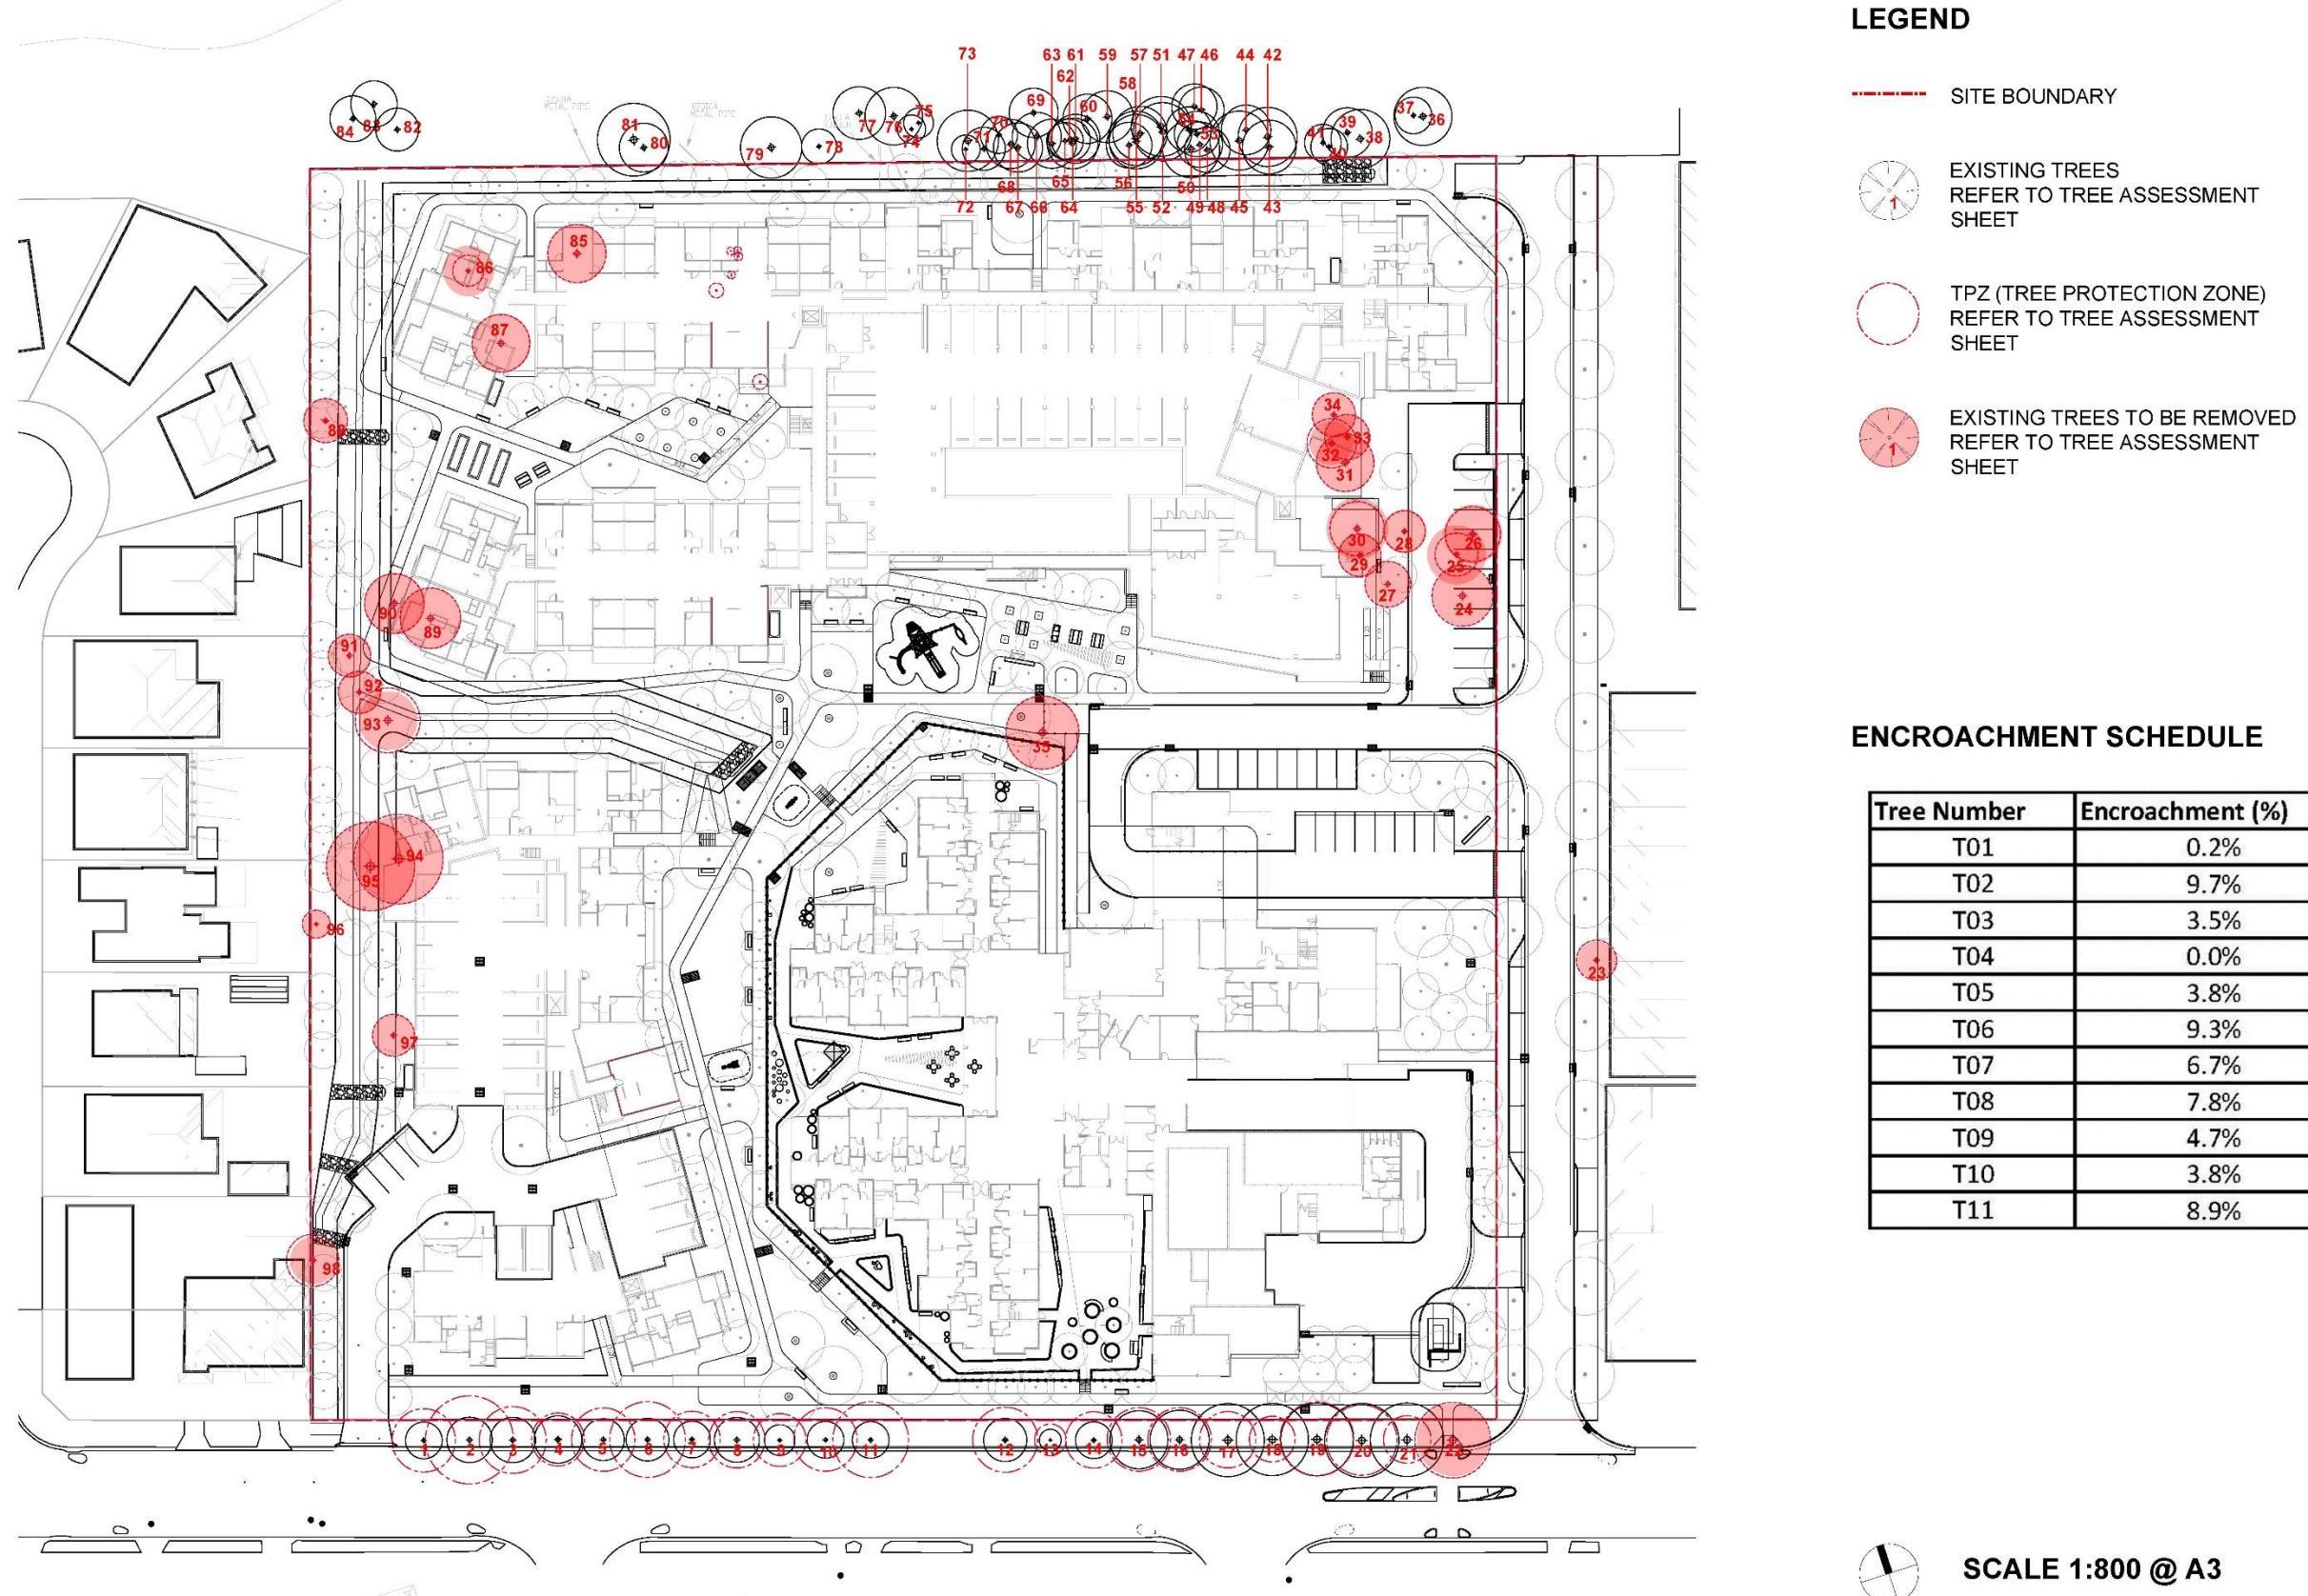
Figure 4: Impact assessment

It is also noted that Tree Number 23 on the Council land on the currently unformed Bullecourt Lane will be impacted by the reconstruction of the new entry road required to service the development. The TPZ will be encroached by 28% which is generally not acceptable under *AS 4970:2009 Protection of trees on development sites*. Root pruning for any roadworks will create a significant encroachment and removal is recommended.

This tree will require removal to implement these works and Anglicare will need to seek consent for removal from Council. This is a *Melaleuca decora* of low vigour and fair condition with a short term retention value (Refer Appendix 1: Tree Assessment Schedule)
