CONSERVATION MANAGEMENT PLAN

Former Fire Station No. 3 William Street, Fairfield

January 2020

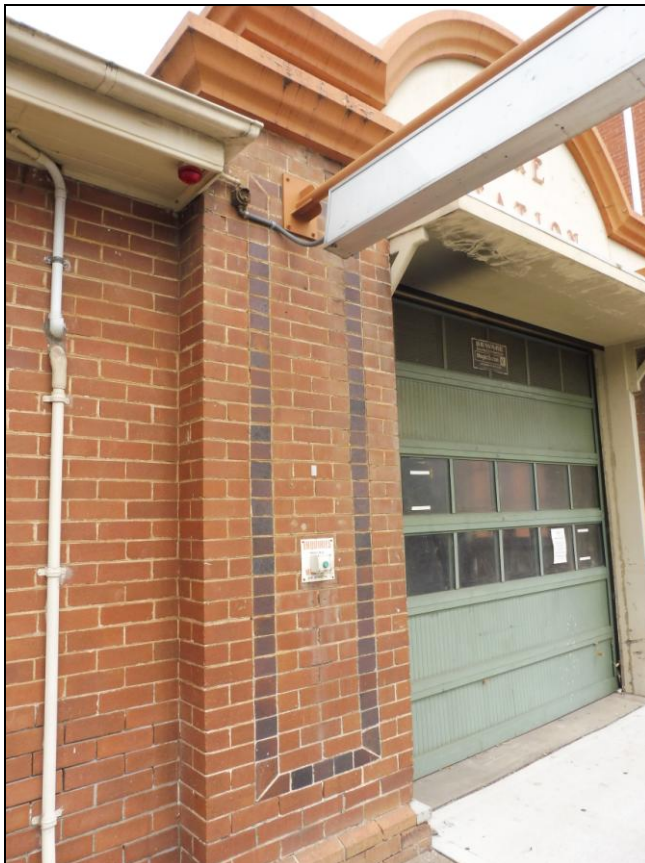
Figure 3.12 Service elements including the emergency call button and signs have been added (and removed) from the façade. The brickwork at the base of the central pilaster has sustained some damage. Some of the mortar joints in the brickwork have also failed.

- repair to damaged brickwork and failing mortar joints on the front façade;
- repair of cracked brick and infill of an opening on the north eastern brick façade;

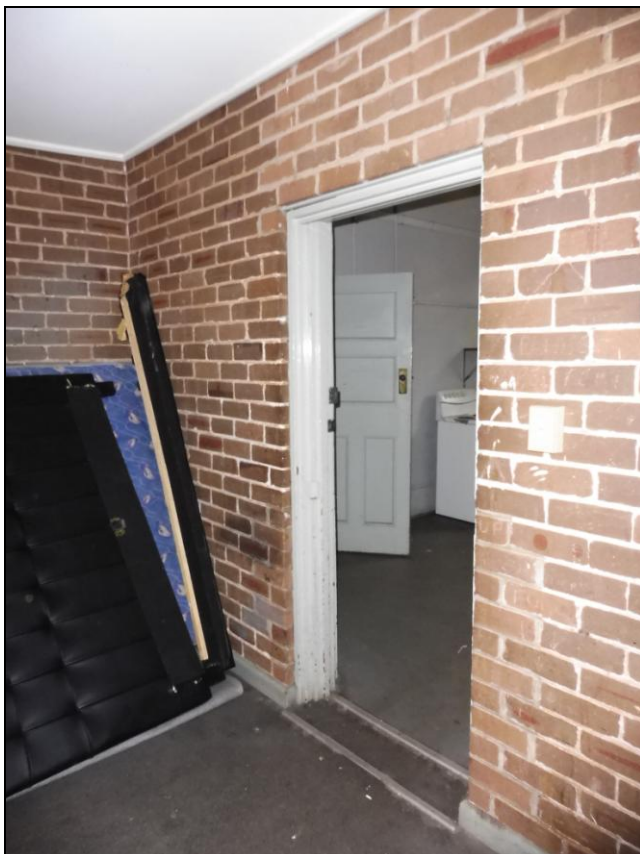
Figure 3.26 The northern façade of the rear wing has undergone some modifications and extension. It appears that an original window in what was the single men's' room has been converted into a doorway and an early door has been infilled.

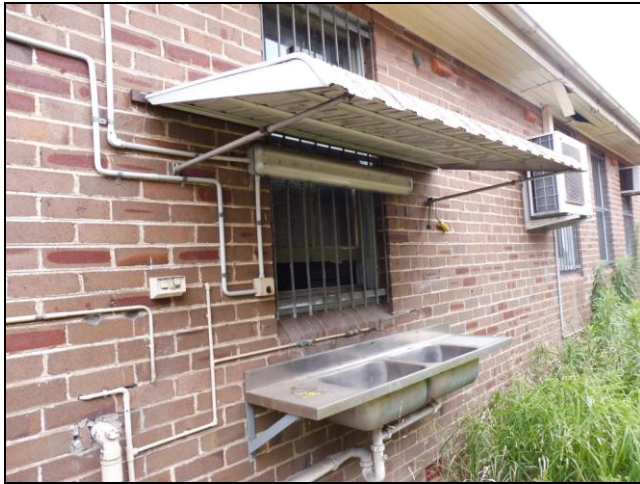
Figure 3.35 The southern façade and part of the eaves lining has been affected by the addition of services including a sink, lighting and air conditioning units. A modern steel bracketed awning has also been fixed to the façade.

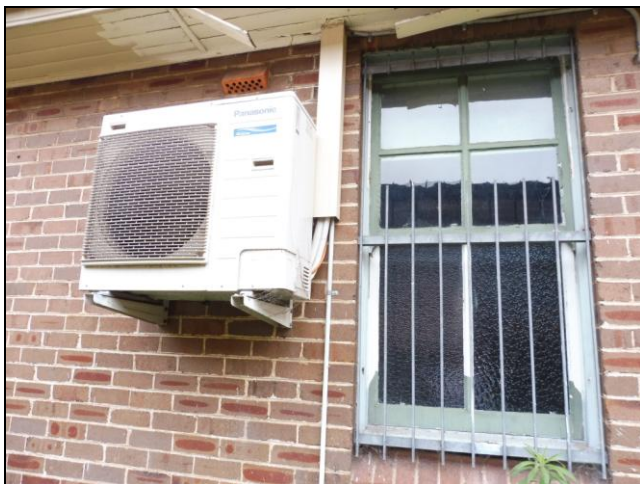
Figure 3.36 Detail of one of the southern side windows. Note the AC unit and damage to the boarded eaves lining.

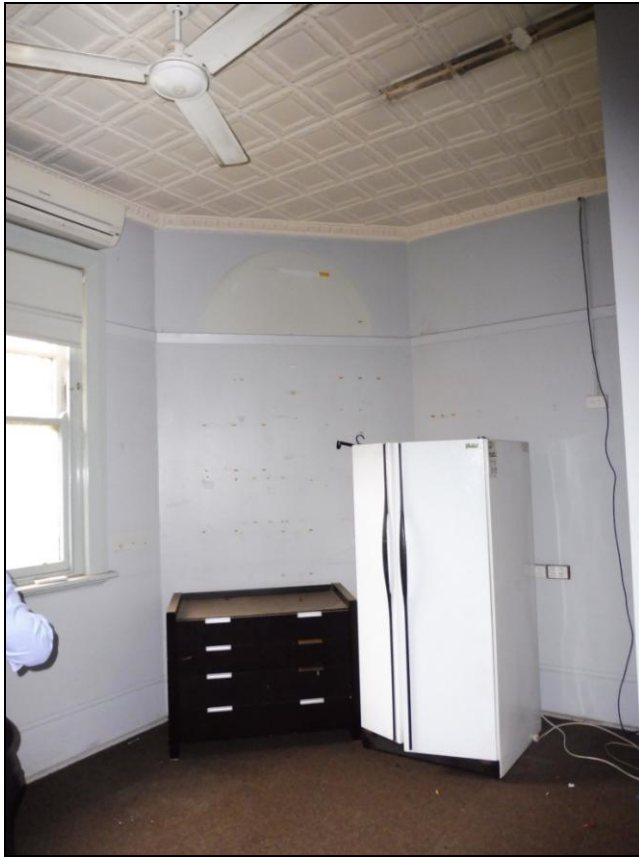
Figure 3.56 The splayed fireplace breast. The fireplace has been infilled and surround has been removed.
