Arboricultural Development Assessment Report

Anglicare, St Lukes 4 Lindsay Evans Place, Dapto NSW 2530 RAC PROJECT 16th July 2019

Prepared by: Paul Vezgoff Consulting Arborist ISA, AA Arboriculture Australia Registered Consultant

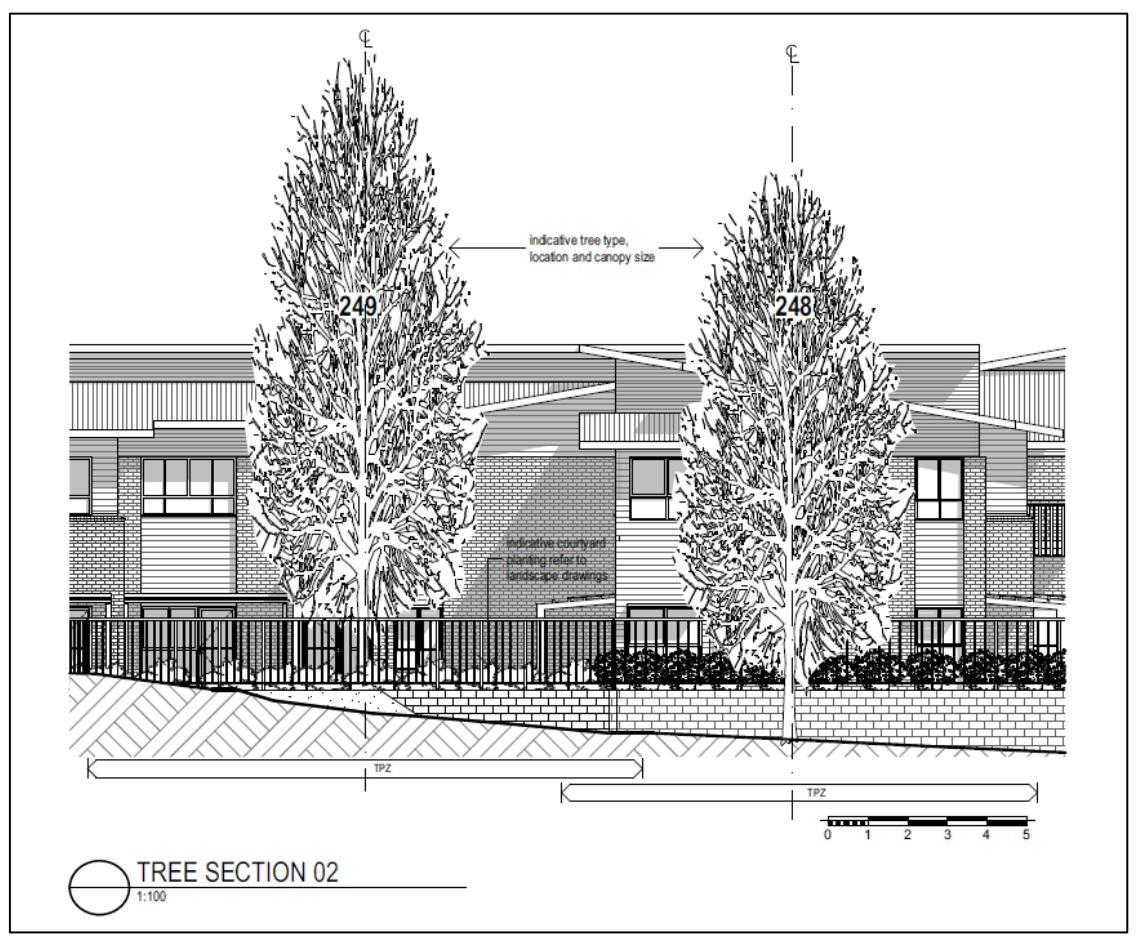
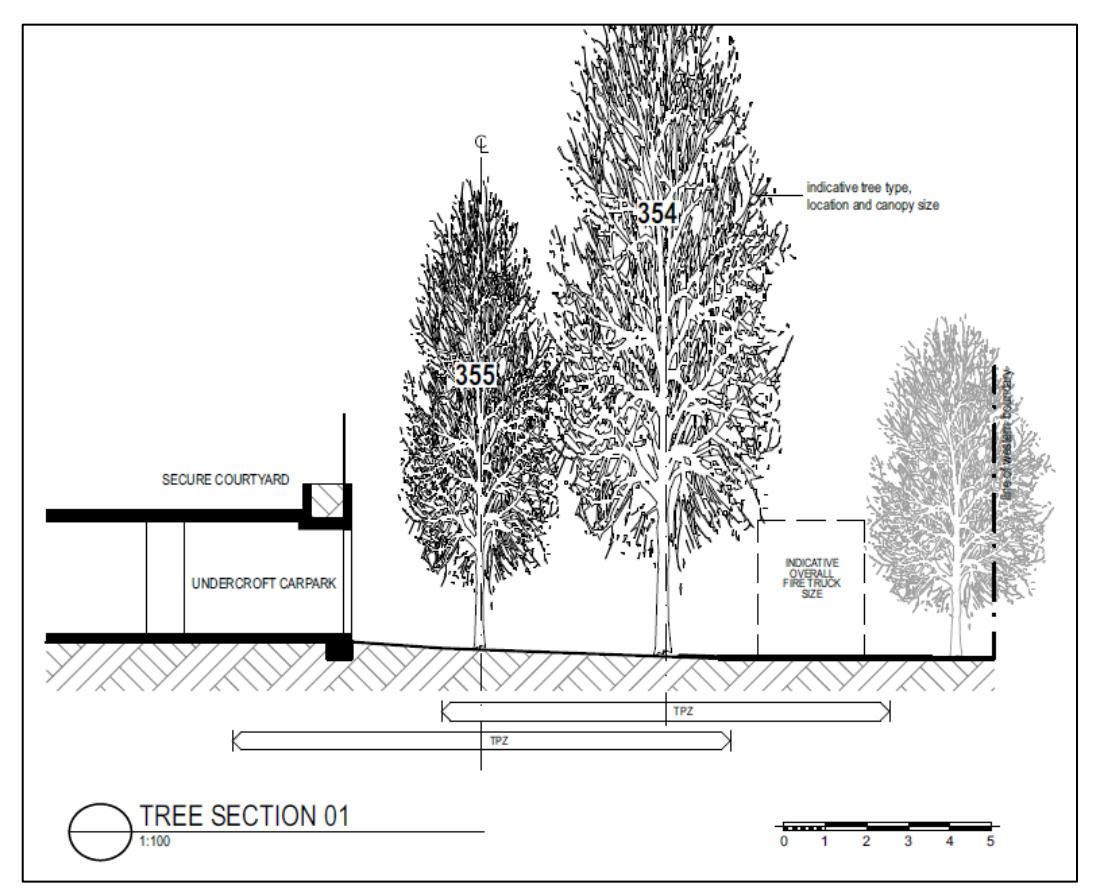
249	TPZ: 8.4m SRZ: 2.9m	Incursion of TPZ due to level changes. Tree 249 has RL of 29. Retaining wall near this tree will be block work. Incursion of 19.7% to TPZ due to wall footing.	R 84m 40m Incursion: 19.7%, 43.7 m ²	Footing across the TPZ of Tree 249 to be pier and beam construction. See Diagram 1. Beam to be ABOVE grade. No soil level changes at base of Tree 249.
355	TPZ: 6m SRZ: 2.6m	Total incursion of TPZ is 25.7%. This is a large incursion however landscaping at the base of the tree by way of lawn removal and providing a mulched garden area with regular watering will help the tree cope with these construction impacts. The blue incursion is a paved courtyard so excavations will be minimal in this area of the TPZ.	Incursion: 22.9%, 26.2 m ²	Area to me mulched as part of the tree protection zone. See Diagram 2. Regular watering to occur once construction commences.

Diagram 1: Portion of Merrin & Cranston Architects Section near Trees 248 and 249.

Diagram 2: Portion of Merrin & Cranston Architects Section near Trees 248 and 249.

- **4.4** Removal of hard surfaces below Trees 248, 249 shall be undertaken with a flat bucket excavator, with surfaces removed pulling away from the trees. A spotter should be used to ensure that the bucket attachment does not contact the main stem and damage the trunks. The proposed retaining wall near Tree 248 will increase soil levels up to one (1) metre around this tree. Ideally a retaining wall could be installed so as to keep the trunk clear of soil. This type of design should not be closer than two (2) metres to the main stem. Strip footings to be avoided vis the use of pier and beam type construction with the beam above grade.

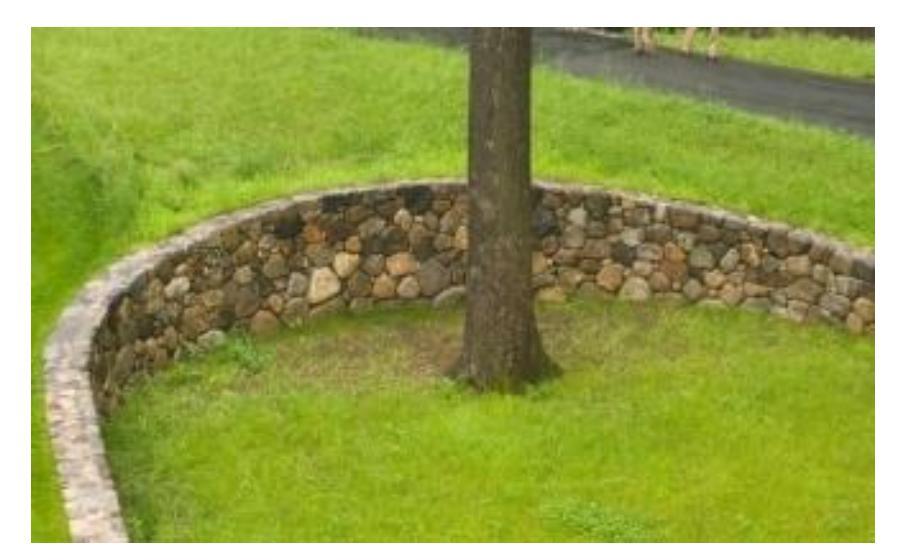
Image 1: Image showing a design concept that allows an increase in levels over the TPZ that may have to be implemented for Tree 101 and Tree 341.

- **4.3** Removal of hard surfaces below Trees 101 and 102 shall be undertaken with a flat bucket excavator, with surfaces removed pulling away from the trees. A spotter should be used to ensure that the bucket attachment does not contact the main stem and damage the trunks. Trees 101 and 102 have a stormwater pipe located within the respective TPZ distance. It is recommended that this pipe be left in place, if possible. In terms of design there should be no level increases within the TPZ distances of this tree that require strip footings. A retaining wall could be built across the TPZ of Tree 101 and 341, provided the existing grade could be bridged via the use of pier and beam type construction or the wall altered around the base of the tree as seen in Image 1 below.

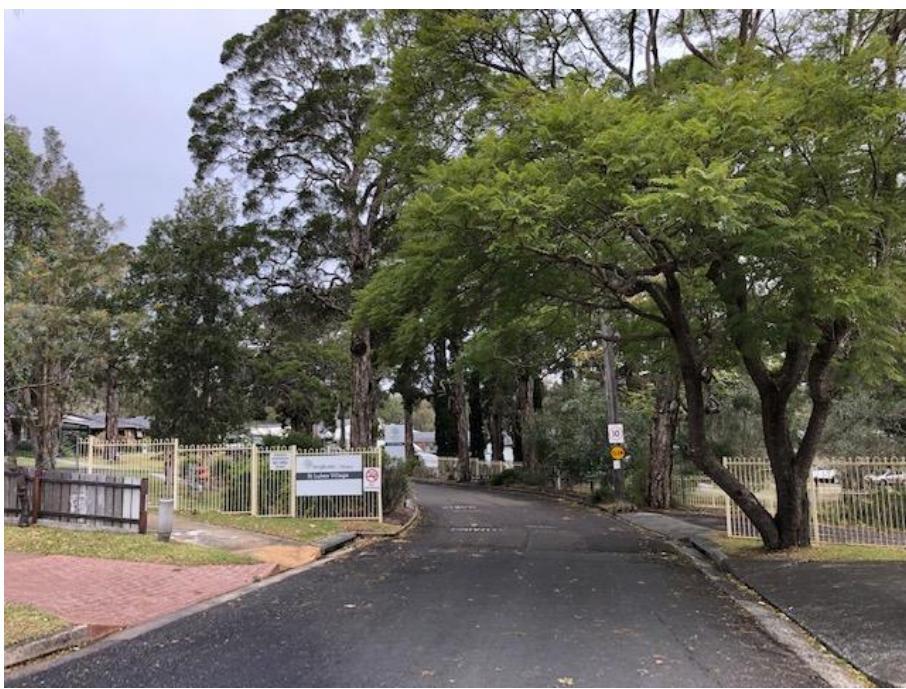
Plate 1: Entry to the site showing Tree 1 to the right that will require canopy reduction pruning. P. Vezgoff.

- **4.12** No services shall be trenched through the SRZ distances of any tree to be retained.
- 4.13 Pruning of the Council street tree numbered as Tree 1 near the site entry from Lindsay Place is required. The eastern portion of the canopy of Tree 1 requires reduction pruning as the broad spreading canopy will be damaged by trucks entering and leaving the site. These branches should be reduced back so as to maintain the canopy of the tree (ie, no lopping or 'flat topping'). Pruning points should be no greater than 100mm in diameter. This pruning is known as selective pruning and can be read about in more detail in the Australian Standard for the Pruning of Amenity Trees (AS 4373) 2007. Council may choose to undertake this pruning themselves.

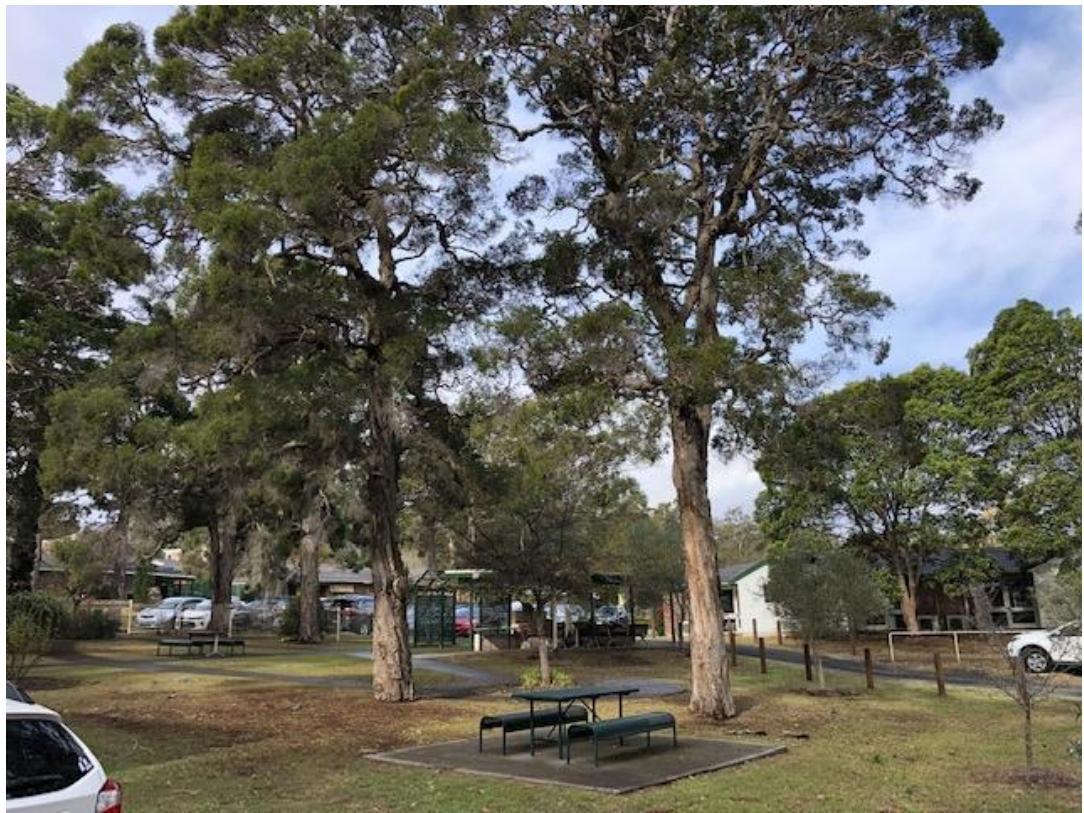
Plate 3:. Trees to the North of the existing structure (246, 247, 205, 403, 404). P. Vezgoff.

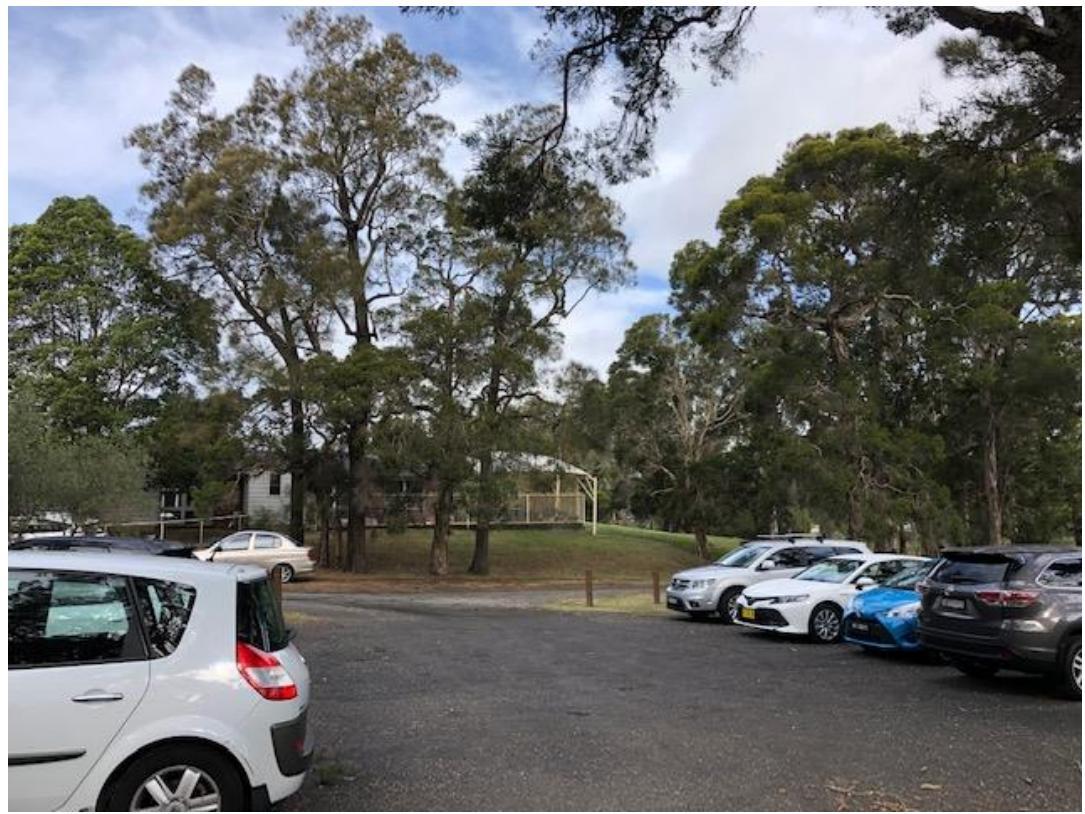
Plate 4: Trees 388-398. P. Vezgoff.
