# ***Arborist Report***

**Client: ICONFM Australia Pty Ltd**

Address: 1 Larapinta Place,

Glenhaven N.S.W 2156

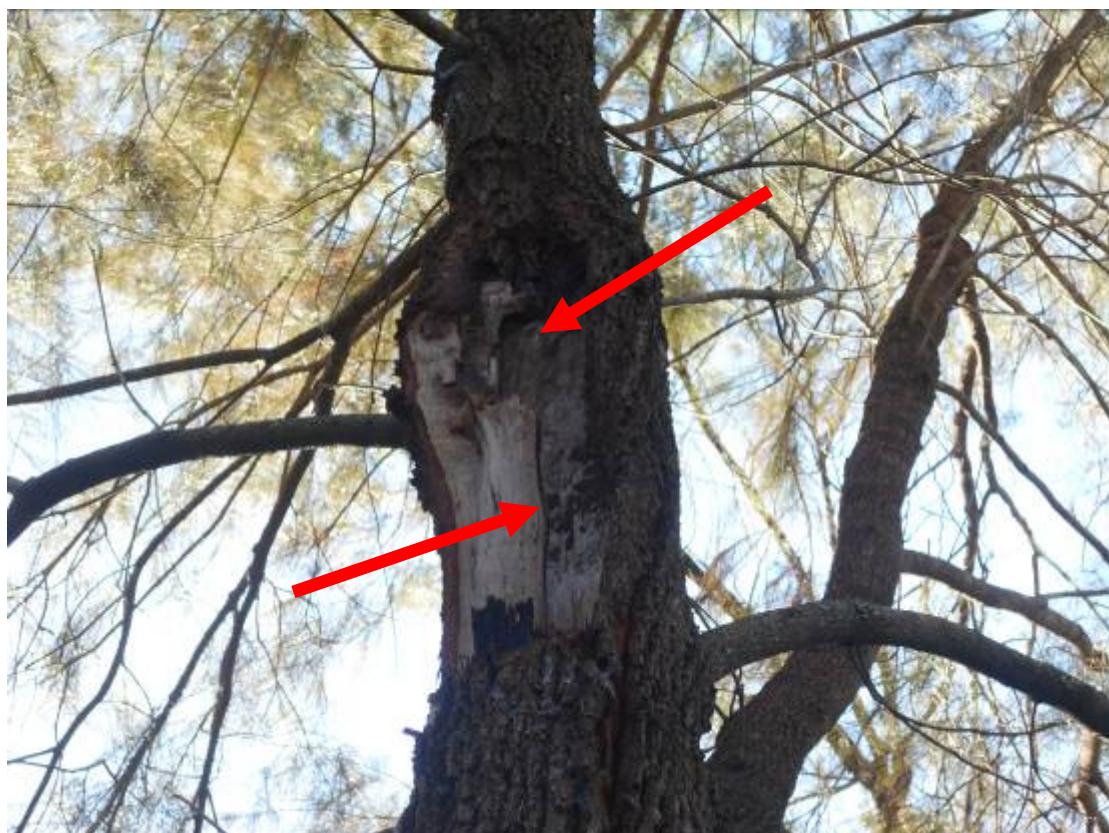
Tree A5 has a branch failure at 3 metres above ground level and is a short lived species. This type of species are considered pioneer species that are located in disturbed sites. One of their roles is to establish a seedbank and allow bigger species to get established. This species is earmarked for removal before commencement of building works on site.

Figure 4 – showing the branch failure that has removed a section of the trunk. This species would not be suitable to long term retention.

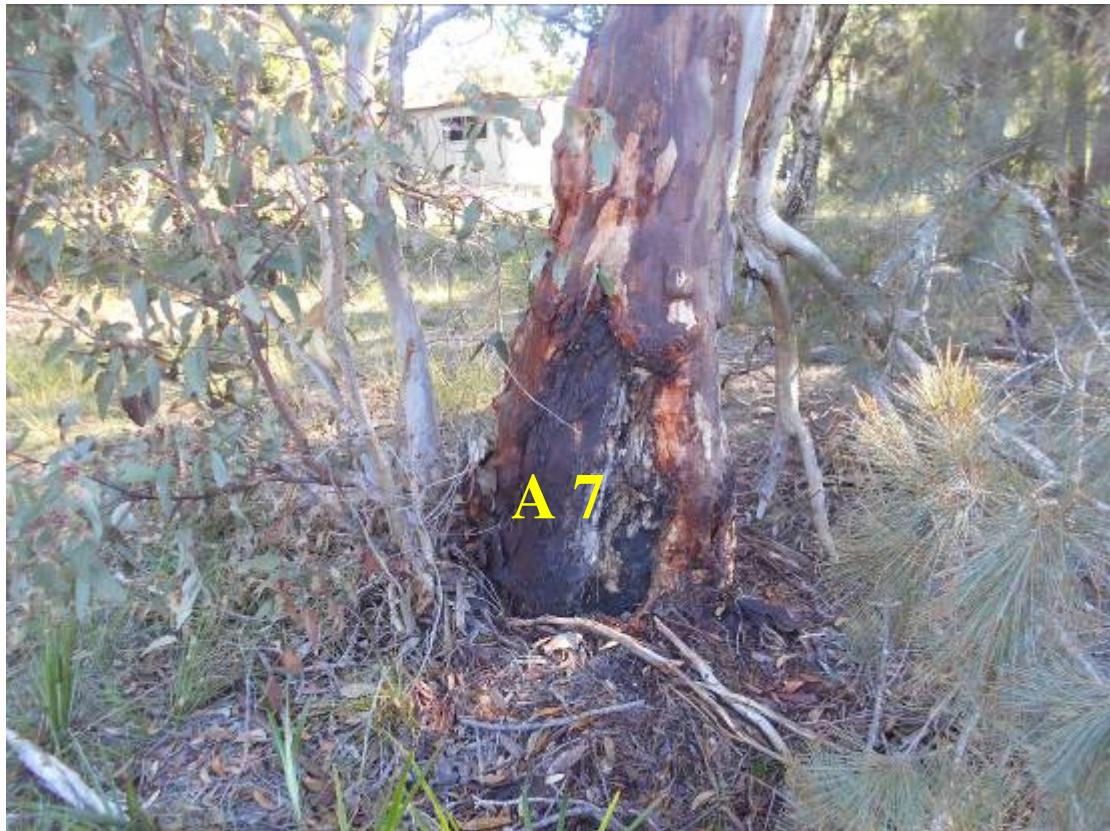
Figure 5 – showing the location of Tree A7 in the bushland zone of the subject property. This species like all the *Eucalyptus haemastoma* in the surveyed area have decayed sections and cankers. This tree has the potential to be retained and incorporated into the development.

Tree A7 if retained would benefit from removing the dead tree in the fork union. The other tree has partially failed and is resting in the fork union of Tree A7. It would be beneficial to remove the fallen tree before commencement of building works on site.

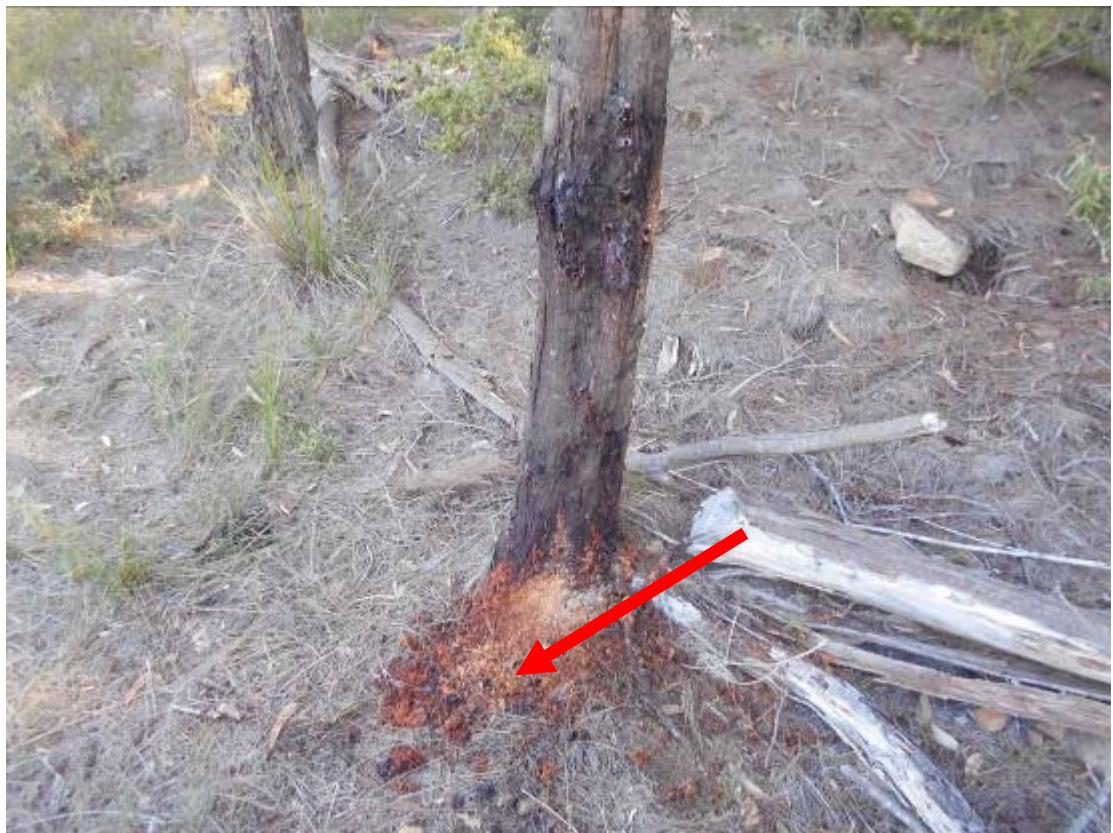
Tree A10 is at the top end of its maturity with extensive borers within the trunk and the main scaffolds of the tree. This species has a short life span and is reduced dramatically by the borer activity. This species has been earmarked for removal before commencement of building works on site.

Figure 6 – showing the borer activity that is evident in Tree A10. This species has been earmarked for removal before commencement of building works on site.

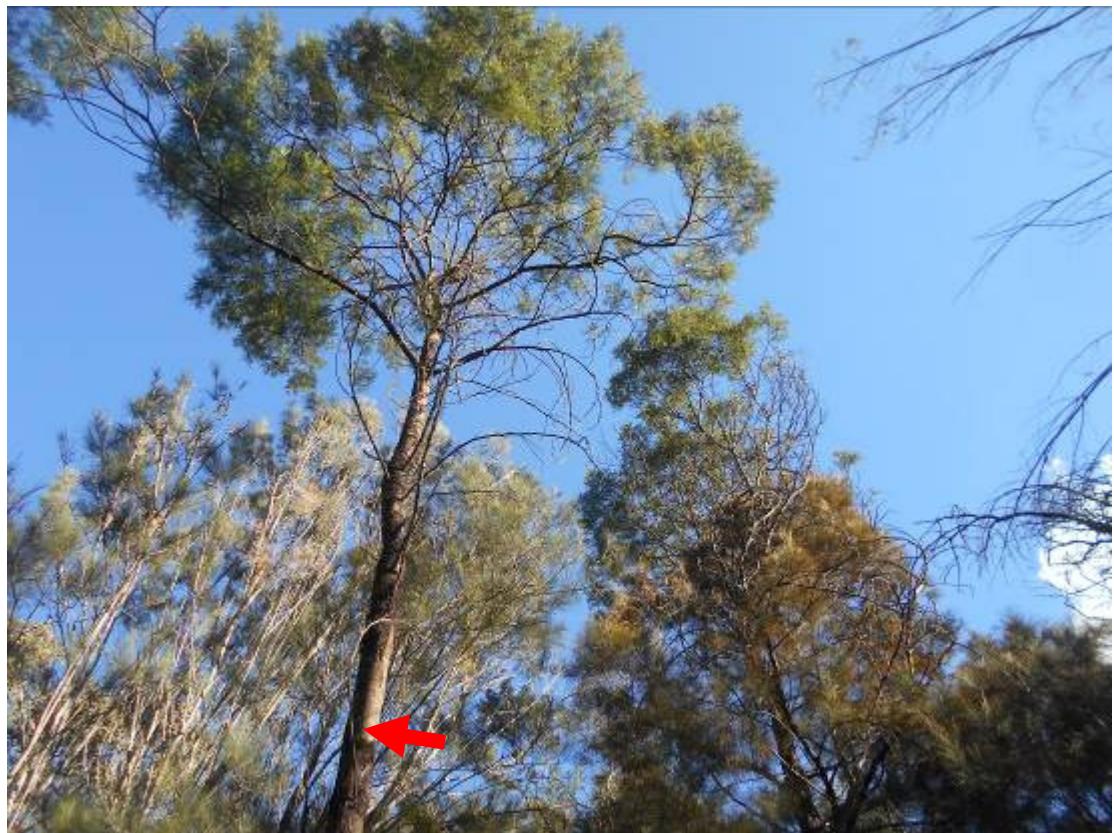
Tree A12 is at the upper end of its maturity with deadwood in all four quadrants. This species has a thinning canopy and is entering into a senescent phase. This species has a short life span and is reduced dramatically by the borer activity. This species has been earmarked for removal before commencement of building works on site.

Figure 7 – showing the location of Tree A12 that is at the top end of its maturity. This species and several others on site are at the top end of maturity and have been earmarked for removal.

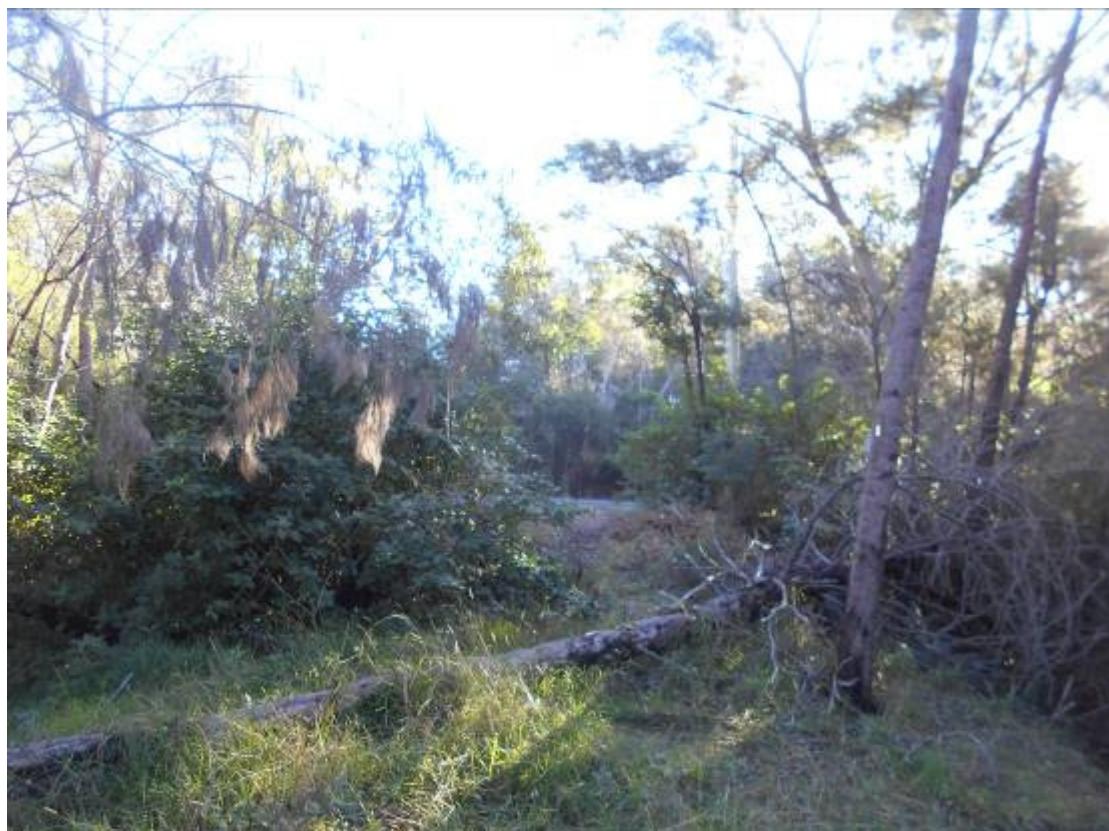
Figure 8 – There is an unsealed road that extends into the subject property with a fallen tree along the path. There are several weed species including Lantana camara. This area could be managed including removal of the fallen tree and weed species. This could also include removal of selective species to reduce the canopy and extend the distance to the bush interface to the north.

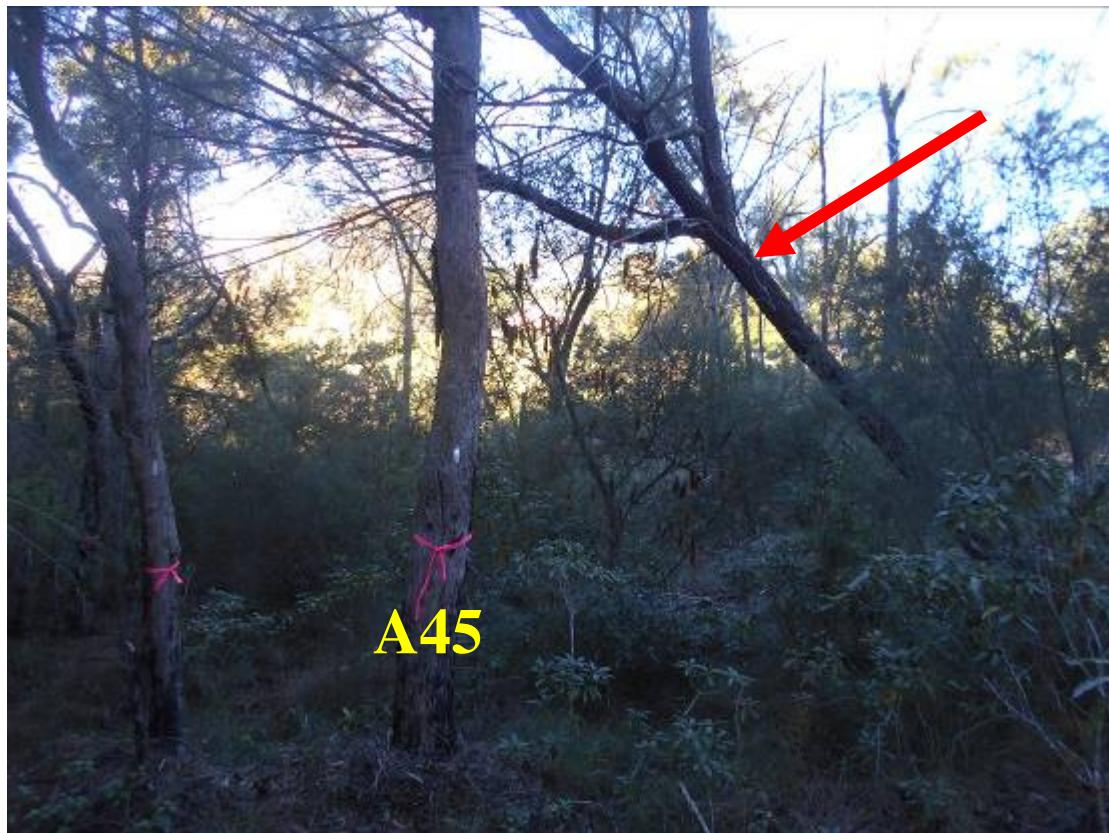
Tree A45 could be retained unless required to be removed for the purposes of asset protection. Tree A5 has a partially fallen Casuarina that is resting in the fork union of the tree. The failed tree is resting in the tree as outlined in Figure 9. The casuarina that has fallen into Tree A45 has been earmarked for removal before commencement of building works on site.

Figure 9 – showing the location of Tree A45 in relation to the dead tree. The dead tree would benefit from removal in order to preserve Tree A45 on the proviso that it meets bushfire requirements.

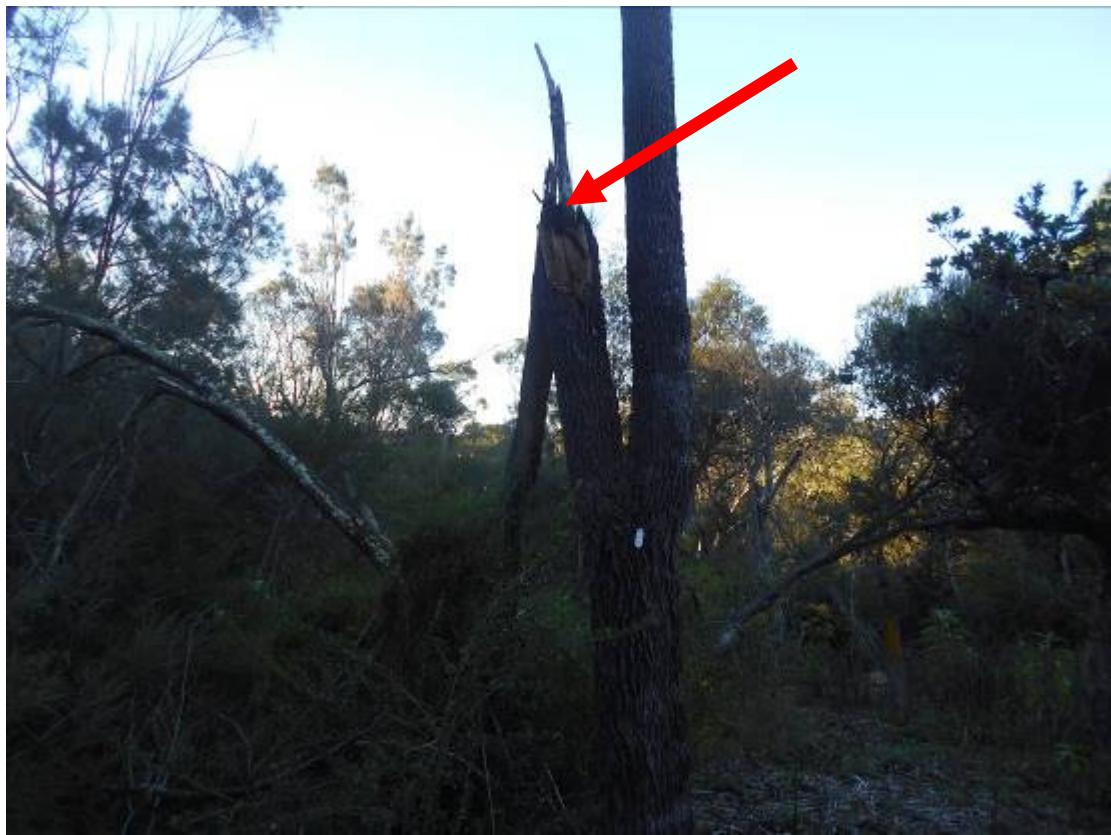
Tree A54 has a short life span due to the failure that has occurred to one of the two central scaffolds. Tree A54 has had a branch failure occur to the trunk at 3 metres above ground level. This species also has a sparse canopy and has a short life span. This species has been earmarked for removal before commencement of building works on site.

Figure 10 – showing the partially failed leader that has occurred to Tree A54. This species has been earmarked for removal before commencement of building works on site.

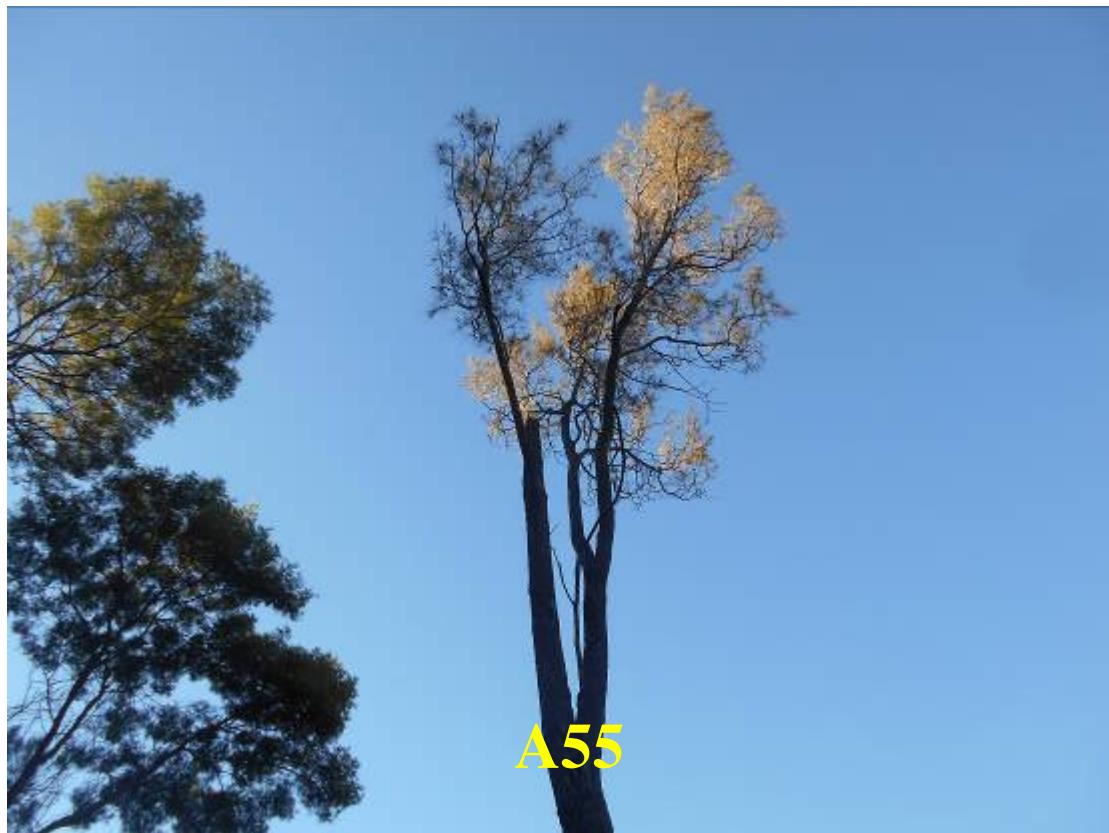
Tree A55 is at the top end of its maturity with extensive borer activity. This species has a moderately sparse canopy and will soon enter into an over mature phase. This species has been earmarked for removal before commencement of building works on site.

Figure 11 – showing the sparse canopy associated with Tree A55. This species is short lived (0 – 5 years) and would benefit from removal. This species has been earmarked for removal before commencement of building works on site.

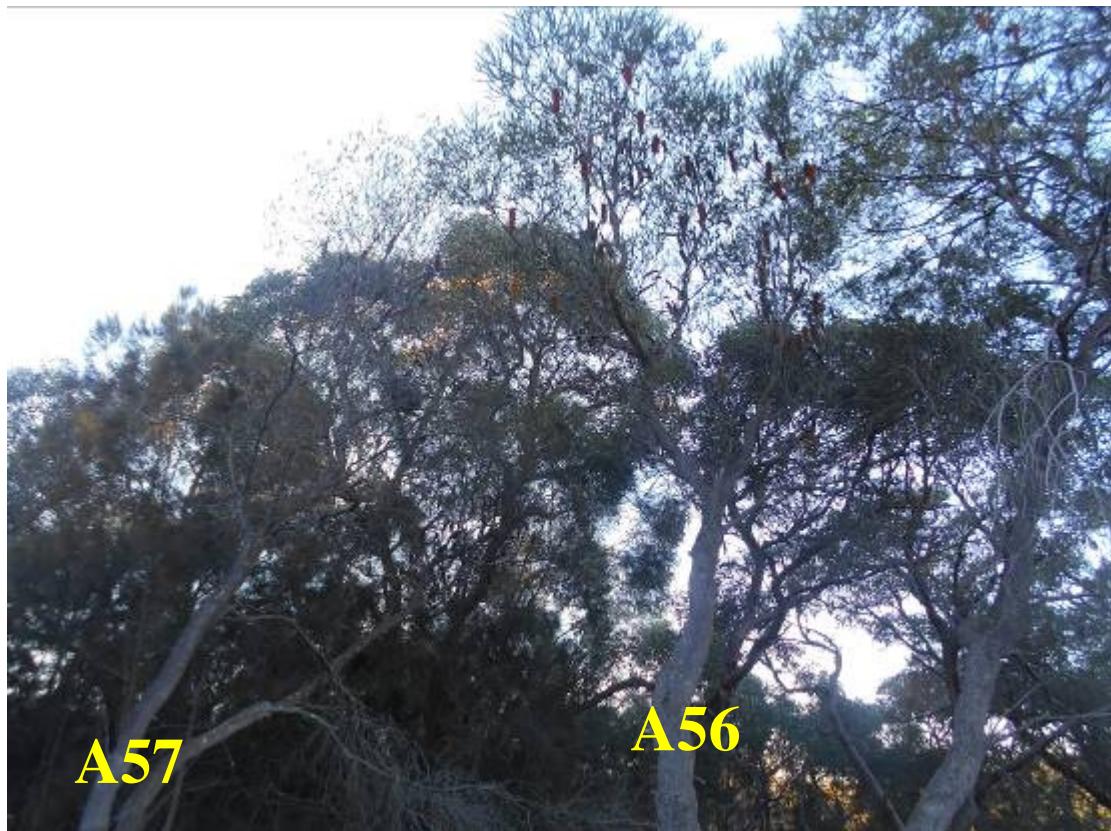
Tree 56 & A57 have a moderately sparse canopy and are entering into an over mature phase. Trees A56 & A57 have a reduced canopy cover and a live crown ratio of 60 – 65%. Trees A56 & A57 have been earmarked for removal due to their short life span and poor condition. This species has been earmarked for removal before commencement of building works on site.

Figure 12 – showing the location of Trees A56 & A57. Both these species have entered into an over mature phase and are earmarked for removal before commencement of building works on site.
