Geotechnical Investigation Report

Proposed Development at:

1 Larapinta Place
Glenhaven NSW 2156

G18202-2

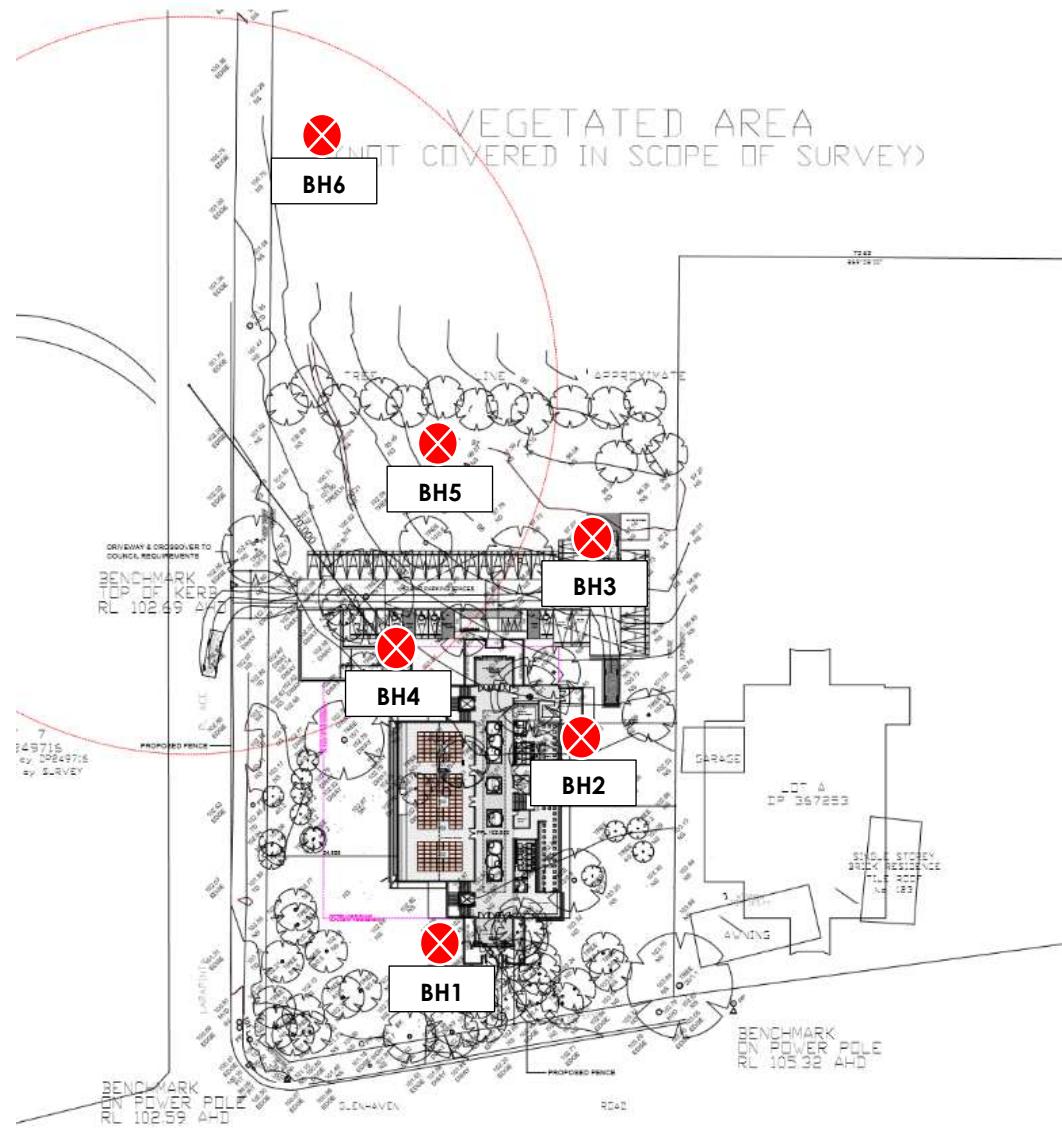
Figure 1
Site Plan

Approximate Borehole Location
