Arborist Impact  
Assessment

54 -68 Ferndell Street  
South Granville 2142  
New South Wales

5th of June 2019

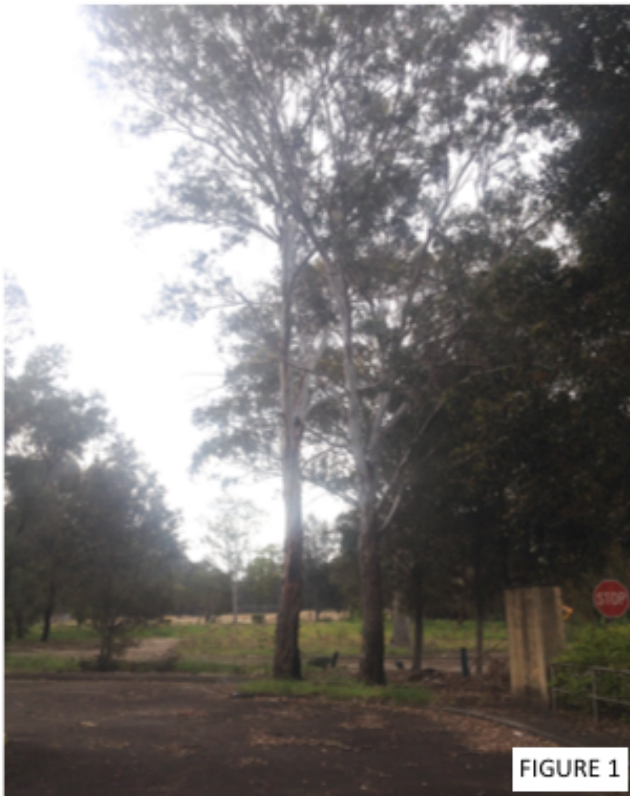
FIGURE 1. Trees 44 & 45

| Tree No. | Location | Scientific & Common Name | Crown Spread (m) | Height (m) | Diam (cm) | TPZ SRZ (m) | Condition of Tree & Failure potential (Health & Structure) (Defect & Measurements) | TULE | Retention Values | Impacts |
|---|---|---|---|---|---|---|---|---|---|---|
| 45 | | <u>Eucalyptus sideroxylon</u><br>Ironbark | 10 | | 45<br>46 | 5.4<br>2.39 | Semi mature, Inclusions at 10m, minor fracture. | 2d | Mod | Remove & Replenish |

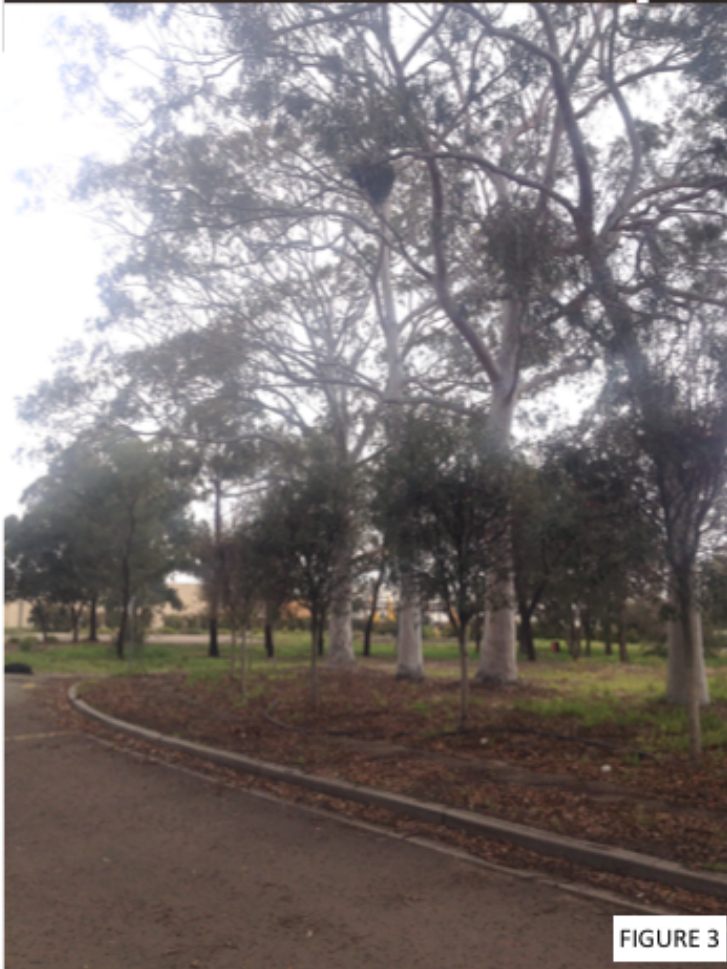
FIGURE 3.  
Trees 66 - 70

| Tree No. | Location | Scientific & Common Name | Crown Spread (m) | Height (m) | Diam (cm) | TPZ SRZ (m) | Condition of Tree & Failure potential (Health & Structure) (Defect & Measurements) | TULE | Retention Values | Impacts |
|---|---|---|---|---|---|---|---|---|---|---|
| 66 | | <u>Corymbia citriodora</u><br>Lemon Scented | 18 | 25 | 74<br>90 | 8.88<br>3.17 | Semi mature, moderate condition. | 2d | High | Remove & Replenish |
| 67 | | <u>Corymbia citriodora</u><br>Lemon Scented Gum | EW 12<br>NS 10 | 25 | 68<br>20 | 8.16<br>1.68 | Semi mature, moderate condition, unbalanced canopy to East West. | 2d | Mod-High | Remove & Replenish |
| 69 | | <u>Corymbia citriodora</u><br>Lemon Scented | 20 | 16 | 52<br>54 | 6.24<br>2.55 | Immature, moderate condition and exposed roots with physical damage | 2d | Mod | Remove & Replenish |
| 70 | | <u>Corymbia citriodora</u><br>Lemon Scented | 20 | 24 | 59<br>60 | 7.08<br>2.67 | Semi mature, moderate condition. | 2d | Mod-High | Remove & Replenish |

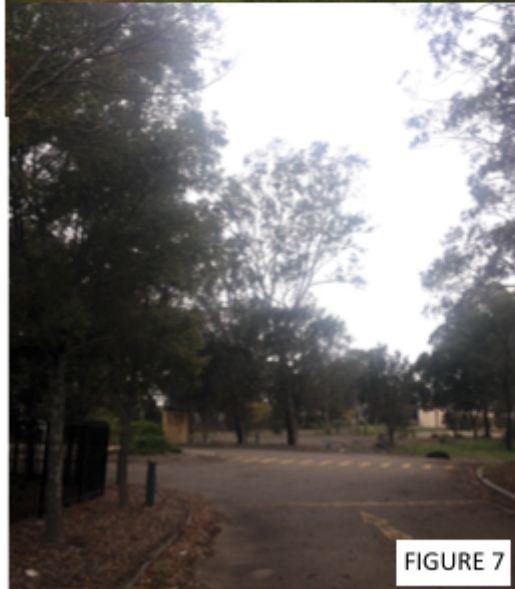
FIGURE 7.  
Trees 24 & 25

| Tree No. | Location | Scientific & Common Name | Crown Spread (m) | Height (m) | Diam (cm) | TPZ SRZ (m) | Condition of Tree & Failure potential (Health & Structure) (Defect & Measurements) | TULE | Retention Values | Impacts |
|---|---|---|---|---|---|---|---|---|---|---|
| 24 | In carpark | <i>Eucalyptus tereticornis</i><br>Forest redgum | 5 | 11 | 30<br>35 | 3.6<br>2.13 | Immature, moderate condition, sparse foliage crown, dehydration. | 2d | Low | Remove & Replenish |
| 25 | | <i>Eucalyptus tereticornis</i><br>Forest redgum | 5 | 10 | 21<br>28 | 2.52<br>1.94 | Immature, moderate condition, sparse foliage crown, physical damage at base. | 2d | Low | Remove & Replenish |
