Arborist report

Impact assessment

DA 2019/00061

11 - 17 Mosbri Crescent, The Hill 2300
Arcadia Park and Mosbri Crescent Park

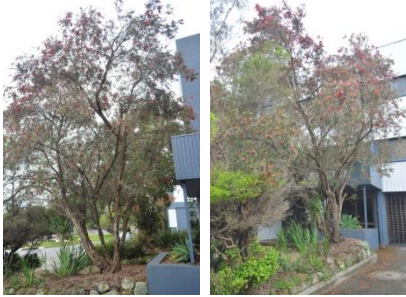
1 - Weeping bottlebrush

Seven leading trunks, divergent from the root crown, several inclusions. Leans slightly west. Directionally pruned east and south. Poor foliage cover.

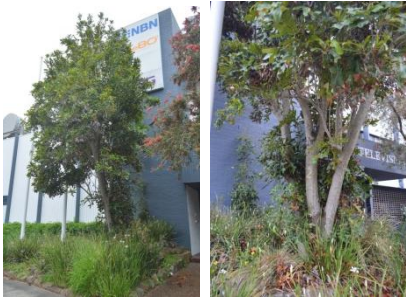
2 - Queensland firewheel

Short trunk with three leaders. Root crown shoots. Directionally pruned south. Leans slightly west. Foliage tips browned.

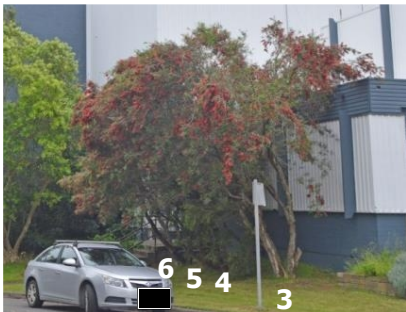
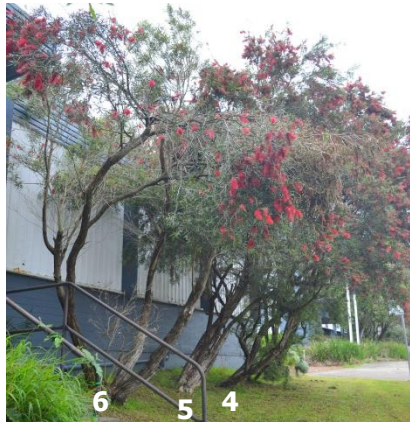
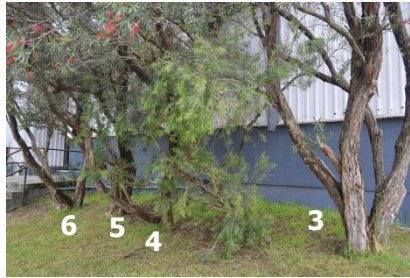
6 - Weeping bottlebrush

Three trunks arising from ground surface, divergent. West leader pruned out, other directional pruning. Branch failure west. Tear out wound to south leader. Inner canopy and epicormic dead wood.

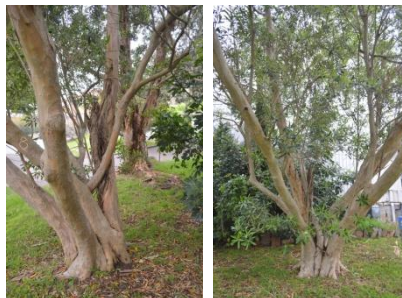
7 - Water gum

Seven leading trunks, divergent from the root crown, partially anastomised. Basal flare. Surface root west. Dead stub with dieback into one of the trunks, additional impact wound by crossed over leader, wounded with probable *Nectria* canker or other fungal pathogen. Twig failures, dead hanger in canopy.

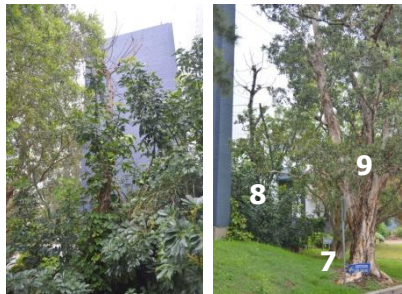
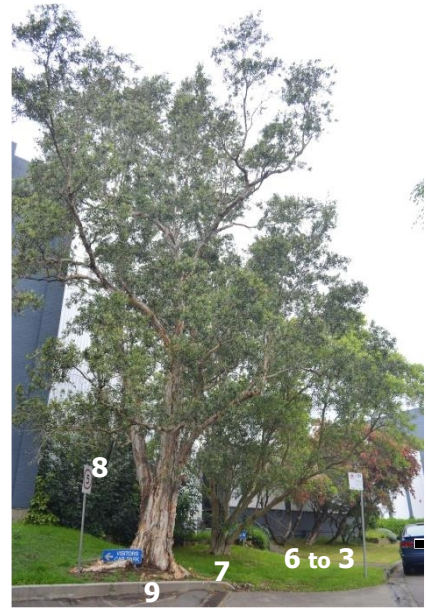
8 - Queensland umbrella

Lopped. Largely deceased with new growth at root crown. *Monstera species* taking over trunk and surrounding ground surface.

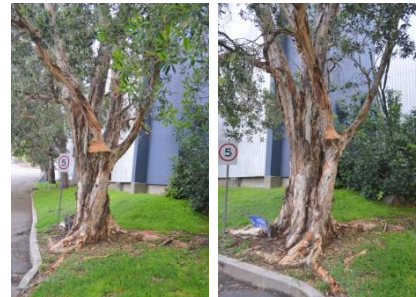
9 - Broad leaved paperbark

Basal flare, trunk fluted. Fused trunks. Large surface root network, wounded east - mechanical damage.

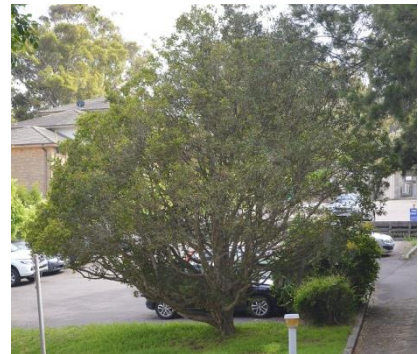
10 - Magenta lillypilly

Multi-stemmed acaulescent, with two main trunks, fusing leaders south-west. Basal flare, surface roots. Broad spreading habit. Significantly Psyllid afflicted foliage, small leaf size. Sporadic foliage cover.

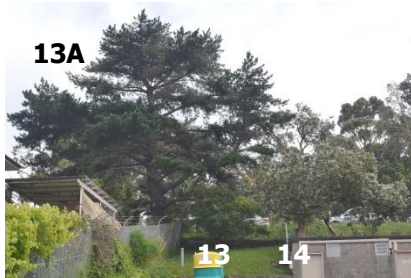
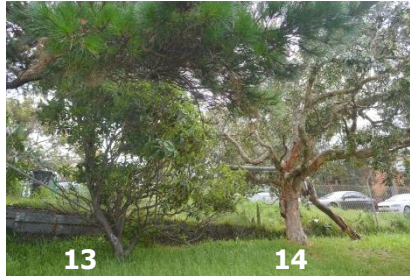
14 - Broad leaved paperbark

Co-dominant. Basal flare. Branching south. Extensive branch bow and sweep.

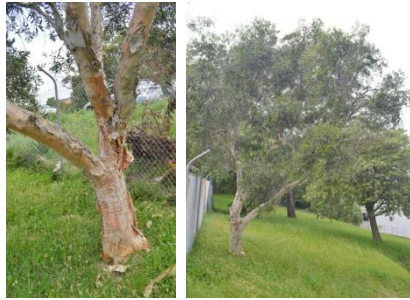
15 - Broad leaved paperbark

Basal flare. Short trunk, co-dominant, divergent. Larger leader is a fusion of two, included bark.

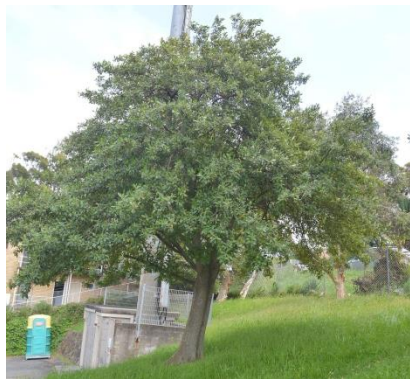
16 - Norfolk Island hibiscus

Basal flare, predominantly south. Trunk fluted. Balanced branch distribution at central branch junction, at ~1.8m.

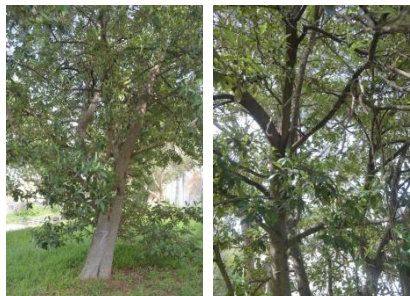
17 - Norfolk Island hibiscus

Basal flare, predominantly south. Trunk fluted. Co-dominant, differing sizes. Balanced branch distribution at central branch junction, at ~1.6m. Branch bow and sweep, low hanging canopy. Upper canopy branch congestion, acute.

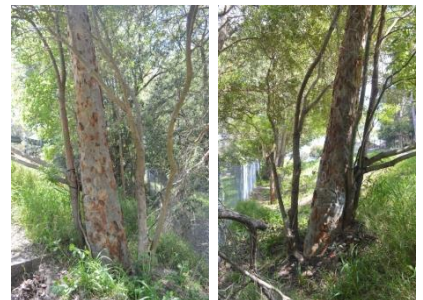
20 - Smooth bark apple gum

Leans north-east. Branching over road. Dead wood. Dead canopy. Suppressed.

- 4.14. As the site has a future, long term plan, and due to their condition, trees **19, 20 and 21** along Kitchener Parade should be considered to be replaced. This should be supported by approval to remove from the determining authority and was discussed in the Arborist document of 8/4/2020. Further information is given in the Summary section of this document, page 3.

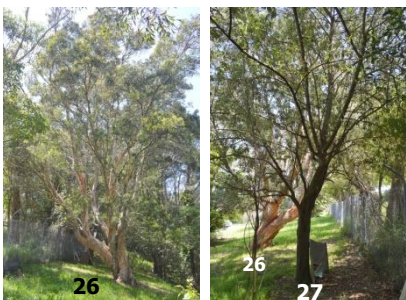
27 - Norfolk Island hibiscus

Acaulescent, differing sizes. Directionally pruned. Foliage concentrated at branch ends.

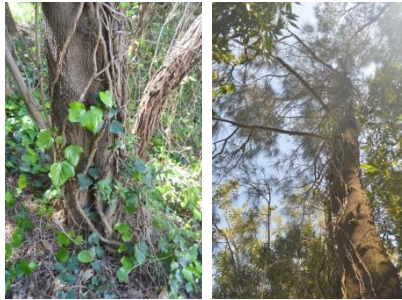
28 - Casuarina

Asymmetrical. Exotic *Ivy species* affliction to framework. Amongst a grove of same and understory Pittosporum.

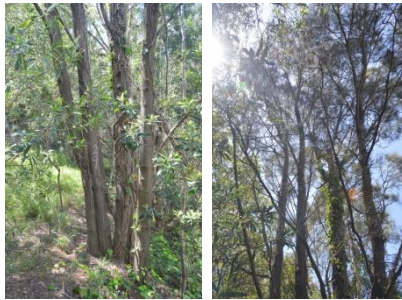
29 - Casuarina

Part of a lignotuber cluster. Exotic *Ivy species* affliction to framework. Amongst a grove of same and understory Pittosporum.

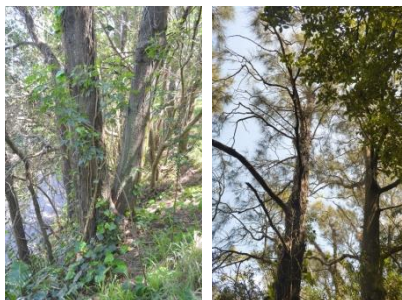
30 - Casuarina

Acaulescent, co-dominant. Basal flare, trunk fluted. On landform drop-off, leans south. Exotic *Ivy species* affliction along southern trunk.

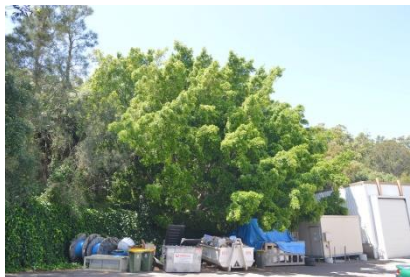
31 - Small fruited fig

Acaulescent, ~ 9 trunks. Basal flare, fissures. Surface roots to ~7m south.

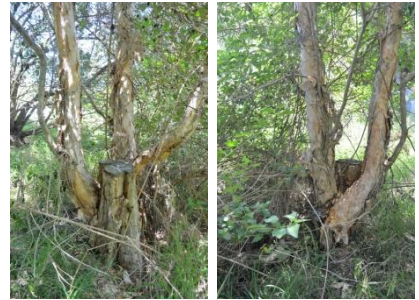
32 - Broad leaved paperbark

Lopped. All growth upright, acute epicormics. Failed west branch. Dense understory.

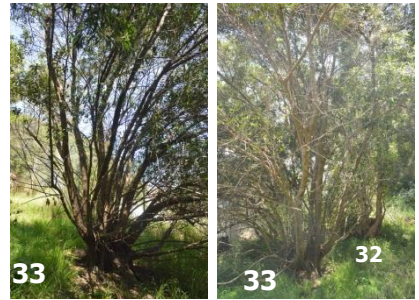
33 - African olive

Lopped at root crown. Congested epicormic regrowth. Foliage concentrated at ends. Inner twig dieback.

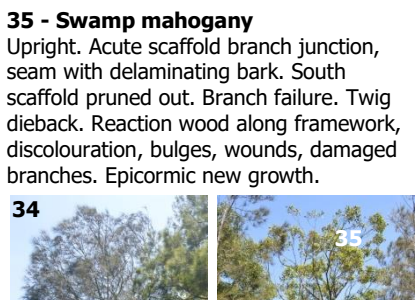
34 - Casuarina

Trunk taper. Low branching at ~1.5m into 3 leaders. Deeply fissured, growth splits. Directionally pruned north-west. Poor foliage cover.

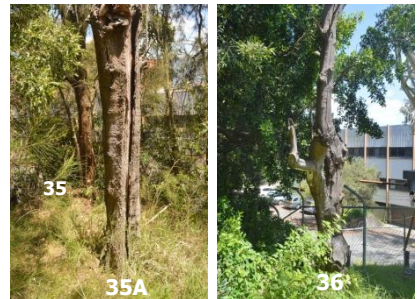
36 - Casuarina

Pruned. Storm damaged. Delaminated bark, disintegrating. Dead.

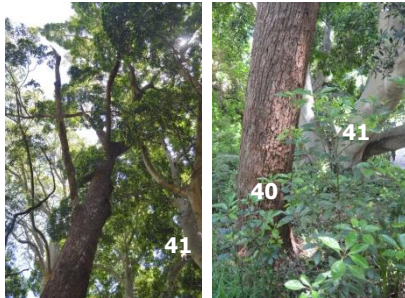
41 - Small fruited fig

Persistent *Monstera species* affliction. Poor foliage cover, south side.

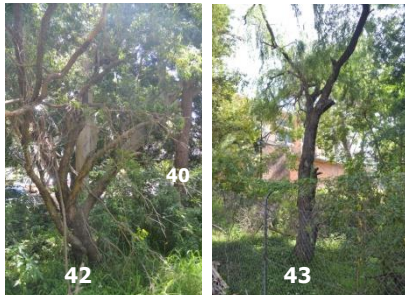
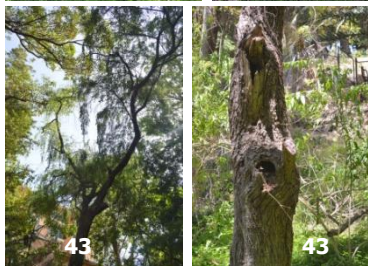
43 - Weeping willow

Low hollow, failed scaffolds. Internal cavity. Large diameter dead wood. Branching southwards, bowed.

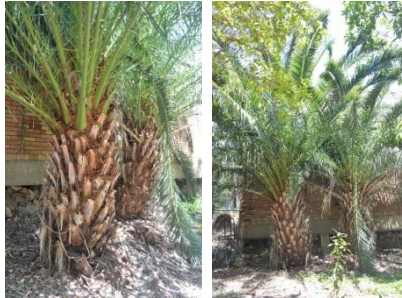
On retaining wall. Adjoins palm 44.

Both palms had rudimental crown lifting.

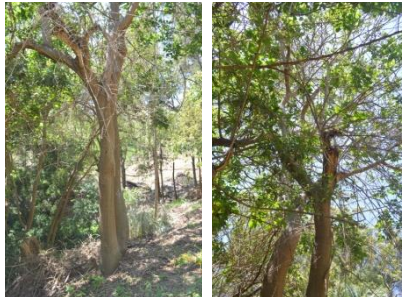
46 - Coral

Acaulescent co-dominant. Larger leader head failure. Elevated root plate. Large diameter failed branches west-south-west. Twig dieback. Branch bow and sweep, interaction - rub wound, rib.

- **TREE PROTECTION MEASURE:** *Tree 46 to be retained with excavation not to occur within SRZ. A bond for retention of the tree could be conditioned by the determining authority if found necessary. Pruning may be required to mitigate risks of failure and provision of a safe working environment.*

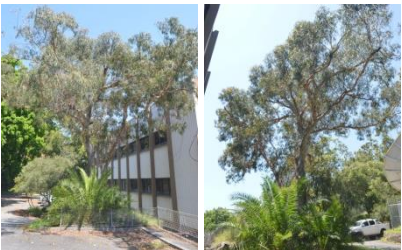
47 - Willow gum

Basal flare. Surface roots. Leans north-east. Low scaffold at ~2m. Pruned. Storm afflicted, epicormic regrowth.

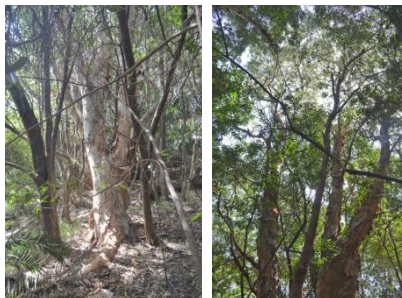
47A - Broad leaved paperbark

Basal flare. Large diameter surface root south-west. Co-dominant at ~1.1m, divergent to upright leaders. Above canopy.

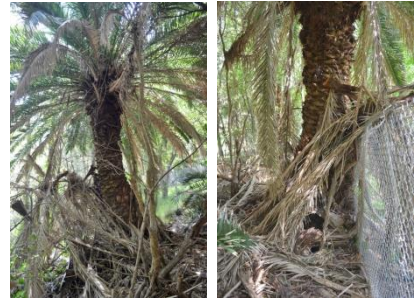
48 - Canary Island date palm

On boundary. Elevated root plate. Trunk bowed west to east. Crown lifted. Accumulation of dead fronds and vegetative matter at base.

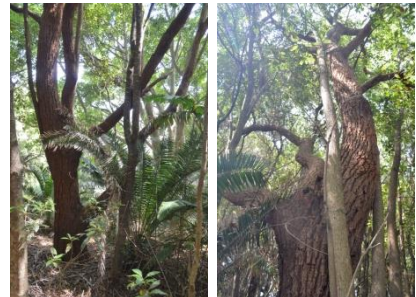
49 - Swamp mahogany

Basal flare. Co-dominant. Apical failure. Branching north, bow and sweep. Deep seams at branch junctions, inclusions, cracks. Surrounding tall Pittosporum saplings.

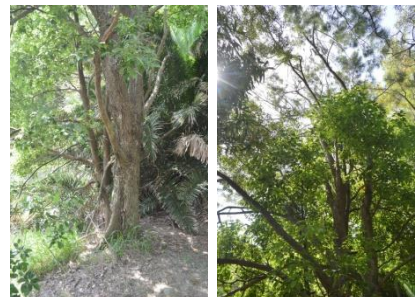
50 - Casuarina

Basal flare, trunk fluted. Camphor laurel sapling alongside causing suppression of lower branching. Dead wood. Foliage concentrated at ends.

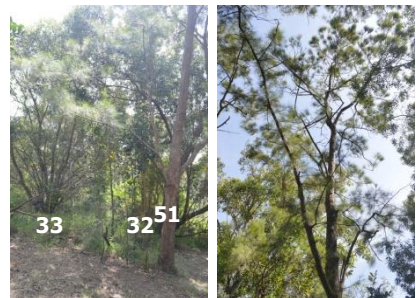
51 - Casuarina

Basal flare. Upright. Balanced branching. Twig dieback and small diameter dead wood. Trunk has latent bud shoots.

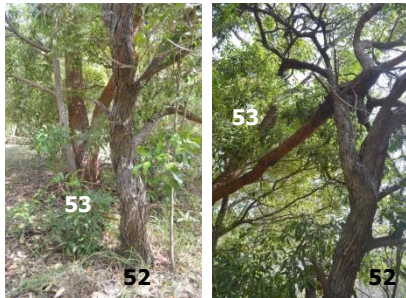
53 - Swamp mahogany

Stout trunk. Co-dominant at ~1m. Scaffold failure north-west. Transverse scars.

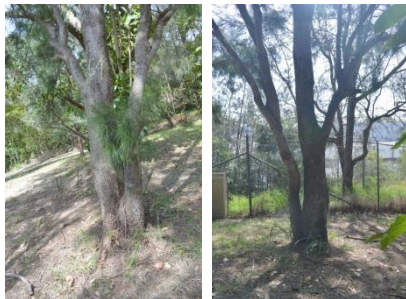
54 - Casuarina

Basal flare. Surface roots, wounded - mechanical damage. Co-dominant at root crown, leaders of differing sized. Small diameter failed branches, dead wood. Epicormic regrowth.

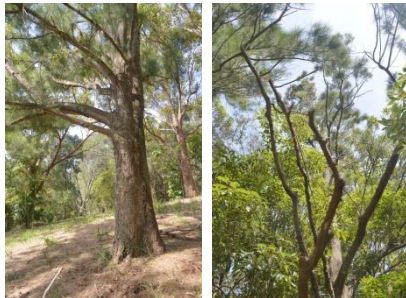
55 - Casuarina

Basal flare, trunk fluted, tapers. Co-dominant at ~1m, seam with rib formation. South side canopy suppression, lengthy dead branches, asymmetrical.

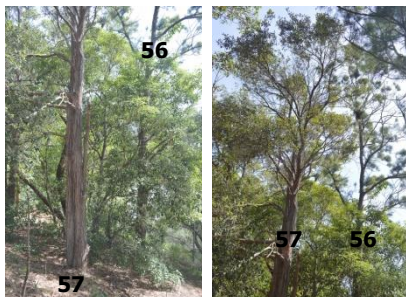
57 - Turpentine

Acaulescent, co-dominant, acutely convergent to root crown. Low dead wood.

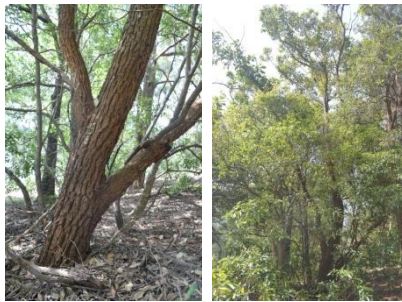
58 - Swamp mahogany

Leans east. Low branching. Trunk and branch bow and sweep. Canopy interaction with adjoining trees.

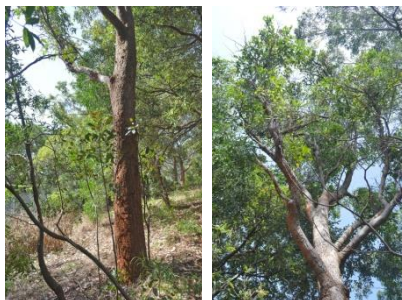
59 - Swamp mahogany

Upright. Trunk taper. Much epicormic regrowth along branch lengths has died. Tear out wounds north-west. Twig dieback. Failed branch stubs.

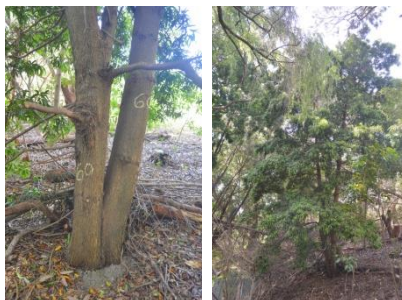
60 - Plum pine

Co-dominant at root crown, acutely divergent. Lower branch abscission. West branches on boundary fence.
