## **Arboricultural Impact Assessment**

Lot 1 in DP654433 & Lot C in DP38865  
#392 Galston Road  
GALSTON

Requested by Treysten  
C/- SDH & Associates Pty Ltd

13<sup>th</sup> May, 2011.

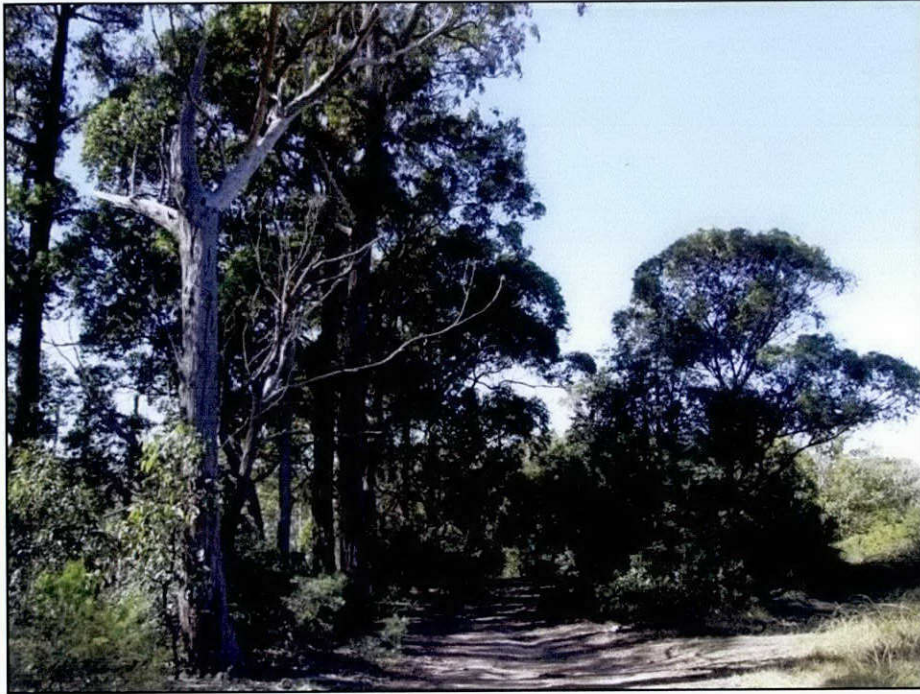
**Figure 1 Showing the existing access road from Mid Dural Road and Trees 40-51**

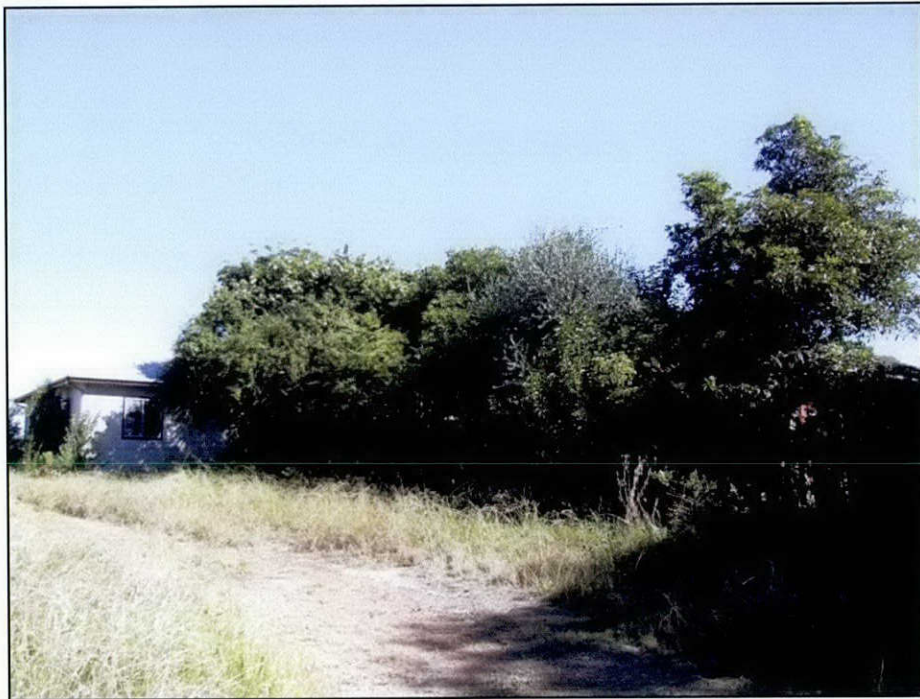
**Tree 25** is a *P. undulatum* (Australian Daphne). This tree is mature, in good health and fair structural condition. The tree is amongst *Ligustrum* spp. (Privet) and *Cotoneaster* spp. (Cotoneaster). Hazard rating is 4. SULE is 2B.

**Figure 2 Showing Tree 25 and associated weeds**

1. The tree passes the VTA. It is suitable to be considered for retention. It is a member of STIF. This species is exempt from HSC TPO. ). It would be difficult to remove the *Cotoneaster* spp. (Cotoneaster) and *Ligustrum* spp. (Privet) without damaging the *P. undulatum* (Australian Daphne). This tree is just on the edge of the driveway and again it would have its Structural Root Zone (SRZ) compromised. Retaining this tree is probably not the best option. It could be retained but compromised. Again another replacement Sydney Turpentine Ironbark Forest understorey (same species) could be replanted.
2. It is located within the proposed building footprint. Removal is recommended.
3. N/A

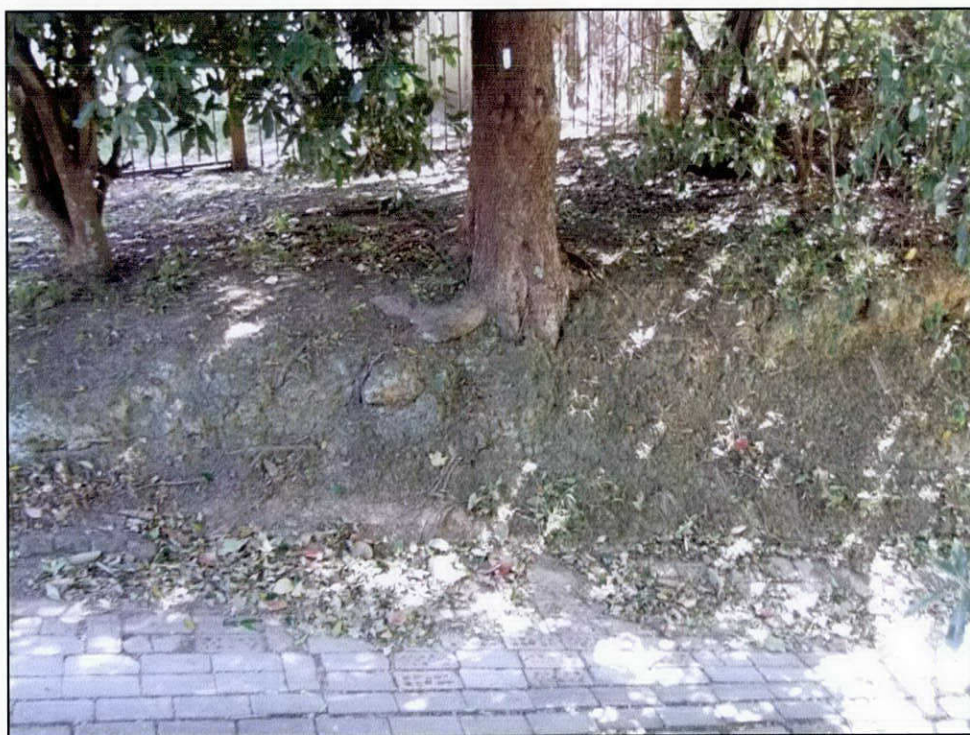
**Tree 31** is a *S. paniculatum* (Magenta Cherry). This tree is mature, in good health and structural condition. The tree is on the cut for the drive. Hazard rating is 4. SULE is 2B.

**Figure 3 Showing Tree 31 on unretained cut for driveway to house**

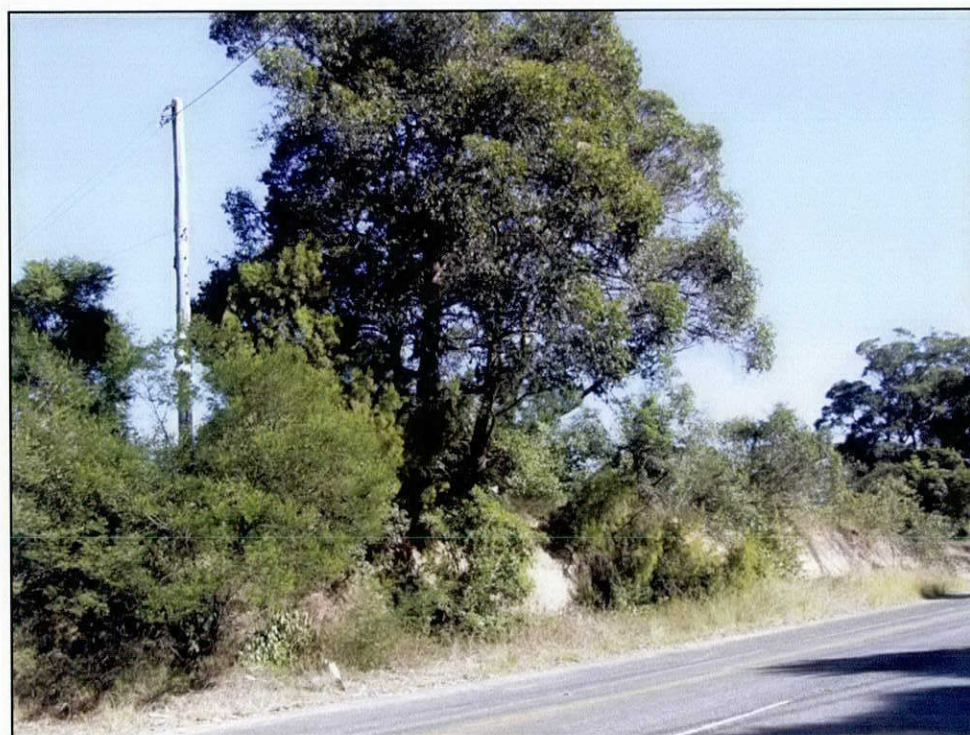
**Tree 28** is a *E. acmenoides* (White Mahogany). This tree is mature, in good health and poor structural condition. There is a trunk wound at 1.5 metres, small deadwood and 1 metre to a 4 metre cut. Hazard rating is 5. SULE is 2B.

**Tree 29** is a *E. acmenoides* (White Mahogany). This tree is mature, in good health and structural condition. It is 1.5 metres to a cut. The tree passes the VTA. Hazard rating is 5. SULE is 2B.

**Figure 4 Showing Trees 28 and 29 and unretained cut on Mid Dural Rd**

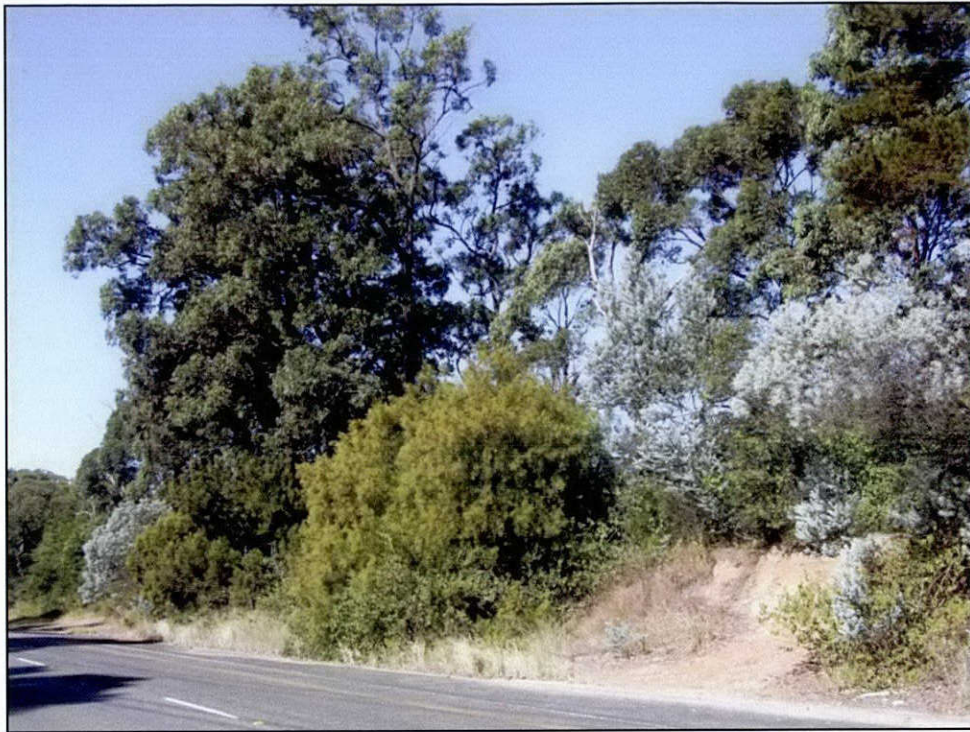
**Figure 5 Another view of remnant vegetation and cut on Mid Dural Rd**

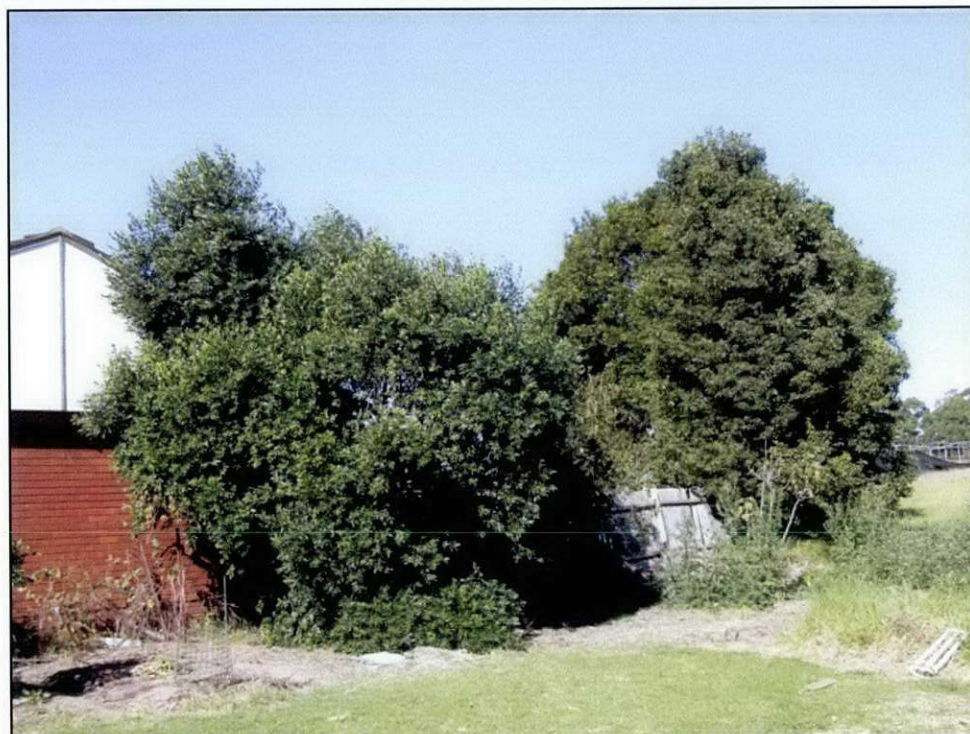
**Tree 18** is a *S. paniculatum* (Magenta Cherry). This tree is mature, co-dominant, in good health and structural condition. It has an inclusive main fork union, small deadwood and girdling roots. Hazard rating is 4. SULE is 2B.

**Tree 19** is a *C. camphora* (Camphor Laurel). This tree is mature, multi trunked, in good health and poor structural condition. SULE is N/A.

**Figure 6 Showing Trees 18 and 19**

- 1. The tree passes the VTA. It is suitable to be considered for retention.**
- 2. It is located within the proposed building footprint. Removal is recommended.**
- 3. N/A**

1. The tree fails the VTA. It is not suitable to be considered for retention.
2. This species is listed in HSC LCDA Appendix 5 as a Noxious Weed. It is located within the proposed building footprint. Removal is recommended.
3. N/A

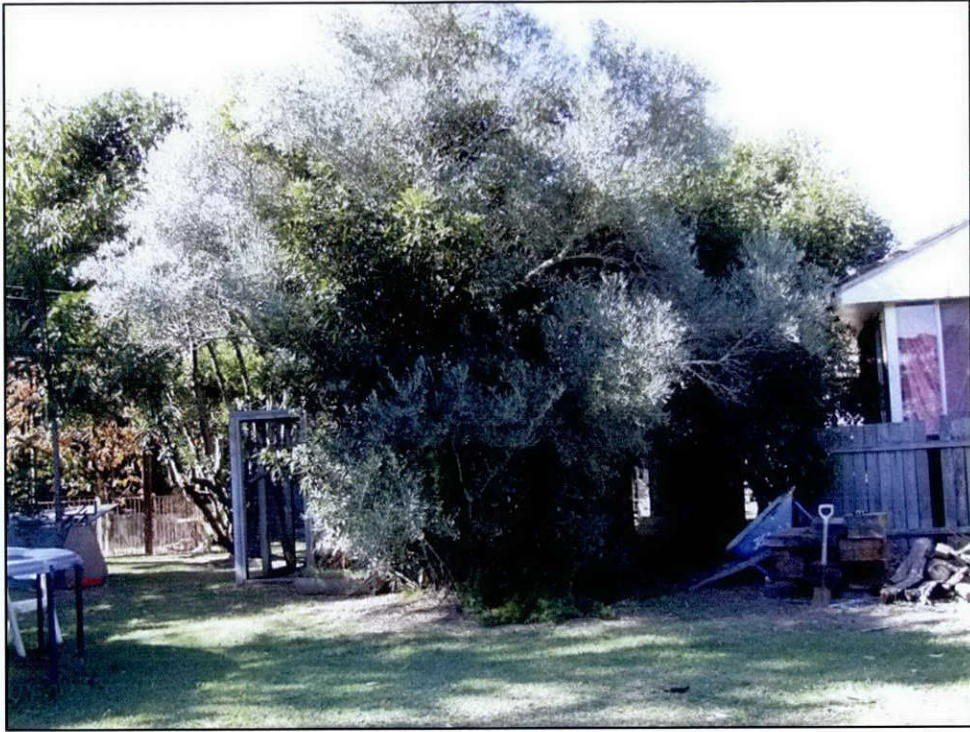
**Tree 20** is a *Chionanthus ramiflora* (Native Olive). This tree is mature, tri-dominant, in good health and fair structural condition. It has an inclusive fork union. Hazard rating is 3. SULE is 2B.

**Figure 7 Showing Tree 20**

1. The tree passes the VTA. It is suitable to be considered for retention.
2. It is located within the proposed building footprint. Removal is recommended.
3. N/A

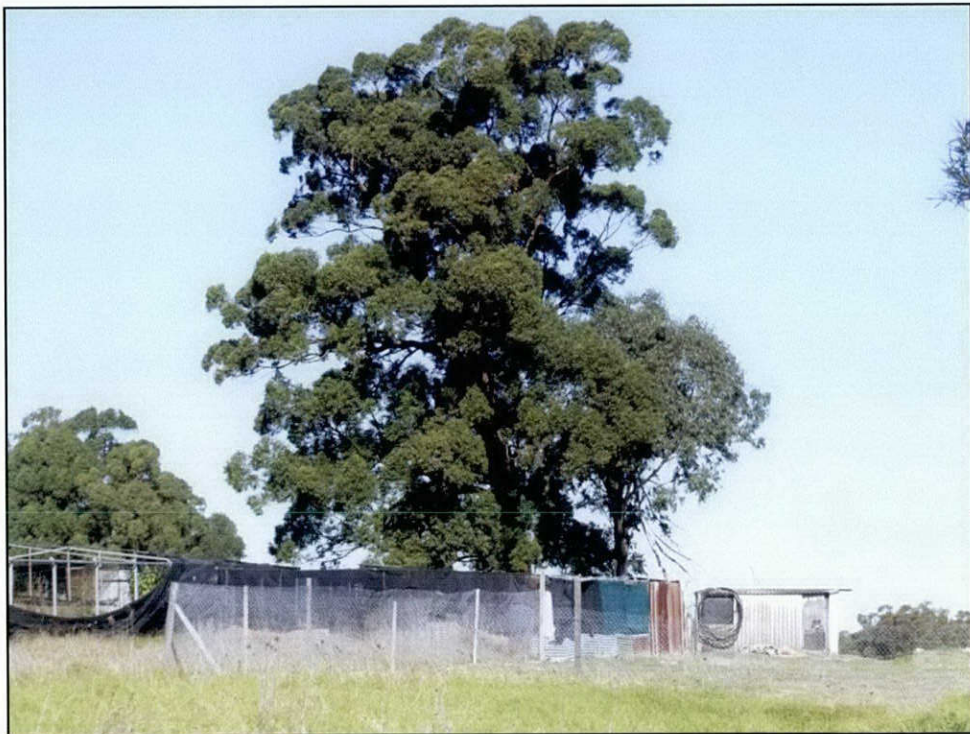
**Tree 13** is a *E. microcorys* (Tallow-wood). This tree is very mature, in good health and structural condition. There are epicormics and large deadwood present. The bark in the root buttress has been eaten by goats. Hazard rating is 6. SULE is 3D.

**Tree 14** is *Unknown species*. This tree is mature, in good health and fair structural condition. There is small deadwood and epicormics present. Hazard rating is 5. SULE is 2B.

**Figure 8 Showing Trees 13 and 14**

- 1. The tree fails the VTA. It is not suitable to be considered for retention.**
- 2. It is located within the proposed building footprint. Removal is recommended.**
- 3. N/A**

- 1. The tree passes the VTA. It is suitable to be considered for retention.**
- 2. It is located within the proposed building footprint. Removal is recommended.**
- 3. N/A**

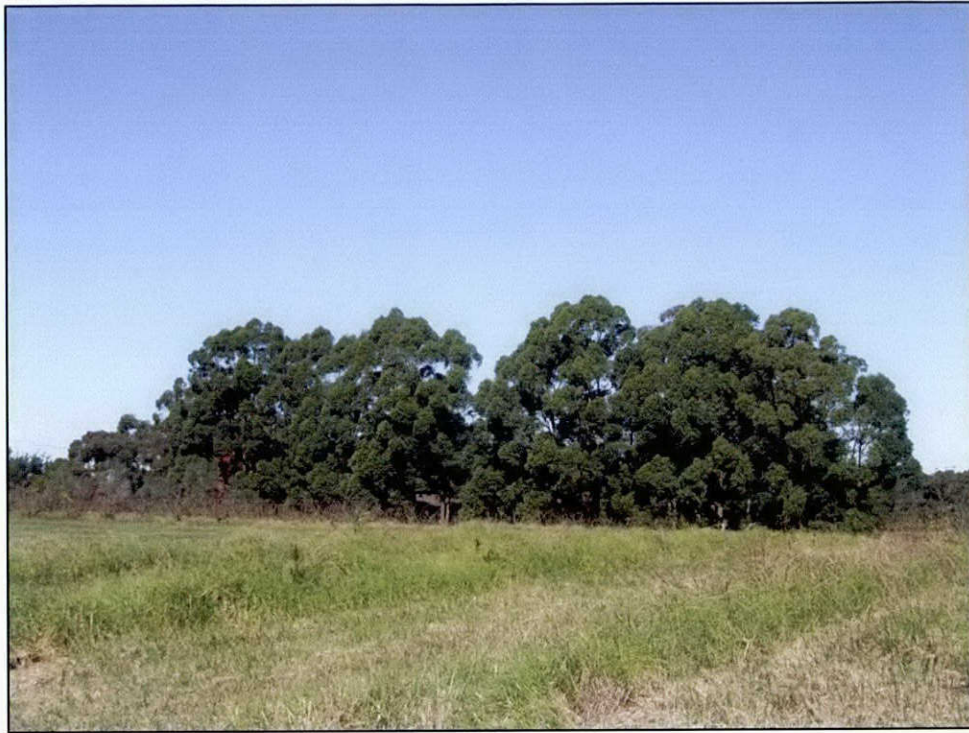
**Tree 11** is a group of 29 x *Eucalyptus microcorys* (Tallow-wood). These trees are young mature, in good health and fair to good structural condition. They have all been lopped and as a result have inclusive fork unions and multiple branch attachments. There is small deadwood present. The trees are located on the bank. Hazard rating is 4. SULE is 2B.

**Figure 9 Showing Group 11 viewed from near Trees 13 and 14**

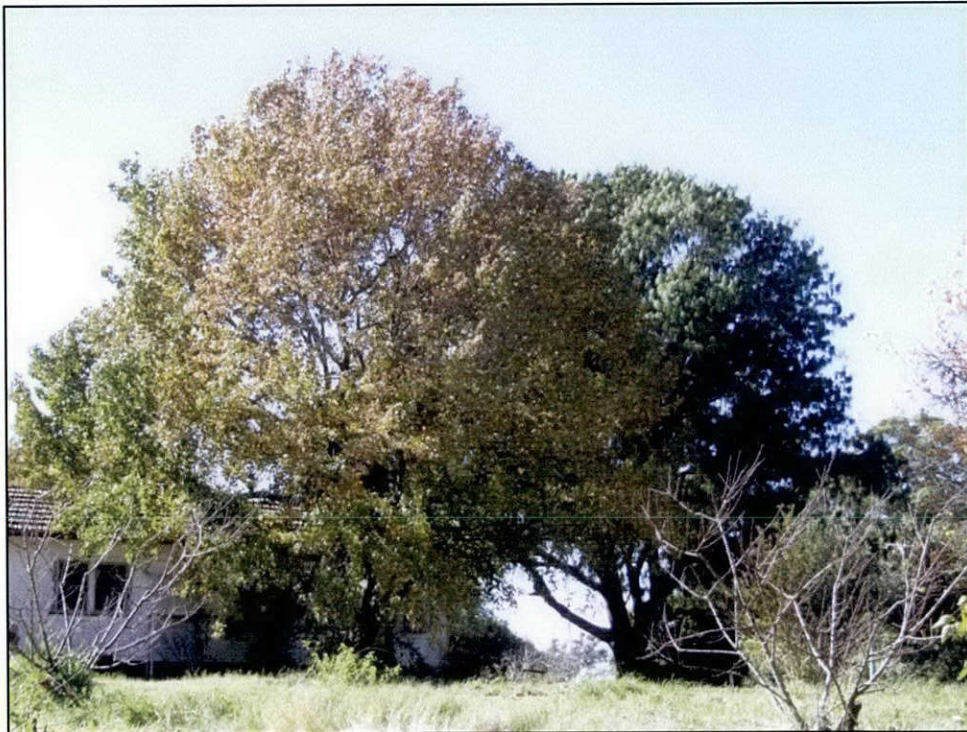
**Tree 2** is a *Pinus patula* (Mexican Weeping Pine). This tree is mature, in good health and structural condition. The crown has been raised and there is small deadwood present. Hazard rating is 4. SULE is 2B.

**Tree 7** is a *L. styraciflua* (Sweet Gum). This tree is mature, in good health and structural condition. The tree has been power line trimmed. Hazard rating is 4. SULE is 2B.

**Figure 10 Showing Trees 2 and 7**

1. The tree passes the VTA. It is suitable to be considered for retention.
2. It is located on the edge of the driveway (<2m). Inadequate space for future growth. This species is listed in HSC LCDA Appendix 4 as an Undesirable Species. There is *Ligustrum* spp. (Privet) at its base. Removal is recommended.
3. N/A

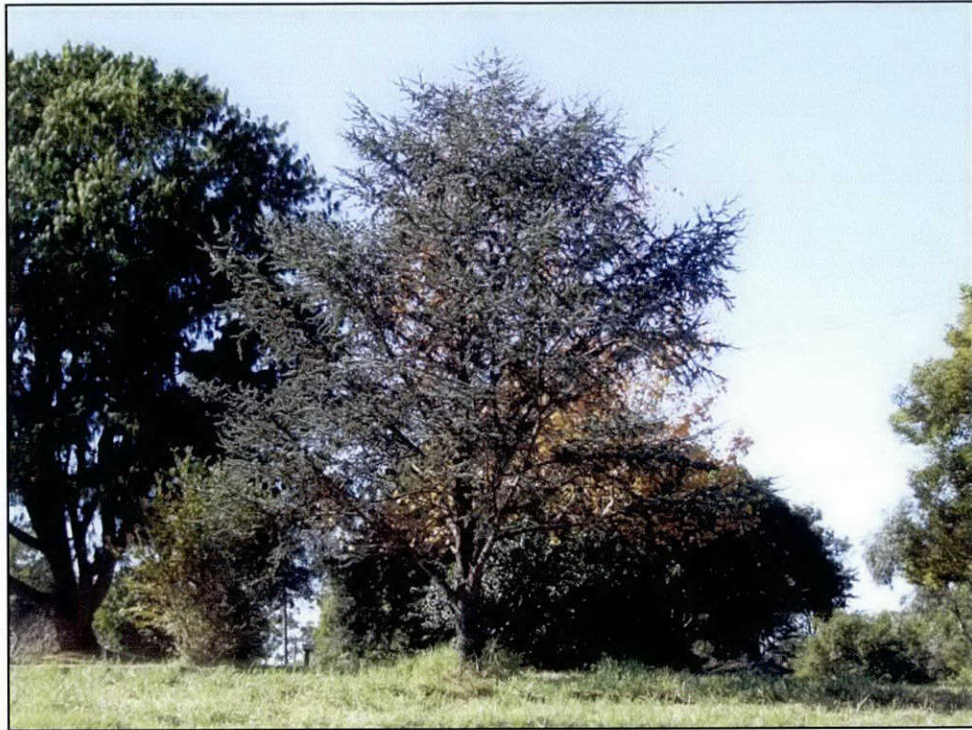
**Tree 9** is a *Cedrus atlantica* (Atlas Cedar). This tree is mature, in good health and structural condition. There is small deadwood present. Hazard rating is 3. SULE is 2B.

**Figure 11 Showing Tree 9**

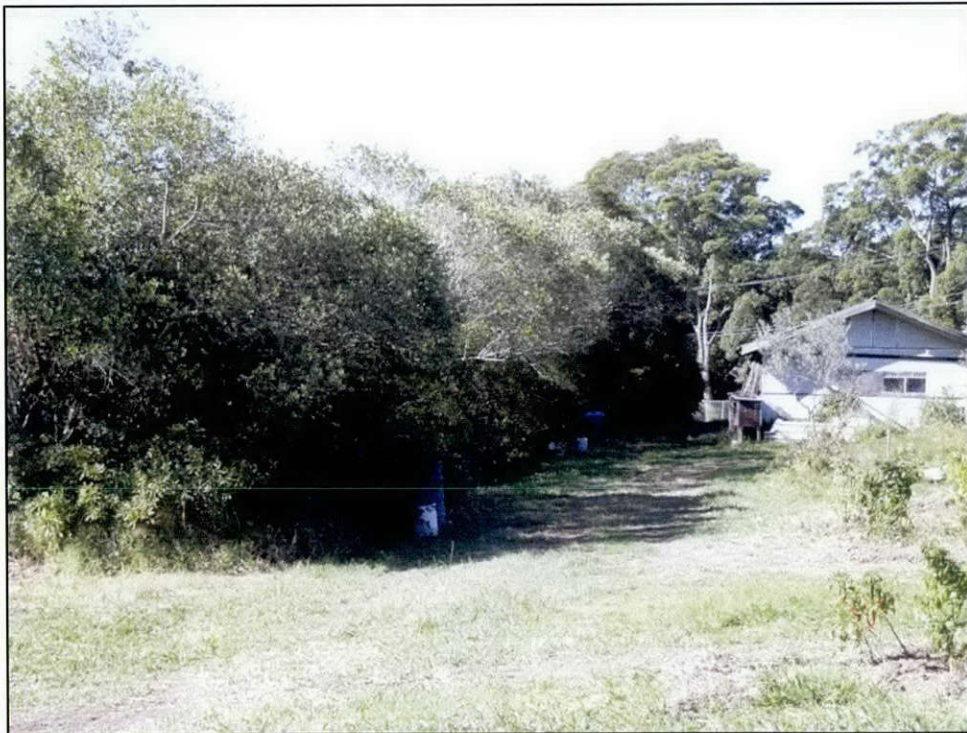
**Tree 12** is a group of 40+ various species. These trees are mature, in fair health and structural condition. They are located on the adjoining site. Hazard rating is 4. SULE is 2B.

**Figure 12 Showing trees referred to as Tree 12 (Group of 40)**
