Zhiva Living Dural Pty Ltd atf The Zhiva Living
C/- Mills Oakley

Drainage Line Classification: 4 Vineys Road, Dural, NSW.

P1806980JR01V03
July 2019

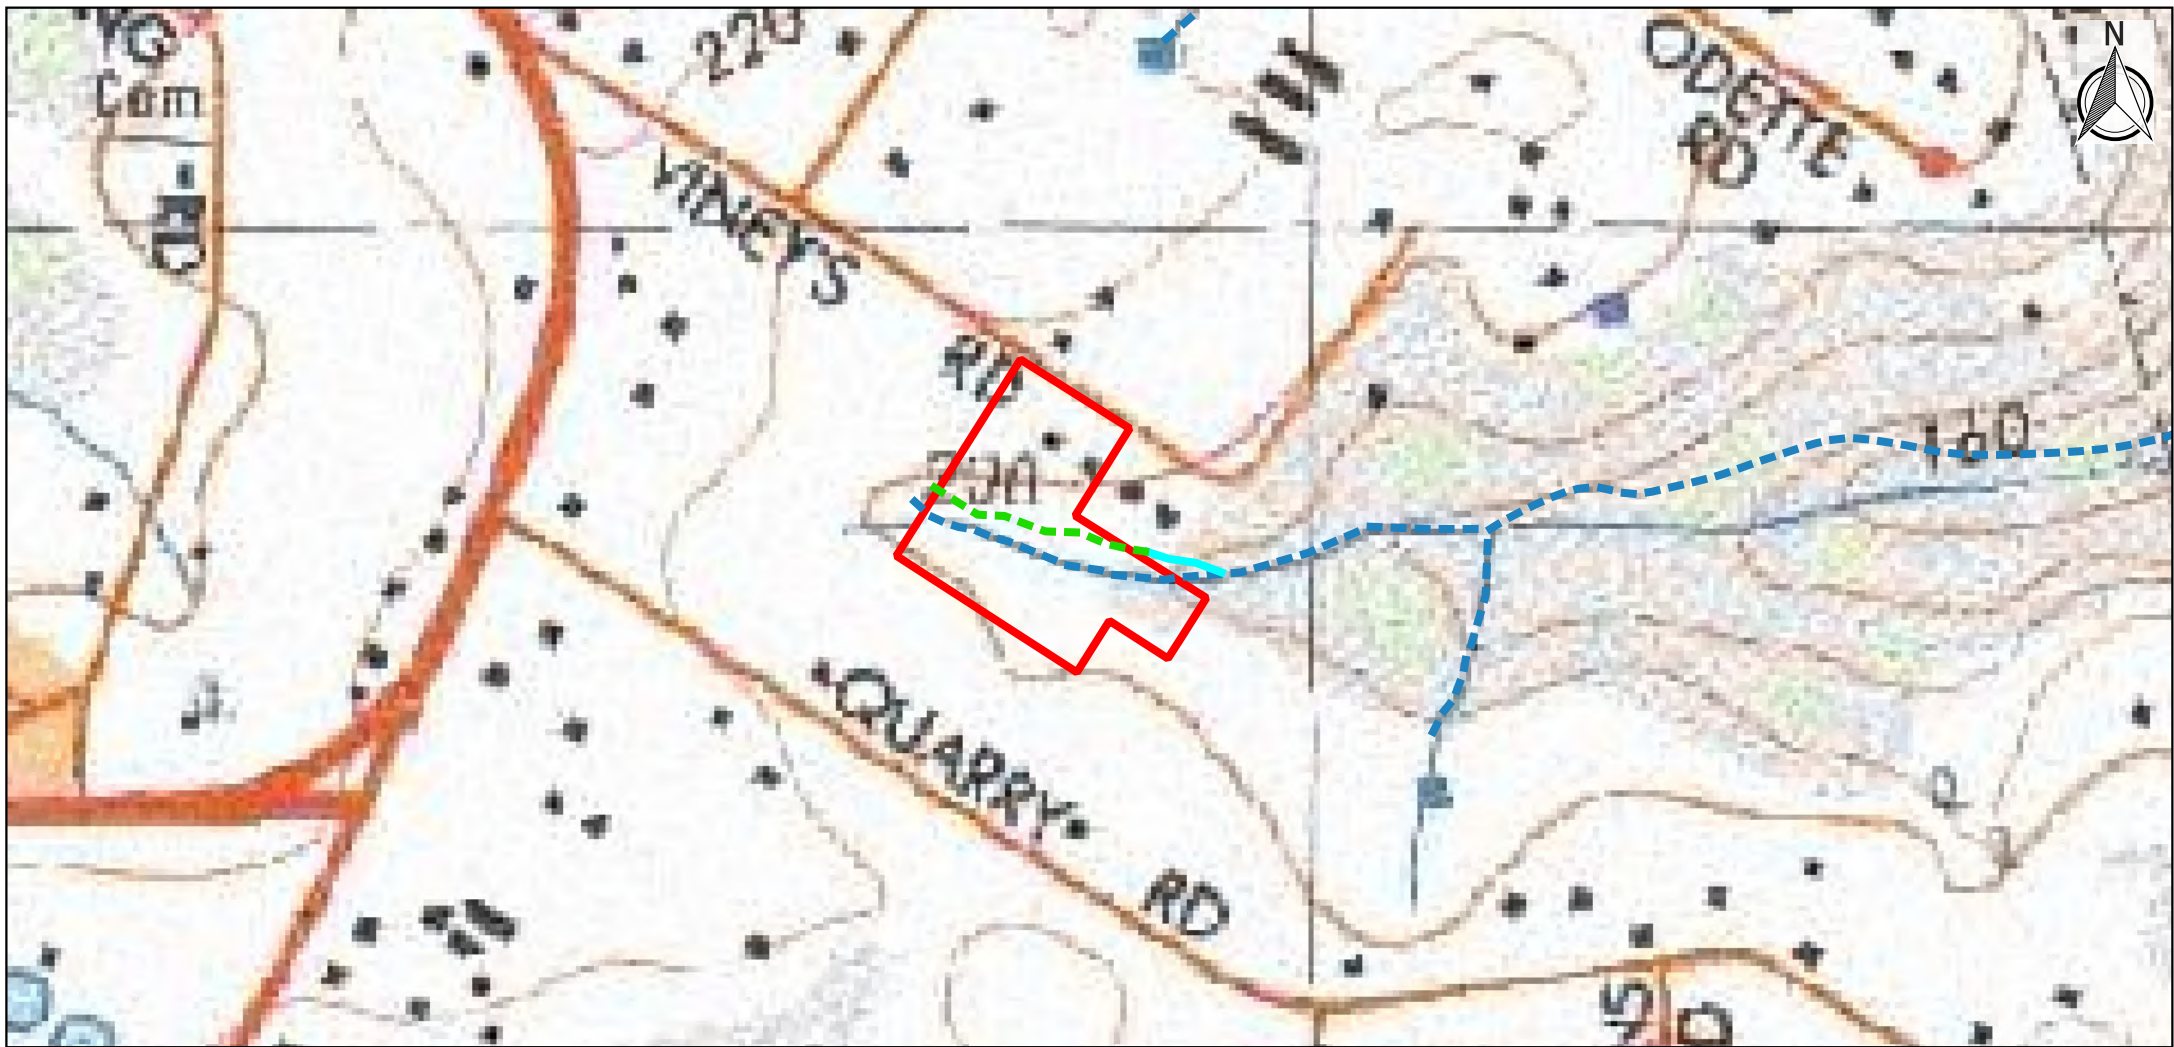
Figure 1 at Attachment B provides a copy of the 1:25,000 scale map for the site. This shows that a 'blue' line is drawn within the site, suggesting that a 1st order watercourse could possibly be present.

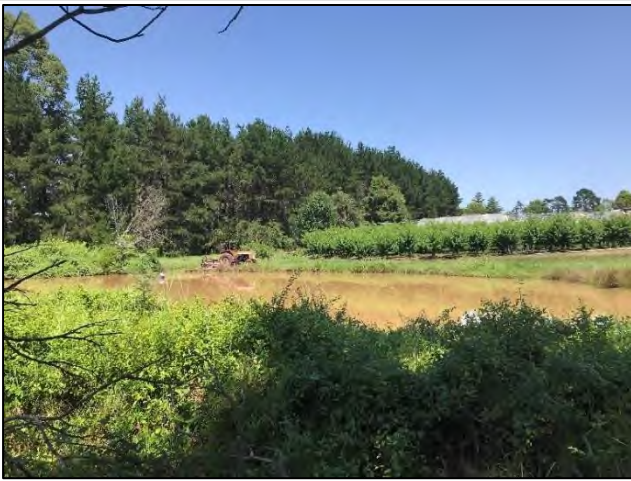
Plate 1: (Reach 1) View west across dam and to orchards on adjacent property to west of the subject site.

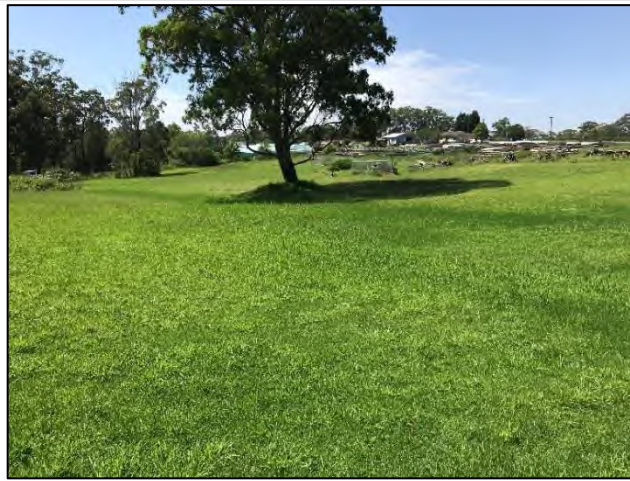
Plate 2: (Reach 2) View south east of grassed swale (observed 'drainage line'), to east of the dam.

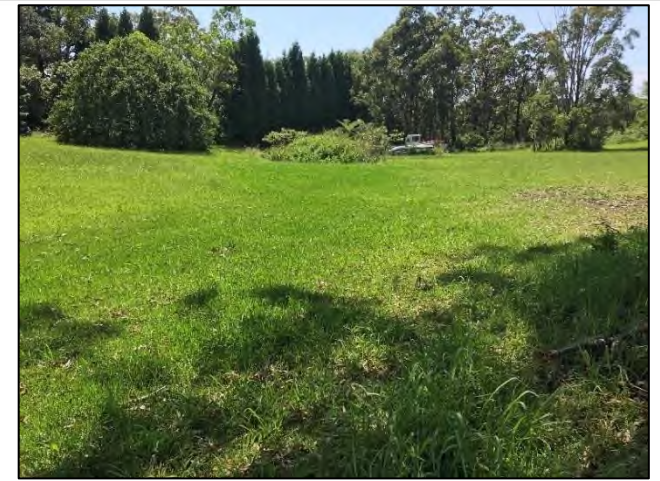
Plate 3: (Reach 2) View west across grassed swale, observed 'drainage line' (Reach 2) toward constructed drainage line (Reach 3).

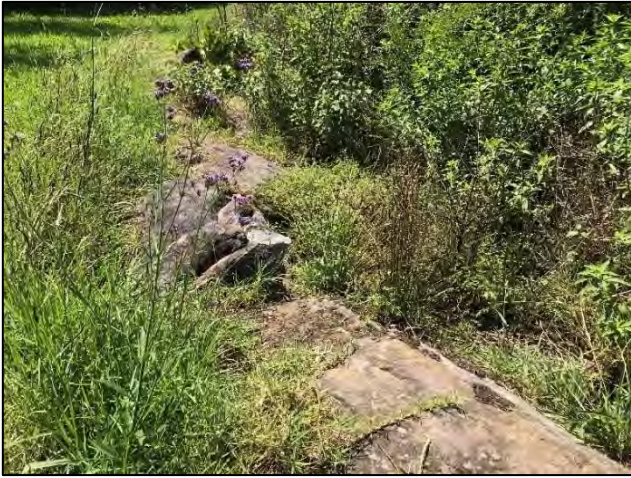
Plate 4: (Reach 3) View west of constructed stormwater drain and old erosion gully head. Vegetation is exotic and of low ecological value.

Whilst we are of the view that Reach 3 is a constructed stormwater drainage channel and not a watercourse, we note that NRAR may ultimately come to a different view. On that basis, we recommend that it be treated as a first order watercourse, and understand that a riparian offset has been incorporated into the site design.

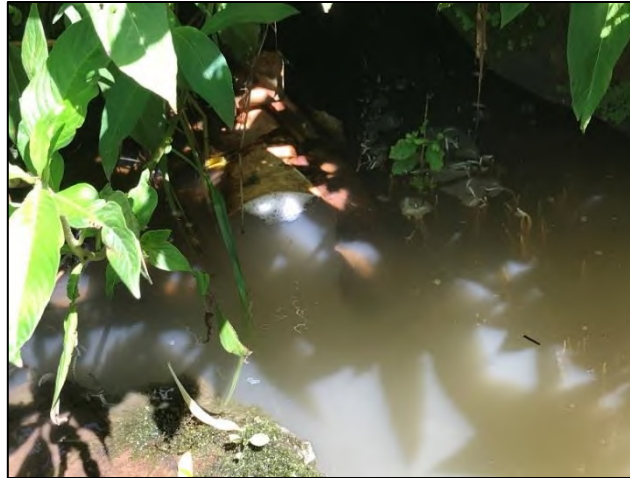
Plate 5: (Reach 3) View north of stormwater pipe discharging to Reach 3.

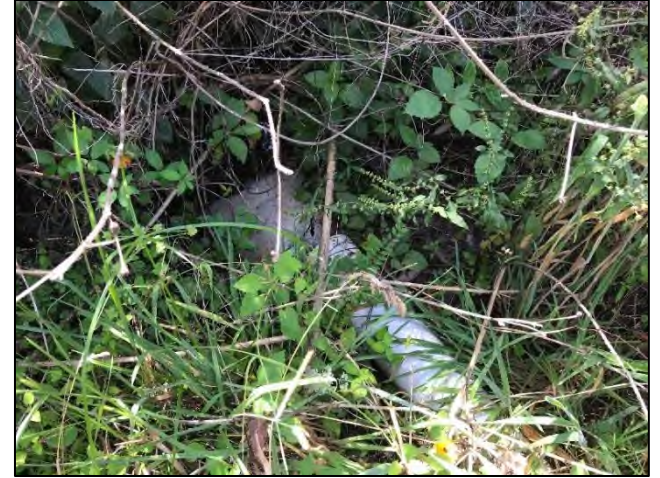
Plate 6: (Reach 3) View south of stormwater pipe discharging to Reach 3.

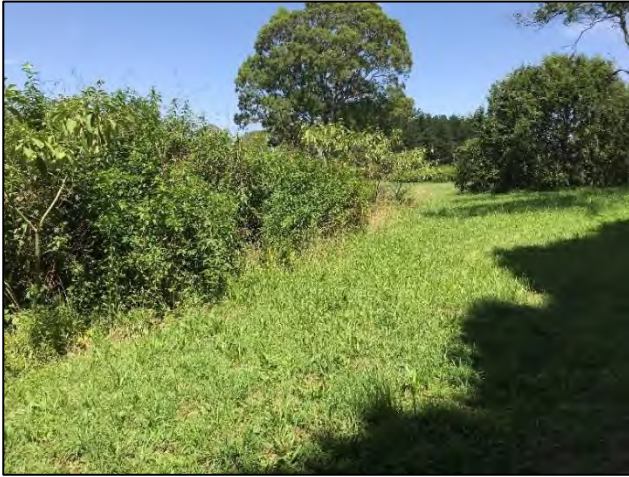
Plate 7: (Reach 3) View west of vegetated (constructed) drainage channel and historical erosion gully.

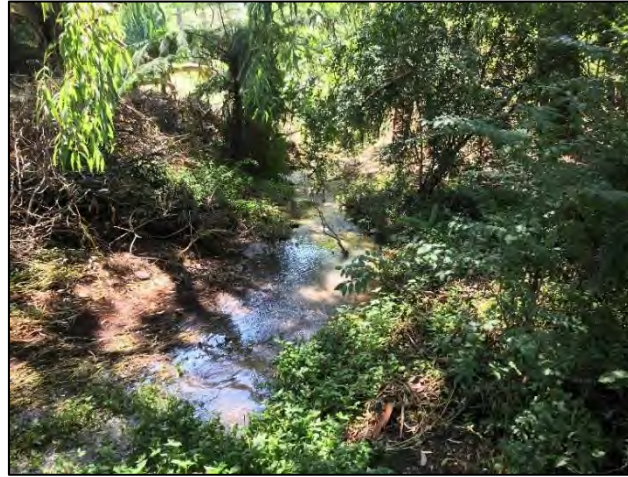
4. Reach 4 is a first order watercourse. It has been modified to some degree, but the extent of riparian vegetation is reasonable and the corridor provides ecological value.

Plate 8: (Reach 4) View east of watercourse banks and channel, and riparian vegetation.
