ARBORICULTURAL IMPACT ASSESSMENT AND TREE MANAGEMENT PLAN

PROPOSED MEDIUM DENSITY RESIDENTIAL DEVELOPMENT

**824 TO 834 FOREST ROAD
PEAKHURST, NSW**

25th September 2018

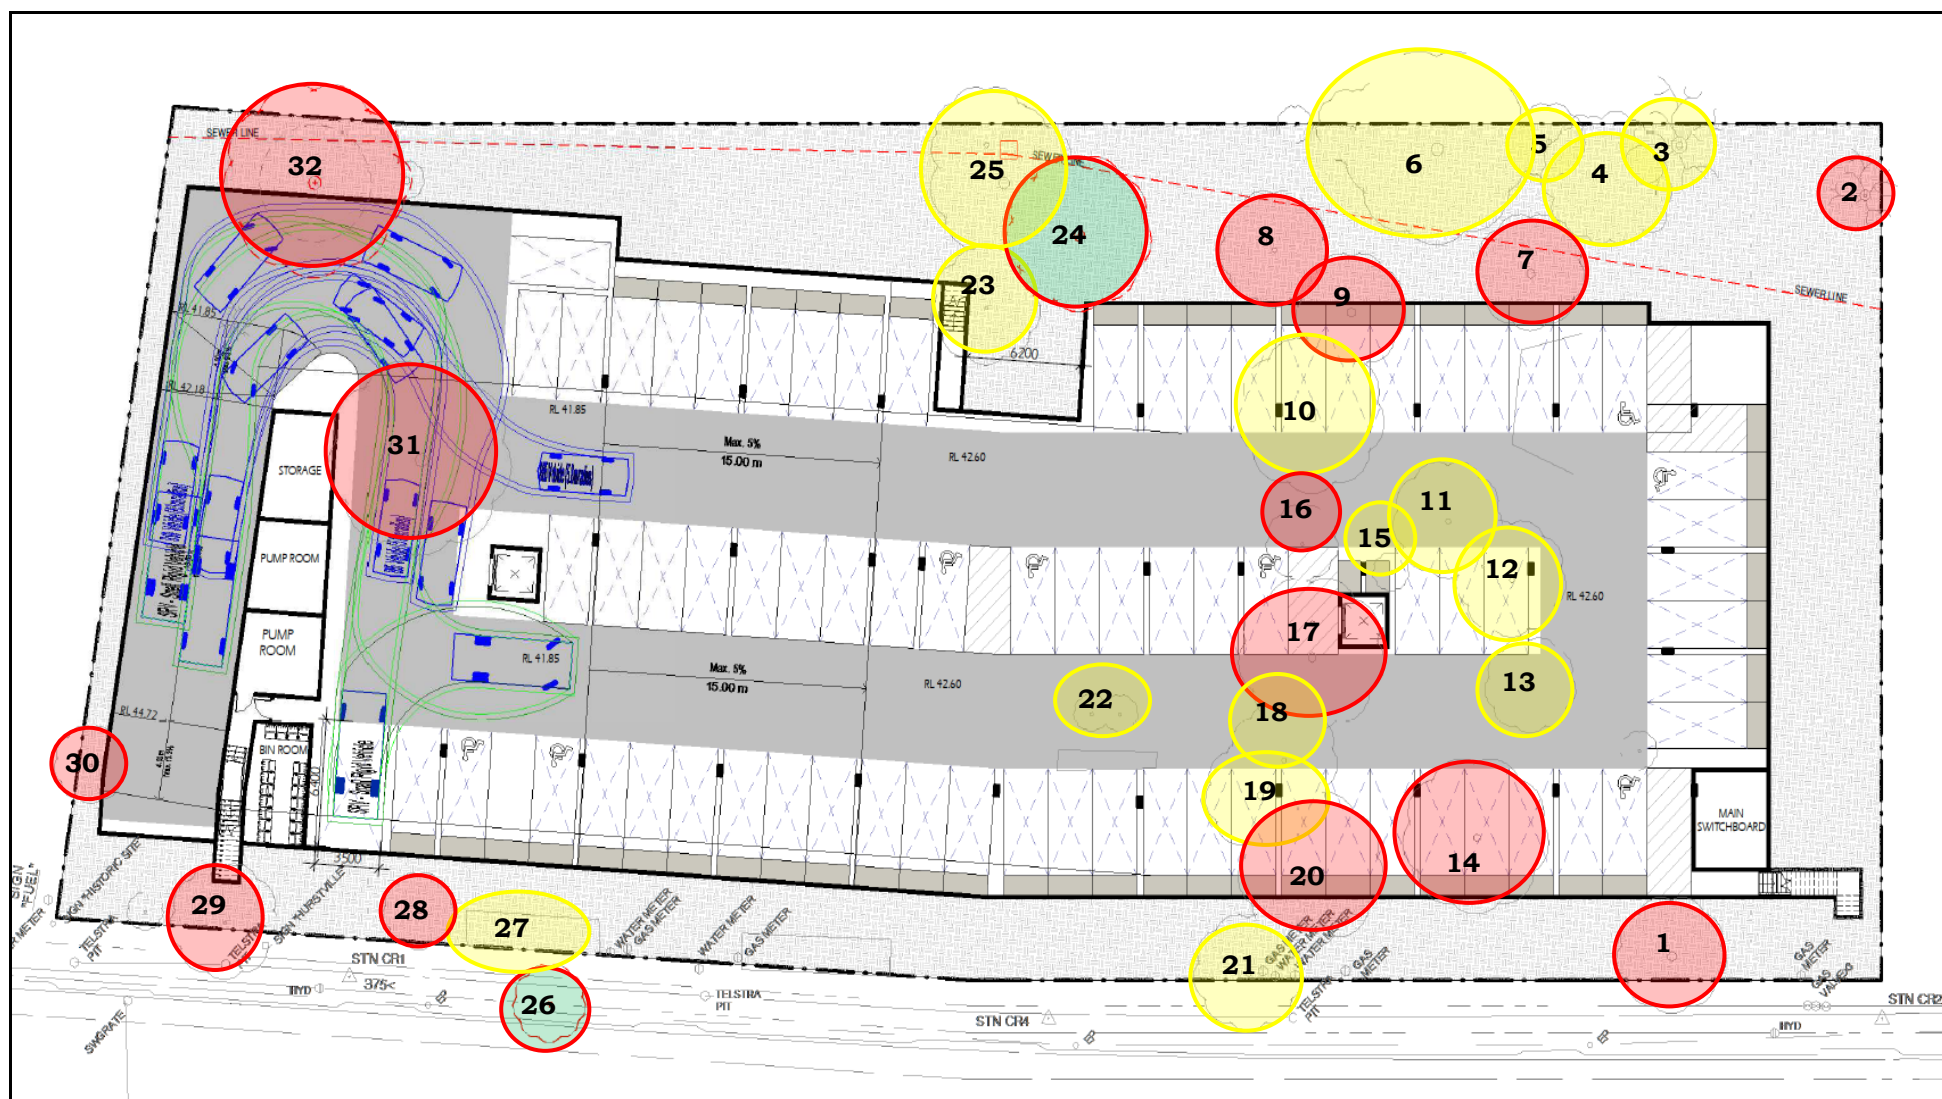
Figure 7 Shows trees to be retained in green, removed in red and TPO Exempt species.

Tree Protection Zone Fencing to be erected in accordance with AS 4970-2009 Protection of trees on development sites, including "No Access Signage" and Annexure B. TPZ fencing may be moved if required for development access requirements.

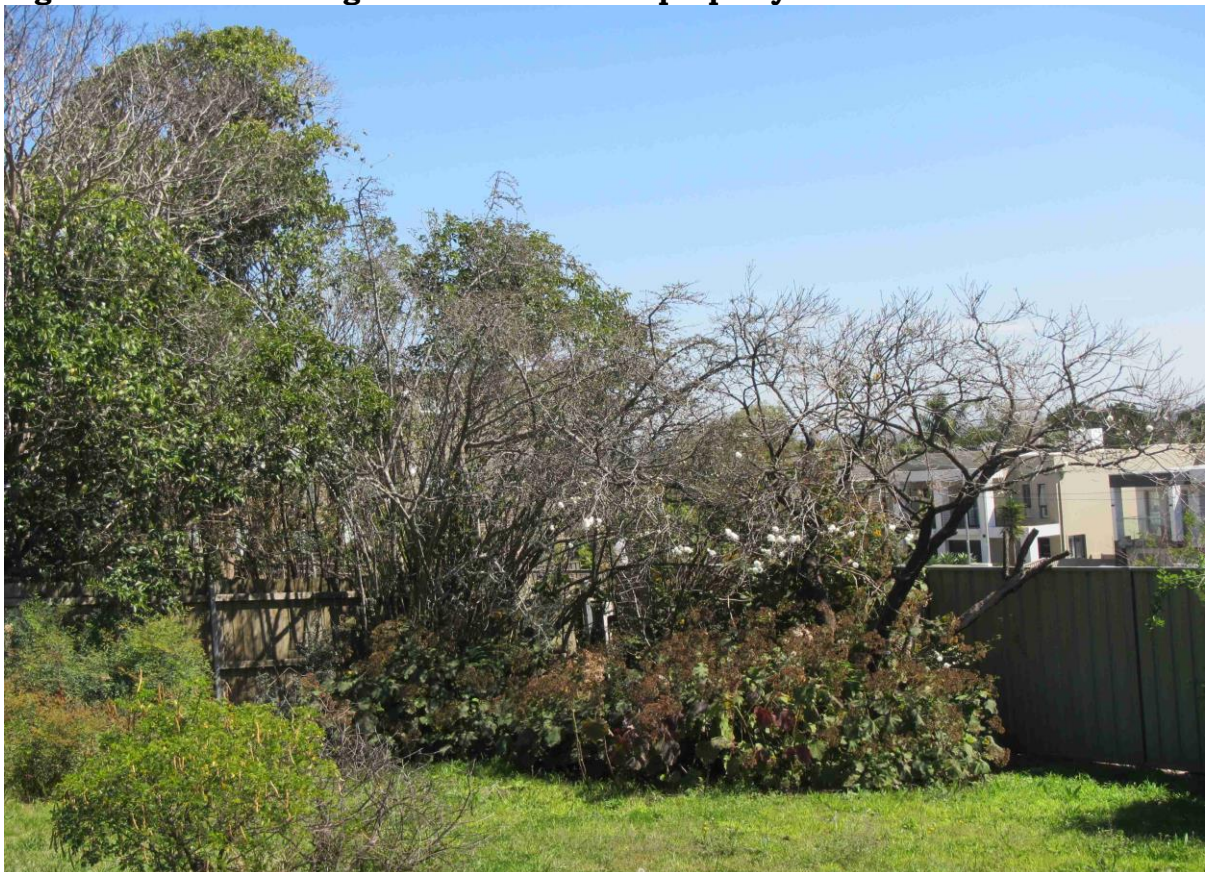
Figure 10 Shows Trees 3, 4 and 5 required to be removed.

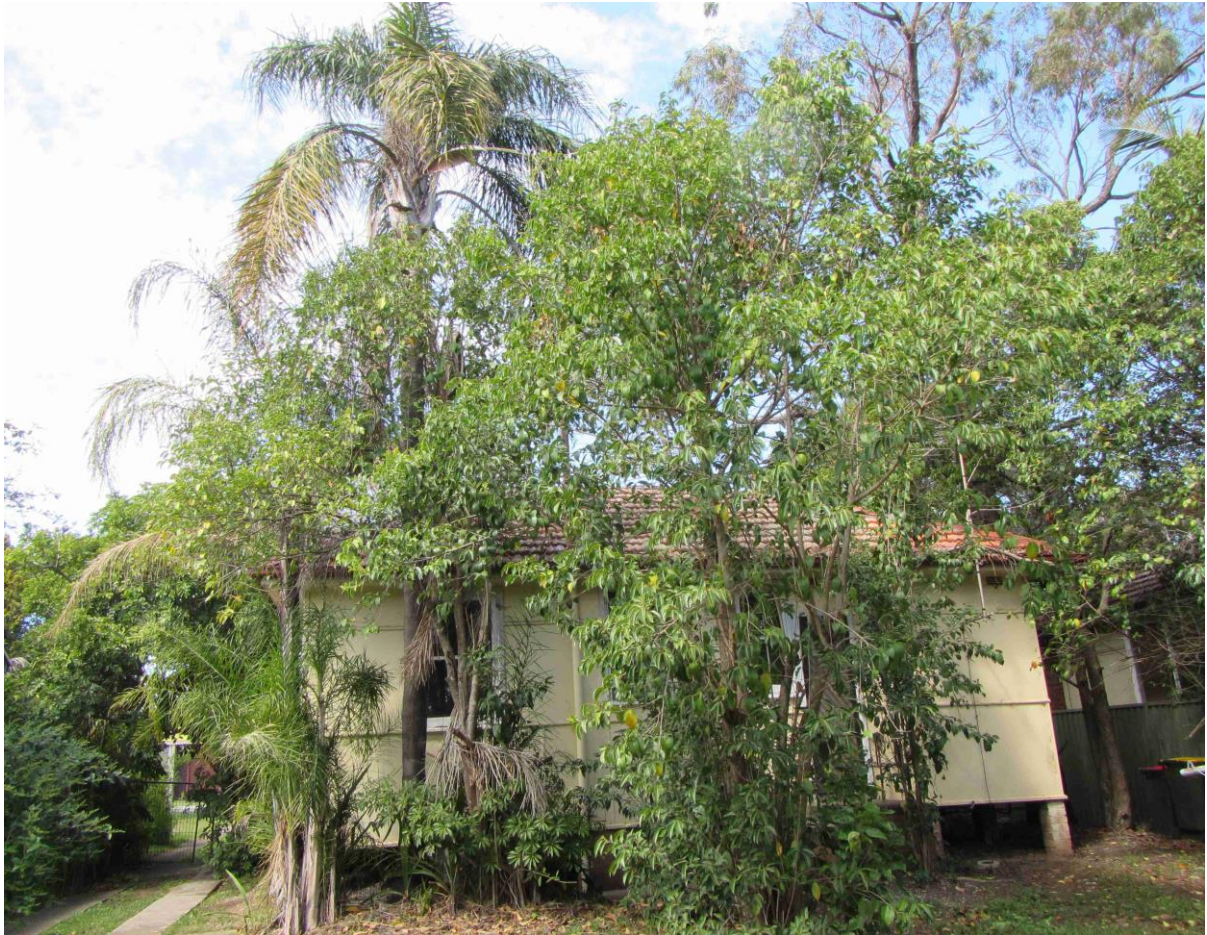
Figure 11 Shows minor TPO Exempt trees and palms numbered 11, 12, 13.

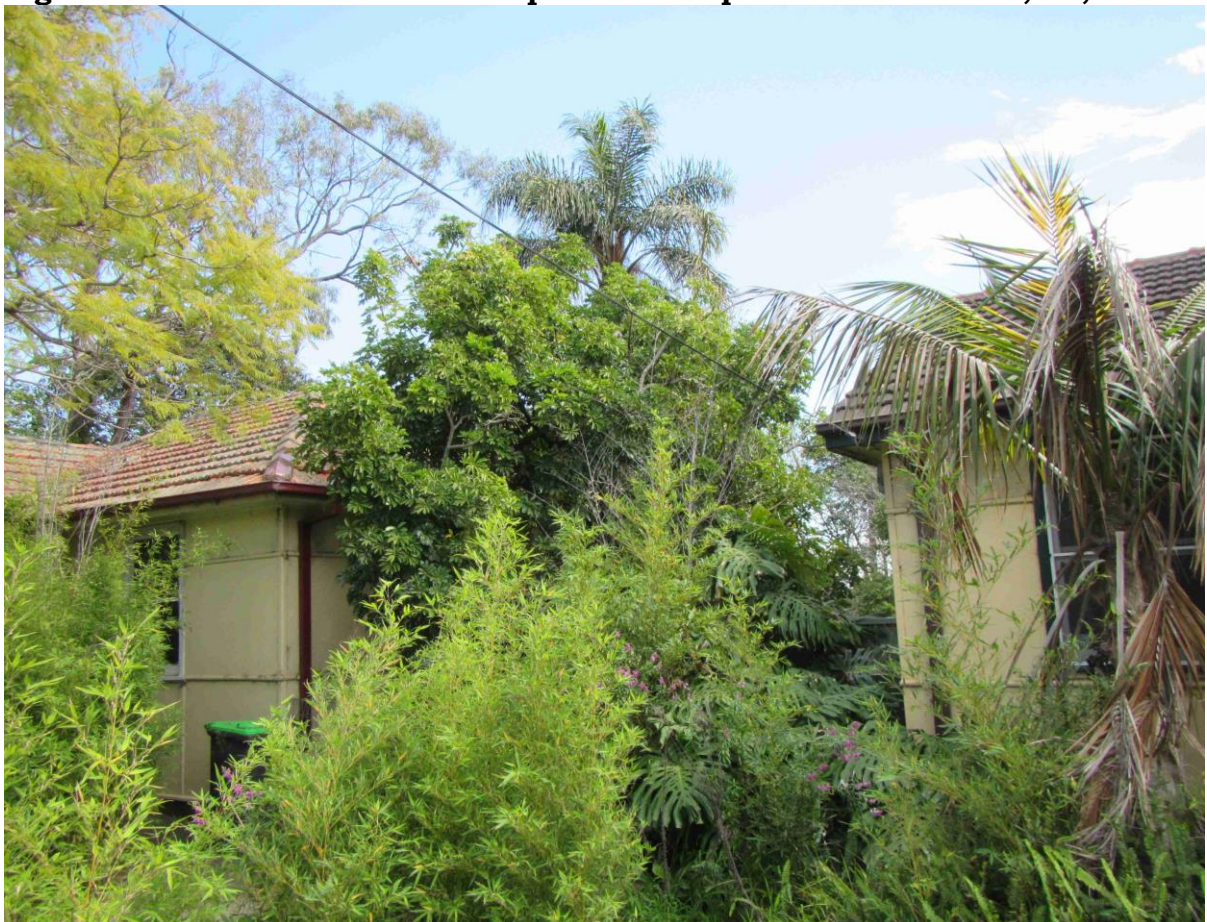
Figure 12 Shows overgrown weed infested property frontage.

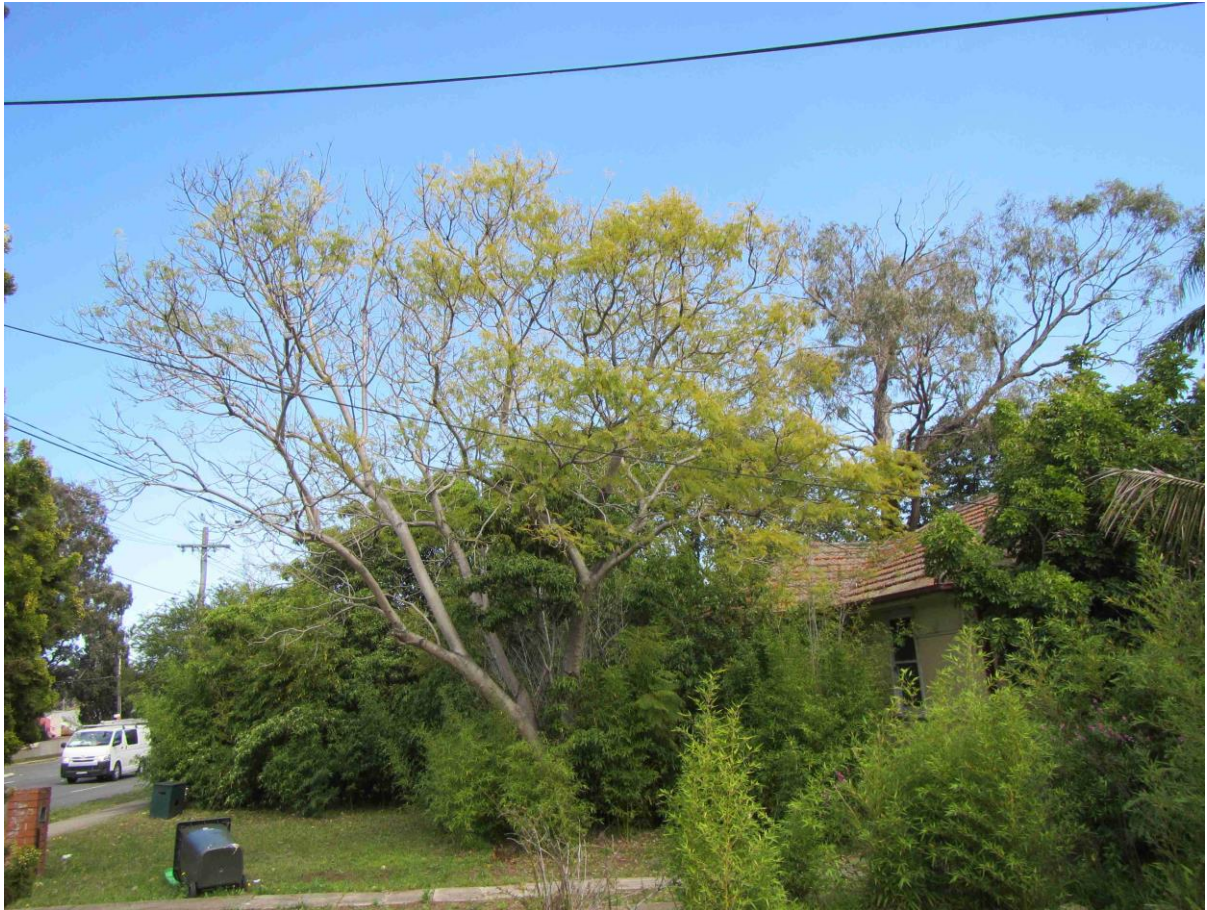
Figure 13 Shows Tree 14 that is required to be removed.

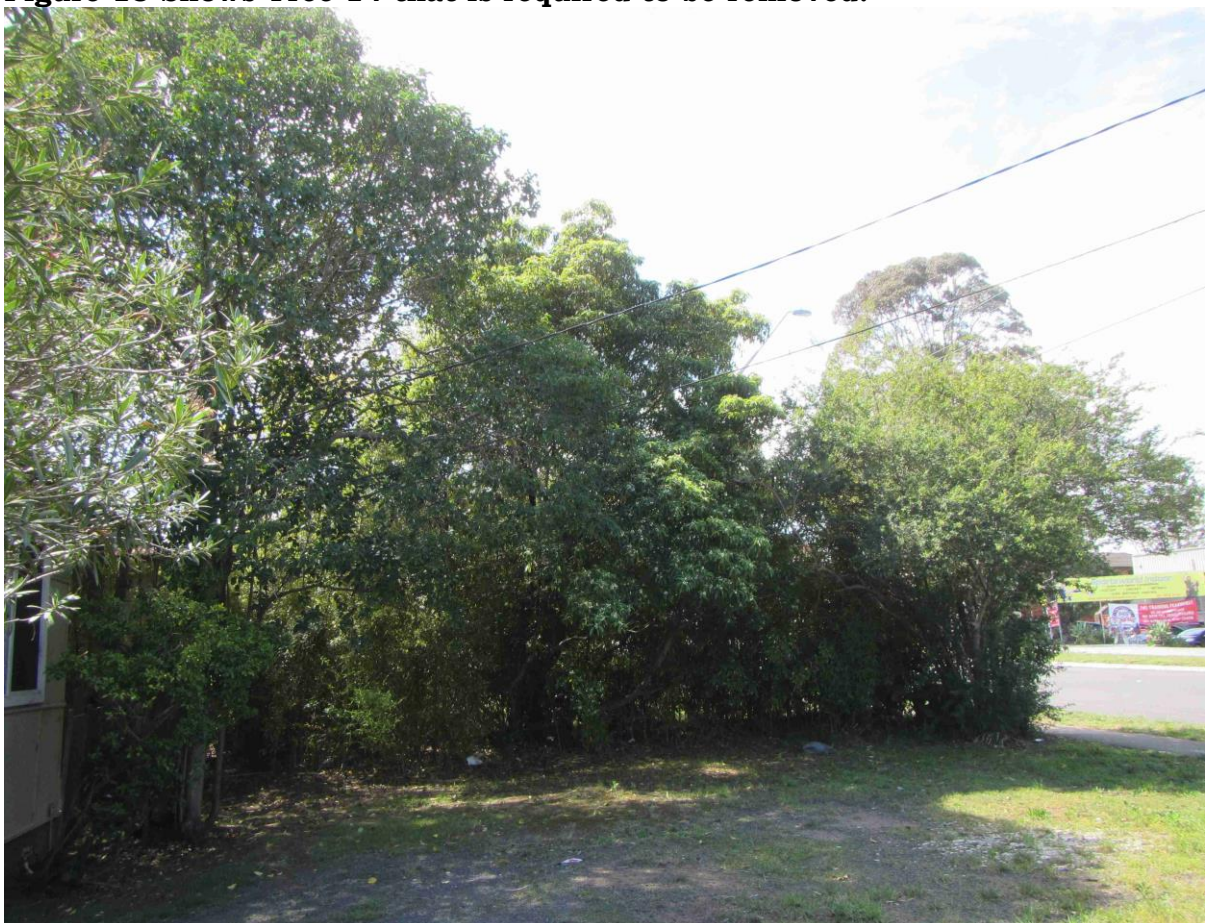
Figure 14 Shows again Privet trees to be removed.

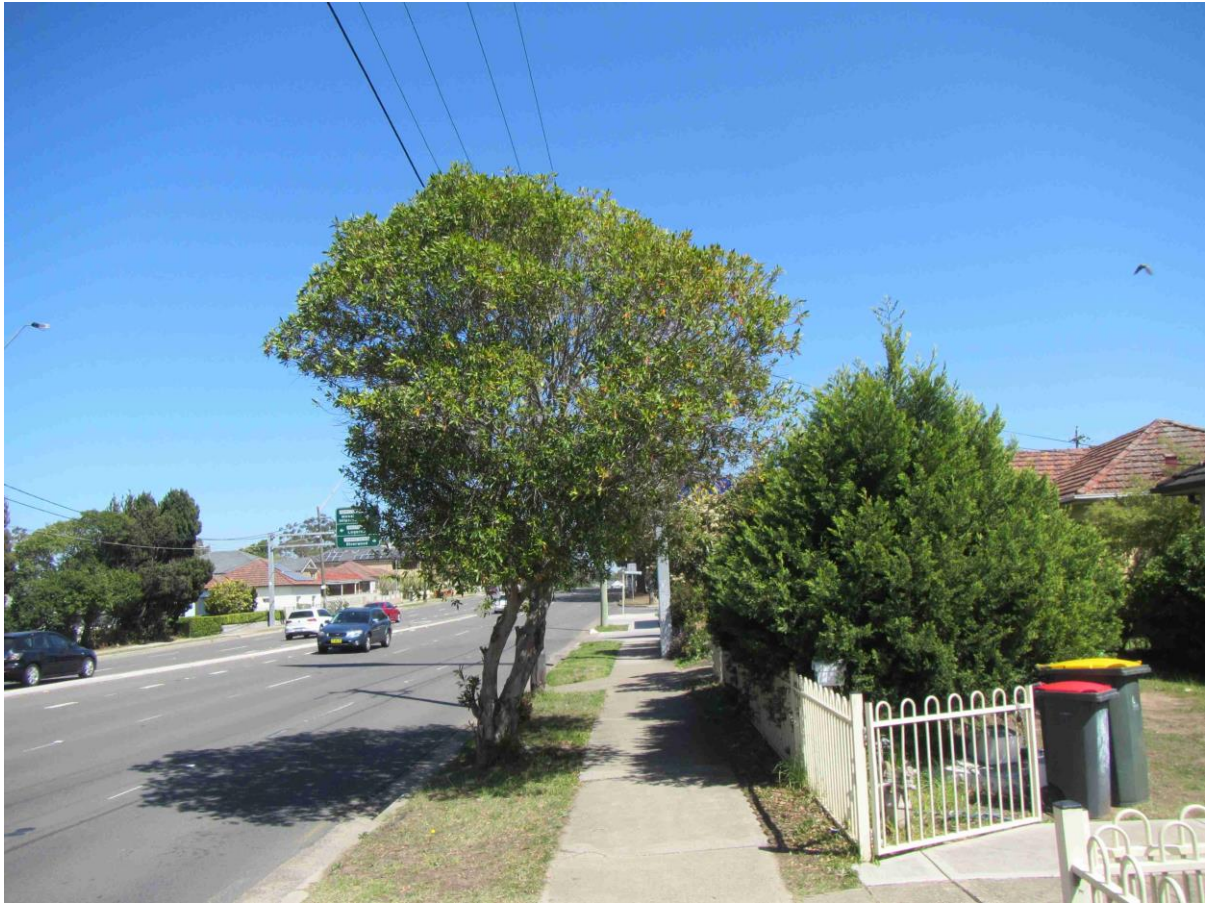
Figure 15 Shows Tree 26 to be retained and protected.

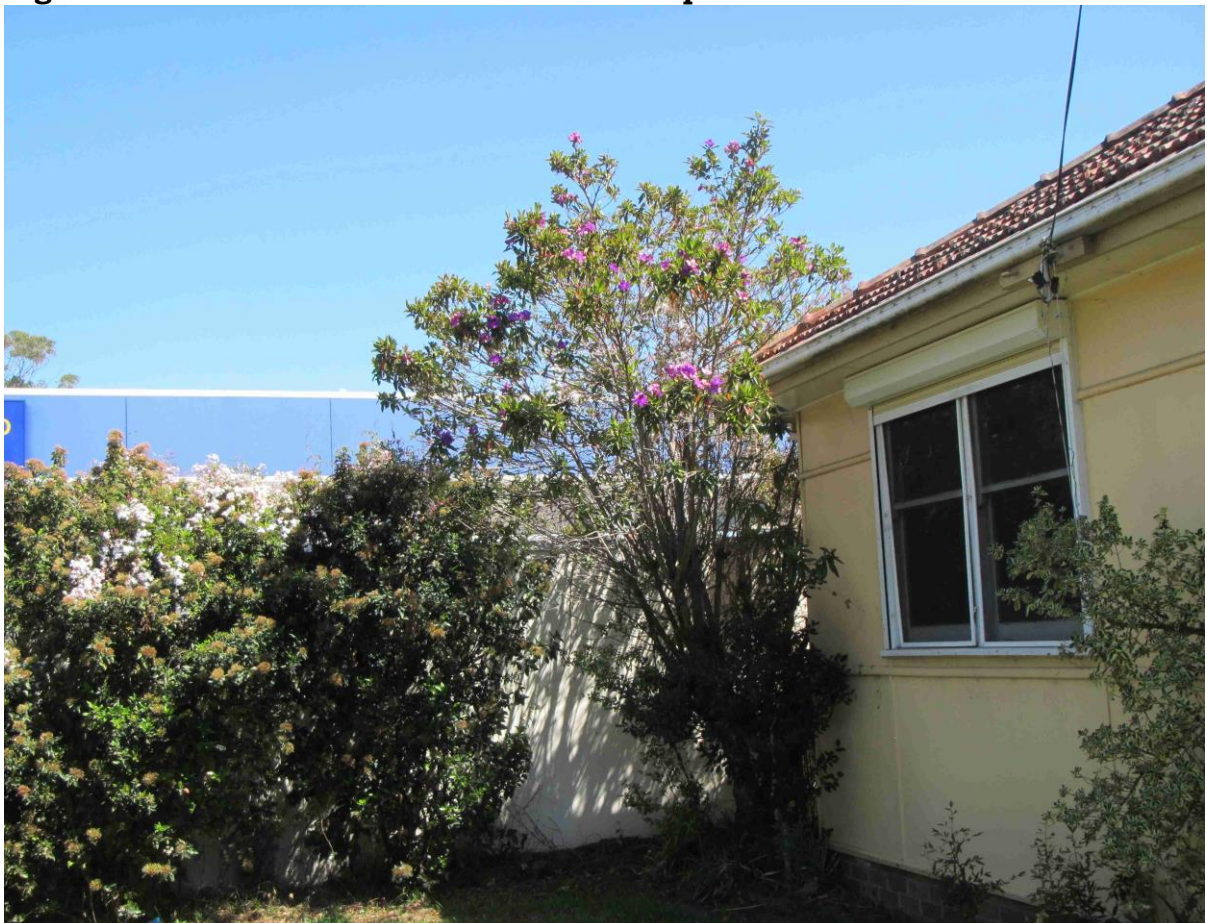
Figure 16 Shows Tree 30 from a distance being a minor Tibouchina.

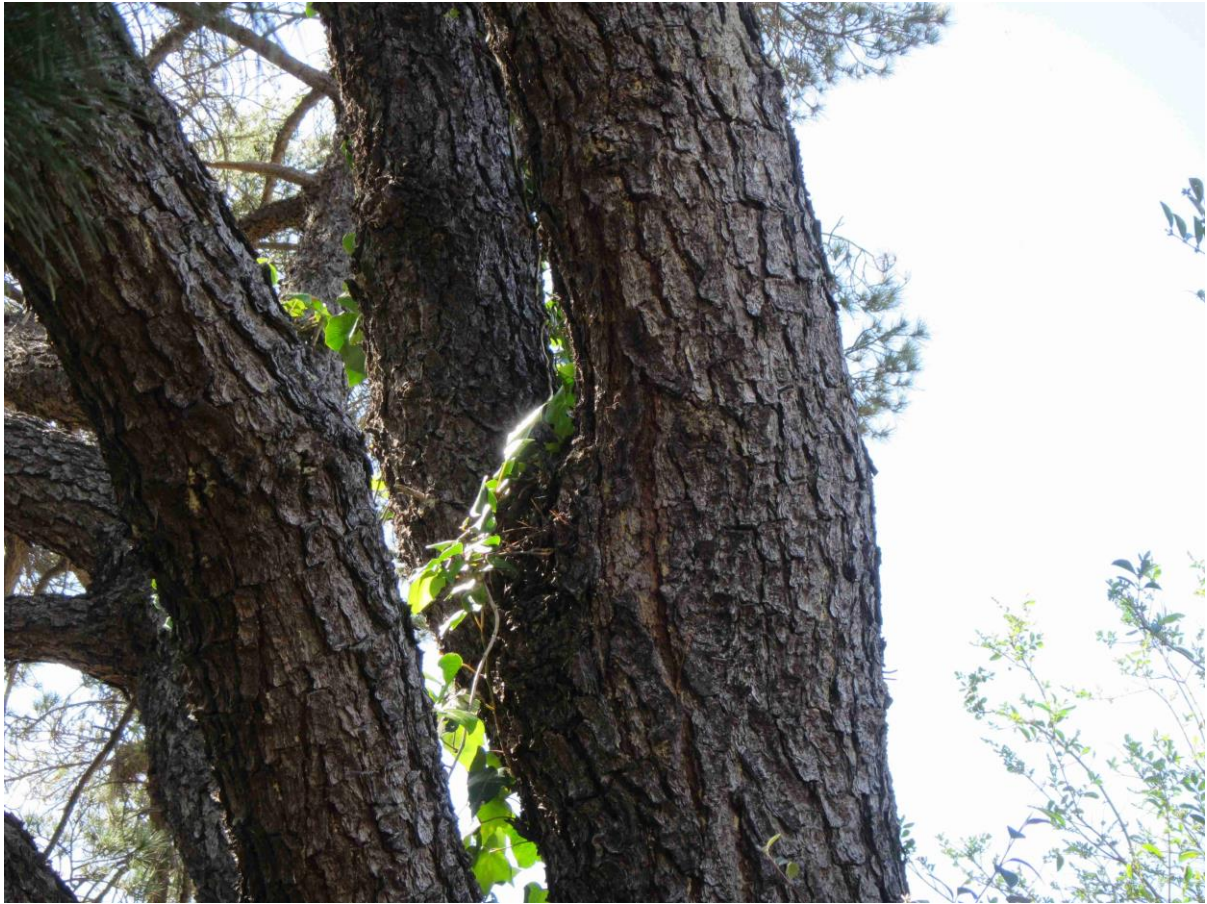
Figure 17 Shows Tree 31 with cracked noted in the branch union.

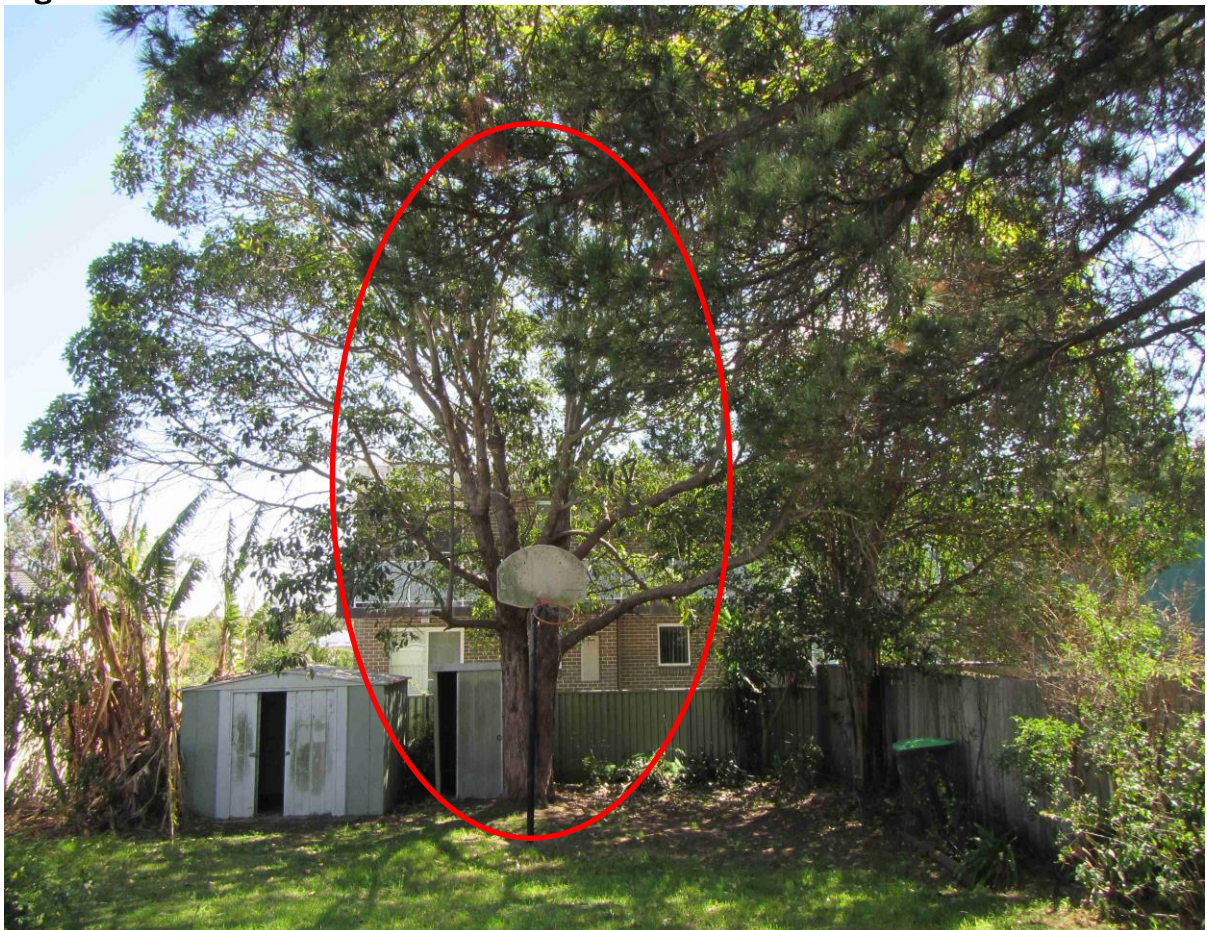
Figure 18 Shows Tree 32 that is proposed to be removed to excavation works.
