Arboricultural Impact Assessment Report

86-92 Old Bar Rd Old Bar

File No: 2328 Version: Final

28 June 2023

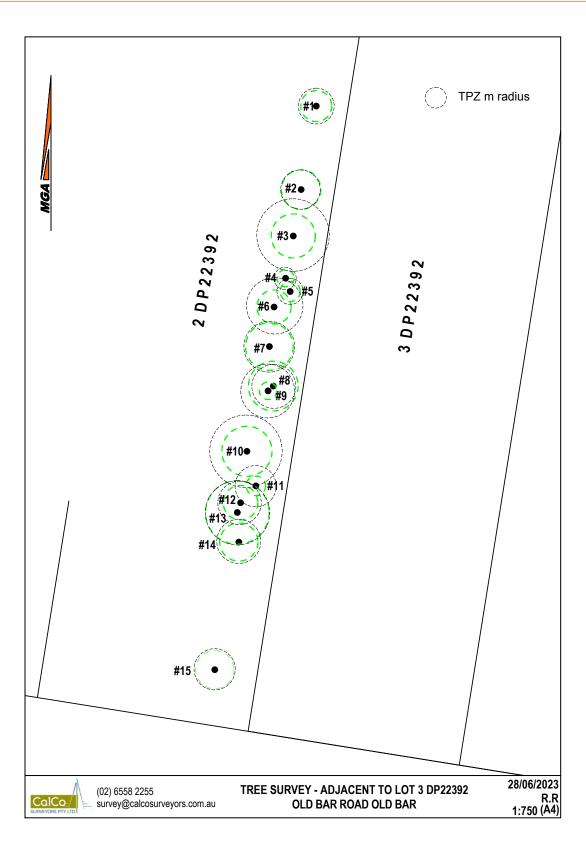
13. Attachment 3. Survey

- 7.4 The TPZ's are shown at Attachment 3. Survey. There is only one tree # 3 that has any encroachment at all into the TPZ. The encroachment is less than 1%. The Australian Standard AS 4970-2009 Protection of trees on development sites Sect 3.3.2 Minor encroachment allows encroachments up to 10% as a minor encroachment. The minor encroachment of less than 1% into the TPZ of this tree will not cause the tree to become unviable.

- 8.1 It is recommended that the development be constructed as planned. The construction of the road along the western boundary will have not have a significant effect on any of the trees growing on the adjoining future reserve and will not cause any of these trees to become unviable.
- 8.2 The site boundary wire panel mesh fence that will be used during construction will provide adequate protection for the trees during construction.
- 8.3 It should be noted that some of the trees described in this report are in poor condition or are dying. The construction of the new development will have no impact on the progression of their growing condition.
