Arboricultural Impact Assessment

Site Address: 31-33 Smith St Charlestown NSW

Clients: GPV Charlestown ATF GPV Charlestown Trust

Date: August 2022

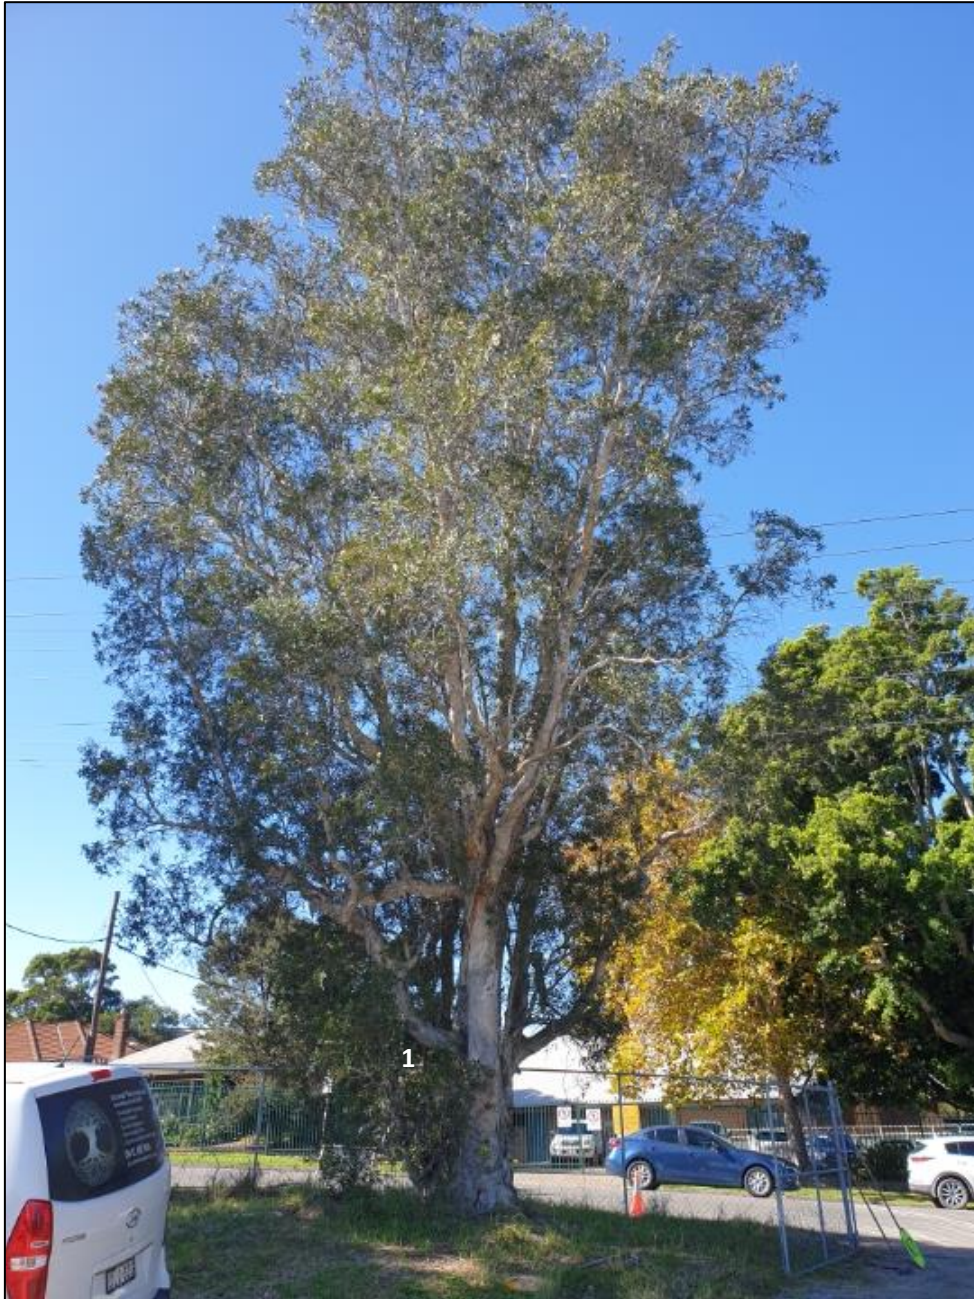
Figure 1 Tree 1 *Melaleuca quinquenervia*

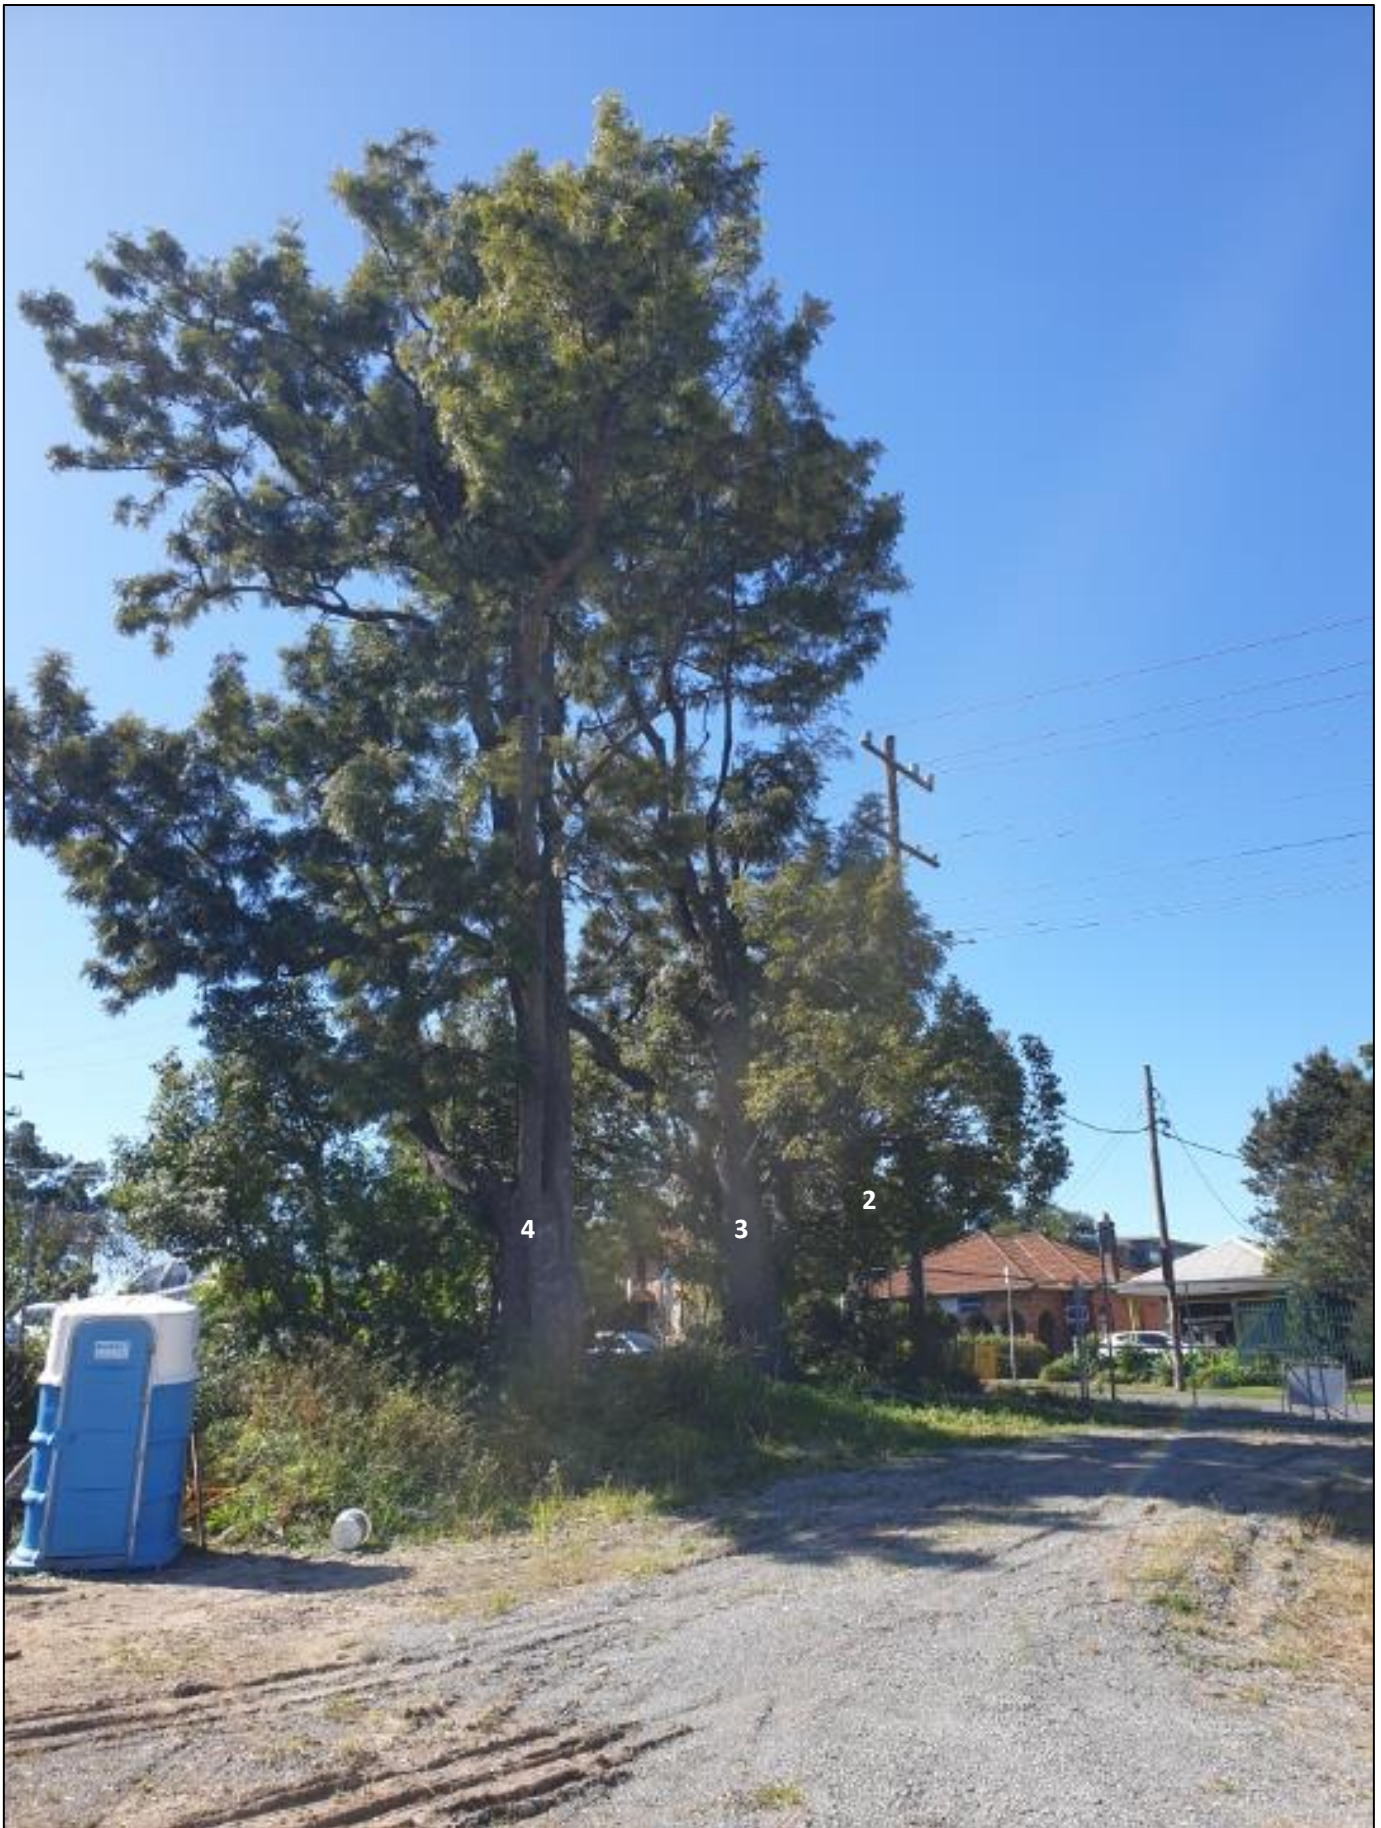
Figure 3 Trees 2 *Cinnamomum camphora* and 3,4 *Grevillea robusta* are proposed for removal

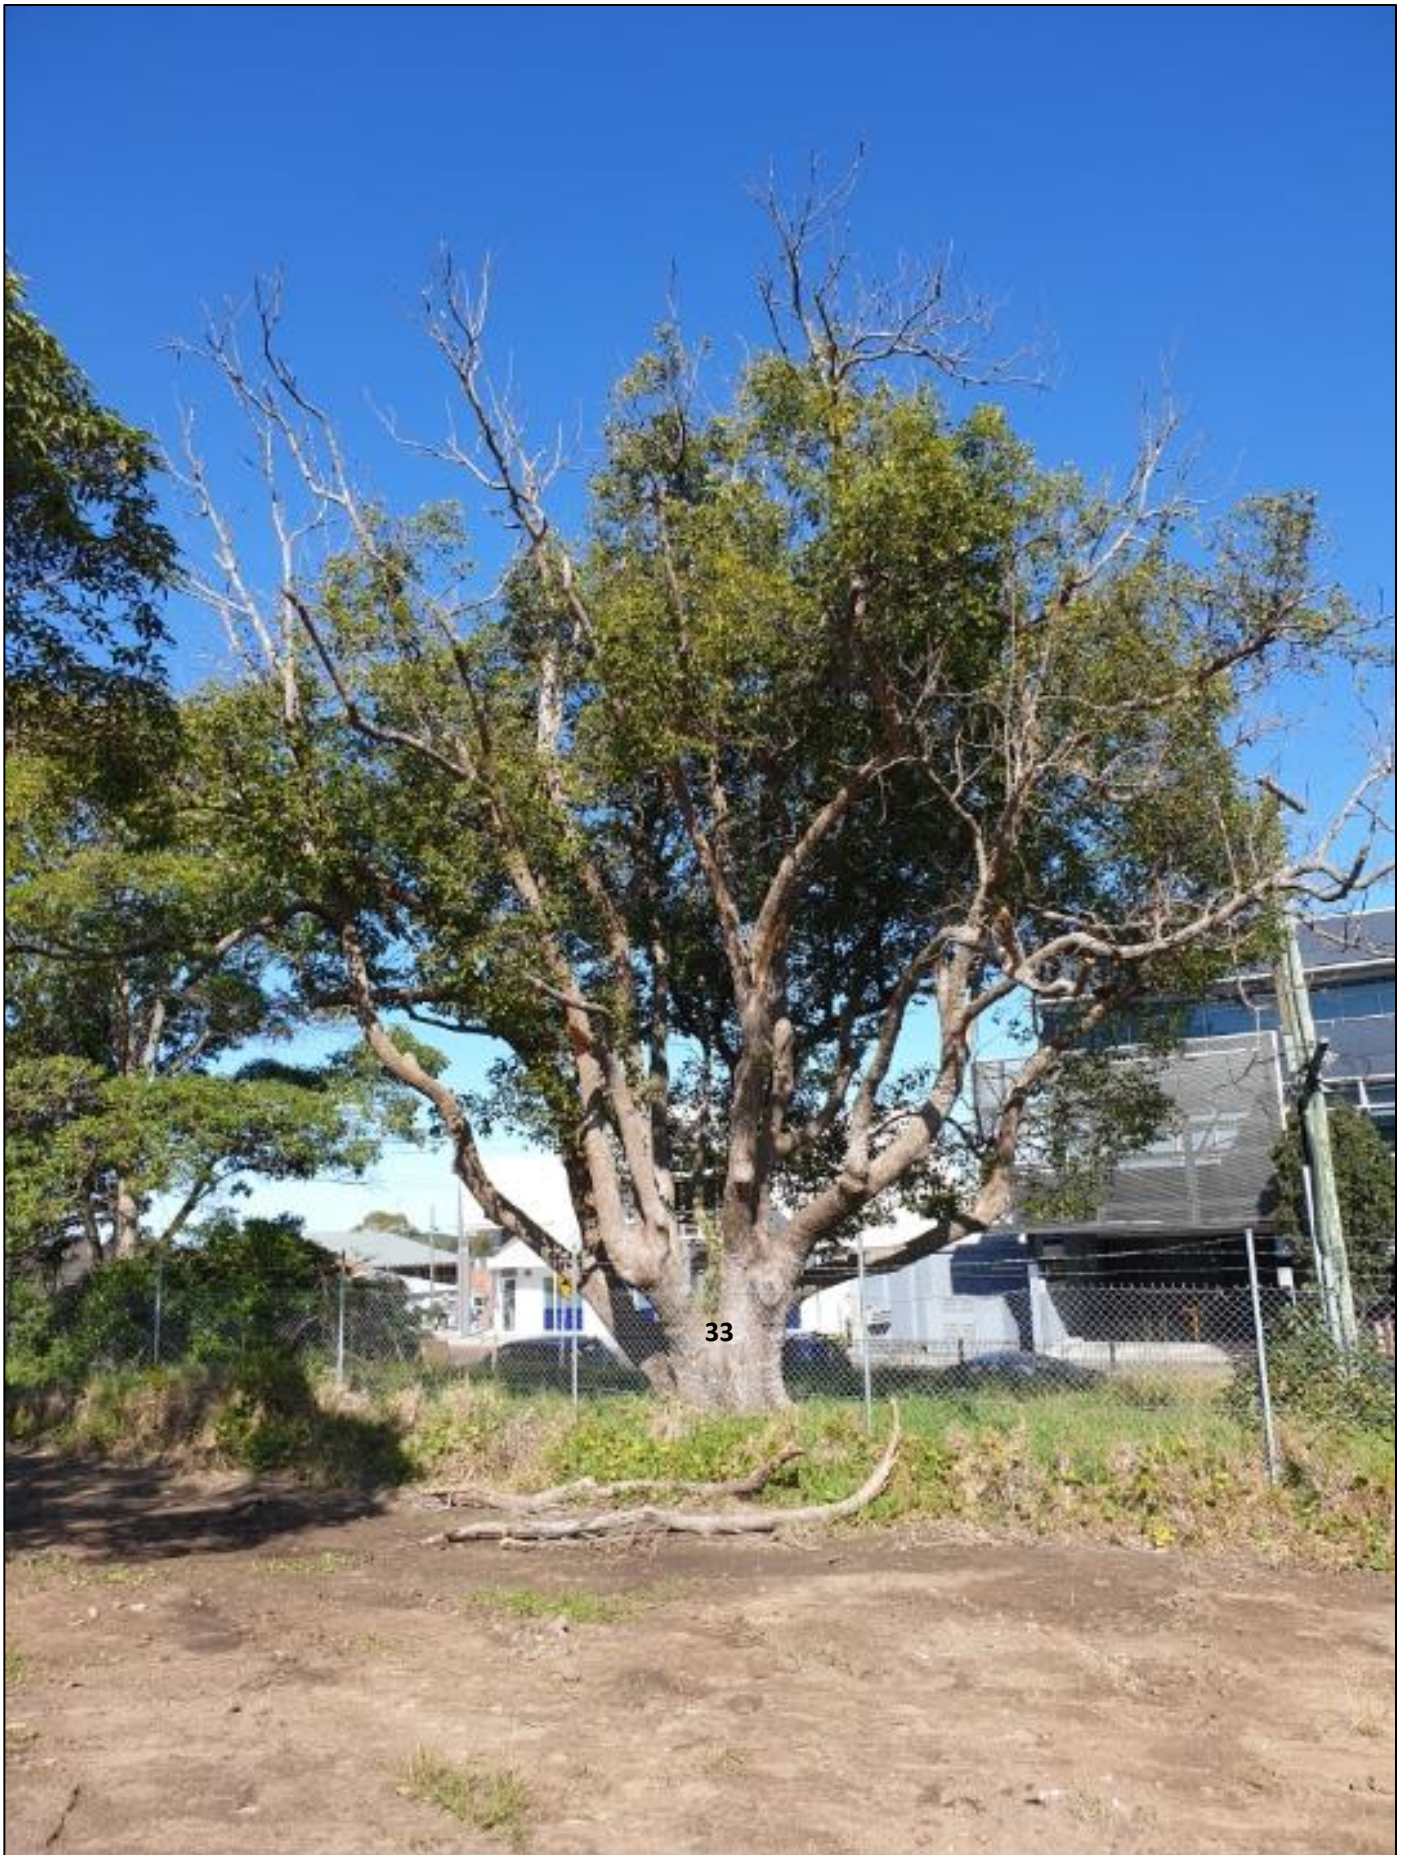
Figure 4 Trees 33 *Cinnamomum camphora* is an exempt species in declining condition

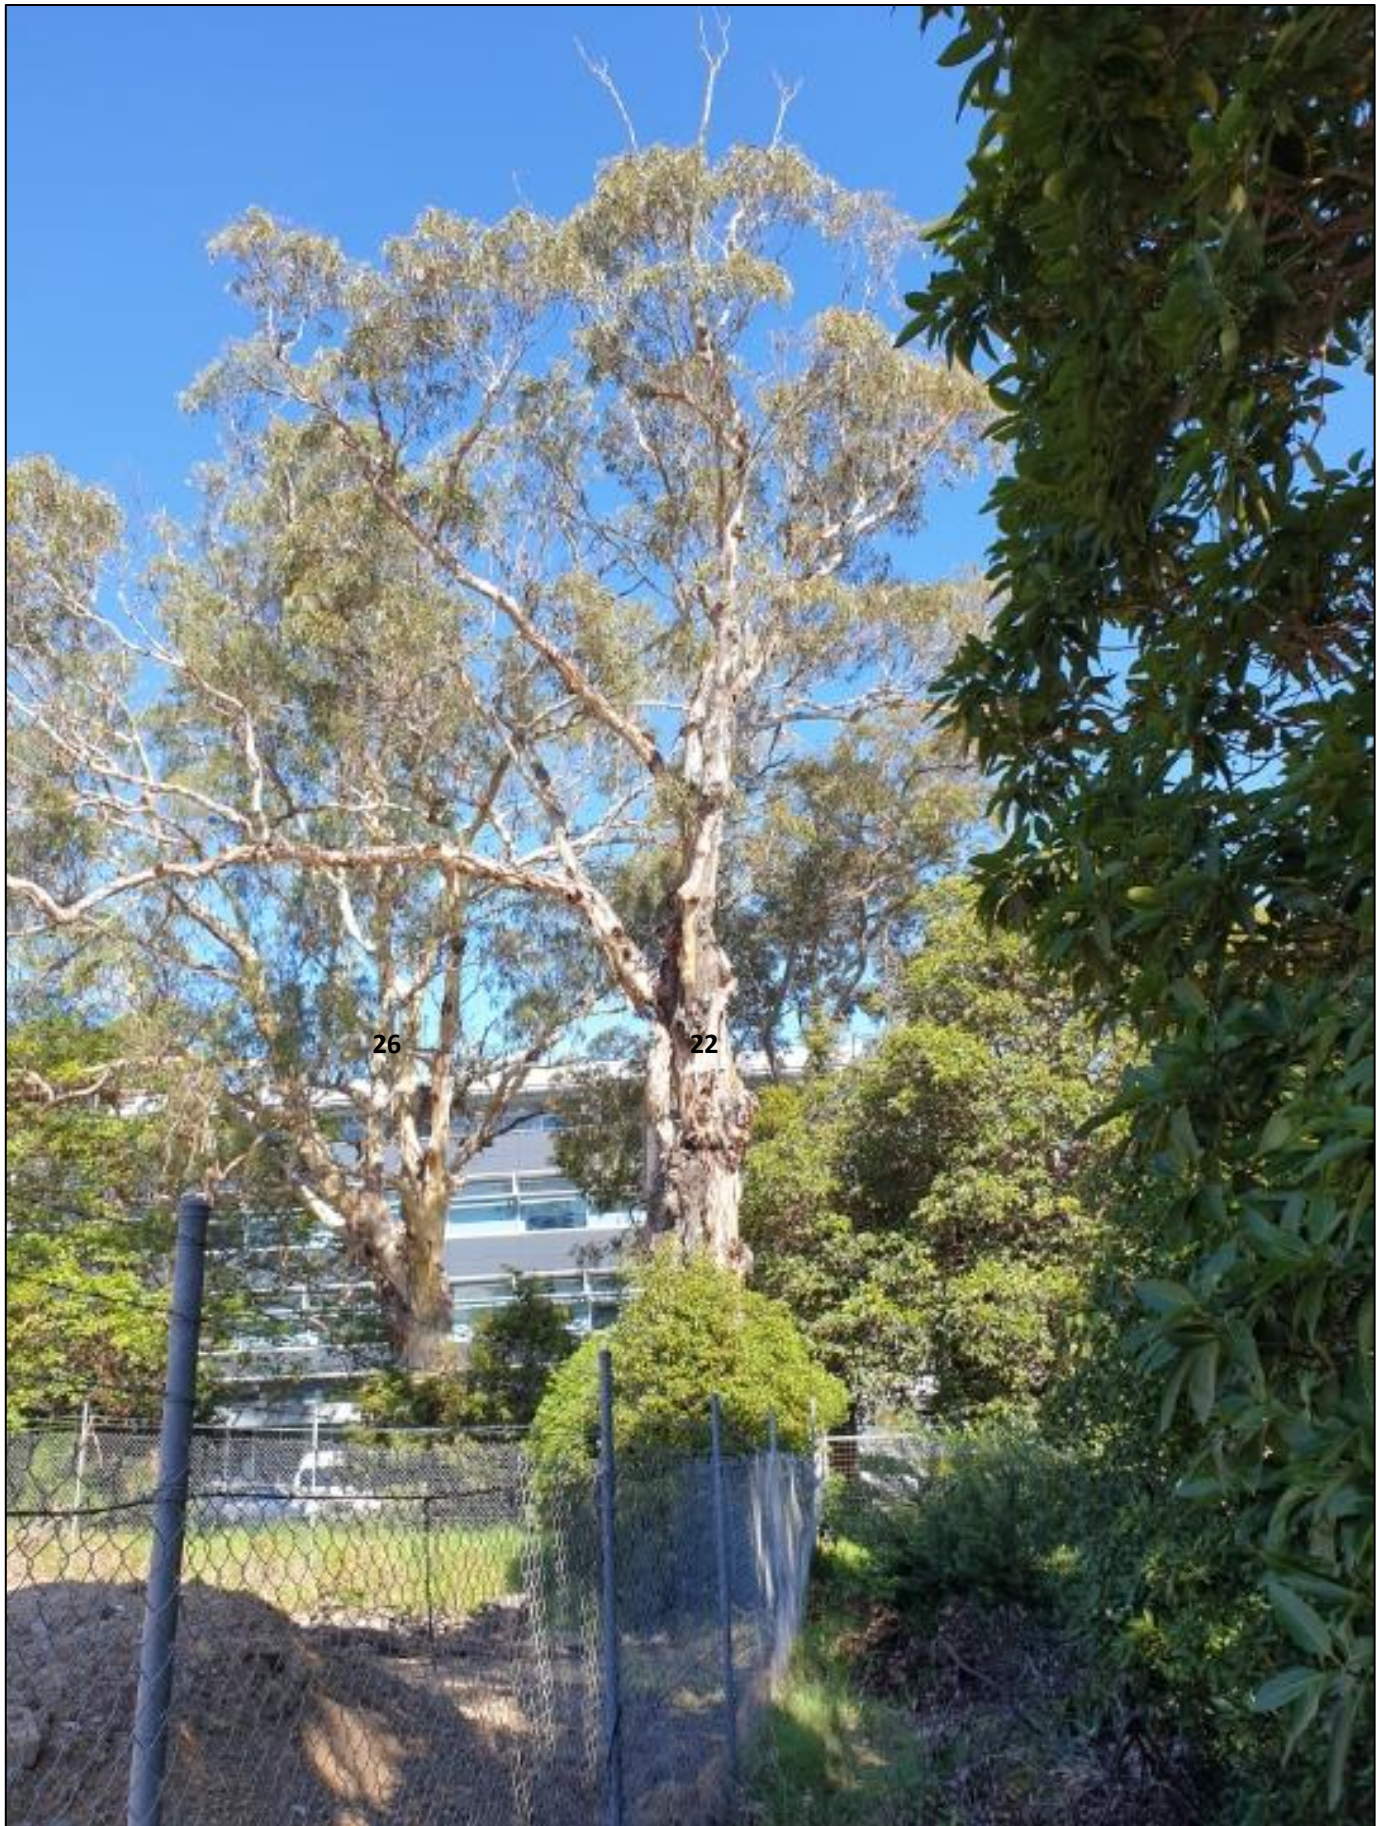
Tree 22 *Eucalyptus bicostata* appears in declining condition and is noted to contain hollows and is therefore attributed with high environmental value, its position however conflicts with the proposed design and is not suited for retention based on increasing personal and property risk due to its declining structural condition.

Figure 5 Hollow bearing Trees 22 *Eucalyptus bicostata* and Tree 26 *Eucalyptus bicostata*

A qualified ecologist should be engaged to oversee the removal of HBT. The tree is to be inspected before being dismantled so that any fauna that may be present can be identified and removed without harm. Felling of the trunk can only be conducted once the ecologist is satisfied that fauna is not present. The hollow sections should be retained for reuse either by mounting in retained trees or placement on ground level for use by terrestrial species.

That the removal of one Hollow Bearing Tree (Tree 22) is supervised by a qualified ecologist and wildlife carer who are retained on-site during the works to manage any fauna that may be disturbed.

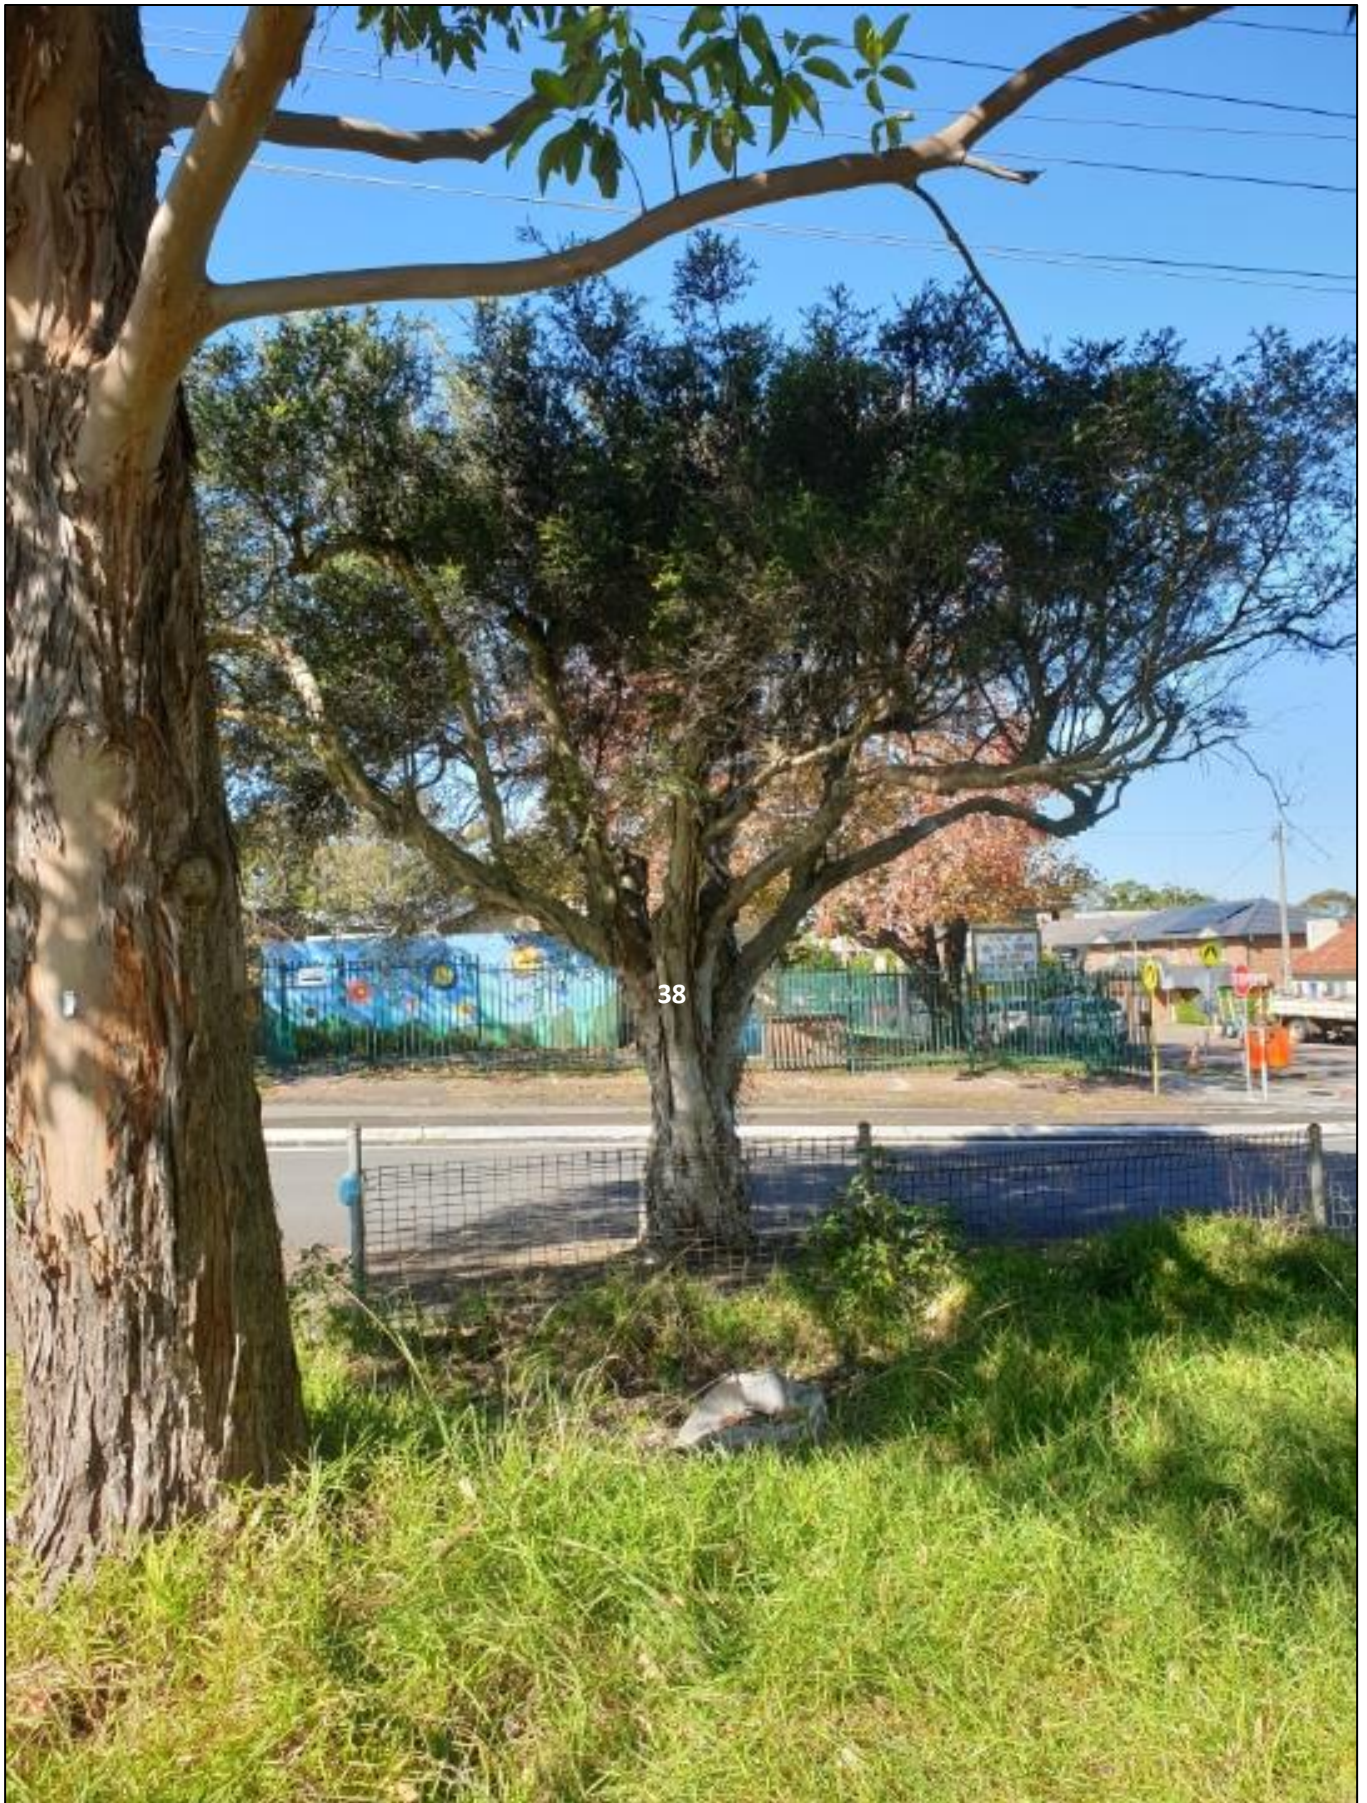
Trees 38 and 43 are Council managed trees growing on the road reserve and are assessed with moderate retention value. The trees will not be subject to major and unsustainable levels of encroachment caused by the provision of utilities and access into the subject site.

Figure 6 Tree 38 *Melaleuca styphelioides* is a Council managed street tree

That *Tree 38 Melaleuca styphelioides* and *43 Aurantica rhombifolium* are public trees proposed for removal.

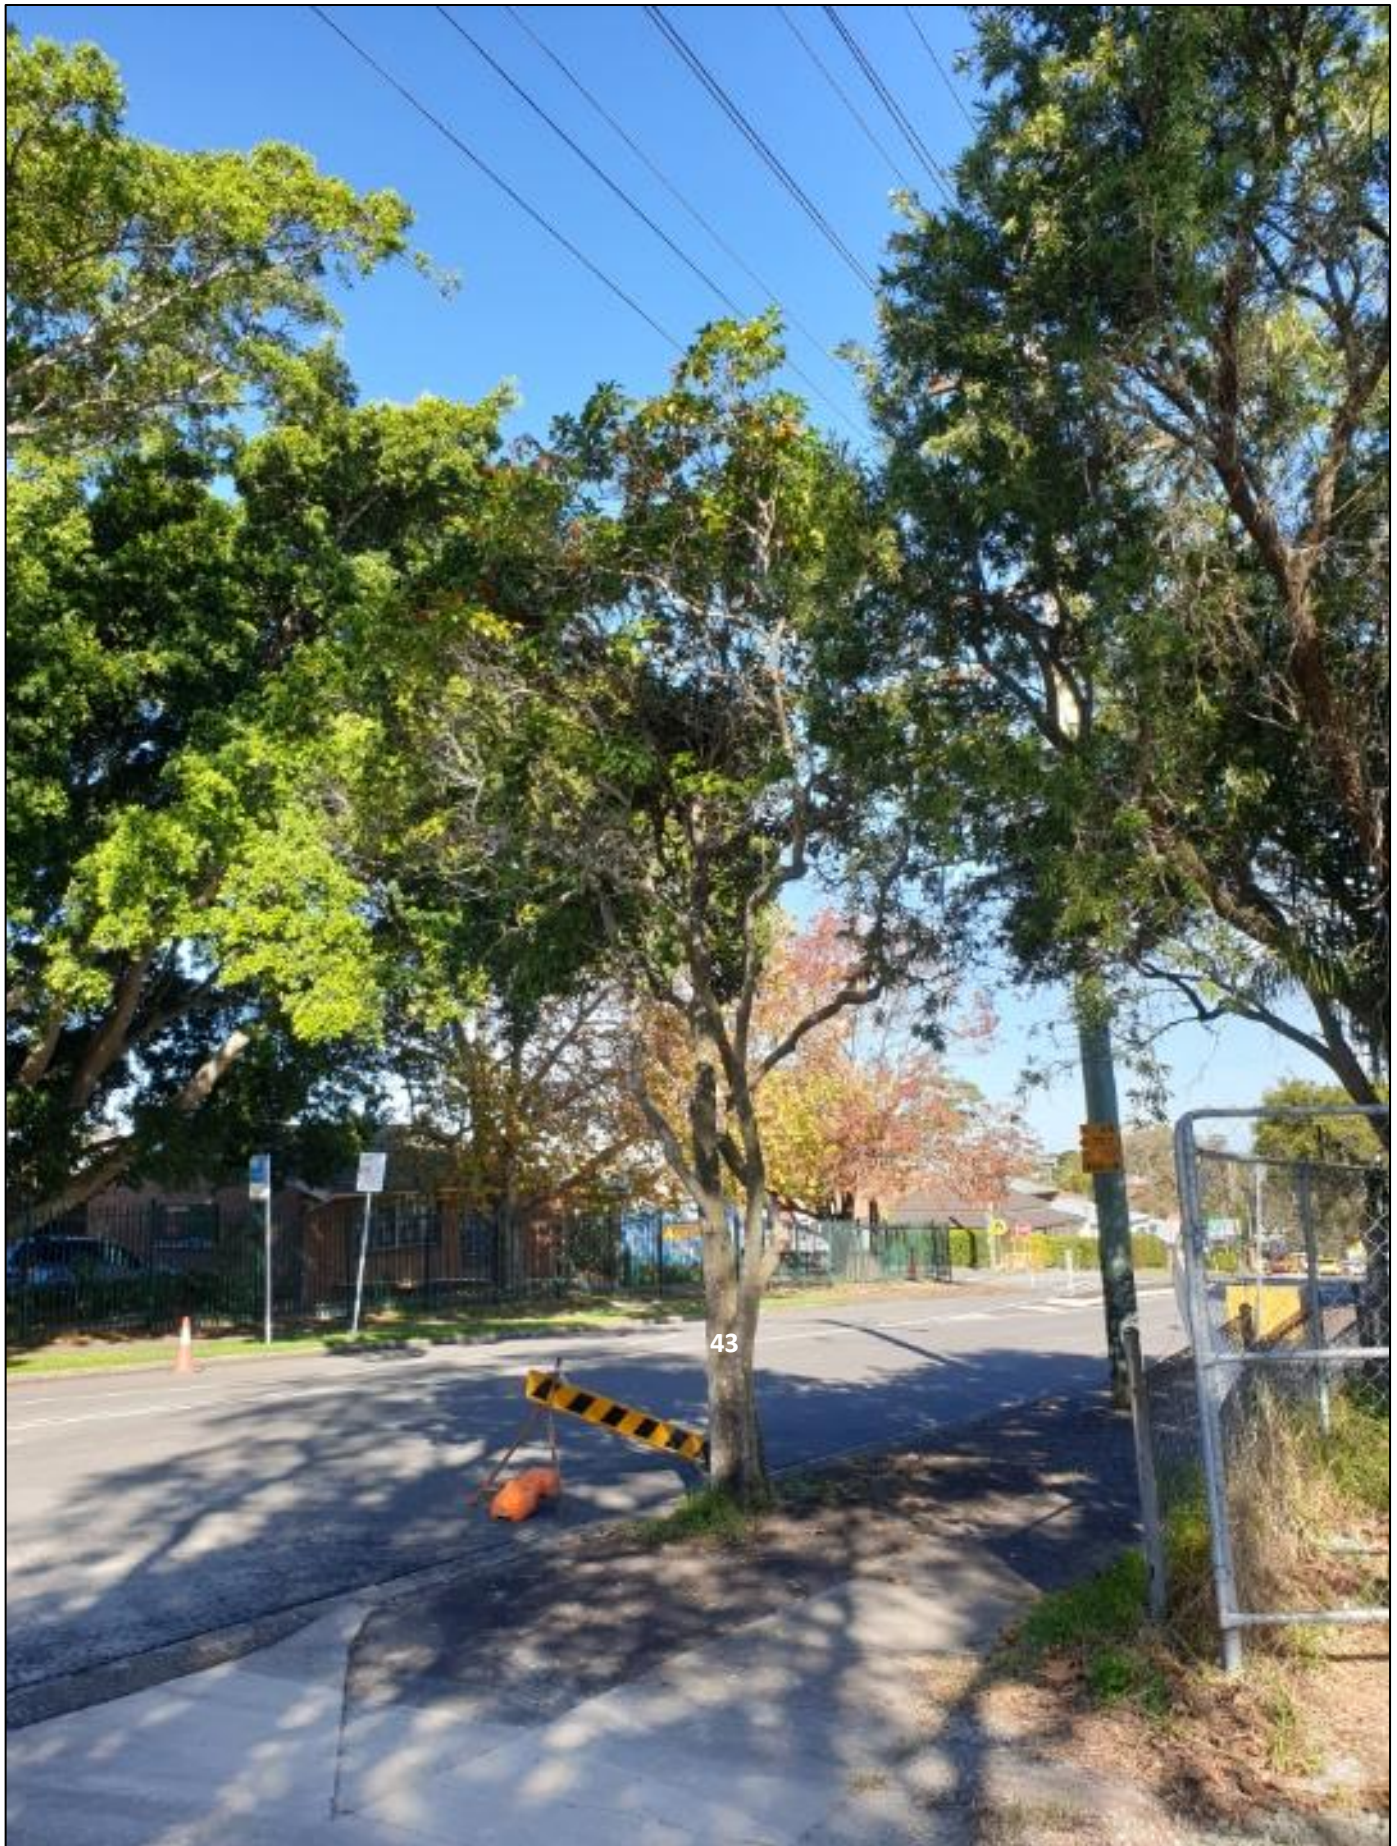
Figure 7 Tree 43 *Auranticarpa rhombifolium* is a Council managed street tree
