## Arborist Report

**Client: Coho Property Pty Ltd**

Address: Corner Stockton & Tomaree Streets, NELSON BAY N.S.W 2315

Project: Corner Stockton & Tomaree Streets, Nelson Bay

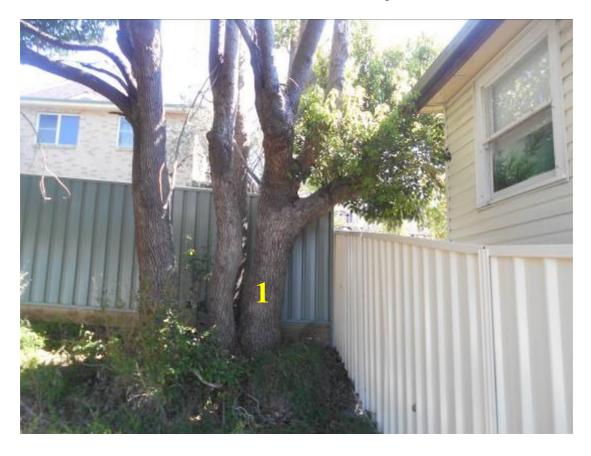
All trees require a S.R.Z and a T.P.Z with Australian Standards 4970- 2009 being used as a guideline. Tree 1 has been given an SRZ and TPZ of 3.14 & 7.80 metres in accordance with Australian Standards 4970 - 2009. Tree 1 will be located 5 metres to the proposed development. AS 4970 - 2009 indicates that the TPZ radius is taken from the centre of the trunk. This leaves a spatial separation of 5.44 metres from the centre of the trunk to the proposed development. The overall loss of TPZ has been calculated at 9.52% that complies with AS 4970 - 2009. This is based on the proviso that no soil changes occur from the trunk to the proposed development inside the TPZ. Tree 1 is classified as a noxious weed in Port Stephens Council. Tree 1 is earmarked for removal before commencement of building works on site.

Figure 3 – showing the location of Tree 1 that is located inside the subject property. Tree 1 has three main leaders. Tree 1 is identified as a noxious weed

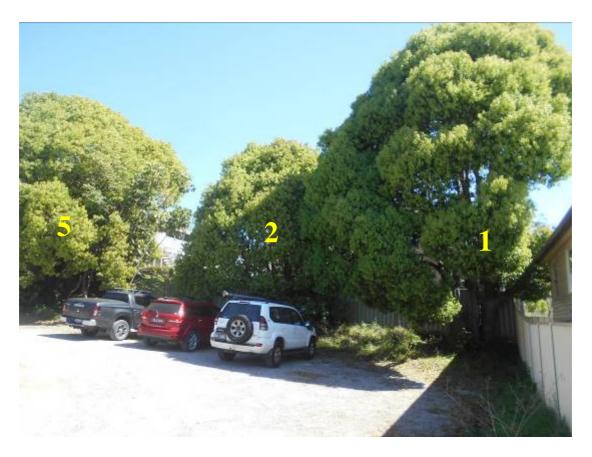
Tree 2 has been given an SRZ and TPZ of 2.85 & 6.96 metres in accordance with Australian Standards 4970 - 2009. Tree 2 is located on the boundary fence however the site survey indicates that this species is located in the neighbour's property. Tree 2 is located 6 metres to the proposed dwelling. AS 4970 - 2009 indicates that the TPZ radius is taken from the centre of the trunk. This leaves a spatial separation of 6.35 metres from the centre of the trunk to the proposed development. The overall loss of TPZ has been calculated at 1.18% that complies with AS 4970 - 2009. This is based on the proviso that the existing soil levels are retained between the trunk and the development inside the TPZ. This species is also classified as a noxious weed in PSC however due to its location on the boundary within the neighbouring property will be retained. Tree 2 is earmarked for retention.

Figure 4 – showing the location of Trees 1, 2 & 5.

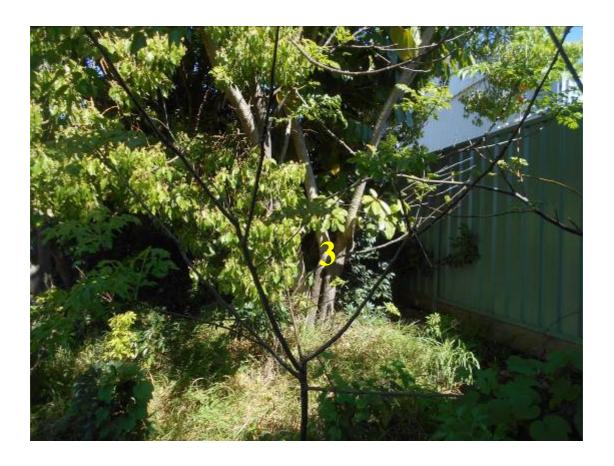
Tree 3 has been given an SRZ and TPZ of 2.08 & 3.36 metres in accordance with Australian Standards 4970 - 2009. Tree 3 is located inside the subject property. Tree 3 is identified as a noxious weed in Port Stephens Council. This species is in a young mature phase of its life cycle. This species is located 4.1 metres to the proposed development. AS 4970 – 2009 indicates that the TPZ radius is taken from the centre of the trunk. This leaves a spatial separation of 4.27 metres from the centre of the trunk to the proposed development. The overall loss of TPZ has been calculated at 0% that complies with AS 4970 – 2009. The development is located outside of the TPZ. This is based on the proviso that the existing soil levels are retained between the trunk and the development inside the TPZ. Tree 3 is earmarked for removal before commencement of building works on site.

Figure 5 – showing the location of Tree 3. This species is classified as a noxious weed.

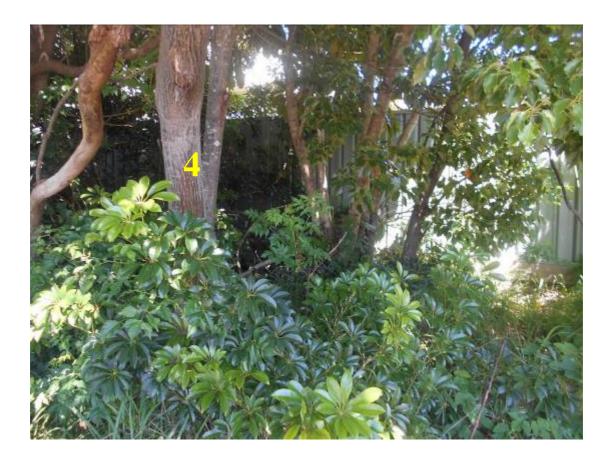
Tree 4 has been given an SRZ and TPZ of 1.61 & 2.00 metres in accordance with Australian Standards 4970 - 2009. Tree 4 is classified as a semi mature White Cedar. Tree 4 is located 1.8 metres to the proposed development. AS 4970 – 2009 indicates that the TPZ radius is taken from the centre of the trunk. This leaves a spatial separation of 1.87 metres to the proposed development. The overall loss of TPZ has been calculated at 0.98% that complies with AS 4970 – 2009. All building works are located at the edge of the TPZ. This species can reach a TPZ of 7 to 8 metres (minimum) when fully mature. This also includes canopy spreads of 7 to 8 metres to each quadrant. This species will outgrow its available growing space when in a mature phase of its life cycle. Two (2) smaller species would be better suited within the landscape plan. Tree 4 is earmarked for removal before commencement of building works on site.

Figure 6 – showing the location of Tree 4 inside the subject property.

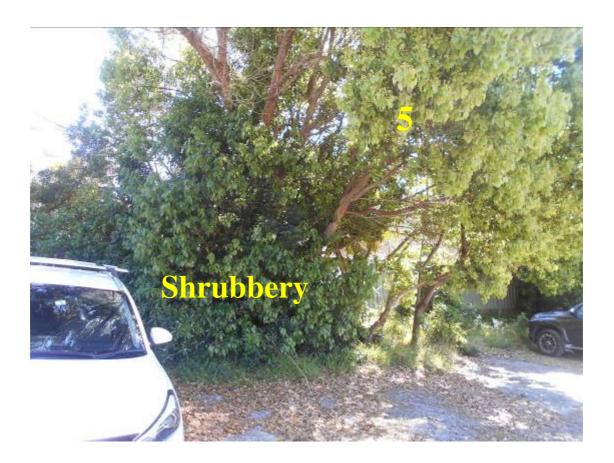
Tree 5 has been given an SRZ and TPZ of 3.01 & 9.12 metres in accordance with Australian Standards 4970 - 2009. Tree 5 is identified as a noxious weed in Port Stephens Council. Tree 5 is located 2.5 metres to the proposed development and associated civil works. AS 4970 – 2009 indicates that the TPZ radius is taken from the centre of the trunk. This leaves a spatial separation of 2.9 metres from the centre of the trunk to the proposed development. The overall loss of TPZ has been calculated at 30.10% that doesn't comply with AS 4970 – 2009. Tree 5 is earmarked for removal before commencement of building works on site.

Figure 7 – showing the location of the shrubbery and Tree 5. Tree 5 is the larger tree identified as a Camphor Laurel.

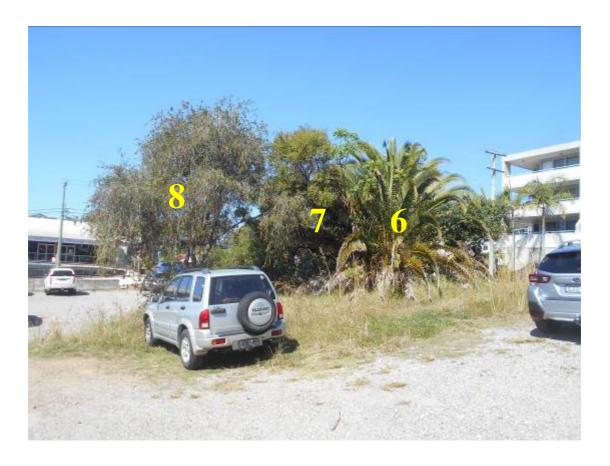
Tree 6 has been given an SRZ and TPZ of 2.67 & 3.00 metres in accordance with Australian Standards 4970 - 2009. Tree 6 is classified as a monocotyledon in accordance with AS 4970 - 2009. The minimum TPZ requirement for a monocotyledon is 1 metre outside of the crown projection. Tree 6 is located 1.8 metres to the proposed development. AS 4970 - 2009 indicates that the TPZ radius is taken from the centre of the trunk. This leaves a spatial separation of 2.1 metres from the centre of the trunk to the proposed development. The overall loss of TPZ has been calculated at 9.41% that complies with AS 4970 - 2009. This species can reach a TPZ of 5 to 6 metres (minimum) when fully mature. This also includes canopy spreads of 5 to 6 metres to each quadrant. This species would outgrow its available growing space when in a mature phase of its life cycle. Two (2) smaller species would be better suited within the landscape plan. Tree 6 is earmarked for removal before commencement of building works on site.

Figure 8 – showing the location of Trees 6 - 8

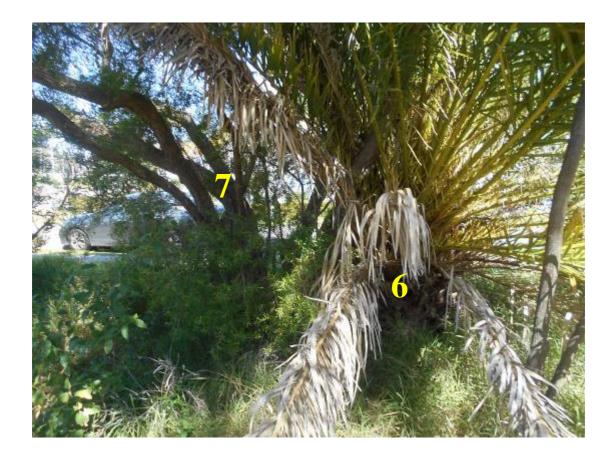
Tree 7 has been given an SRZ and TPZ of 2.30 & 4.32 metres in accordance with Australian Standards 4970 - 2009. Tree 7 is located 1.70 metres to the proposed development. AS 4970 - 2009 indicates that the TPZ radius is taken from the centre of the trunk. This leaves a spatial separation of 1.91 metres from the centre of the trunk to the proposed development. The overall loss of TPZ has been calculated at 22.80% that doesn't comply with AS 4970 - 2009. Tree 7 has a tropism to the northern quadrant. The canopy is to the north and eastern quadrants only. To allow a spatial separation of 1 metre to the development will require 30 - 35% of the canopy being removed. This is an extensive amount of pruning works. Tree 7 is earmarked for removal before commencement of building works on site.

Figure 9 – showing the location of Trees 6 & 7. Tree 7 has canopy only to the north and eastern quadrants. Extensive pruning works would be required for Trees 6 & 7.

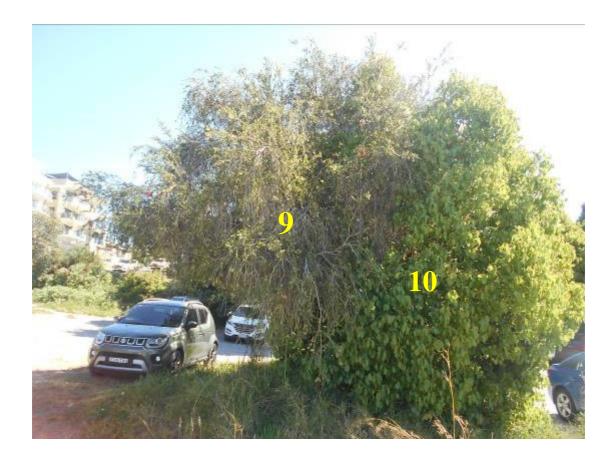
Tree 8 has been given an SRZ and TPZ of 2.23 & 3.48 metres in accordance with Australian Standards 4970 - 2009. Tree 8 is located inside the proposed development. In order for the development to proceed in its current format will require the removal of Tree 8. Tree 8 is earmarked for removal before commencement of building works on site.

Tree 9 has been given an SRZ and TPZ of 2.26 & 4.92 metres in accordance with Australian Standards 4970 - 2009. Tree 9 is located inside the proposed development. In order for the development to proceed in its current format will require the removal of Tree 9. Tree 9 is earmarked for removal before commencement of building works on site.

Figure 10 – showing the location of Trees 9 & 10. Tree 9 comes under council requirements. Tree 10 is classified as a noxious weed and can be removed. Trees 9 & 10 will be located inside the proposed development.

Tree 10 has been given an SRZ and TPZ of 1.63 & 2.10 metres in accordance with Australian Standards 4970 - 2009. Tree 10 is located inside the proposed development. In order for the development to proceed in its current format will require the removal of Tree 10. Tree 10 is earmarked for removal before commencement of building works on site.
