Report on
Preliminary Desktop Assessment

Proposed Water Supply and Sewer Pipeline
Kings Hill, North Raymond Terrace

Project 81502.11
October 2019

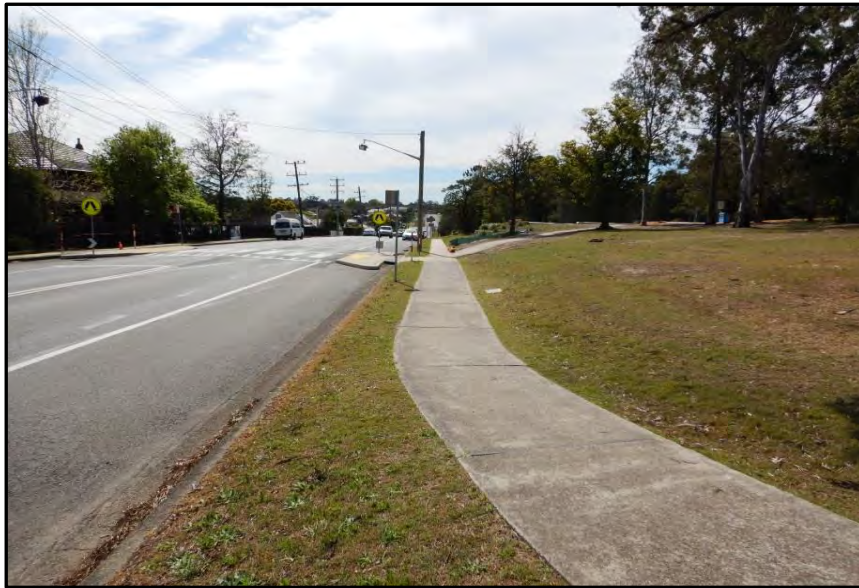
Photo 1: Looking north-east - residential soils anticipated

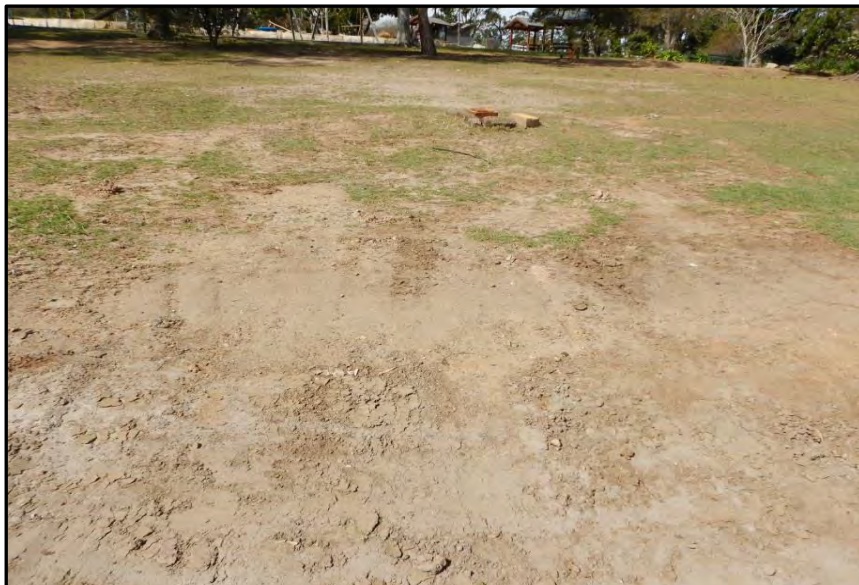
Photo 2: Brown residual clay soils exposed

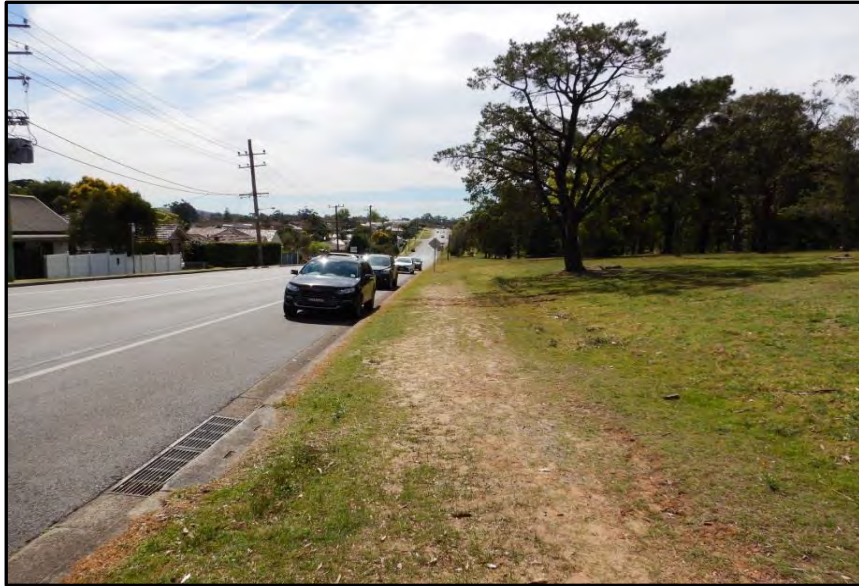
Photo 3: Residual slope - looking north-east

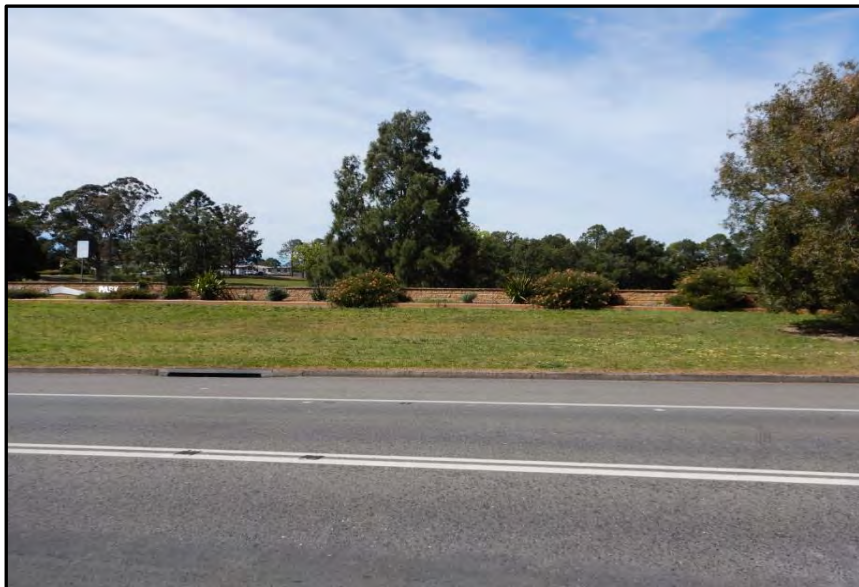
Photo 4: Fill embankment associated with stormwater control - fill possible

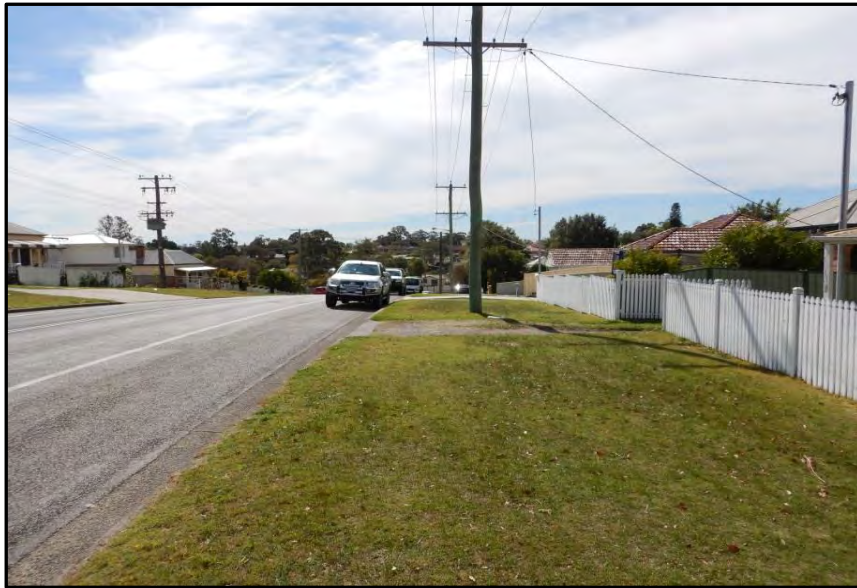
Photo 5: Looking north-east down residual slope

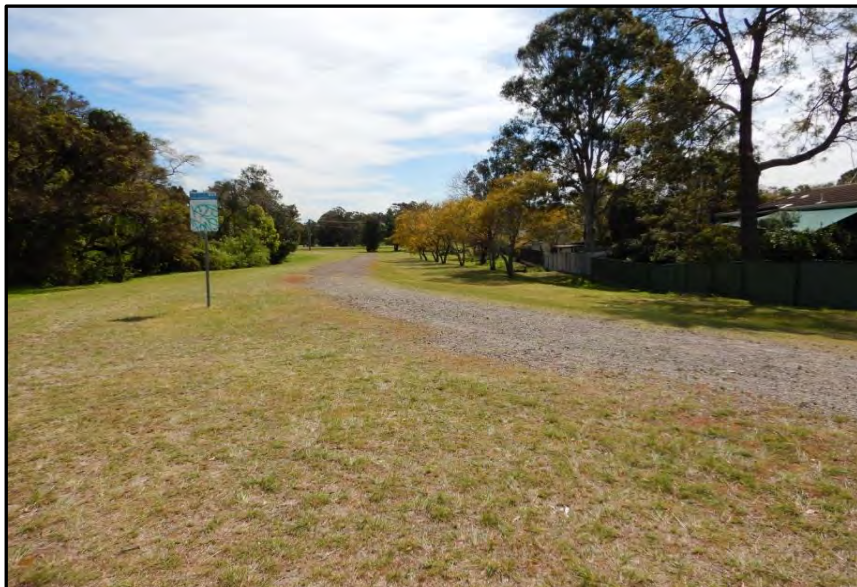
Photo 6: View down drainage gully - fill possible with weak soils

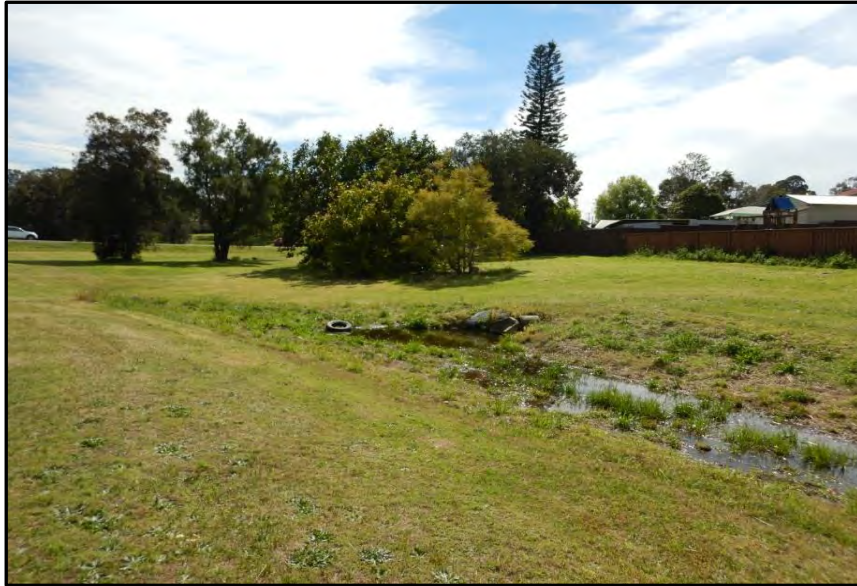
Photo 7: Ponded water and fill at back of allotment - looking north

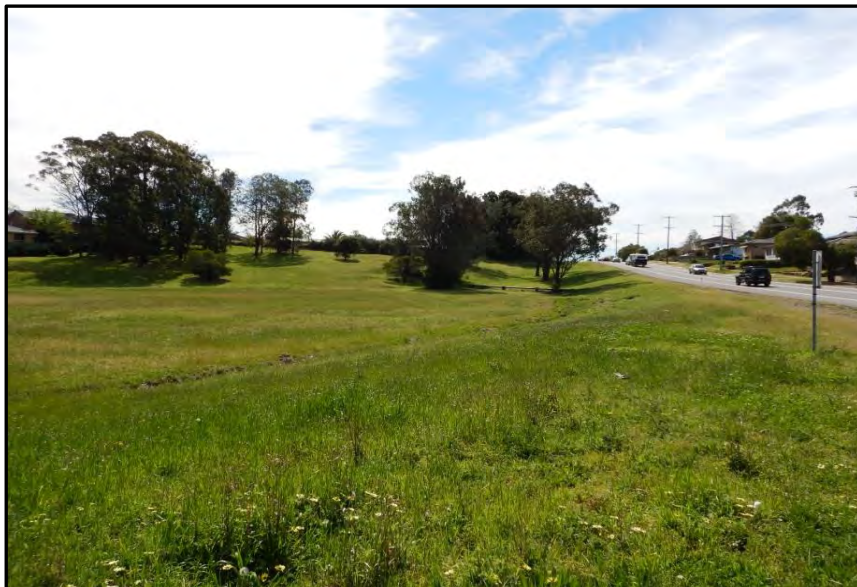
Photo 8: Broad gully with possible weak soils and shallow groundwater

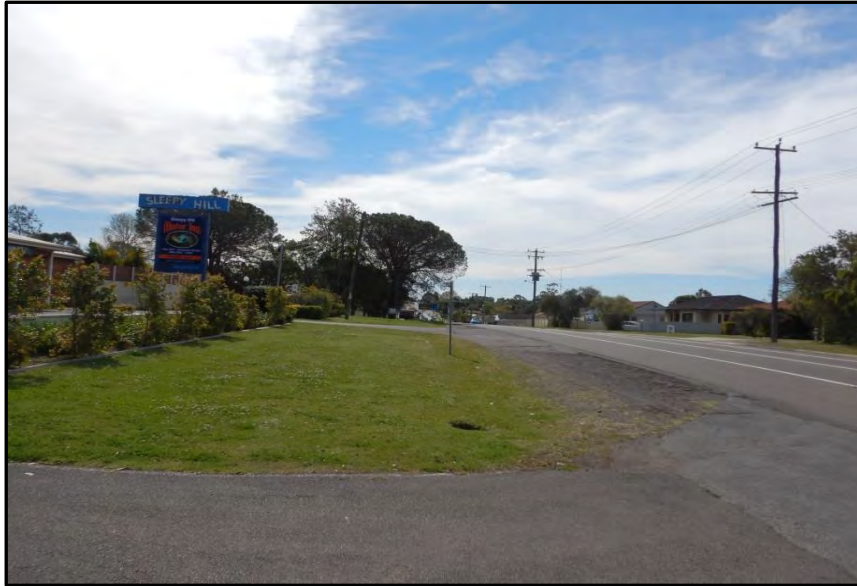
Photo 9: Looking north-east at crest of hill - residual soils

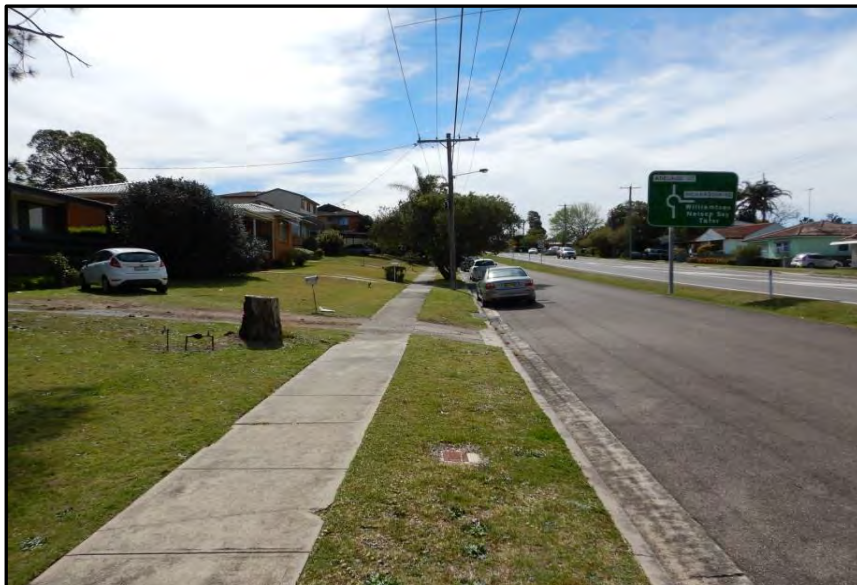
Photo 10: Looking north-east up residual slope

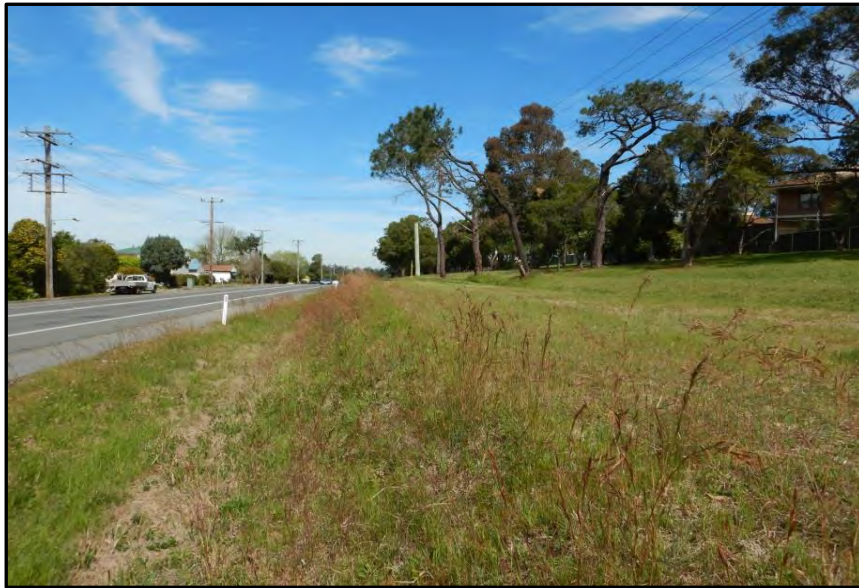
Photo 11: Cut batter of probable residual soils - looking south-west

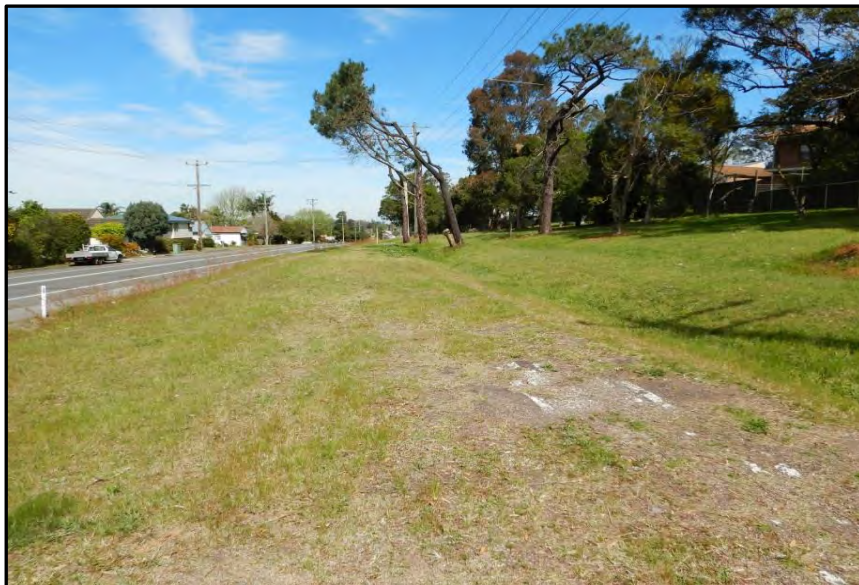
Photo 12: Former road alignment - possible fill

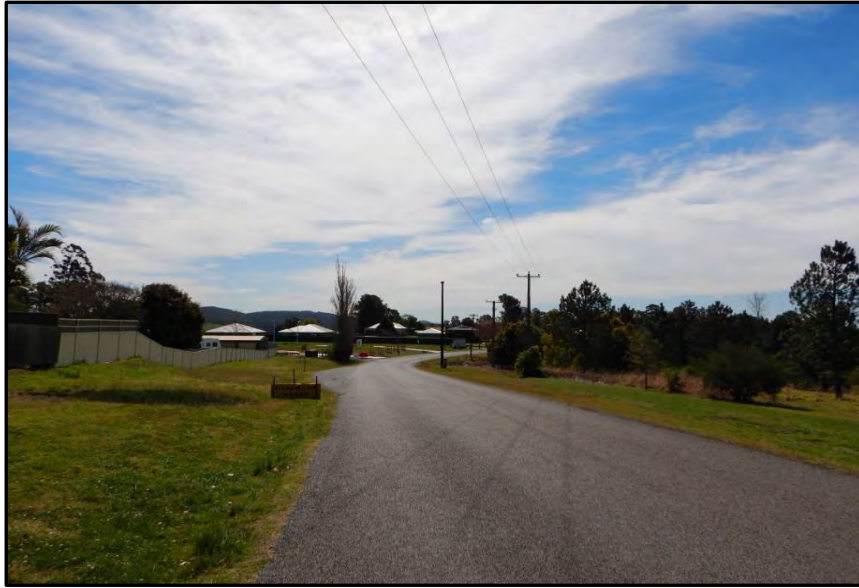
Photo 13: Looking north-east down broad gully - residual soils anticipated

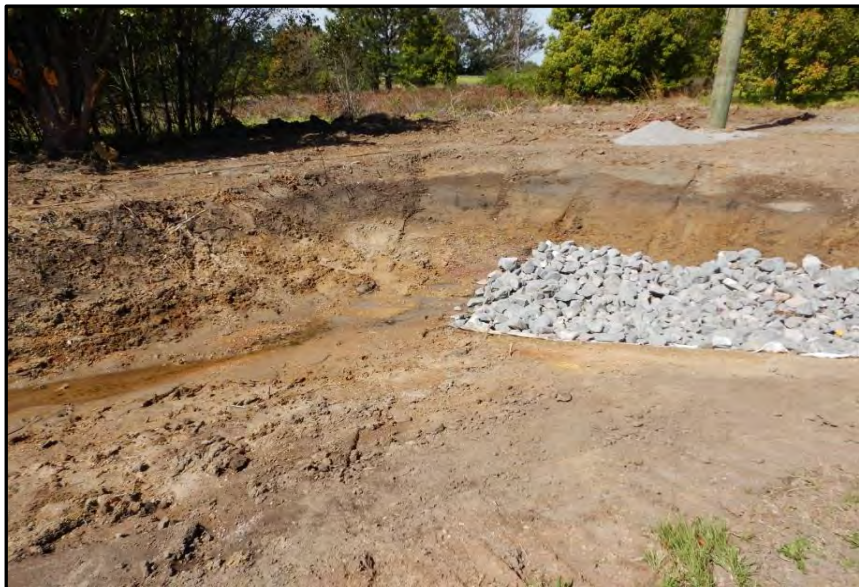
Photo 14: Cutting of about 1.5 m depth with orange brown silty clay exposed

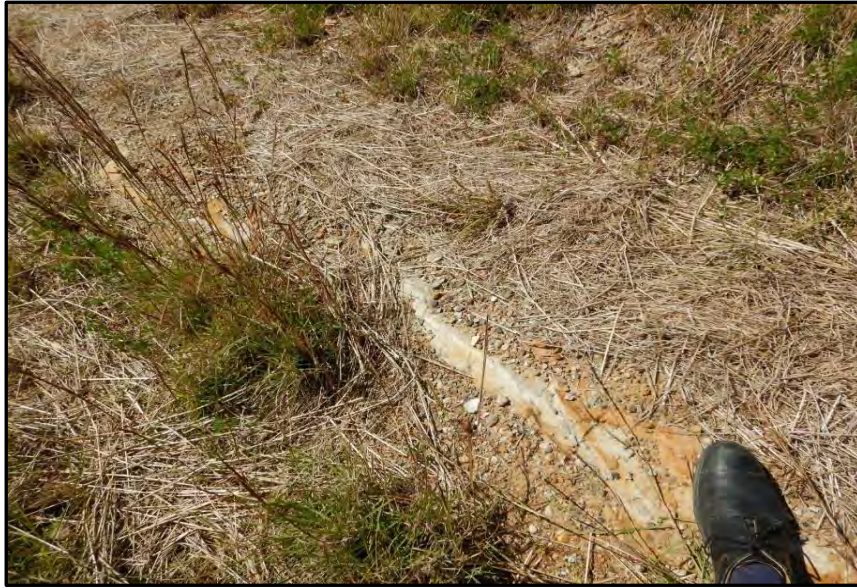
Photo 15: Medium strength sandstone exposed in cutting

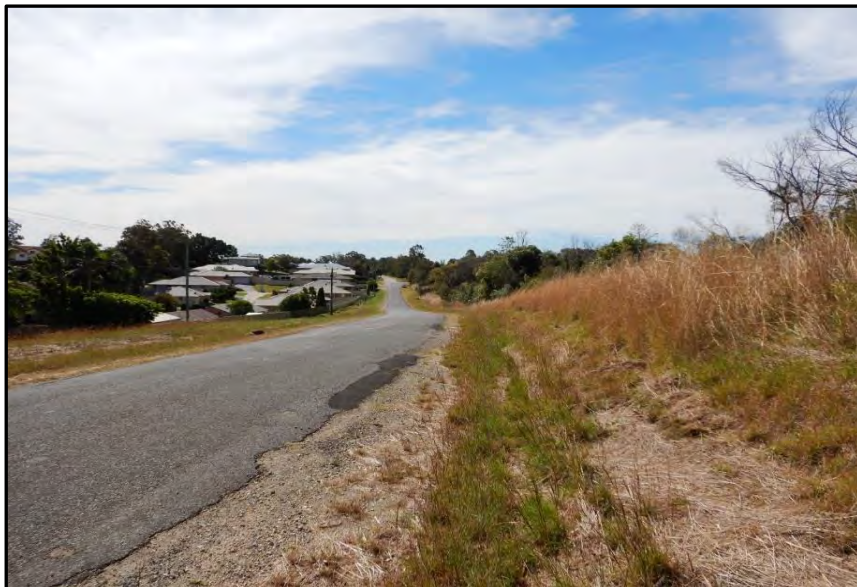
Photo 16: Possible cut on eastern side of road with embankment fill on left

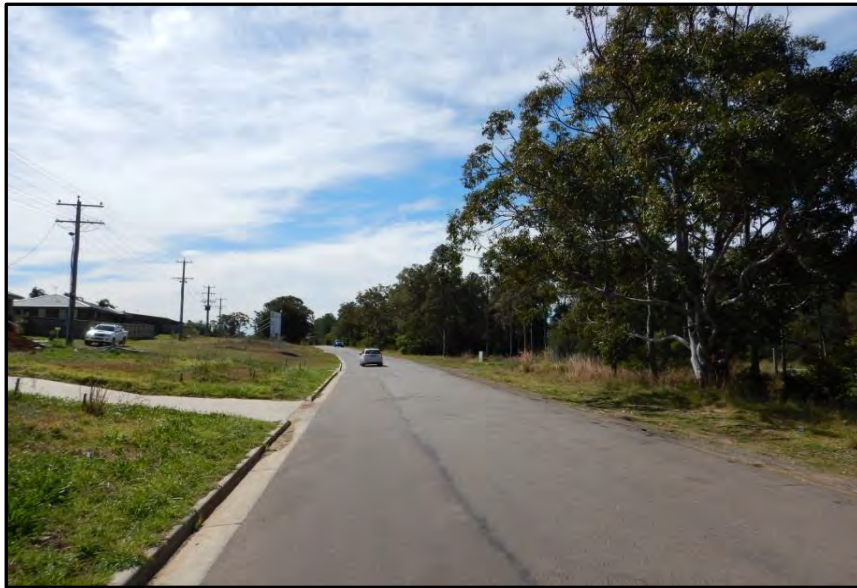
Photo 17: Looking north-east up residual slope

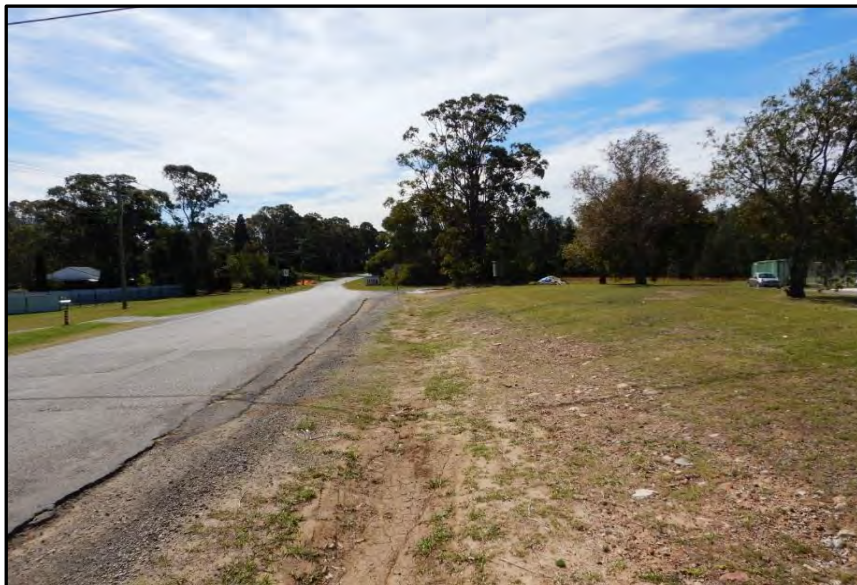
Photo 18: Residual soils, possible shallow rock (evidenced by cobbles near surface)

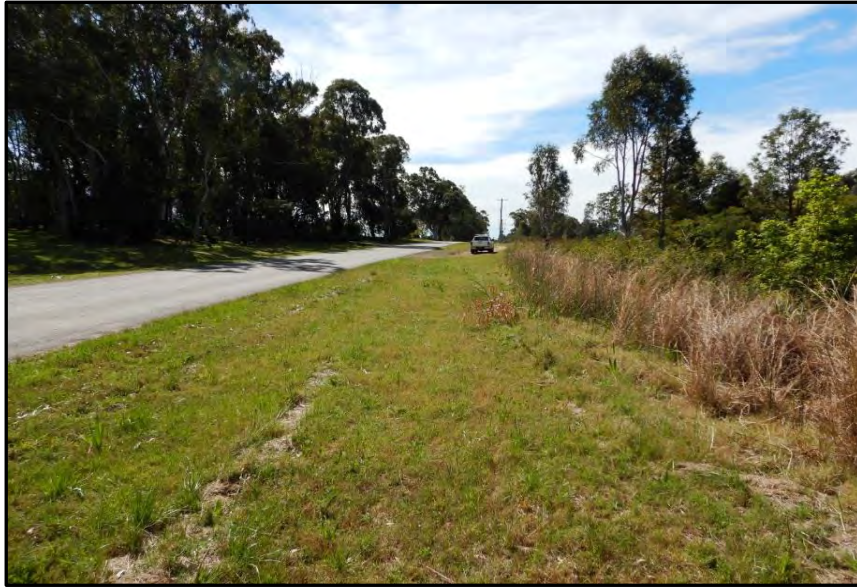
Photo 19: Looking north-east up slight incline (residual soils)

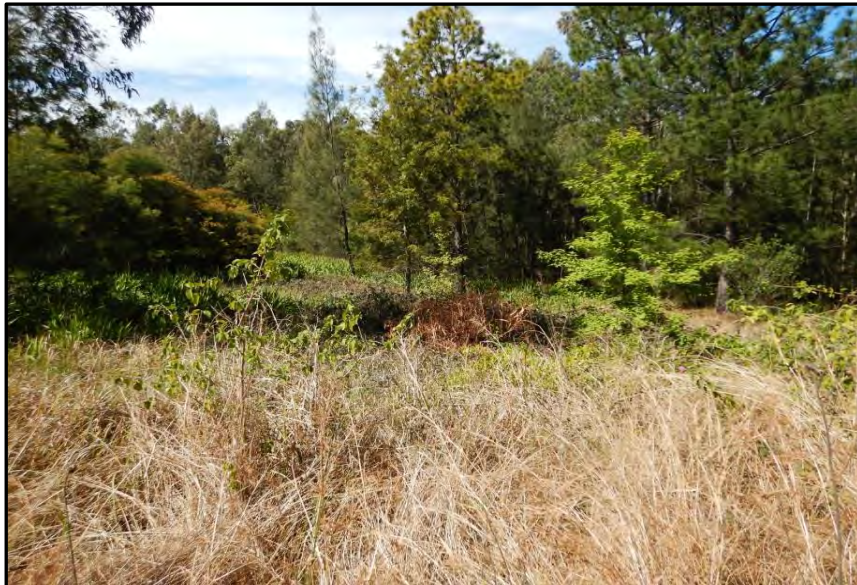
Photo 20: Localised weak soils possible in gully

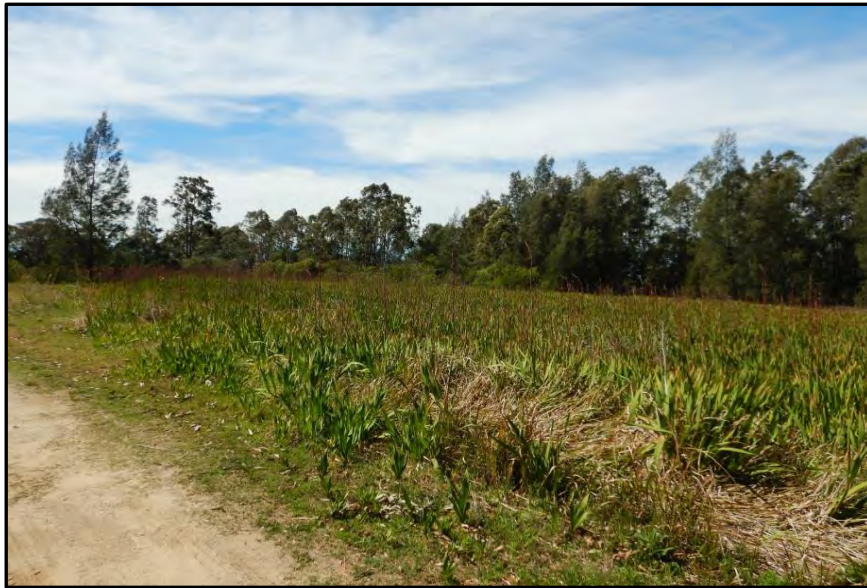
Photo 21: Cleared area - possible fill

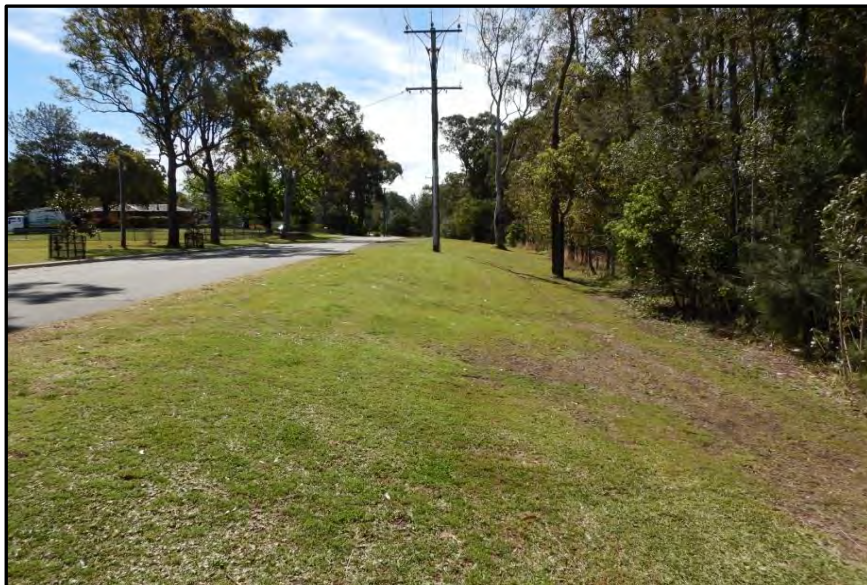
Photo 22: Shallow fill associated with road construction

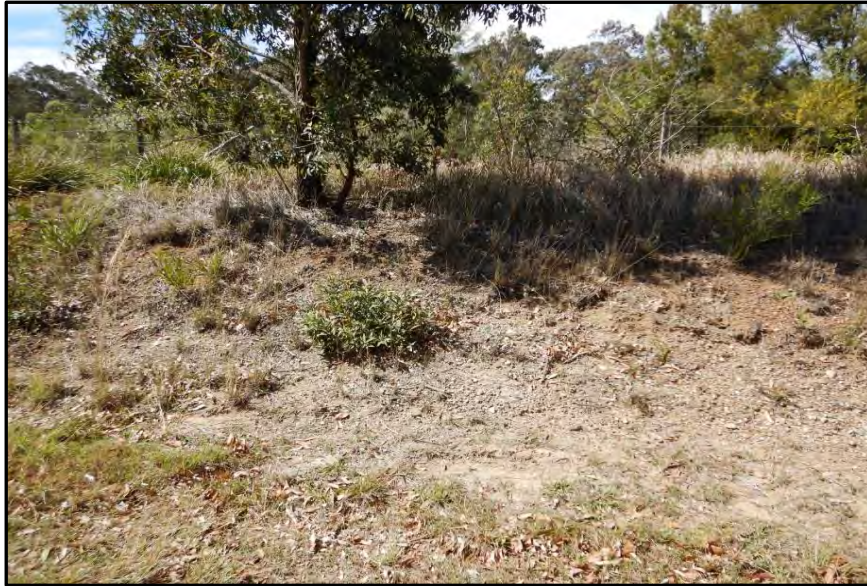
Photo 23: Brown residual sandy clay exposed

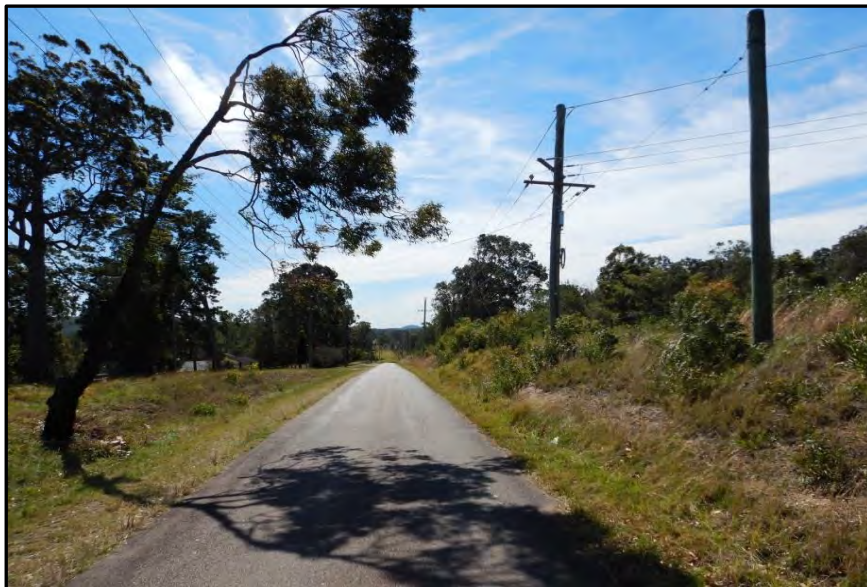
Photo 24: Looking north along cutting

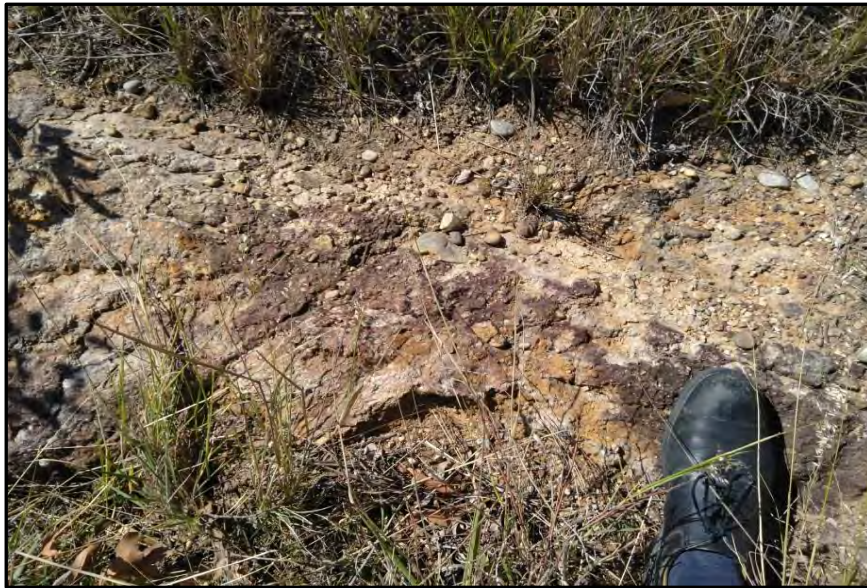
Photo 25: High strength volcanic rock exposed in cutting

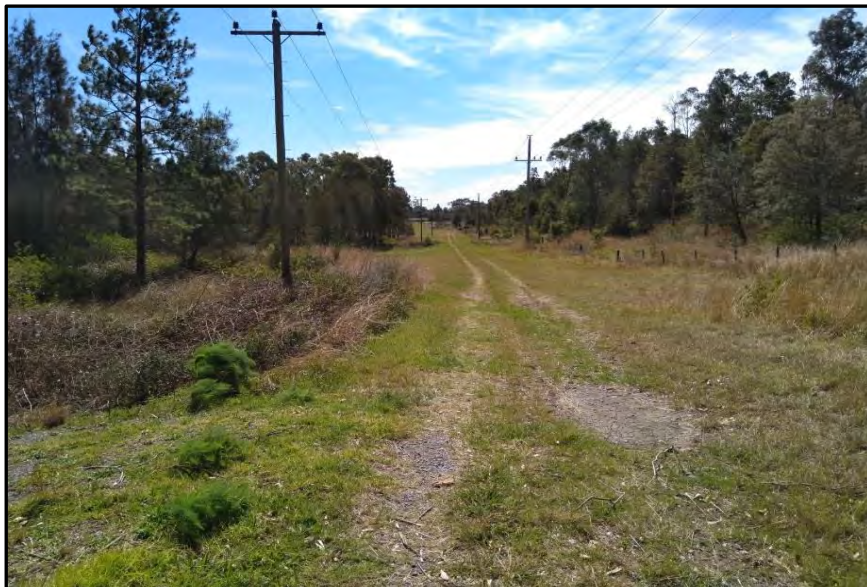
Photo 26: Broad gully , looking north-east some fill possible associated with access track

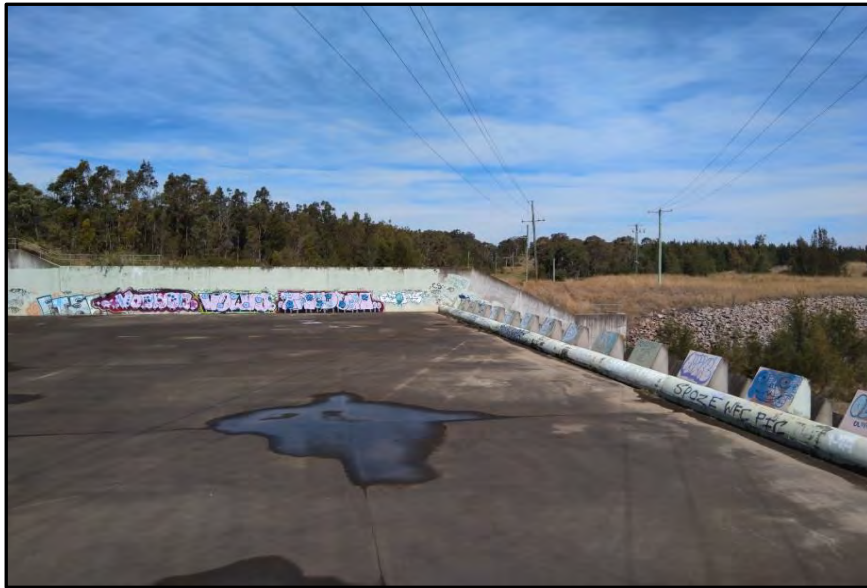
Photo 27: Deep fill anticipated around spillway

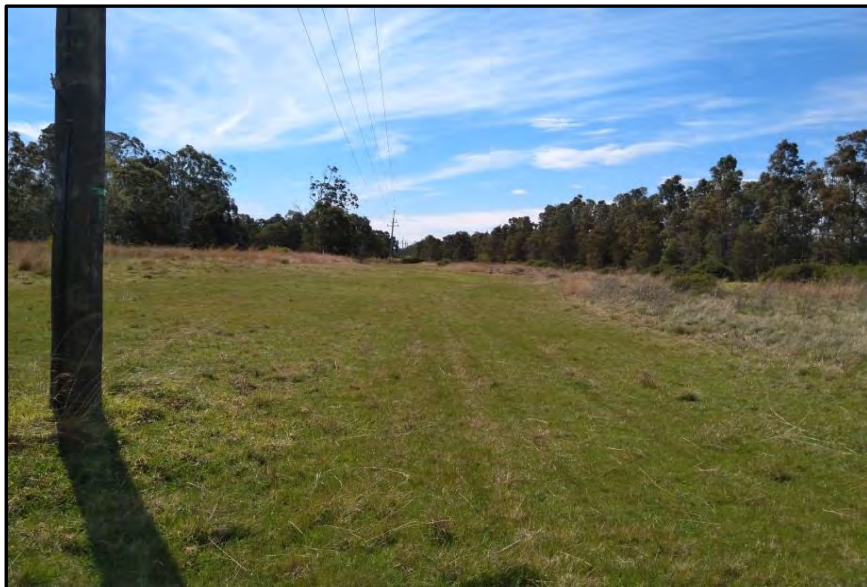
Photo 28: Flat area north of spillway but possibly fill

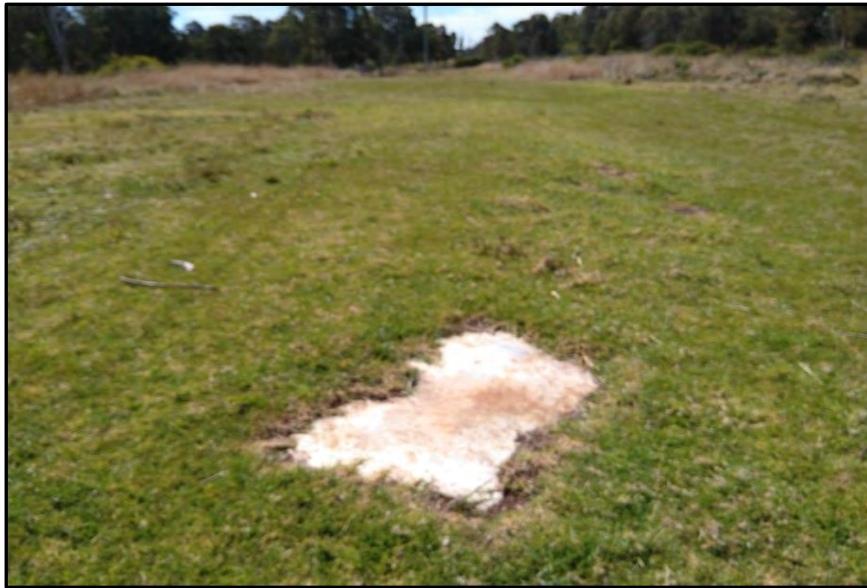
Photo 29: Partially buried metal sheet in probably fill

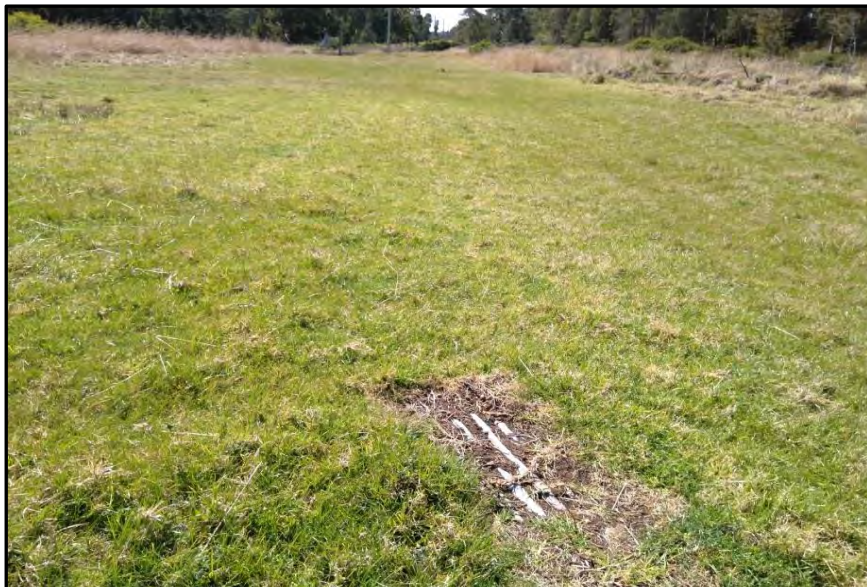
Photo 30: Partially buried sheet of corrugated iron in probably fill

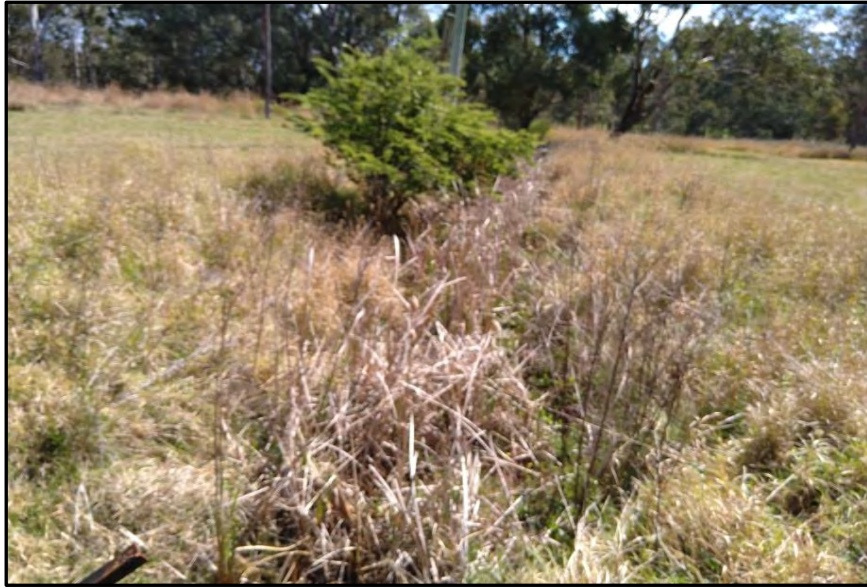
Photo 31: Draing about 1.5 m deep excavated into landform

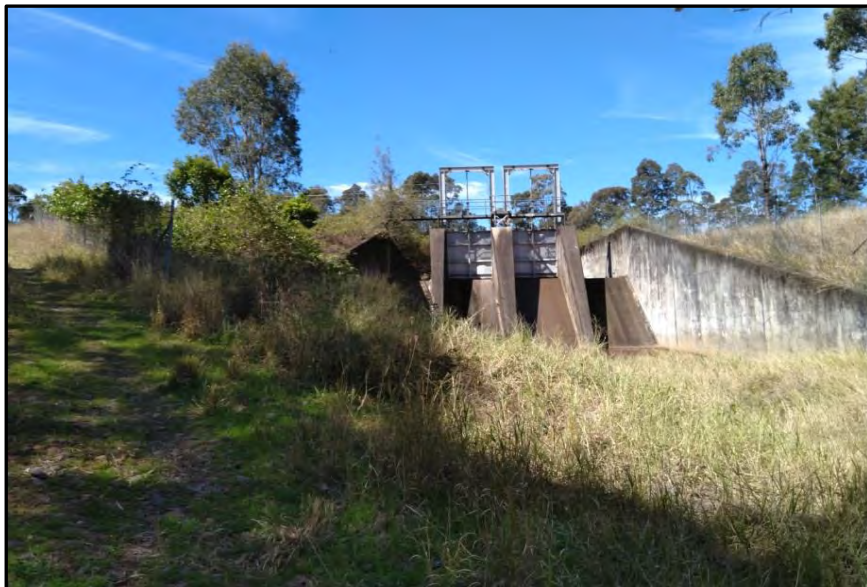
Photo 32: Smaller spillway (fill anticipated immediately adjacent)

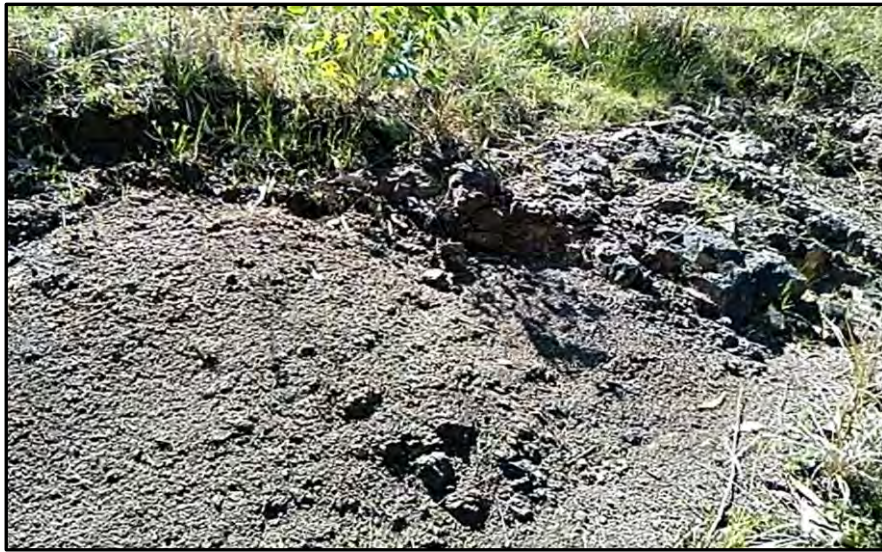
Photo 33: High strength, fractured basalt exposed in access road

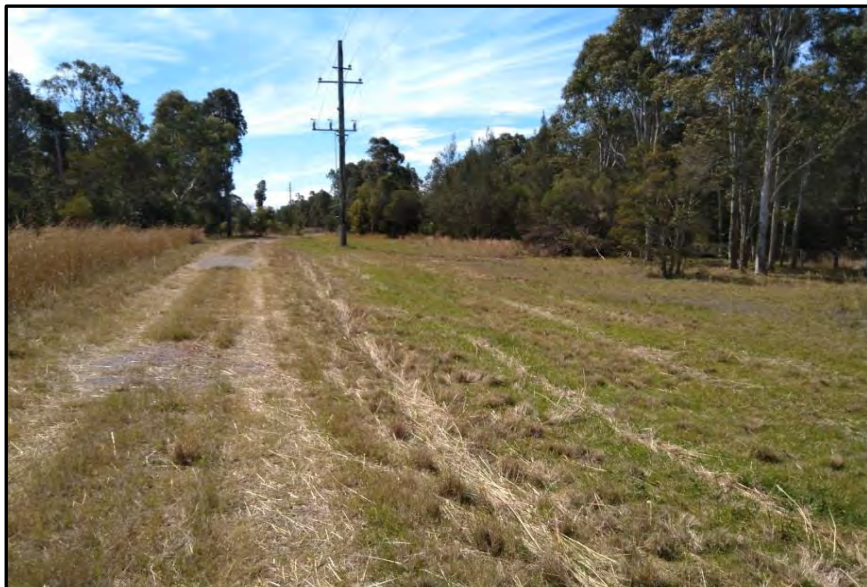
Photo 34: Residual soils anticipated possibly with surficial fill
