Arborcultural Impact Assessment Report

Broadwater Public School

File No: 2324
Version: Final
13 Sept 2023

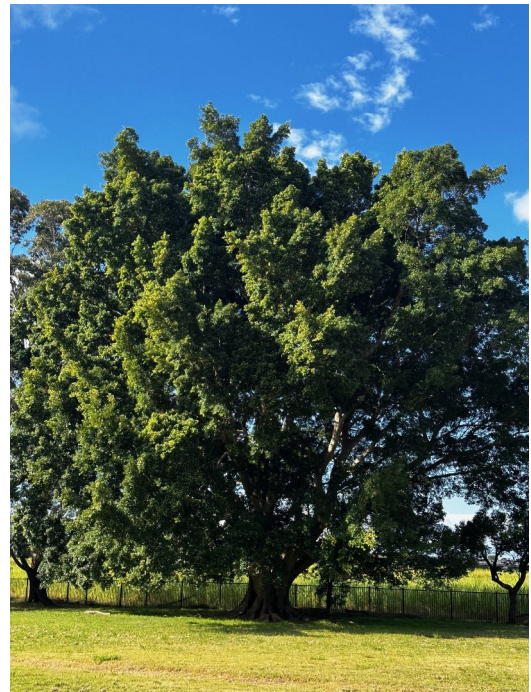
Photo 4. Tree # 5
Weeping Fig

7.3 There are two trees that have an encroachment into their TPZ. These are trees # 5 and 13. The encroachment into tree # 5 is calculated to be 3%. The encroachment in to tree # 13 is calculated to be 1%. The encroachment into trees # 5 and 13 are minor encroachments and are allowed according to the Standard.

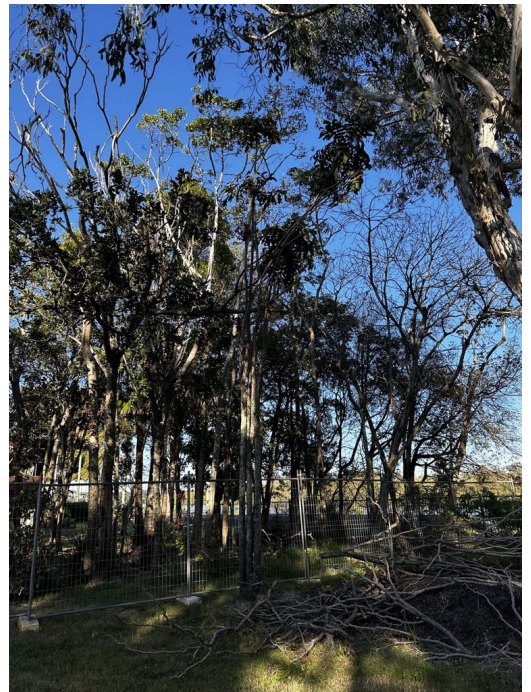
7.5 The group of trees # 22 have 13 trees that are dead. There are a further 2 trees that will be required to be removed to allow construction of a services trench.

Photo 12. Tree # 22
Group of trees. Many have died.

8.1 It is recommended that the new school buildings and related infrastructure should be constructed as planned. The trees required to be removed to allow construction of the new building trees # 3a, 3b, 4a, 4b, 14a, 14b, , 15, 16, 18a, 18b, 23 and 24. There are 15 trees in Group 22 that also should be removed. Thirteen of these trees are dead and another two trees should be removed to allow construction of a services trench. The other trees growing on the school grounds should be retained and protected during construction.
