**Re: Assessment of an Osprey Nest on Lot 33 DP 754405, Ocean Drive, Kew.**

As requested, we provide an assessment of an Osprey nest on Lot 33 DP 754405, Kew under the provisions of the Area 15 Port Macquarie-Hastings Council Development Control Plan 2011.

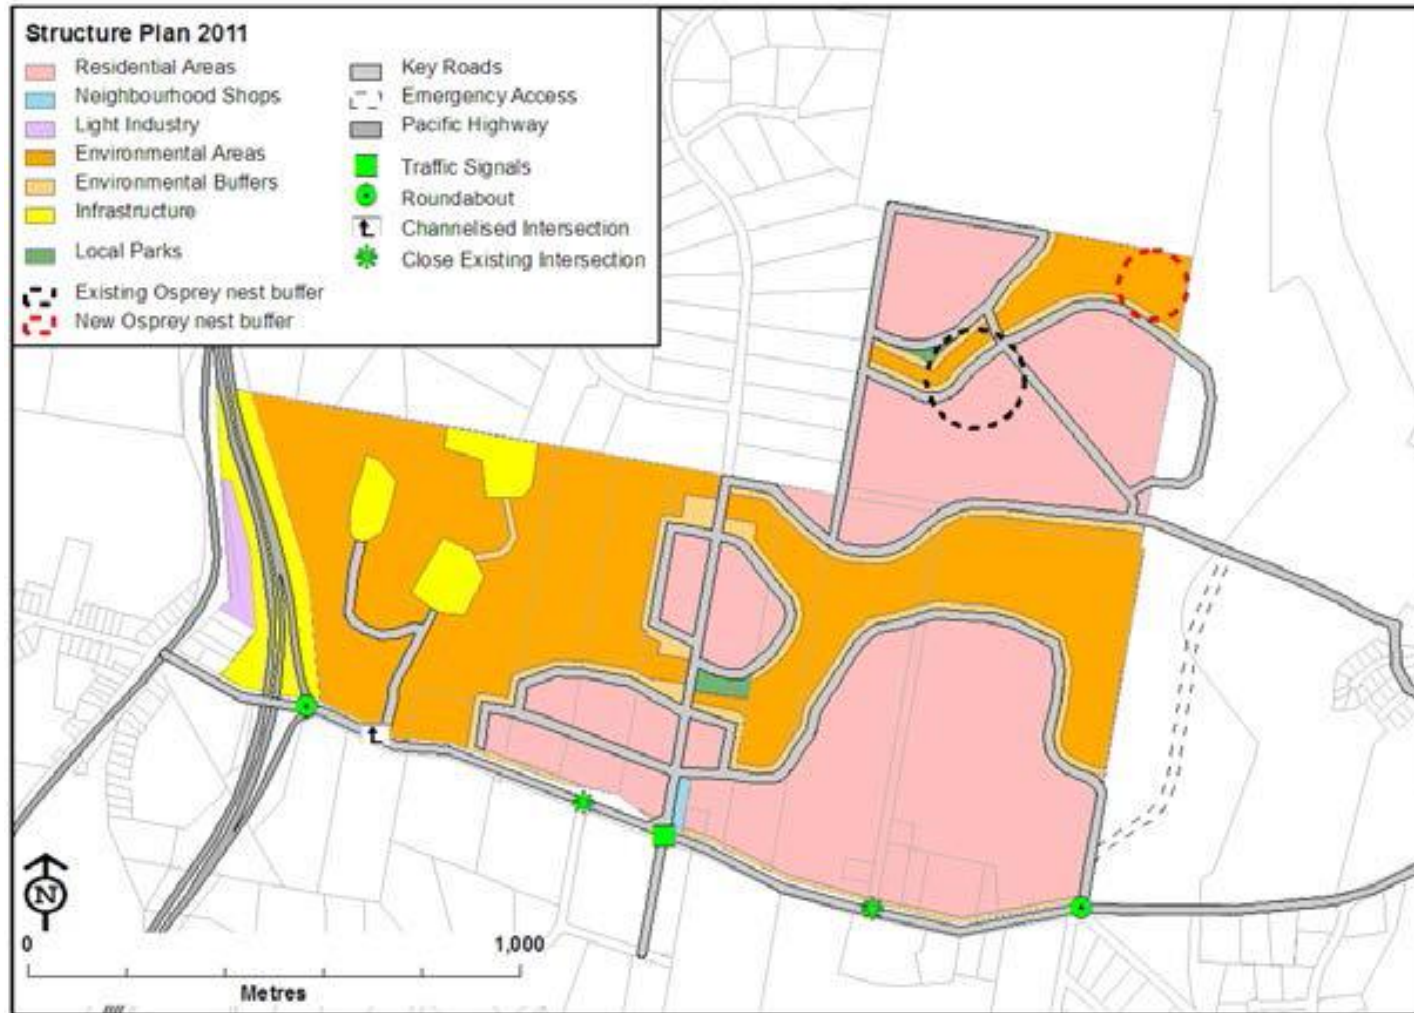
Figure 1: Area 15 Structure Plan indicating Osprey nest location

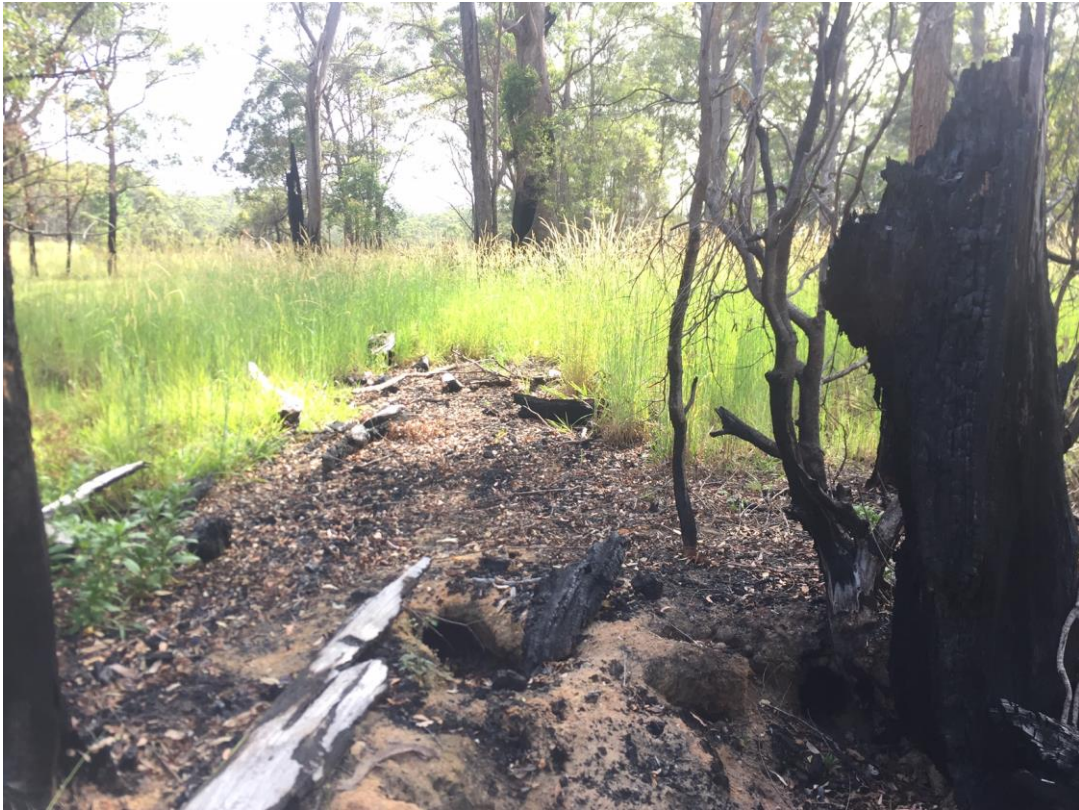
This inspection located the stag, however it was found that it had in fact fallen within the last few months due to a recent fire that had occurred in the vicinity. Communication with the land tenant had indicated that this fire had been the result of a lightning strike to the tree. Much of the trunk had been completely burned and few remnants remained. Fresh charcoal at the site and new regrowth of Pigeon Grass indicate that the fire was relatively recent (Figure 1).

Photo 1: Base of burnt out stag tree where Osprey nest was located

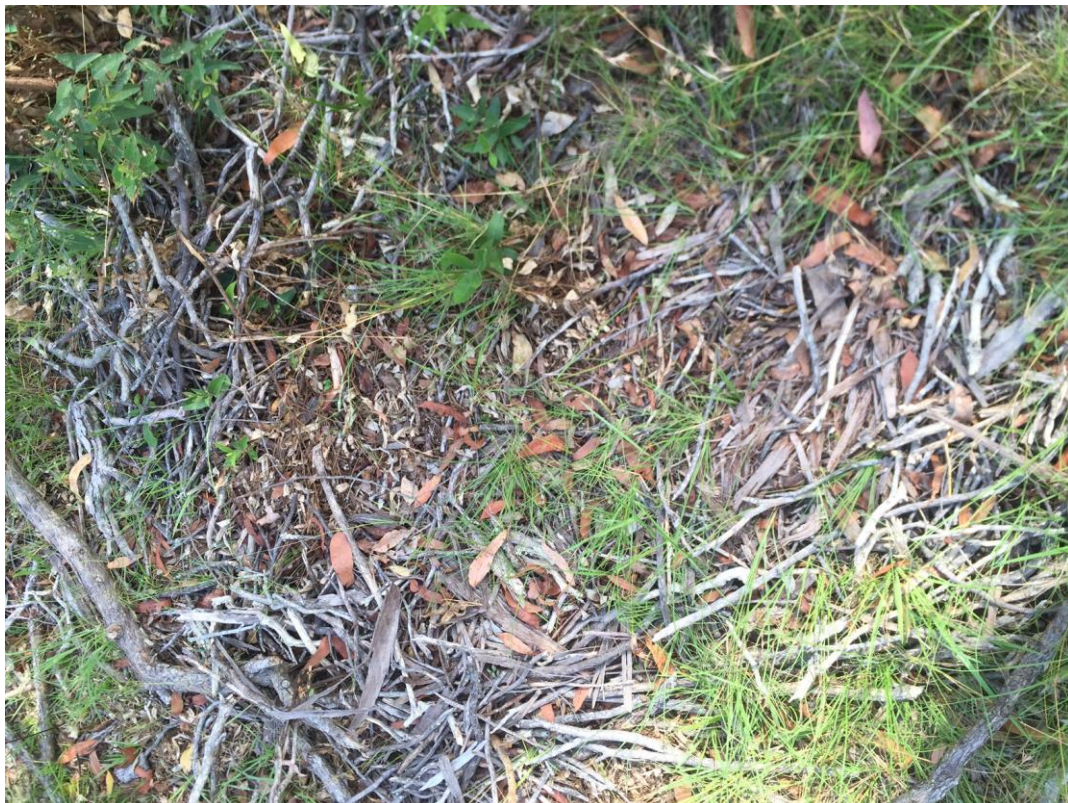
Subsequent search of the ground near the base of the burnt stag located the fallen tree crown and confirmed the presence of an Osprey nest (Photo 2). The nest was characteristic of an Osprey nest measuring approximately 2m in diameter and formed of large woven sticks. The nest had largely decayed with only an outline of the nest being visible indicating a maximum of several months since falling. No remnants of nesting activity were recorded (eg bones, eggs, down feathers).

Photo 2: Remnants of fallen Osprey nest

To satisfy the requirement that Osprey nesting has been abandoned on site, it is recommended that a site inspection is undertaken by an ecologist during the next breeding season to confirm that no further breeding activity is occurring. Recording of further nest activity will re-trigger the Area 15 DCP requirements.

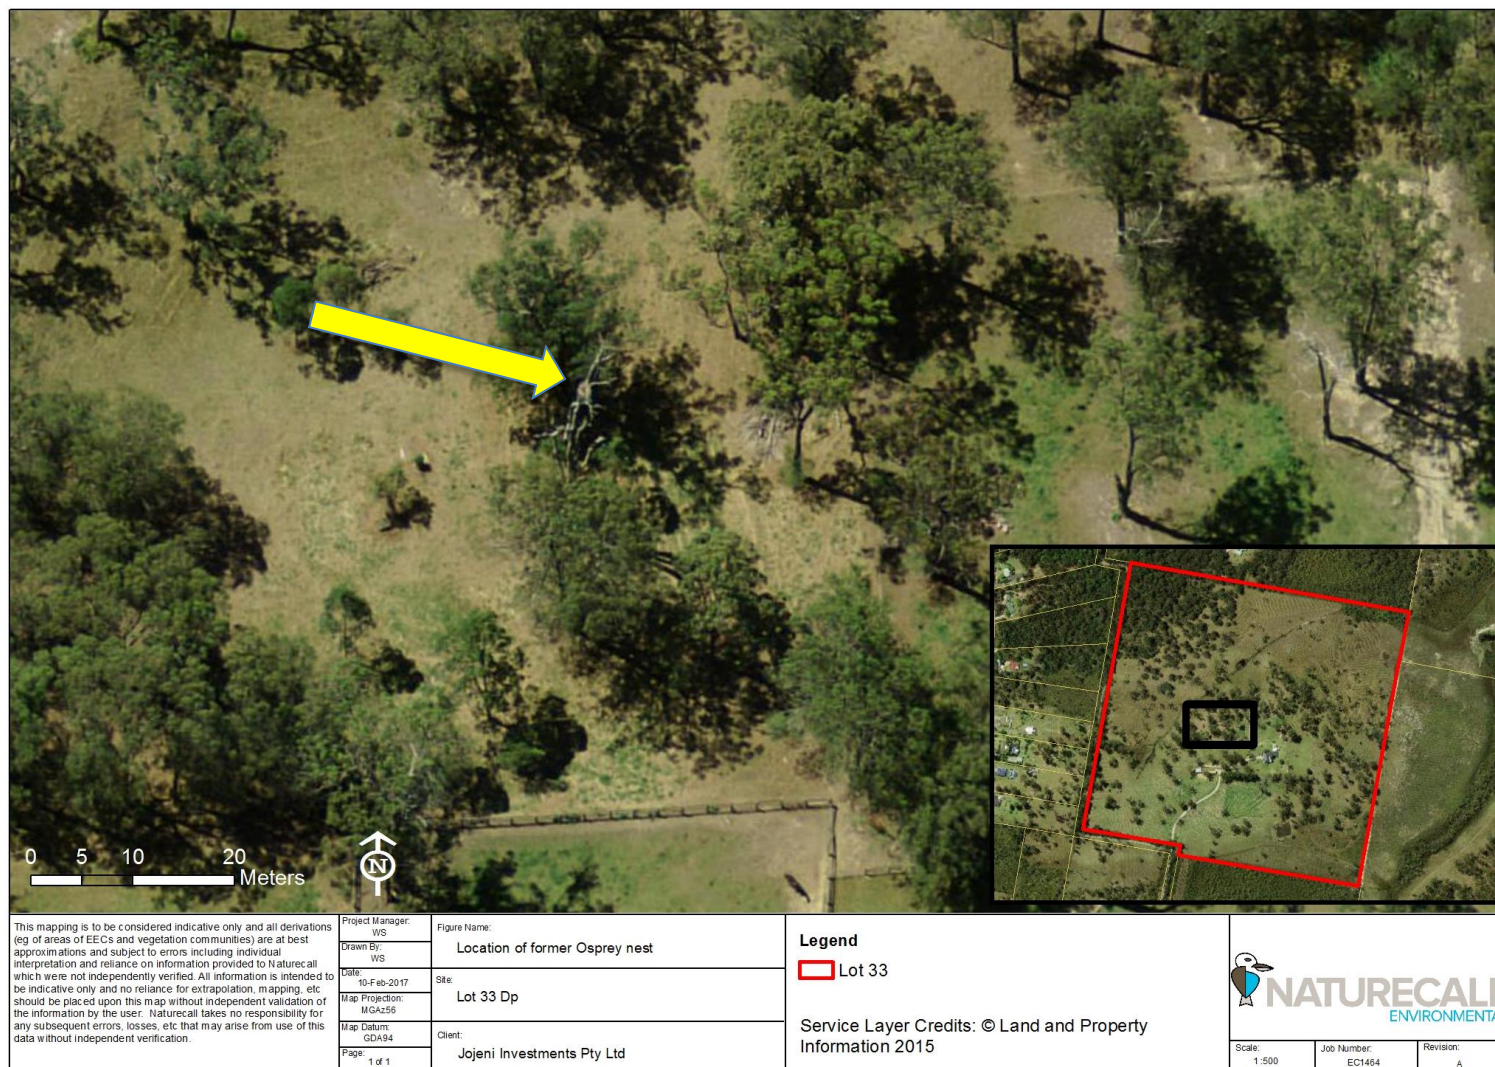
Figure 2: Osprey nest location
