**Arboricultural Impact Assessment**  
**On:Tree Specimens**  
**Location: 9 to 11 Fig tree Ave,**  
**TelopeaNSW2117**

For: 888 Pty Ltd.  
On. 24/7/2016

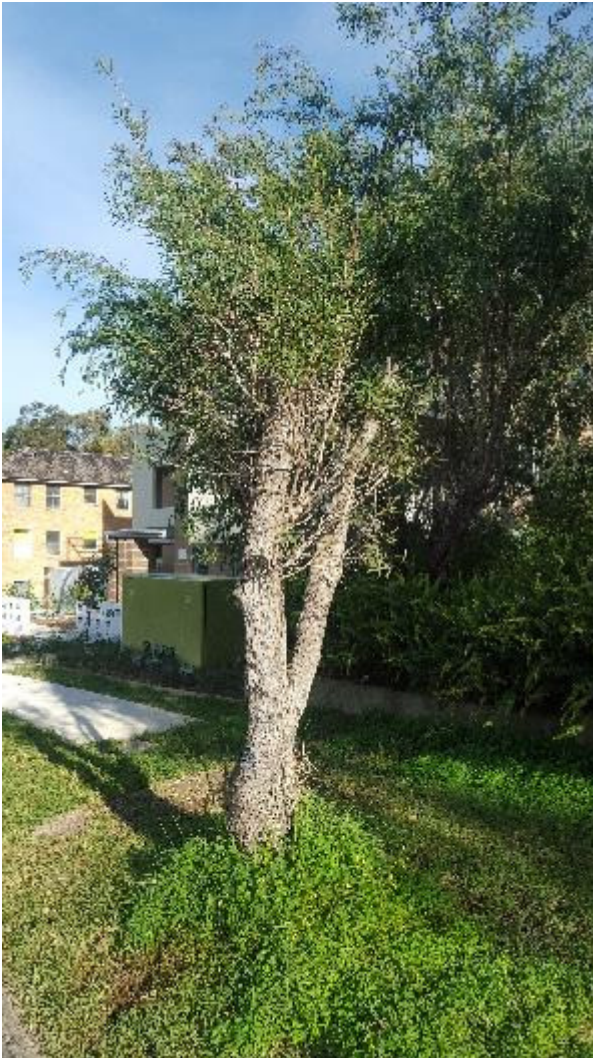
Fig 2. Photo of T1 a *Callistemon viminalis*

**4.1** Tree **T1** is a *Callistemon viminalis* 'Weeping Bottlebrush' which is growing on the nature strip to the Southeast of the Site and is a Council Asset (See Fig. 2). The tree is in poor condition at the time of inspection having been cut back heavily and is now reshooting. The specimen would be suffer a Major Encroachment into its TPZ by the excavation and construction of a concrete footpath crossover to access the Site (See Appendix 2).

**5.2** Tree **T1** is a Council asset which conflicts with the proposed concrete footpath crossover but has been indiscriminately cut back to the point where its canopy is virtually nonexistent.

- 6.1.** Remove Trees **T2, T3, T4, T5, T6, T7, T8, T9, T10, T11, T12, T15, T16, T17, T20, T21 & T22.**
- 6.2** Apply to Council to remove and replace **T1.**
- 6.3** Transplant if possible the four native palm trees **T13, T14, T18 & T19**
- 6.4** Approach the property owner to the North of the Site in regard to the removal of significant weed **T23.**
- 6.5** **T24** is well outside the development area and so no treatment is required regarding its protection.
- 6.6** There is an opportunity to plant new trees in the nature strip to the South of the Site. It is advised that tree specimens be chosen from PCC's list of preferred species.
- 6.7** Removal of trees constitutes a lack of amenity for the area and it is recommended that trees scheduled for removal be replaced in accordance with PCC's list of preferred species.

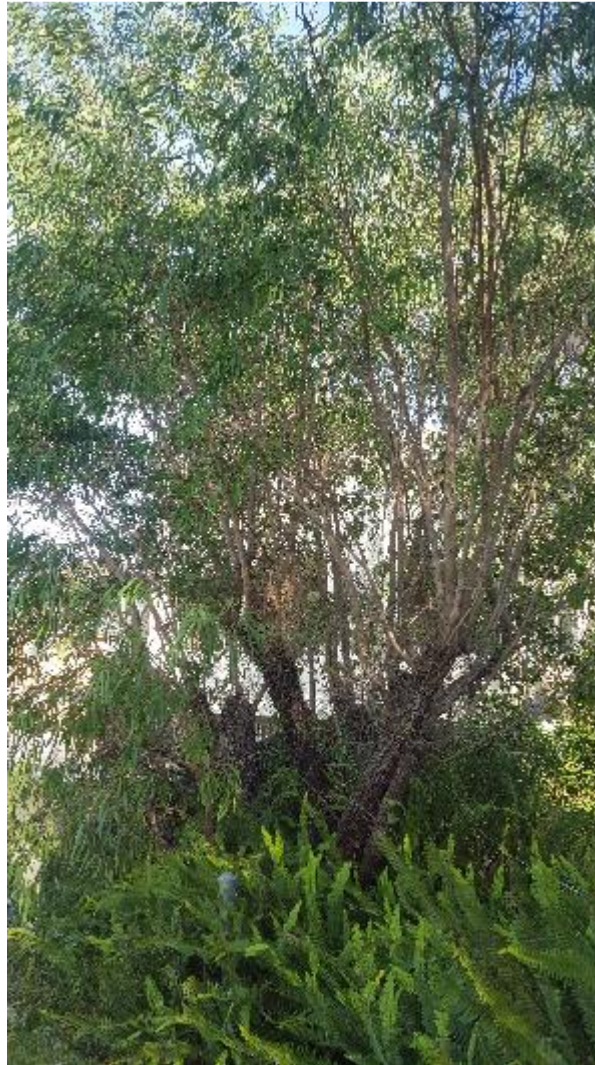
Fig 3. Photo of T2 *Agonis flexuosa*

**4.2** Trees**T2, T3, T4 & T6** are *Agonis flexuosa* or 'Willow Myrtle' which is a native species endemic to Southwest Western Australia that have been planted in front of the property to the Southeast of the Site (See Figs 3, 4, 5 & 7).All of these specimens have been subjected to indiscriminate pruning in that they have been lopped at approx. 1.8m from the ground and their canopies comprising of the resulting regrowth. Tree **T3** in particular has around 30% deadwood in the canopy and is in poor condition.

These trees would experience a Major Encroachment into their respective TPZ'sfrom deep excavation for the new driveway ramp and Onsite Stormwater Detention (OSD) pits to be constructed along the frontage of the Site(See Appendix. 2).

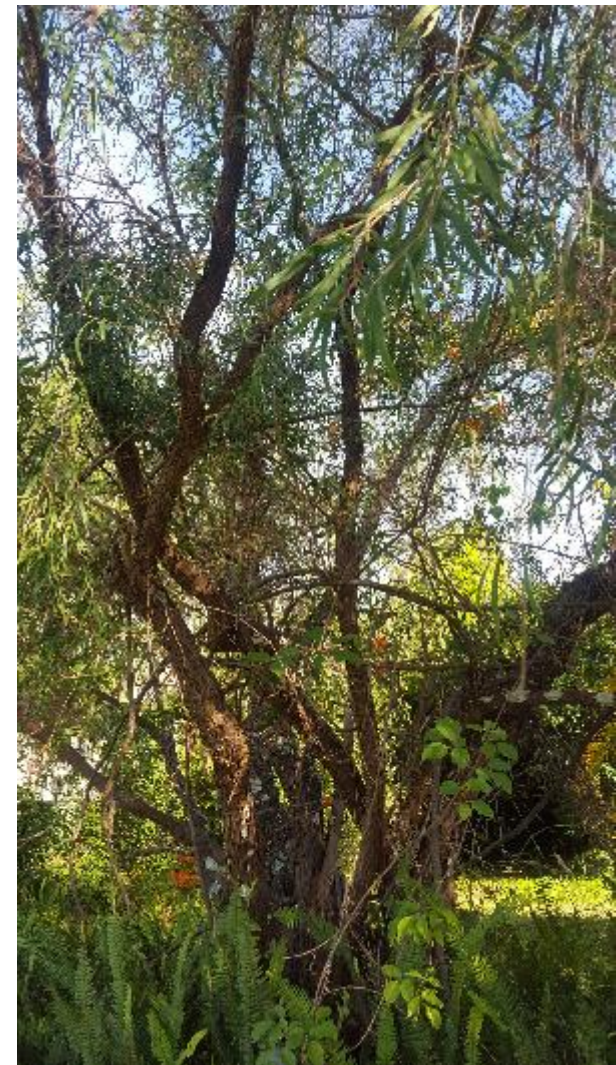
Fig 4. Photo of T3 *Agonis flexuosa*

T3 <i>Agonis flexuosa</i> Common name 'Willow Myrtle' Age class 40 years See Fig. 4.	4m	4 x 4cm 1 x 5cm 1 x 8cm 2 x 8cm 1 x 12cm 39cm at the base	N 3m E 2m S 3m W 3m	A native tree common to South west Western Australia. The tree is growing on the property frontage to the to the East of the Site. At the time of inspection the tree had been cut back heavily at 1.8m with many old pruning points and the resulting regrowth forming a new canopy. the tree consist of 6 main stems meeting in a 'V' shaped junction at ground level. The tree had approx. 30% deadwood in the canopy and is under 5m in height.	A4	N/A	N/A
T4 <i>Agonis flexuosa</i> Common name 'Willow Myrtle' Age class 40 years See Fig. 5.	5m	2 x 4cm 1 x 6cm 1 x 7cm 1 x 9cm 2 x 14cm 50cm at the base	N 3m E 2m S 3m W 3m	A native tree common to South west Western Australia. The tree is growing on the property frontage to the to the East of the Site. At the time of inspection the tree had been cut back heavily at 1.8m with many old pruning points and the resulting regrowth forming a new canopy. the tree consist of 5 main stems meeting in a 'V' shaped junction at ground level.	A5	2.9m	2.4m

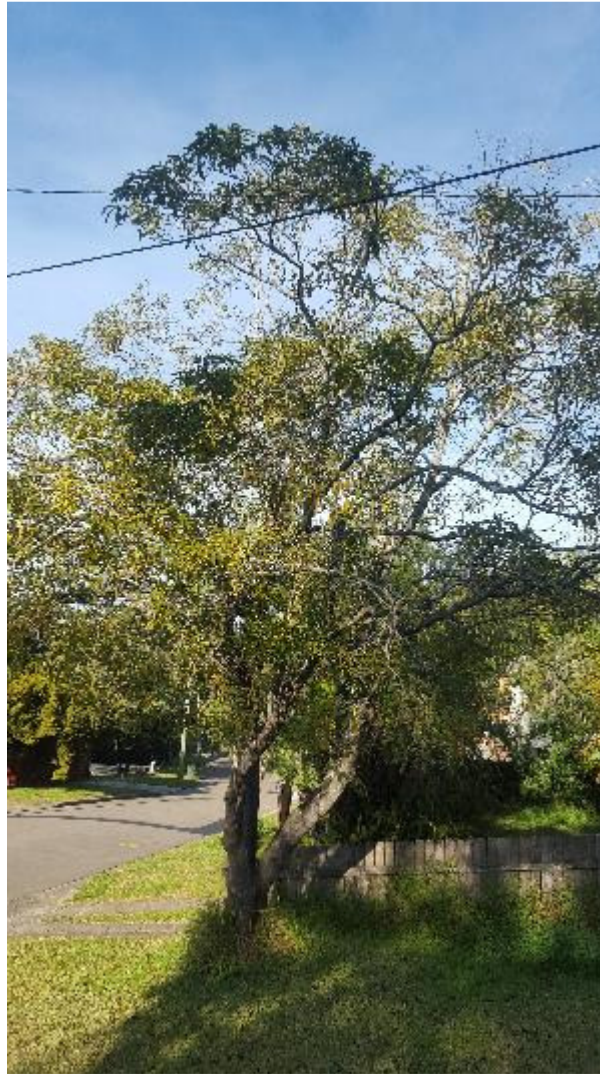
Fig 6. Photo of T5 a *Pittosprum undulatum*

**4.3** Trees**T5** and **T15** are both *Pittosporum undulatum* or 'Native Daphne' (See Figs. 6 & 15). The species is endemic to the area but noted to have 'Weedy' properties and "the species has also proven to be very invasive" (Australian Native Plant Society). Of these specimens **T5** is noted to be in very poor condition whilst **T15**is stunted and appears to have been suppressed by overhanging vegetation.

These treeswill have Major Encroachments into their TPZs and would need to be removed for the development to proceed as planned (See Appendix 2).

T5 <i>Pittosporum undulatum</i> Common name 'Native Daphne' Age class 40 years See Fig. 6.	6m	1 x 10cm 1 x 12cm 1 x 14cm 1 x 15cm 1 x 19cm 36cm at the base	N 4m E 5m S 2m W 3m	An endemic tree common to the Parramatta LGA. The tree is growing on the property frontage to the to the East of the Site. At the time of inspection the tree was in poor health and vigour with approx. 30% dead and sparse foliage in the canopy.	A4	3.84m	2.15m
T6. <i>Agonis flexuosa</i> Common name 'Willow Myrtle' Age class 40 years See Fig. 7.	6m	1 x 8cm 1 x 9cm 1 x 12cm 1 x 20cm 36cm at the base	N 3m E 2m S 3m W 3m	A native tree common to South west Western Australia. The tree is growing on the property frontage to the to the East of the Site. At the time of inspection the tree had 5 main stems meeting in a 'V' shaped junction at ground level. There were no significant pathogens nor signs of mechanical damage.	A1	2.58m	2.15m

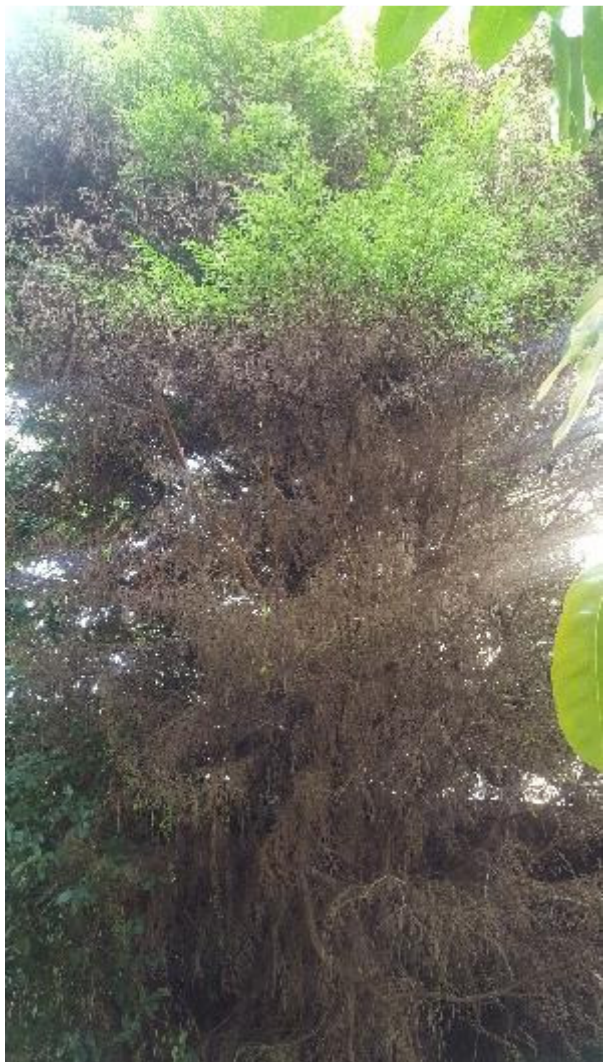
Fig. 8. Photo of T7 a *Cupressus macrocarpa*

**4.4** Tree **T7** is a *Cupressus sempervirens* 'Mediterranean cypress' which is growing in the property near the Western border (See Fig. 8). The tree is multi stemmed though a significant portion have been removed as evidenced by old pruning points.

The tree will be entirely engulfed by the proposed ramp for access to the below ground car park and will need to be removed for the development to proceed as planned(See Appendix. 2).

T7 <i>Cupressus sempevir</i> Common name 'Italian cypress' Age class 40 years See Fig. 8.	6m	Multistemmed some have been removed 46cm at the base	N 3m E 2m S 3m W 3m	An exotic conifer endemic to the Mediterranean. The tree is growing on the border to the to the South of the Site. At the time of inspection the tree was in poor condition and had been cut back heavily at 0.5m from the ground with many old pruning points which have not re shot. The tree has multiple stems meeting in a 'V' shaped junction at ground level.	A4	5.52m	2.39m
T8 <i>Murrayapaniculata</i> Common name 'Murraya' Age class 40 years See Fig. 9.	4m	Multi stemmed 39cm at the base	N 2m E 2m S 3m W 0m	An exotic tree common to South east Asia. The tree is growing to the front of the existing house and assumes a shrublike habit. The tree has been pruned regularly is under 5m in height.	A5	N/A	N/A
T9 <i>Callistemon viminalis</i> Common name 'Weeping Bottlebrush' Age class 30 years	6m	15cm 25cm at the base	N 2m E 2m S 2m W 2m	A native tree common to creeks and damp areas on the NSW coast. The tree is growing centrally on the Site. At the time of inspection the tree had an etiolated habit and is not significant in the streetscape.	A3	1.8m	1.85

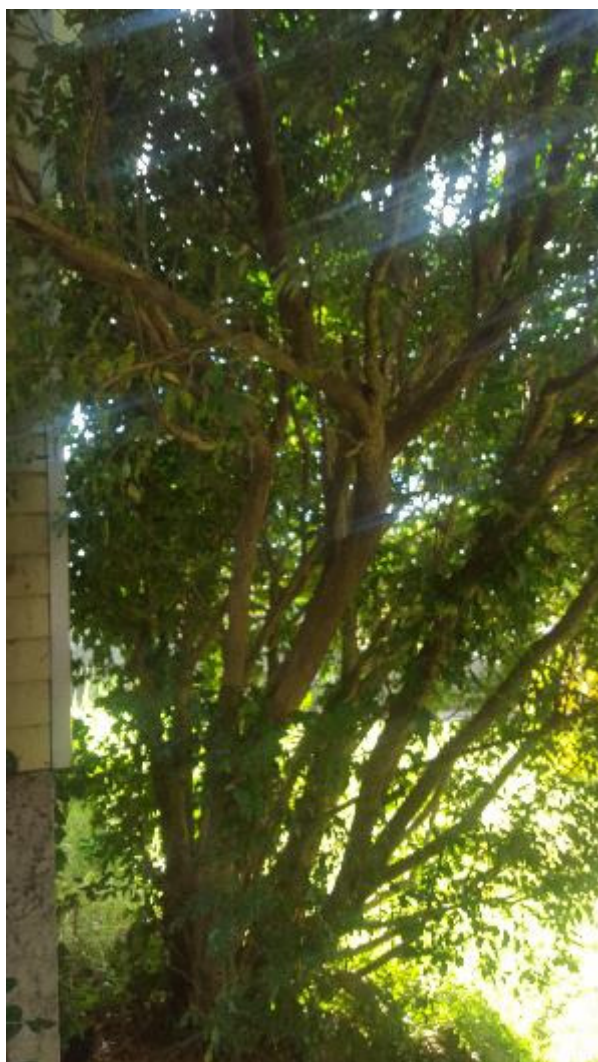
Fig. 9. Photo of T8 a *Murraya paniculata*

**4.5** Tree **T8** is a *Murraya paniculata* also known simply as 'Murraya'. The tree is less than 4m in height and forms a shrublike habit. The tree is not protected by the TPO and will be entirely engulfed by the proposed building footprint(See Appendix. 2).

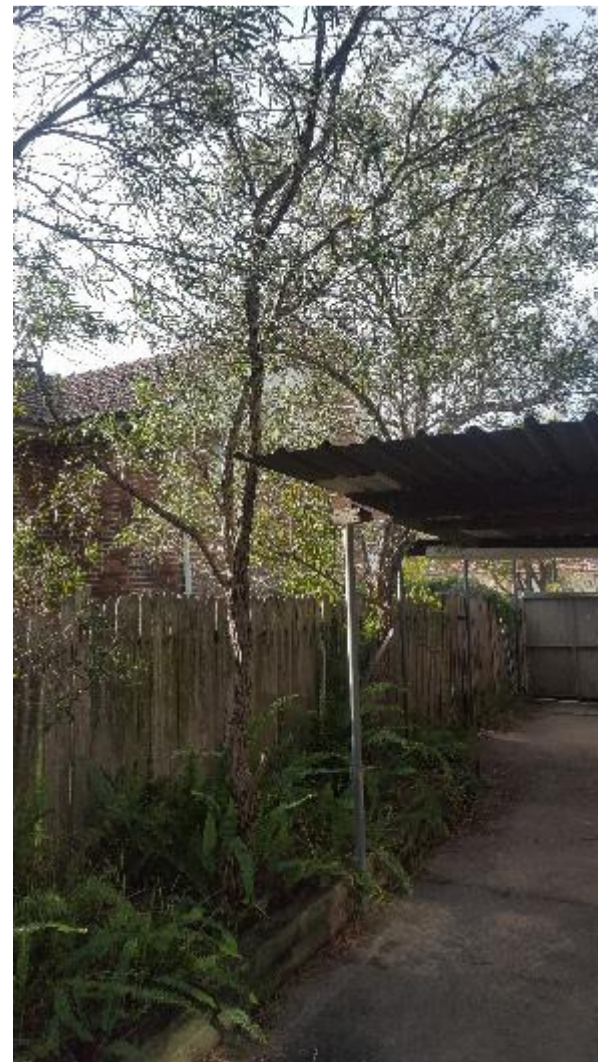
Fig. 10. T9 & T10 both *Callistemon viminalis*

**4.6** Trees **T9, T10, T11 & T20** are all *Callistemon viminalis* or 'Weeping Bottlebrush' (See Figs. 10, 11 & 18). Of these specimens tree **T9, T10 & T11** have been planted in a row along the existing driveway and are relatively small with etiolated habits and not significant in the

landscape. All three trees are centrally placed on the Site and will be entirely engulfed by the new building footprint. By contrast tree **T20** is reasonably large and wide spreading. The specimen has 4 main stems and is good health and condition. The tree will be subject to a Major Encroachment into its TPZ by the building footprint and would need to be removed for the development to proceed as planned (See Appendix. 2).

See Fig. 10.							
T10 <i>Callistemon viminalis</i> Common name 'Weeping Bottlebrush' Age class 30 years See Fig. 10.	5m	8cm 15cm at the base	N 1m E 1m S 1m W 1m	A native tree common to creeks and damp areas on the NSW coast. The tree is growing centrally on the Site. At the time of inspection the tree had an etiolated habit and is not significant in the streetscape.	A3	1.5m Min TPZ	1.5m Min SRZ
T11 <i>Callistemon viminalis</i> Common name 'Weeping Bottlebrush' Age class 30 years See Fig. 11.	4m	7cm 12cm at the base	N 1m E 1m S 1m W 0m	A native tree common to creeks and damp areas on the NSW coast. The tree is growing centrally on the Site. At the time of inspection the tree had an etiolated habit and is not significant in the streetscape. The specimen is under 5m in height and not protected under the TPO.	A3	1.5m Min TPZ	1.5m Min SRZ
T12 <i>Thuja occidentalis</i> Common name 'Italian cypress' Age class 50 years See Fig. 12.	8m	1 x 10cm 1 x 12cm 1 x 15cm 1 x 18cm 40cm at the base	N 1m E 1m S 1m W 1m	An exotic conifer endemic to North America. The tree is located centrally on the Site. At the time of inspection the tree was in reasonable condition 4 main stems and no apparent pathogens. The stems meet in a 'V' at the base.	A2	3.38m	2.25m

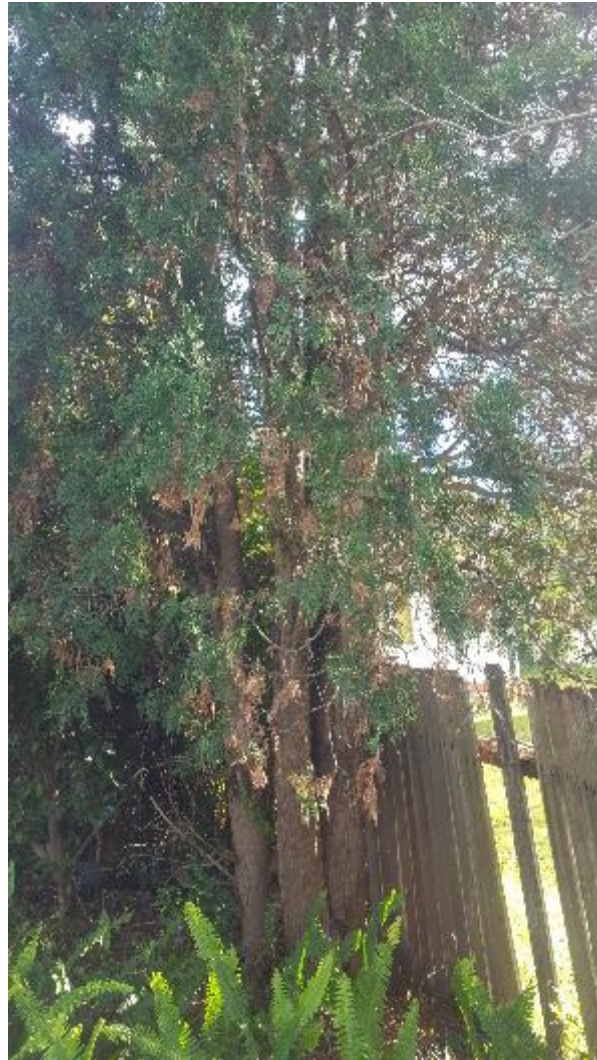
Fig 12. Photo of T12 a *Thuja occidentalis*

- 4.7** Tree **T12** is a *Thuja occidentalis* or 'White Cedar' which is located centrally on the Site (See Fig. 12). The specimen has 4 main stems which adjoin in a 'V' at the base and was in good health and vigour at the time of inspection. The tree will be entirely engulfed by the new building footprint (See Appendix. 2).

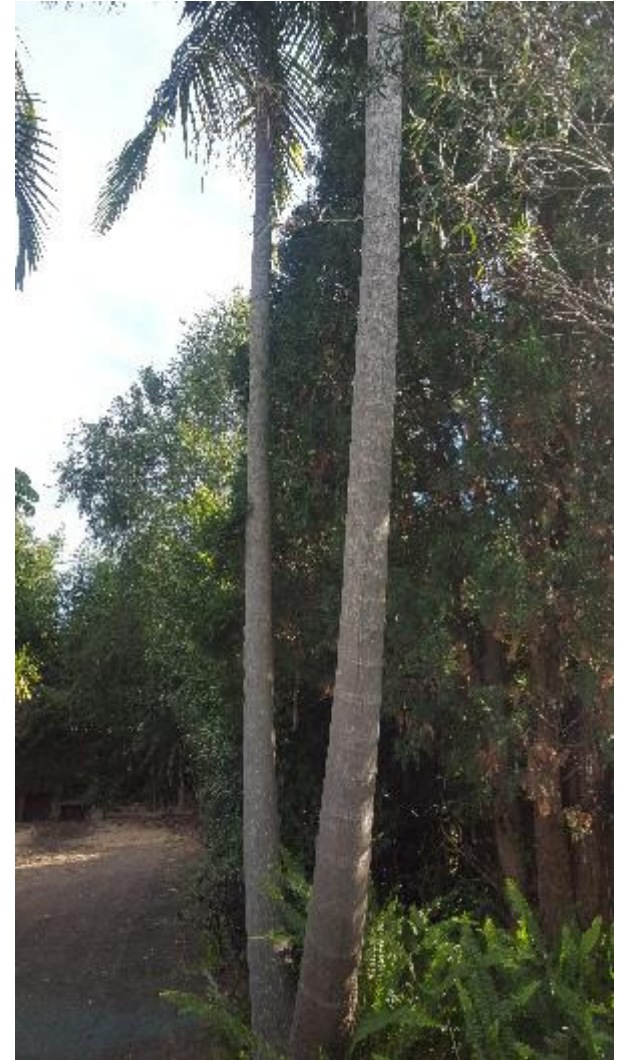
Fig 13. T13 an *Archontophoenix cunninghamiana*

- 4.8** Trees **T13 & T14** are both *Archontophoenix cunninghamiana* or 'Bangalow Palms' which are a native species which have been planted either side of the existing driveway (See Figs. 13 & 14). Both specimen have twin trunks issuing from a common root ball and were on good health and condition at the time of inspection. These trees will be entirely engulfed by the new building footprint (See Appendix. 2). Alternatively they could be transplanted

T13 <i>Archontophoenix cunninghamiana</i> Common name 'Bangalow Palm' Age class 40 years See Fig. 13.	1 x 6m 1 x 8m	1 x 12cm 1 x 15cm 20cm at the base	N 1m E 1m S 1m W 1m	A native palm tree common to littoral rainforest areas on the NSW coast. The tree is growing centrally on the Site to the northern side of the existing driveway. At the time of inspection the tree was in good health and condition and comprised of twostems arising from a common root cluster at ground level. There were no significant pathogens nor signs of mechanical damage.	A2	2.3m	1.5m Min SRZ

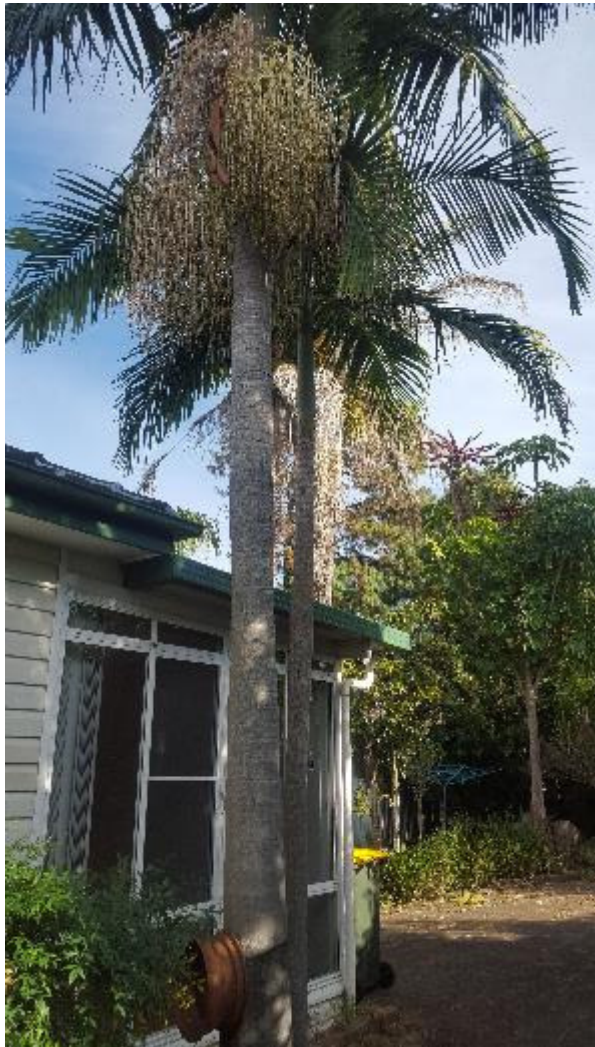
Fig 14. T14 an *Archontophoenix cunninghamiana*

T14 <i>Archontophoenix cunninghamiana</i> Common name 'Bangalow Palm' Age class 40 years See Fig. 14.	1 x 6m 1 x 8m	1 x 12cm 1 x 20cm 25cm at the base	N 1m E 1m S 1m W 1m	A native palm tree common to littoral rainforest areas on the NSW coast. The tree is growing centrally on the Site to the Southern side of the existing driveway. At the time of inspection the tree was in good health and condition and comprised of two stems arising from a common root cluster at ground level. There were no significant pathogens nor signs of mechanical damage.	A2	2.8m	1.5m Min SRZ
T15 <i>Pittosporum undulatum</i> Common name 'Native Daphne' Age class 40 years See Fig. 15.	5m	10cm 15cm at the base	N 3m E 2m S 1m W 3m	An endemic tree common to the Parramatta LGA. The tree is growing on the Southern side of the Site near the border. At the time of inspection the tree was in good health and vigour with approx. 30% dead and sparse foliage in the canopy. The species is known to have 'weedy' properties.	A4	1.5m Min TPZ	1.5m Min SRZ

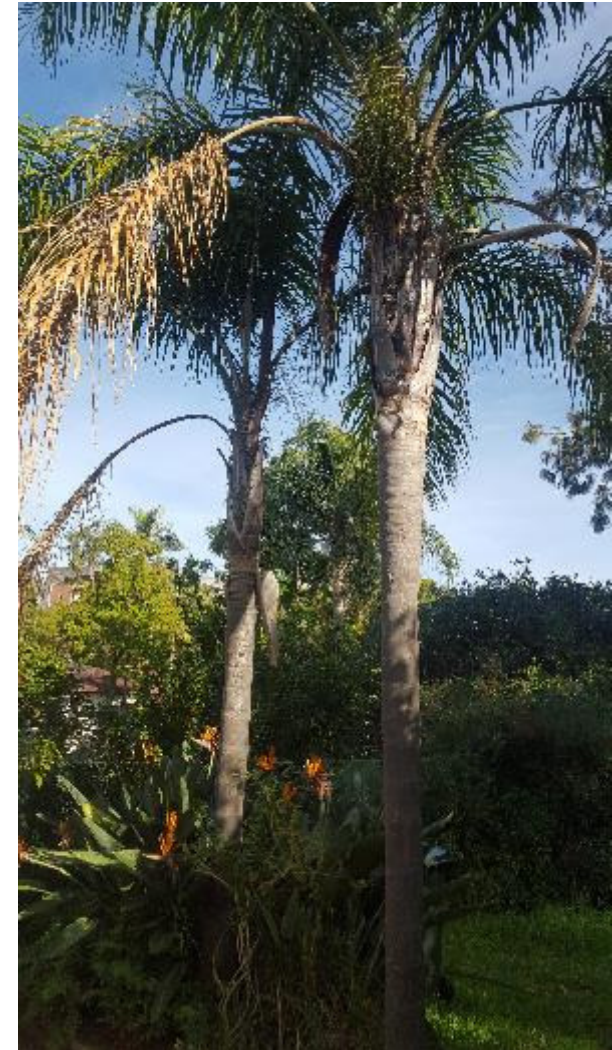
Fig 16. T16 & T17 *Archontophoenix cunninghamiana*

- 4.9** Trees **T16 & T17** are both *Syagrus roman zoffianum* or 'Cocos Palms' which have been planted in the Northwest portion of the Site (See Fig. 16). These are listed as exempt species in the TPO and can be removed without approval. Both trees will be engulfed by the new building footprint (See Appendix 2).

T16 <i>Syagrus romanzoffianum</i> Common name 'Cocos Palm' Age class 40 years See Fig. 16.	6m	N/A	N 1m E 1m S 1m W 1m	An exotic palm tree endemic to South America. The tree is growing to the Southern end the Site. At the time of inspection the tree was in good health and condition however the species is listed in part C of the TPO as exempt from protection in the Parramatta LGA.	B2	N/A	N/A
T17 <i>Syagrus romanzoffianum</i> Common name 'Cocos Palm' Age class 40 years See Fig. 16.	7m	N/A	N 1m E 1m S 1m W 1m	An exotic palm tree endemic to South America. The tree is growing to the Southern end the Site. At the time of inspection the tree was in good health and condition however the species is listed in part C of the TPO as exempt from protection in the Parramatta LGA.	B2	N/A	N/A
T18 <i>Wodyetia bifurcata</i> Common name 'Foxtail Palm' Age class 40 years See Fig. 17.	8m	18cm 24cm at the base	N 1m E 1m S 1m W 1m	Anative palm tree endemic to Nth Eastern Queensland. The tree is growing centrally on the Site. At the time of inspection the tree was in good health and condition with no significant pathogens nor signs of mechanical damage.	A2	2.16m	1.8m

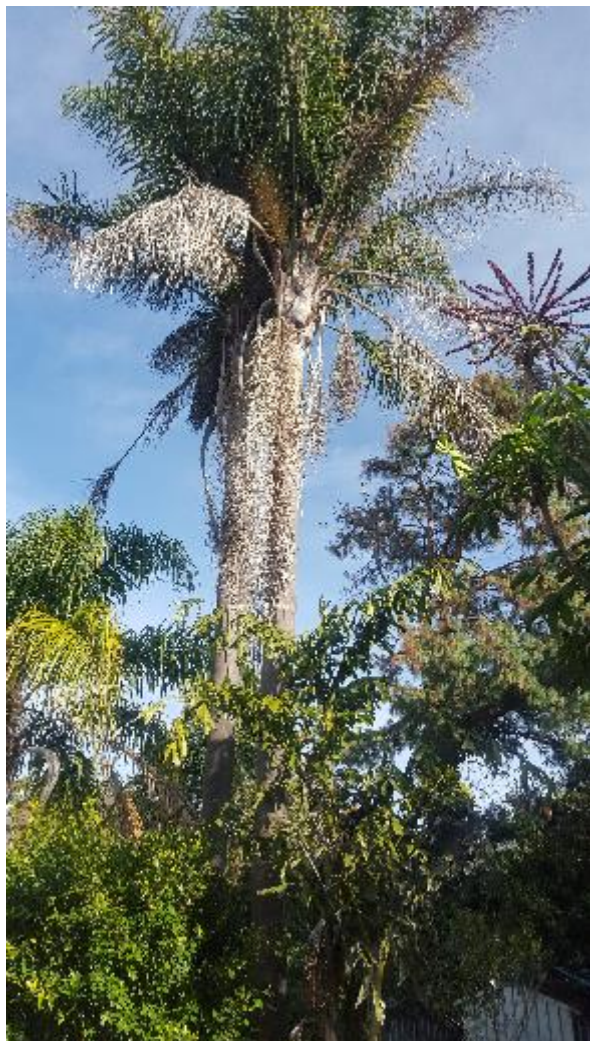
Fig 17. T18 & T19 both *Wodyetia bifurcata*

- 4.10** Trees **T18 & T19** are both *Wodyetia bifurcata* or 'Foxtail Palms' which have been planted in the rear of the existing house toward the Northern portion of the Site and were in good health and vigour (See Fig. 17). Both specimens will be engulfed by the new building footprint and would need to be removed for the building to proceed as planned (See Appendix 2). Alternatively they could be transplanted.

T19 <i>Wodyetia bifurcata</i> Common name 'Foxtail Palm' Age class 40 years See Fig. 17.	8m	20cm 25cm at the base	N 1m E 1m S 1m W 1m	A native palm tree endemic to Nth Eastern Queensland. The tree is growing centrally on the Site. At the time of inspection the tree was in good health and condition with no significant pathogens nor signs of mechanical damage.	A2	2.4m	1.85m
T20 <i>Callistemon viminalis</i> Common name 'Weeping Bottlebrush' Age class 40 years See Fig. 18.	7m	1 x 20cm 1 x 22cm 1 x 23cm 1 x 25cm 49cm at the base	N 2m E 3m S 3m W 5m	A native tree common to East coast NSW. The tree has been planted centrally on the site . At the time of inspection the tree was in good health and vigour with no significant pathogens. The specimen comprises of 4 main stems meeting in a 'V' shape junction at approx. 40cm from the ground.	A2	5.4m	2.45m
T21 <i>Pinus patula</i> Common name 'Mexican Weeping Pine' Age class 50 years See Fig. 19.	18m	48cm 60cm at the base	N 7m E 4m S 2m W 3m	An exotic pine tree common to Central America. The tree is growing in the rear of the property to the to the West of the Site. At the time of inspection the tree was in poor health and vigour with significant dieback on the Southeastern side possibly due to hail damage. There were no significant pathogens or defects noted.	A4	5.76m	2.67m

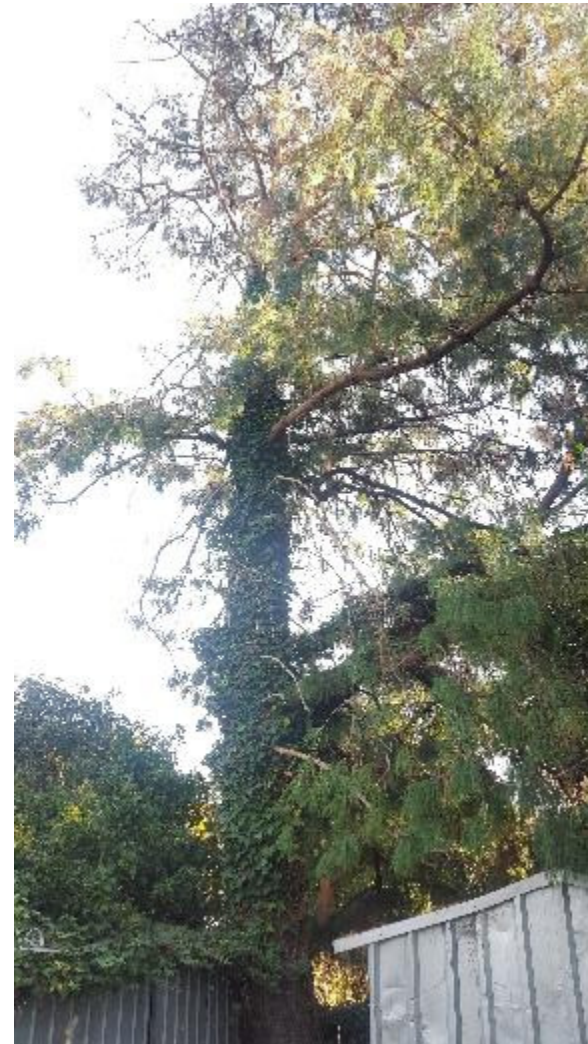
Fig 19. Photo of T21 a *Pinus patula*

- 4.11** Tree **T21** is a fairly large *Pinus patula* or 'Mexican Weeping Pine' and is the largest specimen on the Site. The tree has been planted in the Northwest corner of the Site and was in poor condition at the time of inspection (See Fig. 19). There is a strong bias in the canopy to the North and many dead branches on the tree's Southern side. Upon review of the aerial footage of the Site it is noted that there was a large tree, possibly a Eucalyptus since removed (See Fig 1), which would have been suppressing growth in this specimen's Southern portion. The tree won't be directly affected by the new building footprint but is in poor health and condition.

**5.5** Tree **21** is a large tree in poor condition. It is considered that it should be removed due to poor health and condition rather than impact from the development.

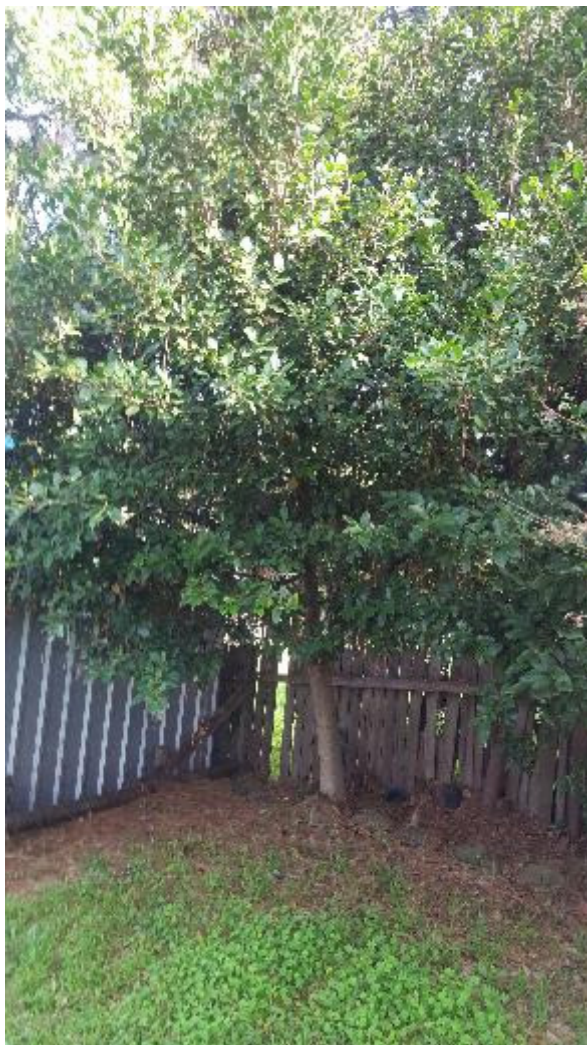
Fig 20. Photo of T22 a *Ficus macrocarpa*

- 4.12** Tree **T22** is a small *Ficus microcarpa* or 'Hills Fig' which is at present under 5m in height and not protected under the TPO (See Fig. 20). The species has the potential to attain a height of 35m and a width of 35 to 40m (Ref. <https://selectree.calpoly.edu/tree-detail/609>).

Therefore the species is not recommended for a small contained area beside a fence line.

T22 <i>Ficus microcarpa</i> Common name 'Hills Fig' Age class 20 years See Fig. 20.	4m	10cm 15cm at the base	N 3m E 3m S 2m W 0m	A fig tree endemic to Northerntropical Australia and Asia. The tree is less than 5m in height and not protected under the TPO	A2	N/A	N/A
T23 <i>Ligustrum sinense</i> Common name 'Small leaved privet' Age class 30 years No Fig available.	5m	N/A	N/A	The tree is a declared noxious weed in the Parramatta LGA	A2	N/A	N/A

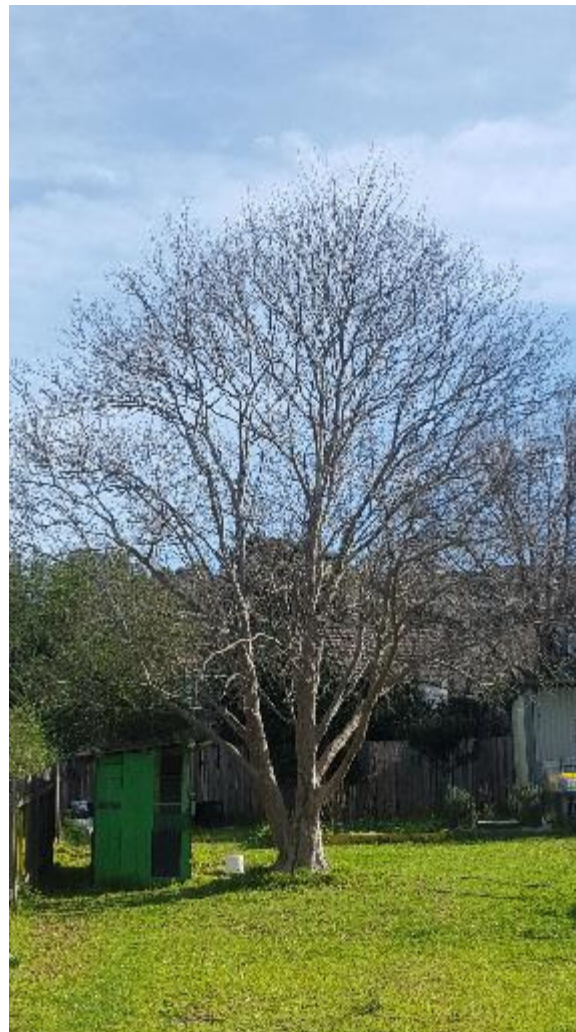
Fig 21. Photo of T24 a deciduous tree well away from the Site

**4.14** Tree **T24** is an exotic deciduous tree growing in the neighbouring land to the East of the Site (see Fig. 21). The specimen is well away from the building footprint and associated construction works and will not be encroached by Site works (See Appendix 2).

**5.7** Tree **24** is a medium sized deciduous tree which is greater than 5m from the construction site and will not be affected by the development.

T24 <i>Deciduous</i> Age class 50 years See Fig. 21.	8m	1 x 30cm 1 x 33cm 51cm at the base	N 4m E 4m S 4m W 4m	An exotic deciduous specimen growing in the neighbouring land to the North that is obviously well away from the building Site. the tree has co dominant stems meeting in a 'V' shaped stem junction at 0.4m from the ground. At the time of inspection there were no significant pathogens or signs of mechanical damage.	A1	5.35m	2.49m
--	----	---	------------------------------	---	----	-------	-------
