**22 CLEELAND ROAD
SOUTH OAKLEIGH VIC 3167
AUSTRALIA**

Ref: 208-20-DE-REV-00

1 December 2020

**12-14 Birnie Avenue, Lidcombe
Review of Windtech Pedestrian Wind Environment Study
Windtech Document Number: WE430-01F03(REV0)-WE Report**

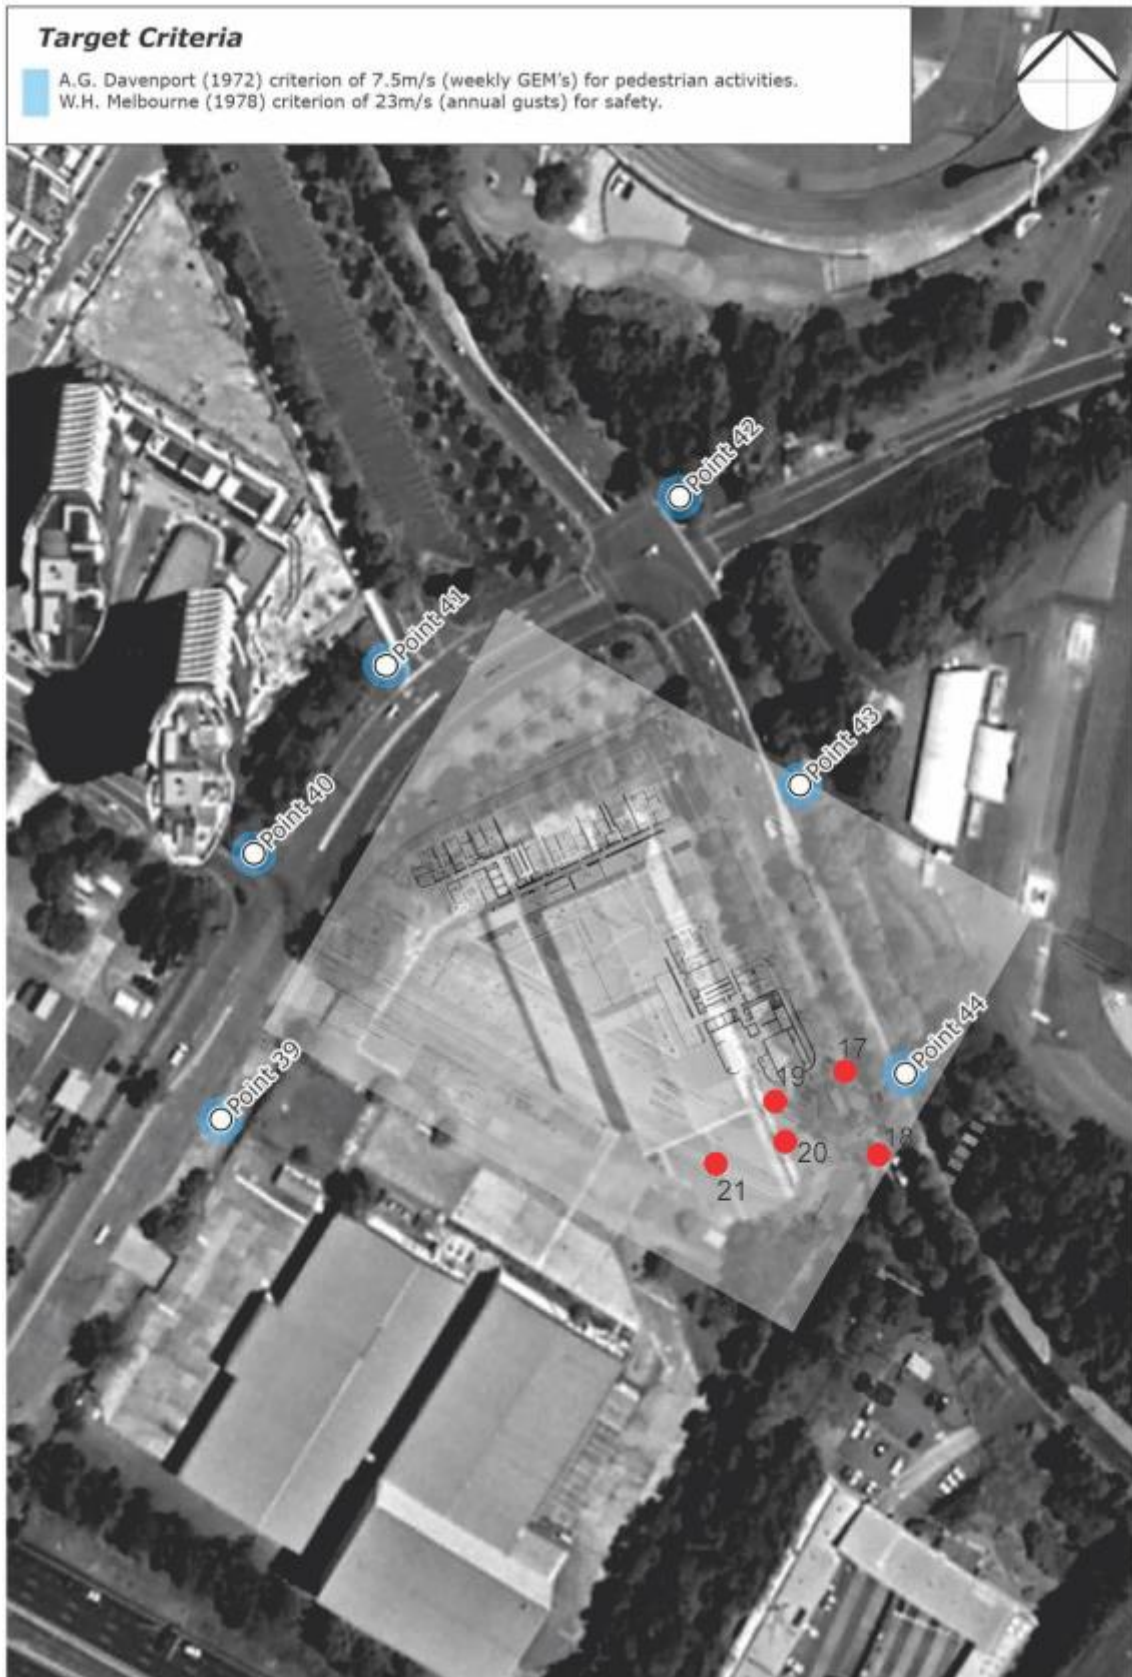
- Windtech have shown for the Existing Configuration a number of locations exceed the safety criterion and this is unexpected for the Industrial Warehouse, particularly at the lower height south end. Figure 1 presents Figure 6b from the Windtech report with the Study Locations at the south end of the building from Figure 6a of the Windtech report. The positions of the Study Locations have been determined by comparing Figures 6a and 6b, since Windtech overlayed the ground plan in Figure 6b. Windtech determined for the Existing Configuration that Study Locations 19, 20, and 21 have wind conditions that exceed the safety criterion. Based on the locations in Figure 1, Study Location 21 is on the roof and Study Locations 19 and 20 are on the east side of the existing building. Windtech need to provide an explanation for the high wind speeds measured at Study Locations 19 and 20 on the east side of the low-rise section of the existing building away from the influence of tall buildings.

Furthermore, these locations are not near the building corner where wind acceleration would be expected.

Figure 1: Test locations from Windtech Report Figure 6a located on Windtech Report Figure 6b
