# ARBORICULTURAL IMPACT ASSESSMENT AND TREE MANAGEMENT PLAN

PROPOSED DEVELOPMENT APPLICATION

THE HUB @ LIDCOMBE

2 BACHELL AVENUE LIDCOMBE, NSW

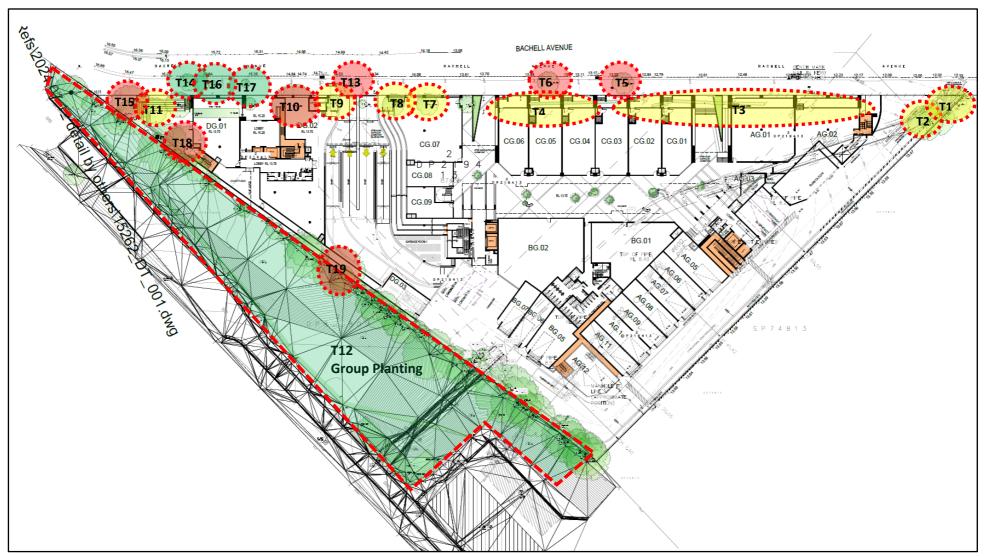
Figure 4 Shows the trees in RED to be removed based on the plans provided. Trees in Yellow are TPO Exempt species and may be removed.

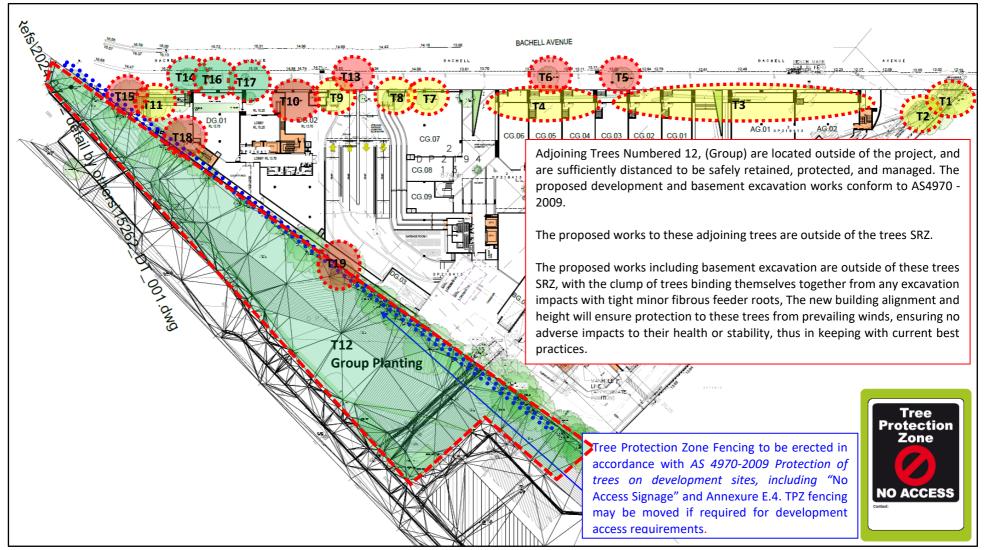
Figure 5 Shows adjoining Trees 12 (group planting) within the NSW Rail Corridor sufficiently distance to be unimpacted.

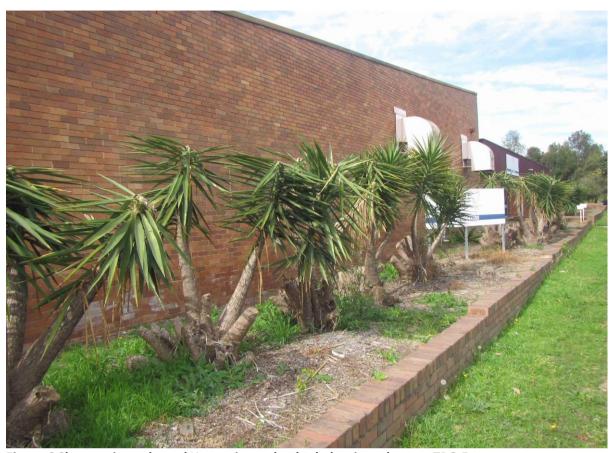
Figure 6 Shows minor planted Yuccas in garden bed plantings that are TPO Exempt.

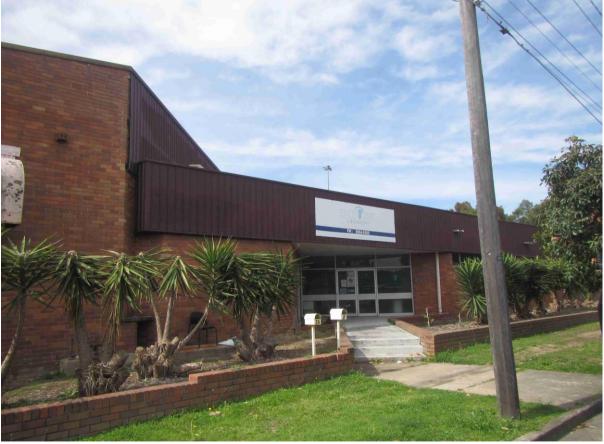
Figure 7 Shows minor landscape plantings to be removed.

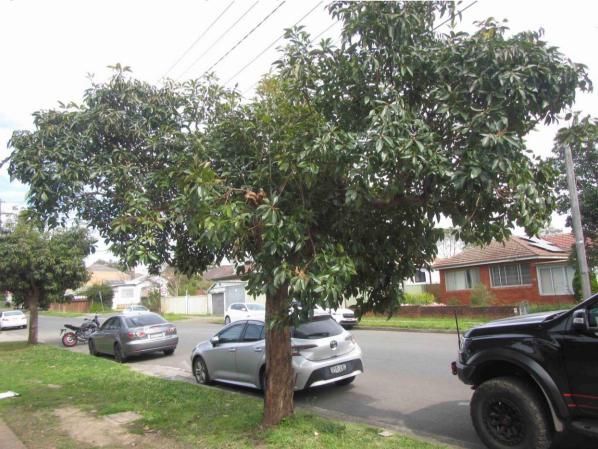
Figure 9 Shows Council Street Trees 5 and 6 that are located underneath overhead power lines and recommended to be removed and replaced with an appropriate new street planting.

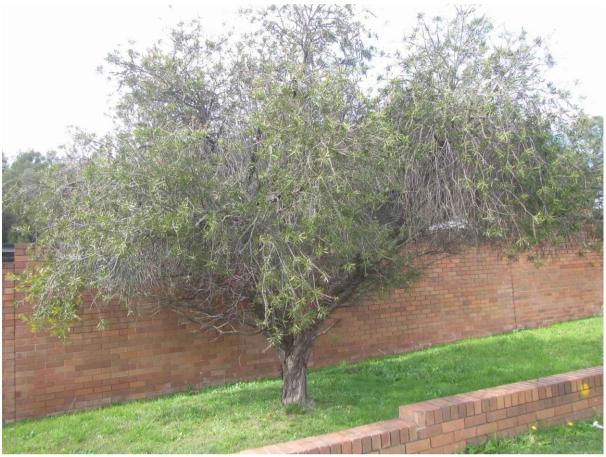
Figure 10 Shows Tree 7 being a minor TPO Exempt shrub to be removed.

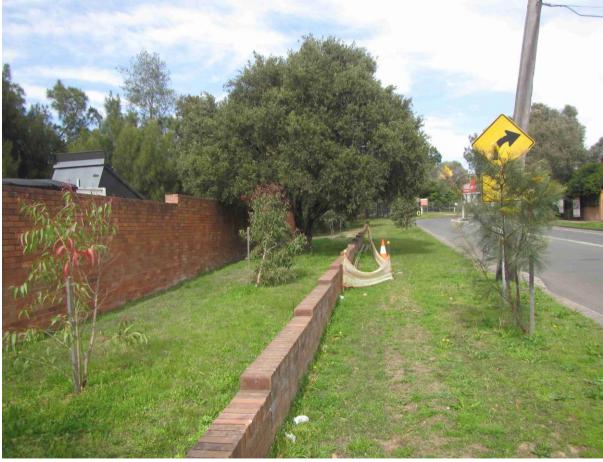
Figure 11 Shows minor shrubs and trees to be removed.

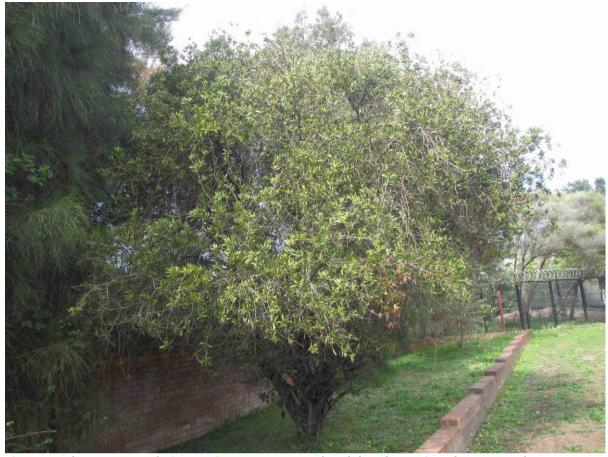
Figure 12 Shows Tree 11 being a minor TPO Exempt bottlebrush tree is to be removed.

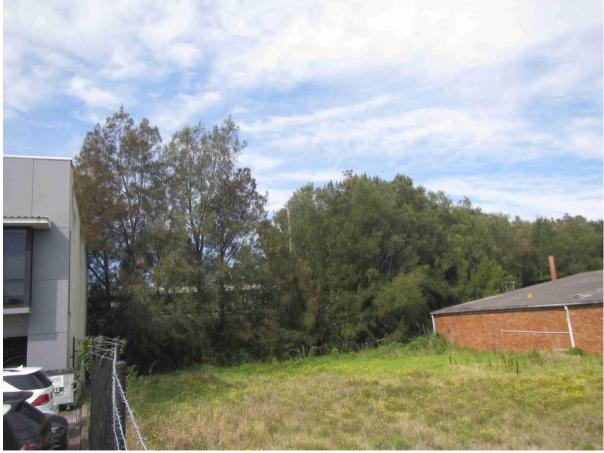
Figure 13 Shows adjoining trees located in the NSW State Rail grounds that are sufficiently distanced with works outside of their SRZ.

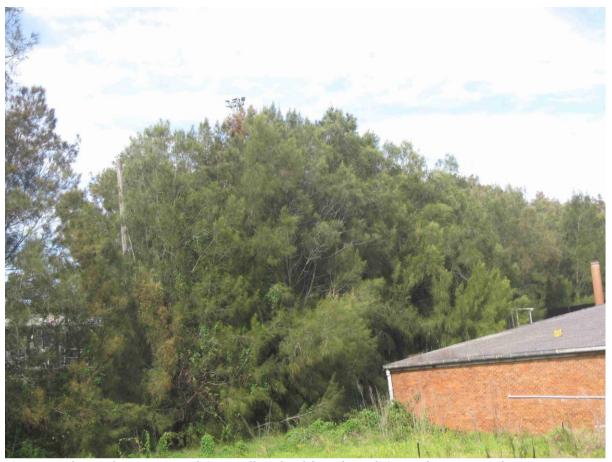
Figure 14 Shows the Swamp Oak in excellent health and condition to be protected.

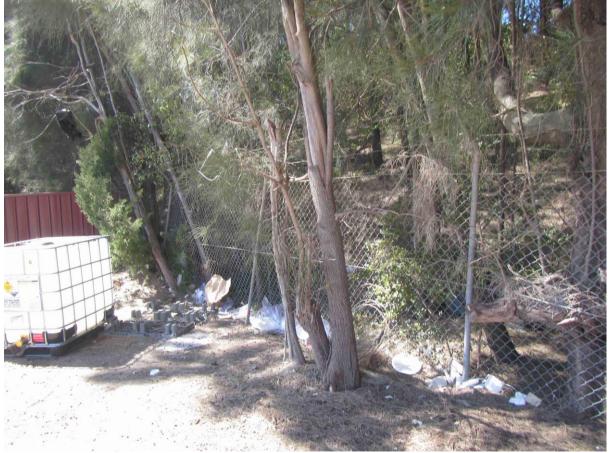
Figure 15 Shows self-seeded Tree 18 that is required to be removed.

Swamp Oaks Trees Numbered 15 18 and 19, are required to be removed based on their location within the proposed building envelope, site excavations, site modifications and scope of works. Trees Numbered 15 and 18 are located within the subject site and not contained in the adjoining Transport Asset Holding Entity adjoining (TAHE) and their removal will not require access into TAHE land. It is anticipated these trees will be replaced in the landscape master plan upon completion.

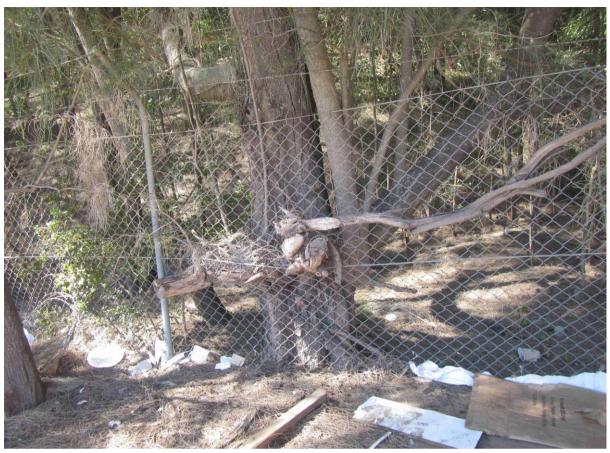
Figure 16 Shows Tree 19 that is required to be removed based on tabled excavation works.

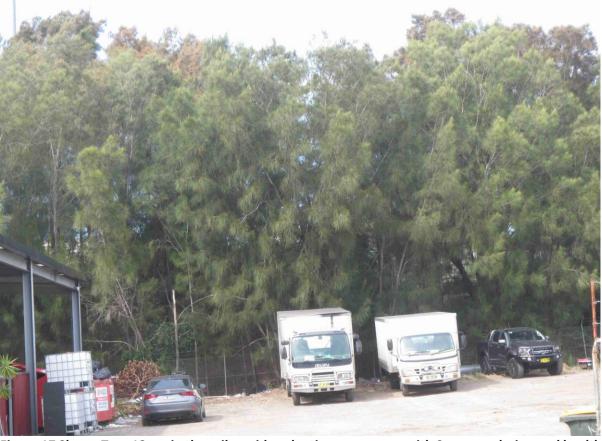
Figure 17 Shows Tree 12 again the rail corridor planting overgrown with Swamp oaks in good health to be unimpacted.

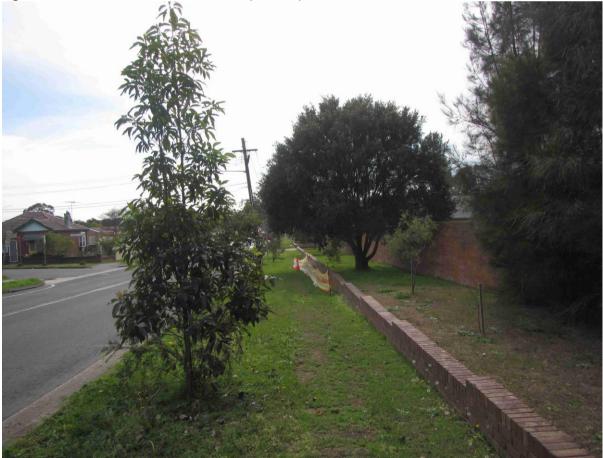
Figure 19 Shows Tree 14, being a minor spotted Gum that may be removed and replaced.

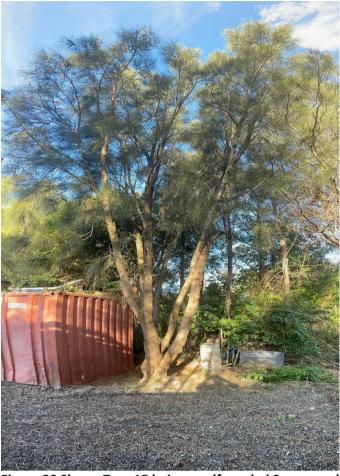
Figure 20 Shows Tree 15 being a self-seeded Swamp oak within the site to be removed.

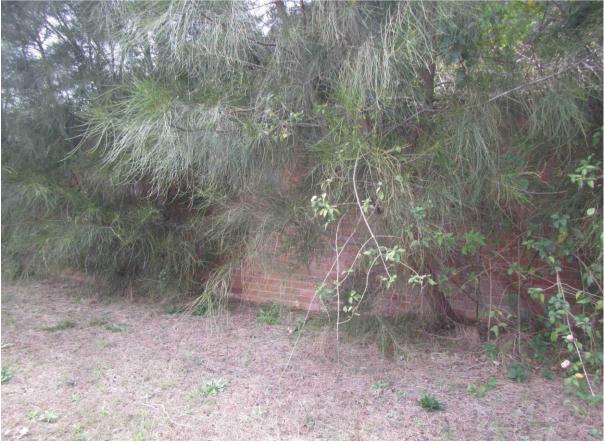
Figure 21 Shows self-seeded Swamp oaks growing along boundary walls to be removed.
