# Construction Impact Assessment and Management Plan

# The Scots College, Macintyre House and Courts.

# Bellevue Hill, Sydney.

Dated: October, 2019.

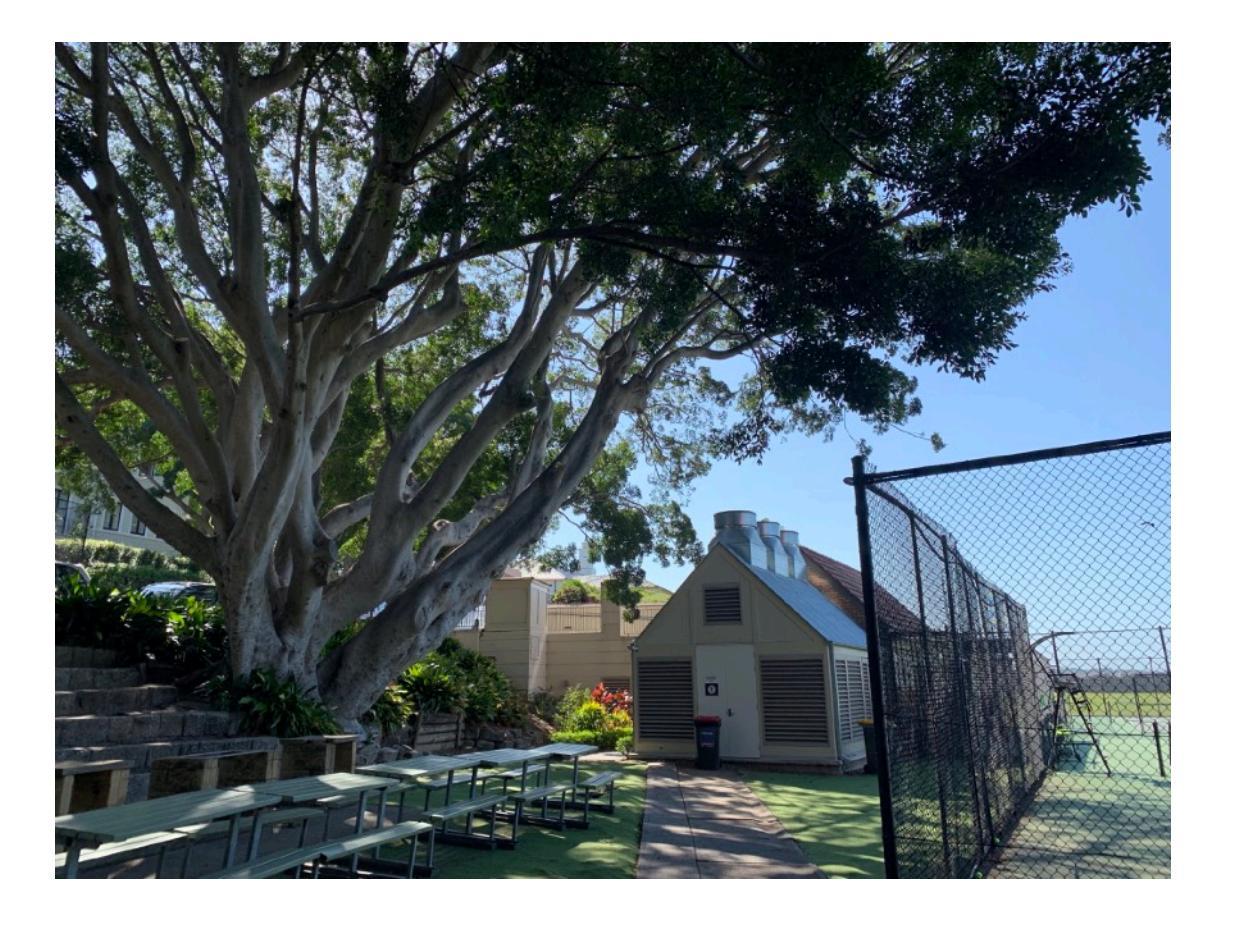
7.2 As previously noted, Tree 1 has developed with a co dominant and included leader. The sub dominant leader is a partially suppressed, horizontal limb that is over 90cm in diameter and sits over a High use Target Zone. The tree is a fully mature example of this species that will soon become over mature and enter into a cycle of decline. This will lead to less cambium flows and a more brittle wood structure. The suppressed nature of this sub dominant leader and its poor basal structure will increase this limbs probability of failure.

7.3 Management options to address this limb are limited given the weights and mass involved, with slings and D shackles rated to less than 3Tonne. Immovable infrastructure and access paths similarly affect Target ratings.

Figure 1 Shows the sub dominant leader of Tree 1.

7.5 Although not required to allow the proposed development to occur it will be recommended that relatively significant pruning works occur to both Trees 1 and 2. It will be recommended that the lower sub dominant leader be removed for Tree 1 and the lower eastern limbs from Tree 2 be removed. The removal of the large diameter leader from Tree 1 will eliminate the

significant hazards associated with its retention and ensure equilibrium between root mass and canopy following construction incursion.

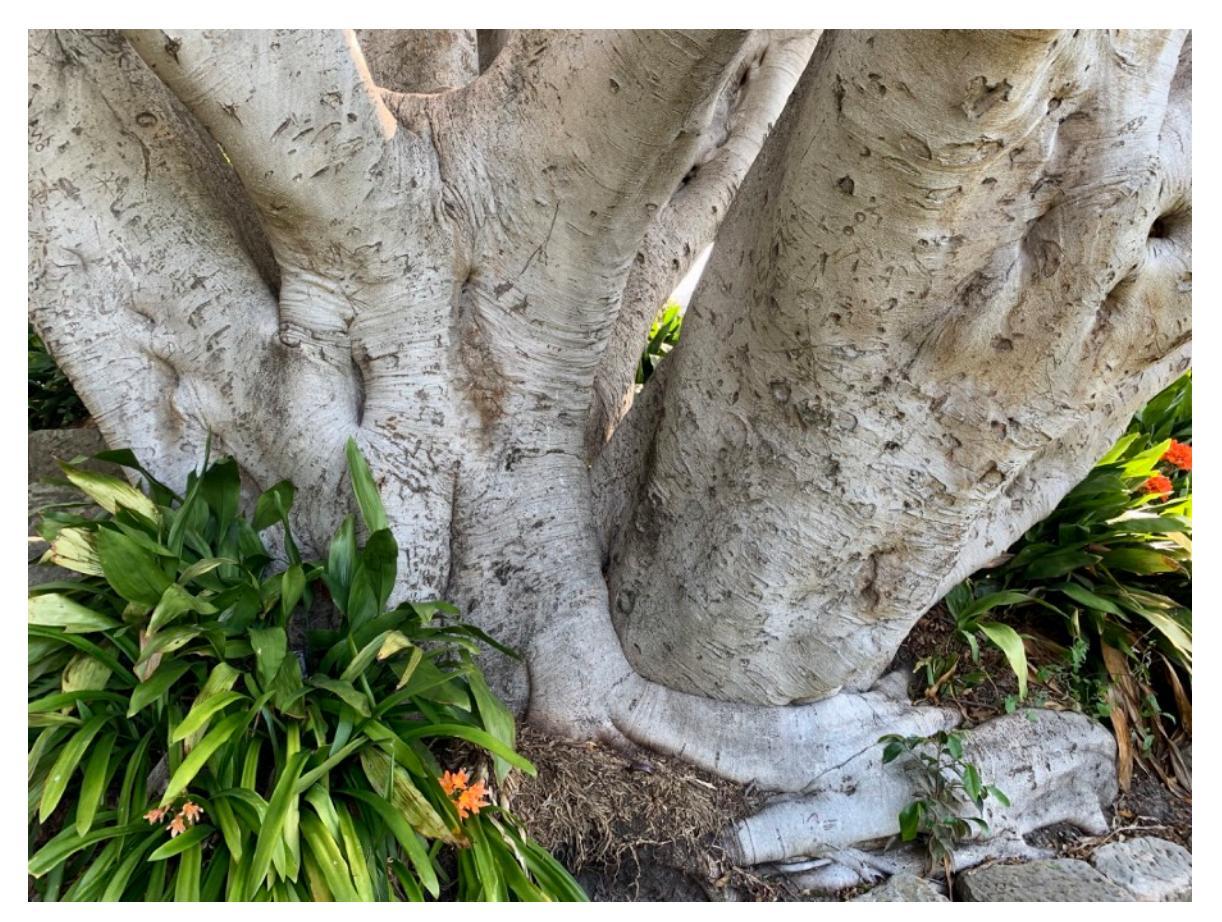
Figure 2 Shows the incursion and girdling detailed.

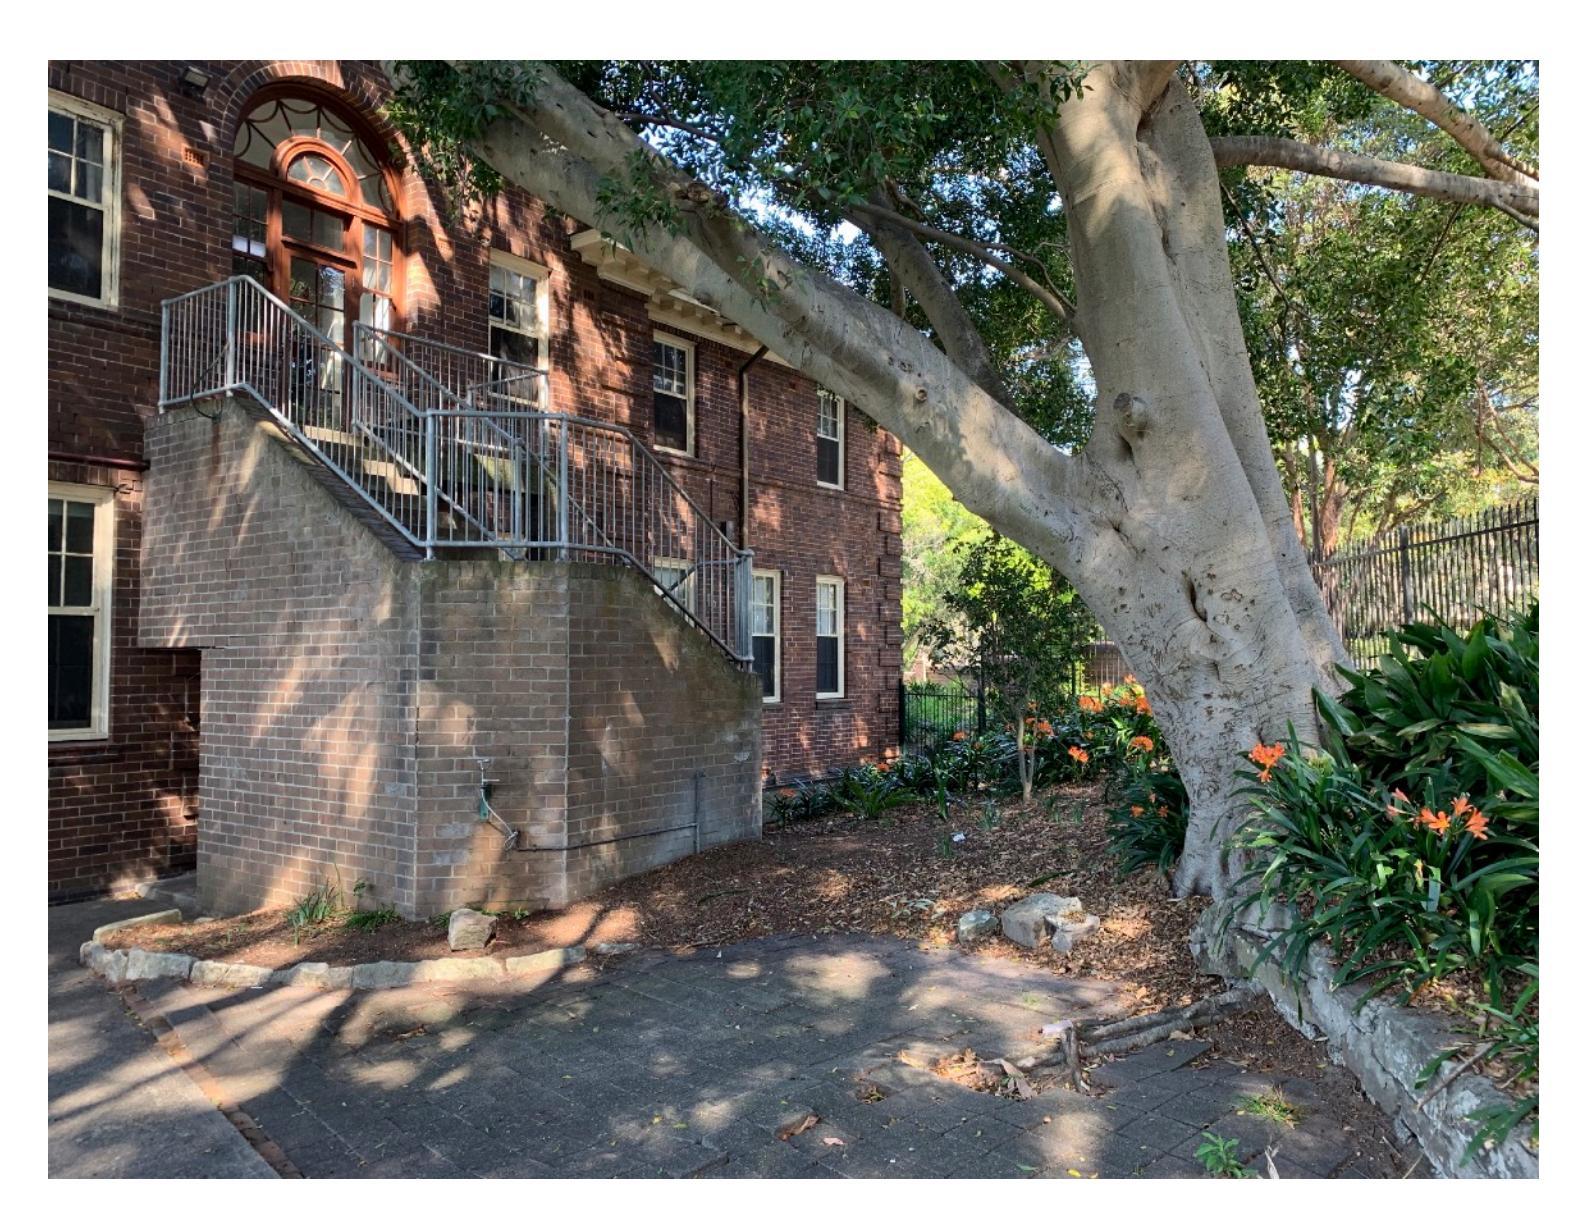
7.5 The suppressed development of Tree 2 has resulted in the formation of a canopy that extends predominantly to the east and over the historic Macintyre House. This is affecting building lines and solar access and would be remedied with the removal of the lower canopy limbs as detailed. This will again also ensure equilibrium with the tree's root system following excavation.

Figure 3 Shows the lower canopy suppressed development of Tree 2 and the impact on Macintyre House.

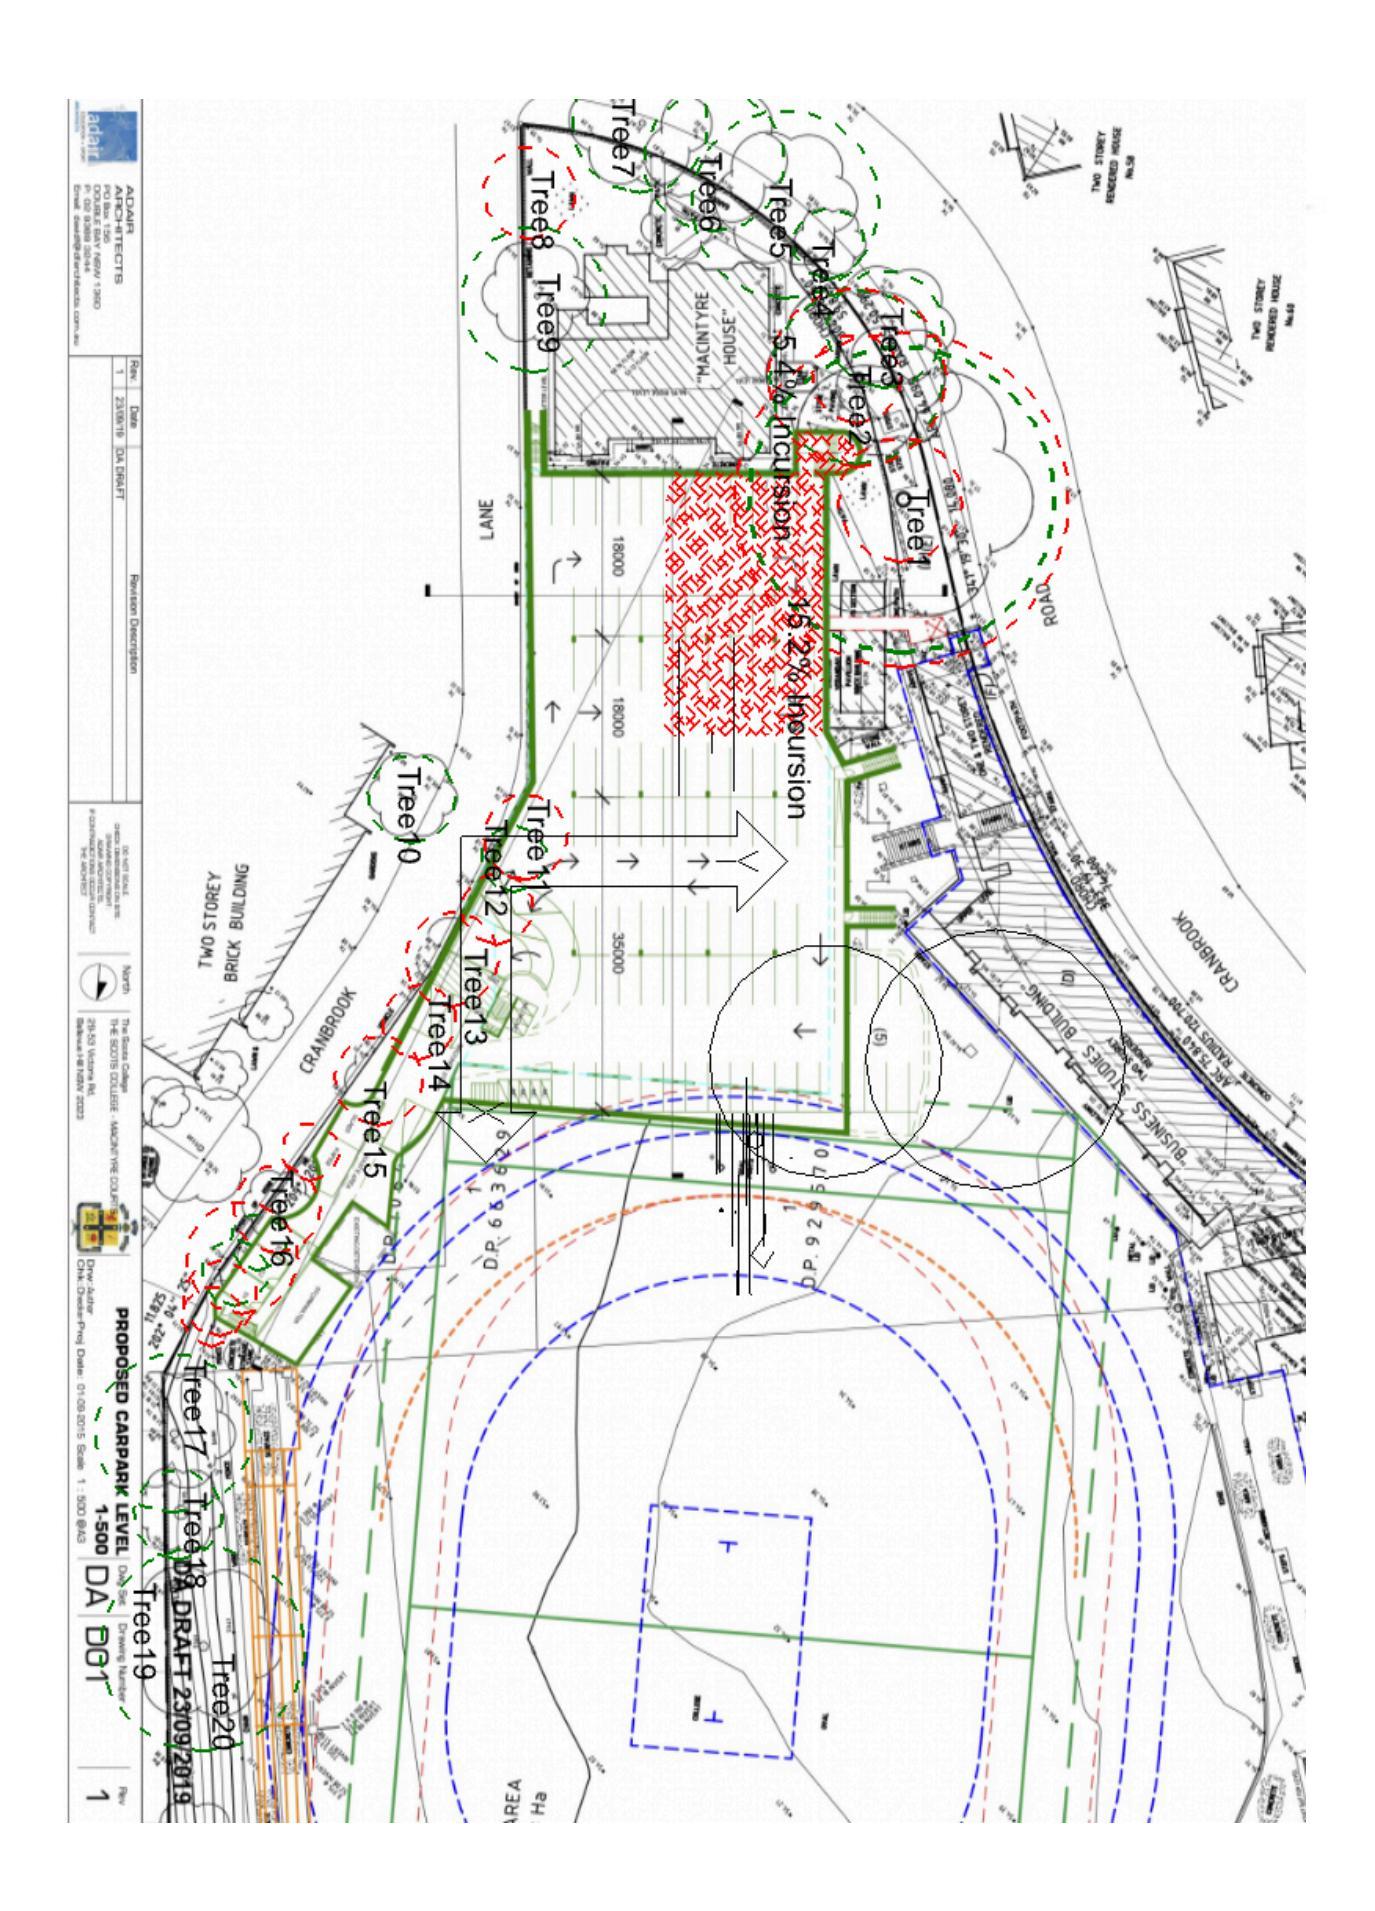
6.14 Tree 11 is a juvenile to semi mature *Agonis flexuosa*, or Western Australian Peppermint located within the southern edge of the garden bed that forms part of the College's Cranbrook Lane boundary. This tree has grown to a height of less than 8m and is supported on three (3) leaders from ground level. These are all partially included, affecting structural integrity and arboricultural value. Moderate Value. Remove.

6.15 Tree 12 is a juvenile *Lophostemon confertus,* or Brush Box, again located within the southern portion of the above mentioned planter. This tree has grown to a height of under 10m and is supported on a co dominant trunk from just above ground level. Part of more recent planting works. Moderate Value. Remove.

Figure 4 Shows Trees 11 and 12 required for removal.

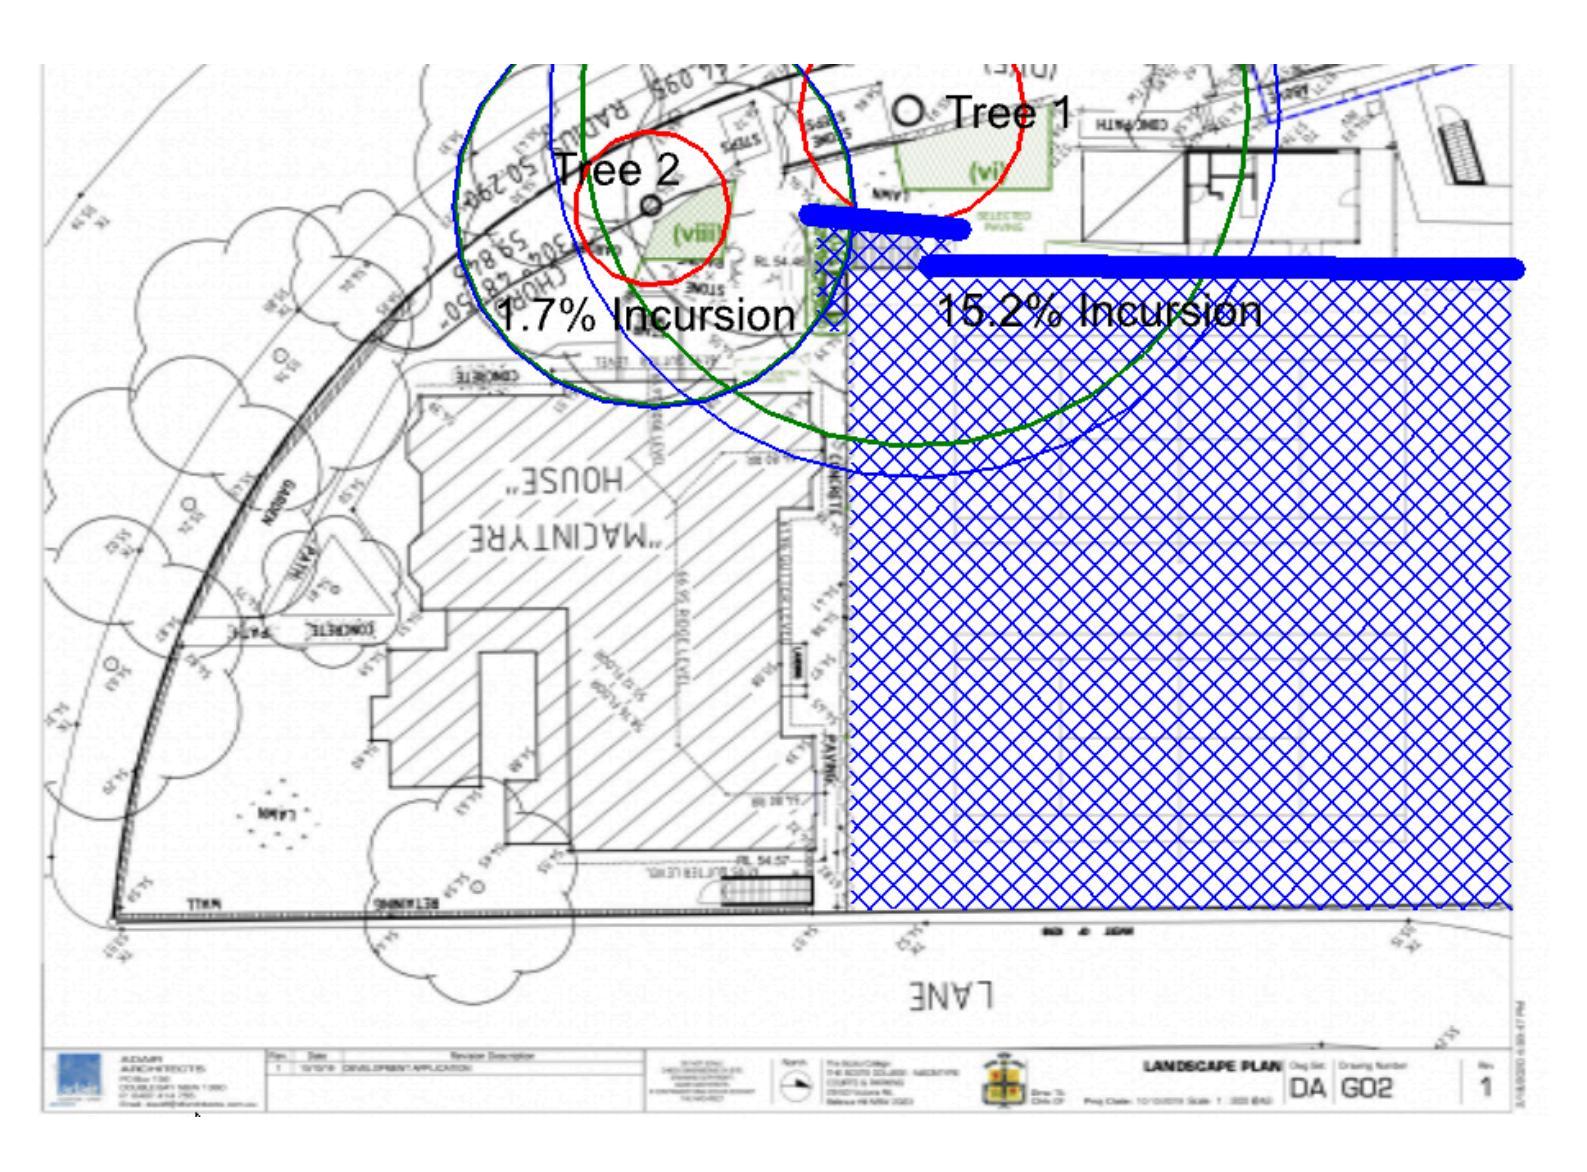
7.2 The proposed works required to allow for the construction of the stairway and for the excavation of the site's western edge will affect approximately 15.2% of Tree 1 theoretical TPZ and 5.4% of that of Tree 2. Australian Standards for the Protection of Trees on Development Sites references incursions of greater than 10% as significant. This will require consideration throughout the construction process.

7.4 As noted and detailed, the proposed works will require excavation within the theoretical TPZ of both Trees 1 and 2. No incursion into either tree's Structural Root Zone (SRZ) and the structural integrity of both trees will be preserved. These incursion will however affect these tree's ability to absorb both soil moisture and nutrients from the surrounding soil profile to varying degrees. The species is well know for its vigorous nature and ability to adapt to a broad range of environmental conditions as well as the impacts of construction. These works are well within their range of tolerance and both trees will be able of compartmentalise the smaller diameter root pruning required.

Figure 5 Shows the theoretical impacts of the construction on both Trees 1 and 2.

9.5 Incursions within theoretical TPZ areas are documented in **Figure 5.** These show significantly greater incursions than will be affecting these trees. Site topography and previous construction has affected the abiotic spread and development of both of these tree's root systems.

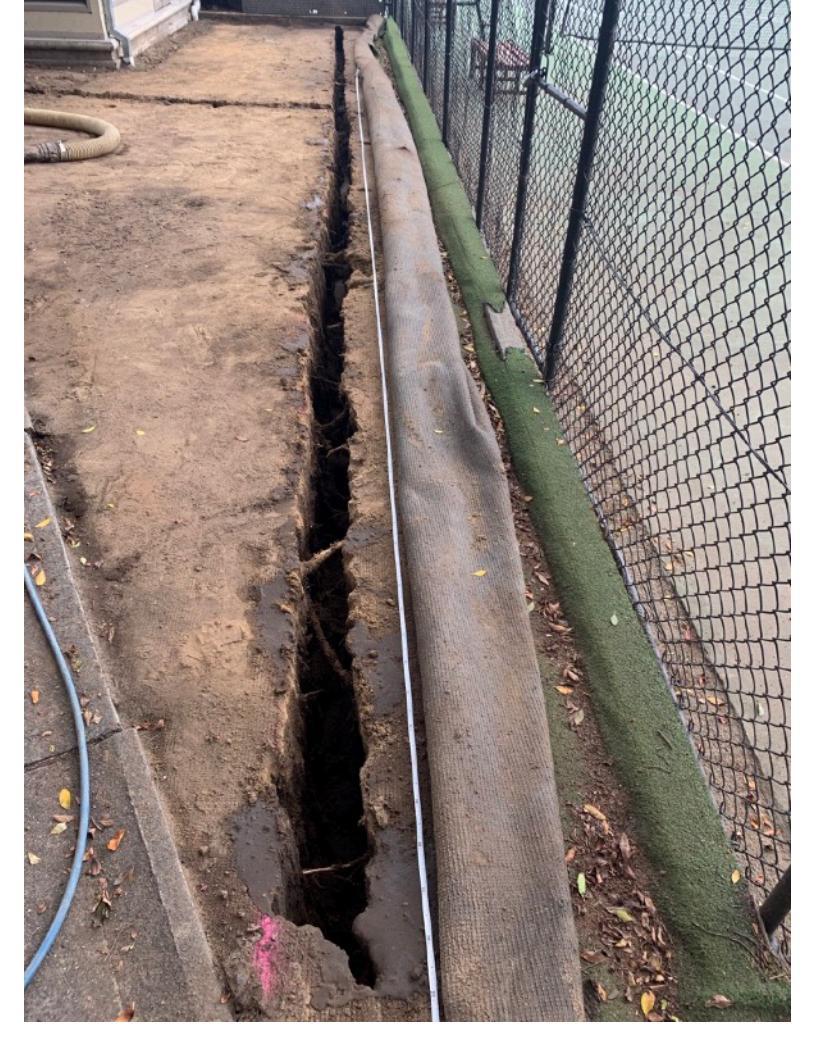
Figure 7 Shows the longest trench and the limited volume f roots uncovered.

9.3 As correctly predicted the root spread and development has been significantly affected by existing infrastructure. The longest trench adjacent to the tennis court had fewer than eight (8) larger diameter woody roots. The central concrete path appears to have involved the excavation and removal of some roots. This may have been done as part of infrastructure works between Macintyre House and the rest of the College.

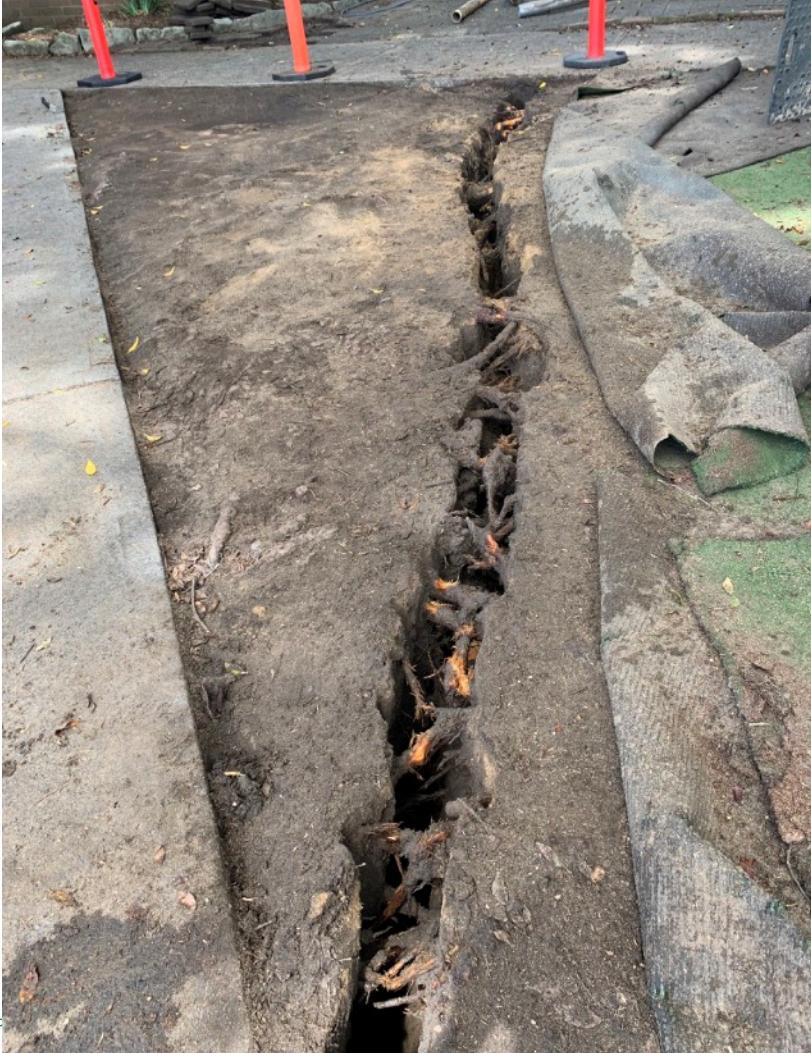
**Figure 8** Shows the roots exposed in the shorter trench. All under 80mm in diameter and in the top 300mm of the soil profile.

9.4 The second shorter trench was excavated approximately 8m from the base of Tree 1. This is outside the tree's SRZ of both Trees 1 and 2. This will not affect the structural integrity of either tree. Multiple roots of less than 40 - 80mm in diameter were located in this trench and will be required for removal to allow the construction to occur.
