# **Arboricultural Impact Assessment**

**Christ Church Bexley**

**Prepared by Alex Austin  
For  
Sustainable Development Group Ltd  
June 2022  
V5**

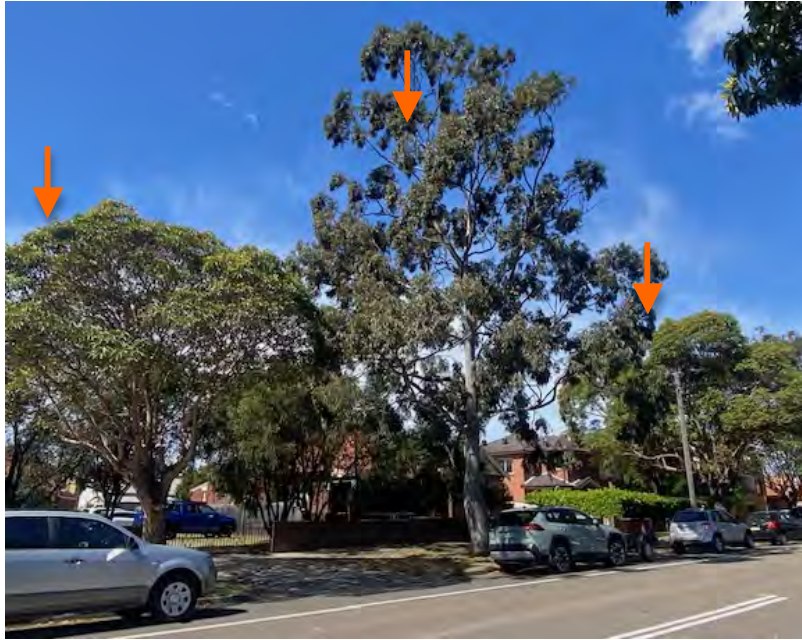
**Figure 5:** Tree 24, 25 & 26 (Left to Right) (Source: Austin 21/09/2021)

Trees 24, 25 & 26 are all considered to be A retention value trees with High landscape significance. The trees are located on the Dunmore Street verge. The trees are in good condition and have a life expectancy of 25+ years. Considerable efforts should be made to incorporate these trees within the project.

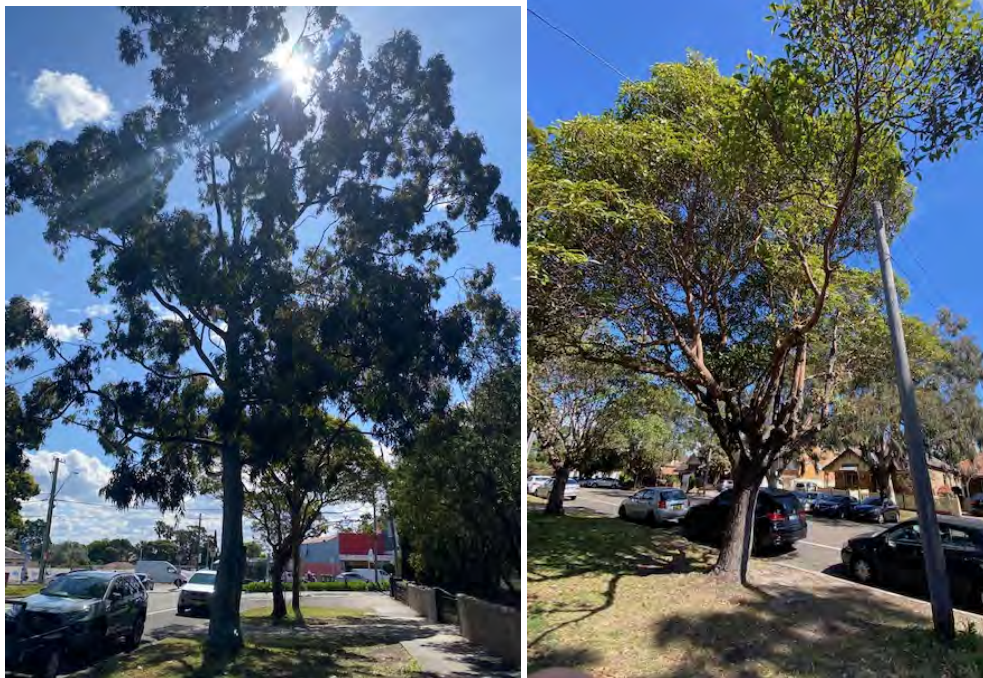
**Figures 6 & 7:** Trees 24 & 25 (Left) and Tree 26 can be observed in the wide verge (Right). (Source: Austin 21/09/2021)

Trees numbered 24 & 25 have major encroachments into the TPZs for the driveway widening. These trees require sensitive demolition, excavation and construction methods combined with tree protection measures and Project Arborist Supervision.

Trees 24 & 25 require trunk wrapping to a height of 2m, in line with AS 4970:2007.

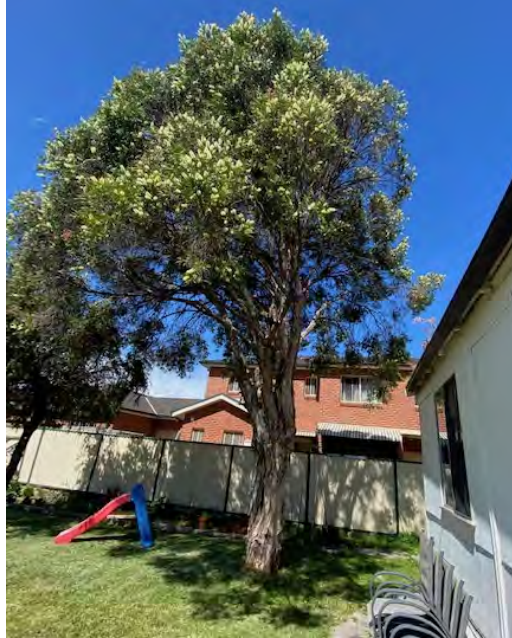
**Figure 8:** Tree 4 in the landscape. (Source: Austin 21/09/2021)

Tree 4 *Melaleuca salicina* (Willow bottlebrush) is located in the rear of 1A Dunmore Street. The tree has medium landscape significance. Observations included; Co dominant stems, included bark, pruned south side for building clearance. Reasonable attempts should be made to retain this tree through the project.

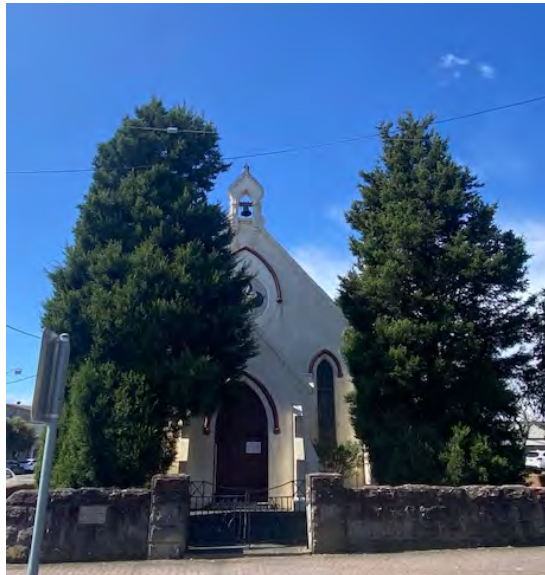
**Figure 9:** Trees 15 & 16 in the landscape. (Source: Austin 21/09/2021)

Trees 15 & 16 *Cupressocyparis leylandii* (Leyland Cypress) are located on the south side(entrance side) of the church and carry medium landscape significance. The dense foliage of the trees is blocking the façade of the church. As these trees continue to grow, the dense foliage will block the façade of the church and trimming will be required to maintain access around the church entrance. Consideration for the removal of these trees and the replacement with an appropriate and species that complements the heritage building is suggested to occur as part of the project.

Two (2) *Platanus orientalis 'digitata'* (Oriental Plane) are proposed to replace the Two (2) *Cupressocyparis leylandii* (Leyland Cypress) (Trees # 15 & 16 at the southern end of the Church building). These tree replacements are expected to provide an improved aesthetic appeal and increased canopy compared to the existing Leyland Cypress.

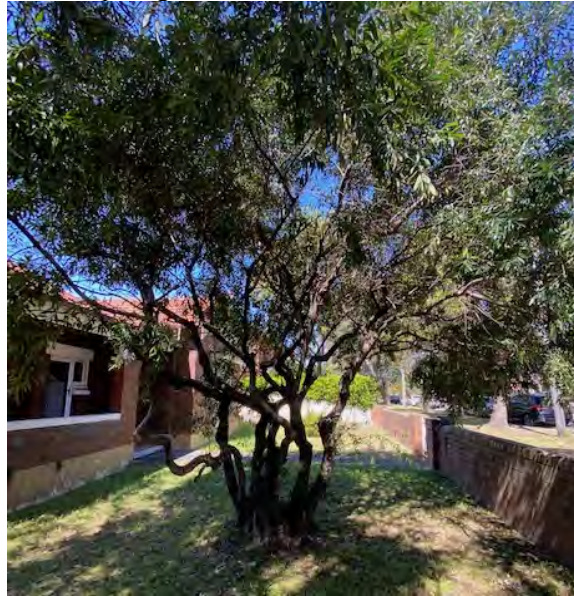
**Figure 10:** Tree 1 in the landscape. (Source: Austin 21/09/2021)

Tree 1 *Olea europaea ssp. Cuspidata* (African olive) is a small tree at the front of 1A Dunmore Street. The tree has Low landscape significance.

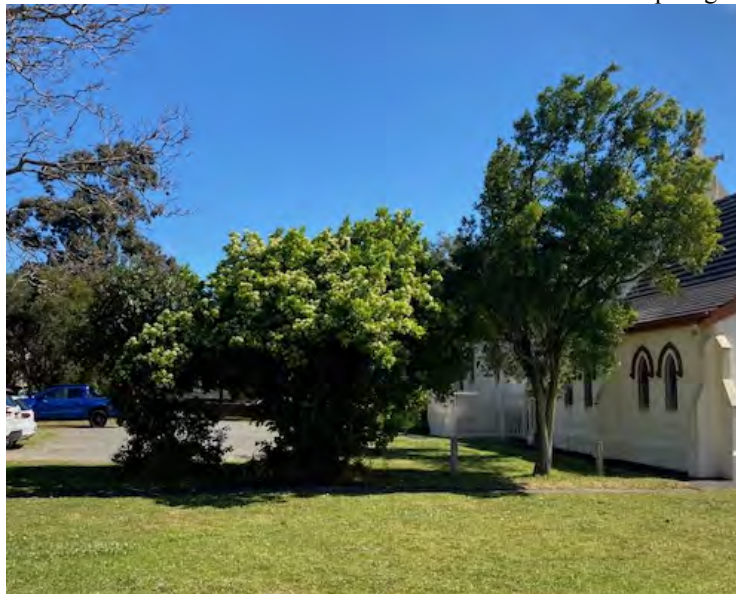
**Figure 11:** Trees 9, 10 & 11 in the landscape. (Source: Austin 21/09/2021)

Trees 9, 10 & 11 are small trees/shrubs in the centre of the site with low landscape significance.

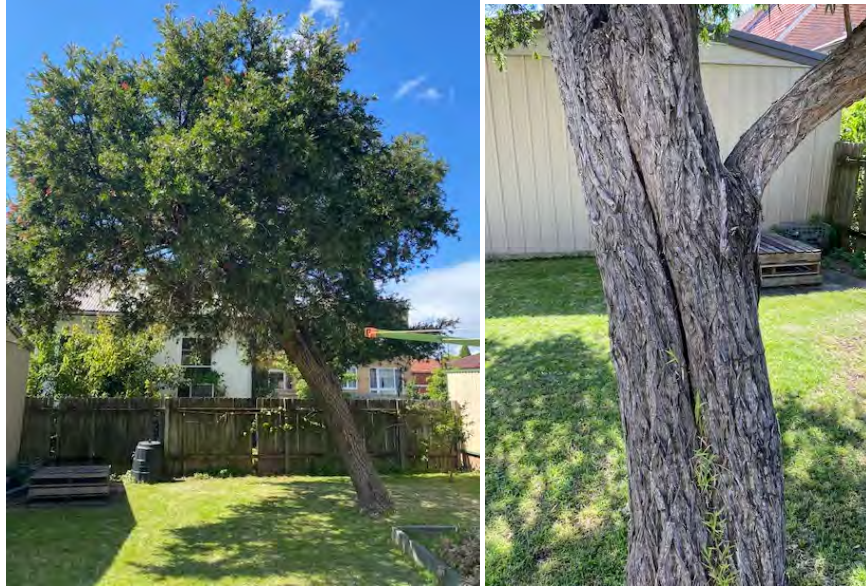
Tree 6 *Calistemon citrinus* (Crimson Bottlebrush) is located in the rear of 1A Dunmore Street. The tree has low landscape significance and a stem split which reduces its life expectancy.

**Figures 12 & 13:** Tree 7 can be observed in the landscape (Left) and the stem split (Right). (Source: Austin 21/09/2021)

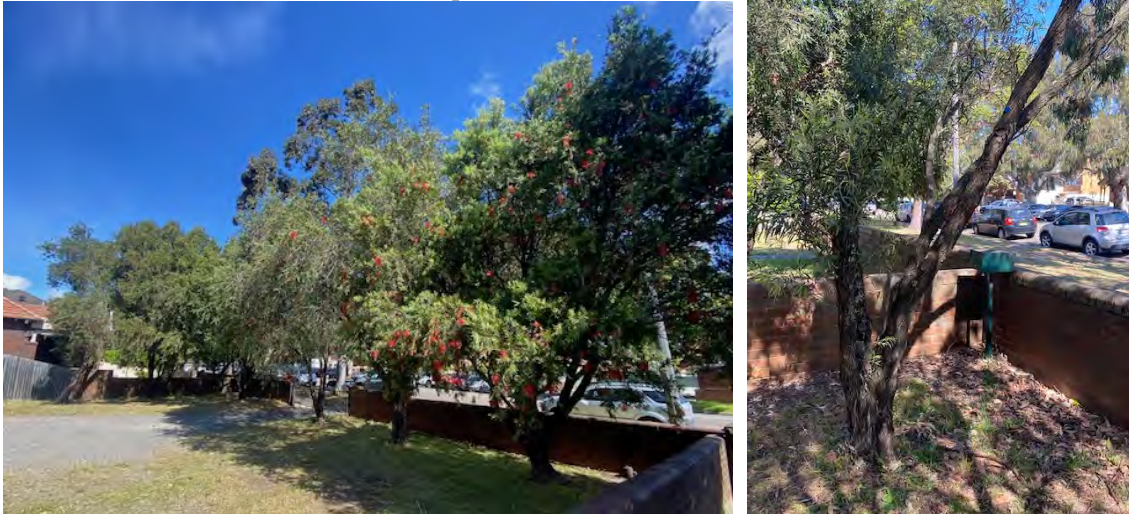
Trees 17 -23 *Callistemon viminalis* (Weeping Bottle Brush) are located around the Dunmore Street frontage of the existing car park. As a group the trees provide amenity benefits as well as screening. Individually, the trees are small and easily replaceable. Tree 21 has poor form from previous branch failure and could be replaced.

**Figure 14 (Left):** Trees 17 -23 in the landscape. (Source: Austin 21/09/2021)

**Figure 15 (Right):** The poor form of Tree 19 can be observed. (Source: Austin 21/09/2021)

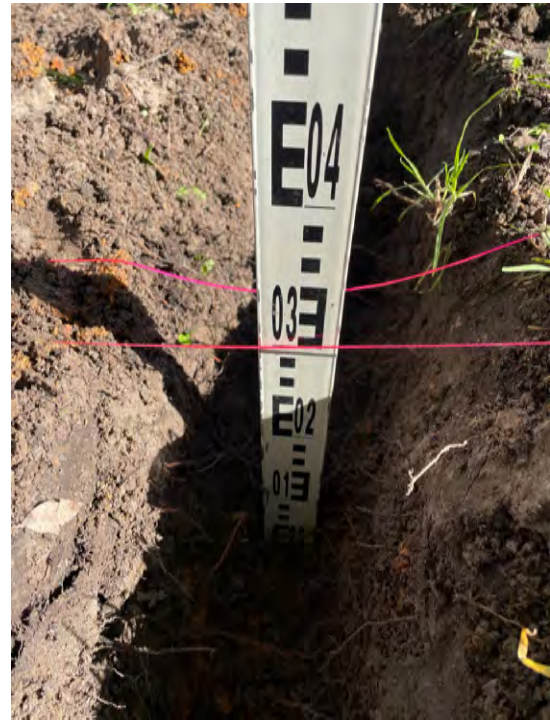
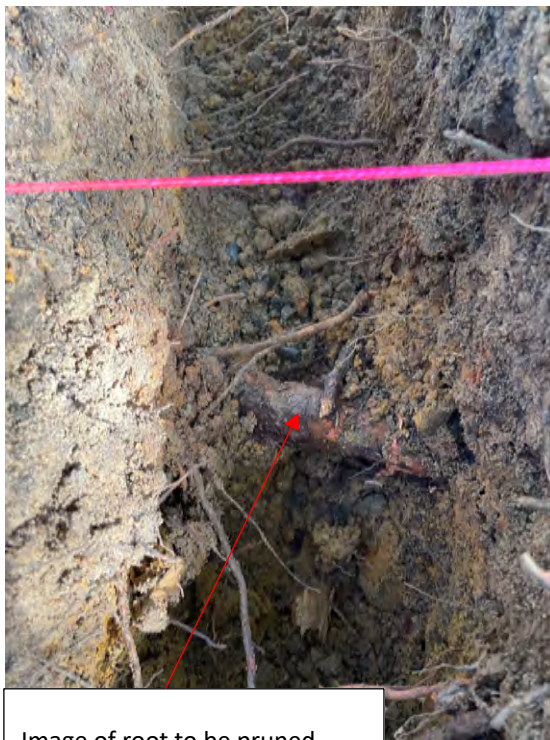
Exploratory root investigation for T24 revealed one 40mm root located at 150mm that would require to be pruned.

Image of root to be pruned

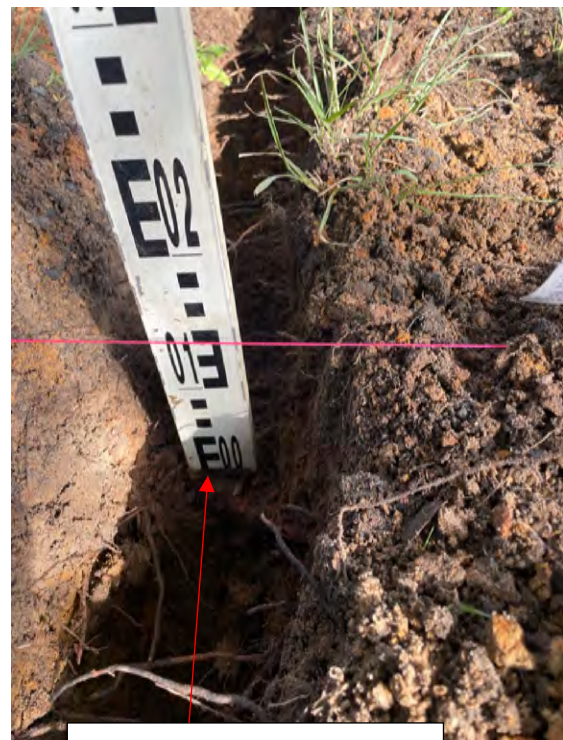
Image depicting root depth

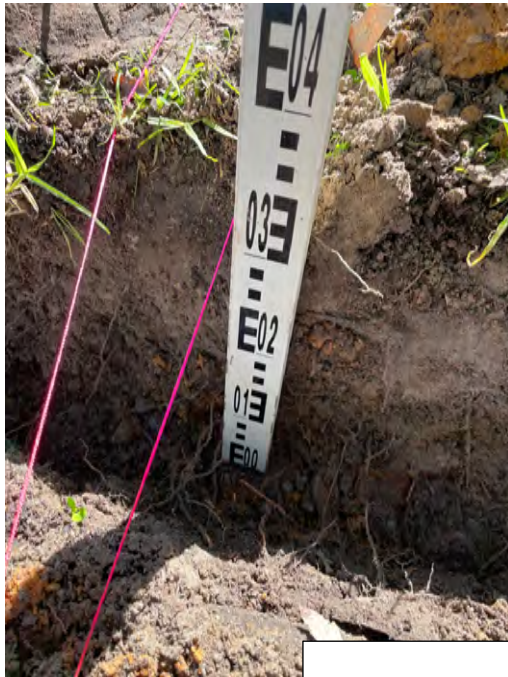
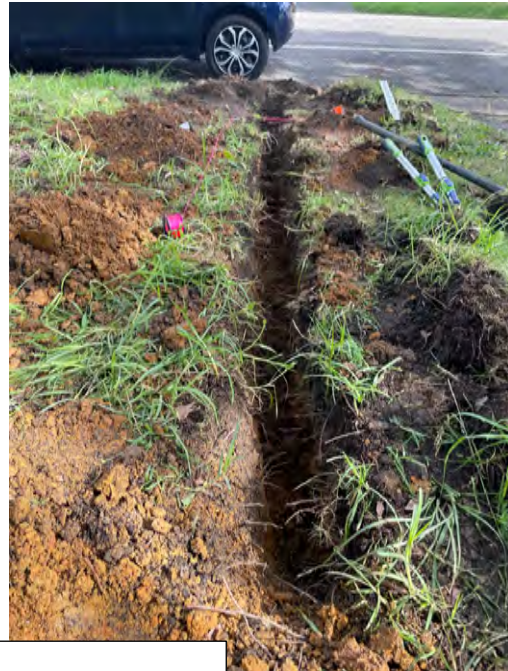
Images showing trench and trench depth.

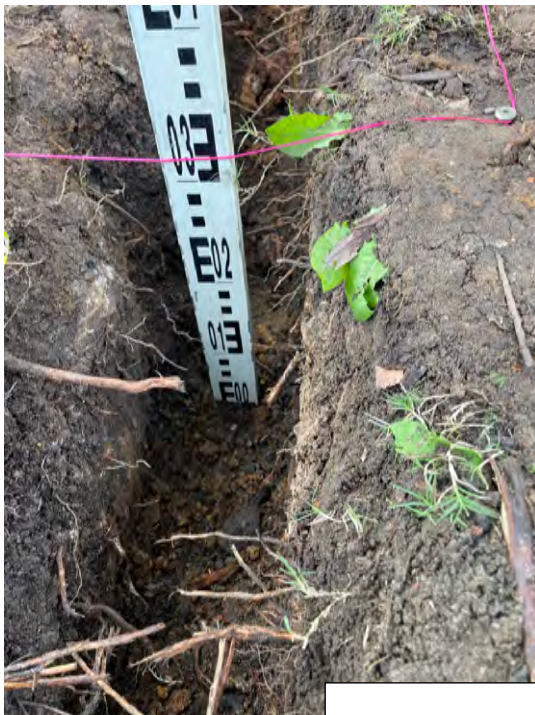
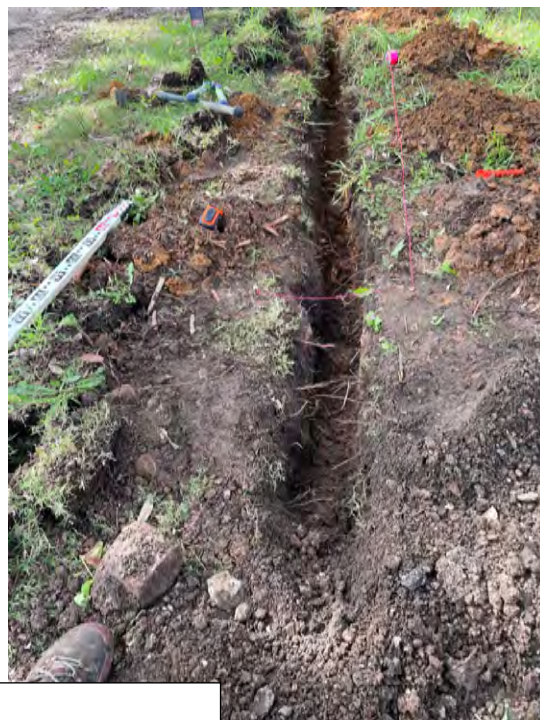
Images showing trench and trench depth.

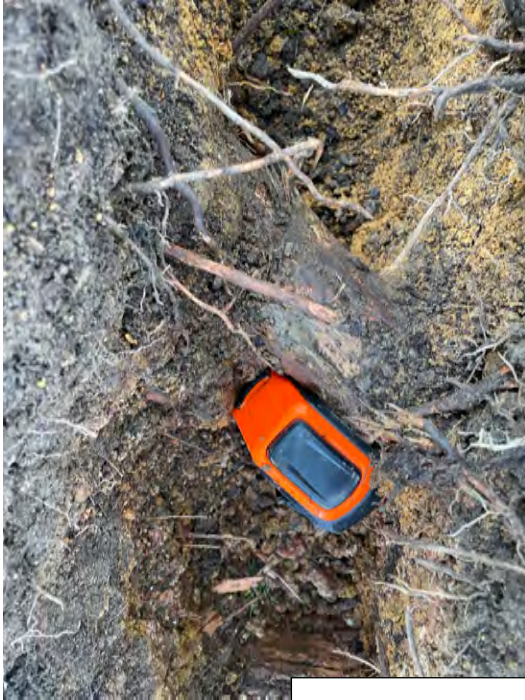
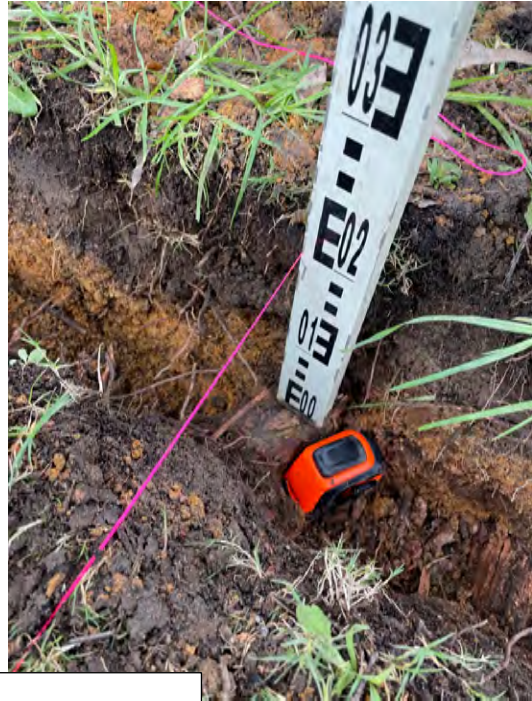
Exploratory root investigation for T25 revealed one 70mm root at 300mm depth to be retained and on 85mm root at 200mm that would require to be pruned.

Images showing 1 x 85mm root to be pruned at 200mm.

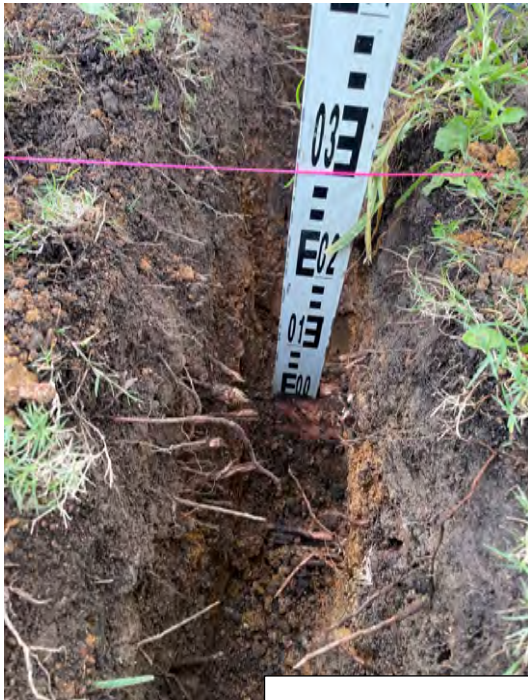
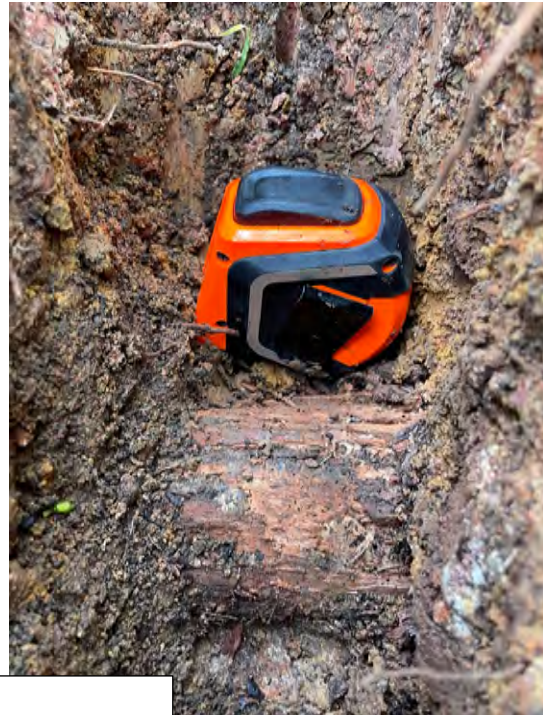
Images showing one 70mm root at 300mm depth to be retained.

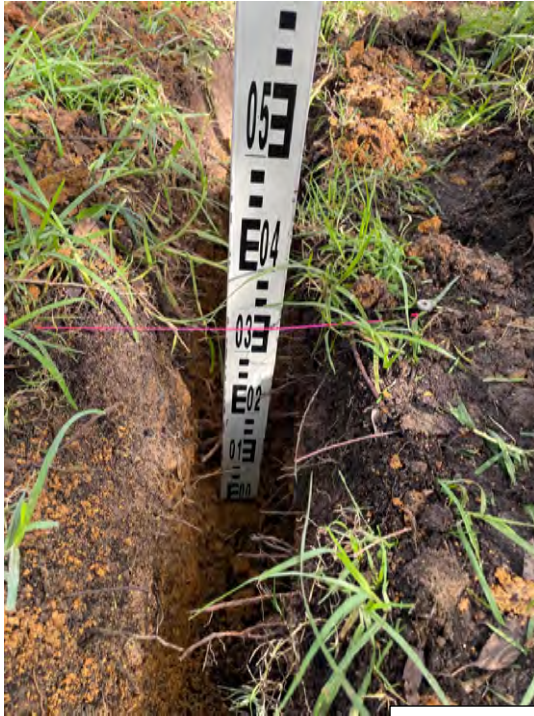
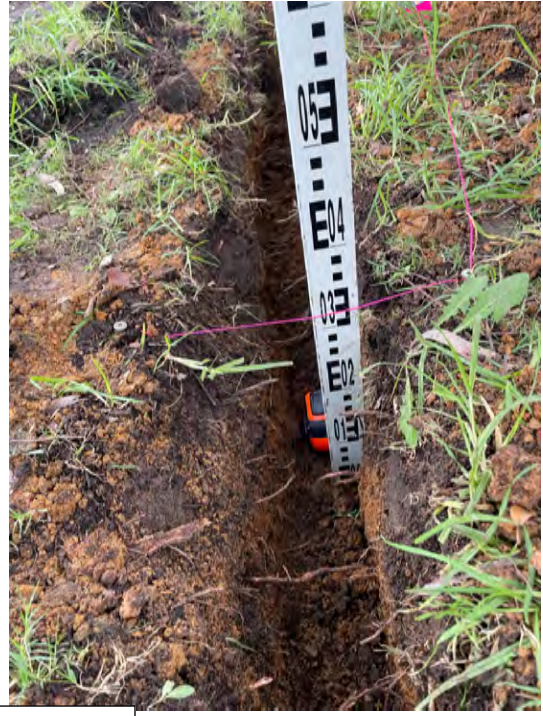
Images indicating trench depth

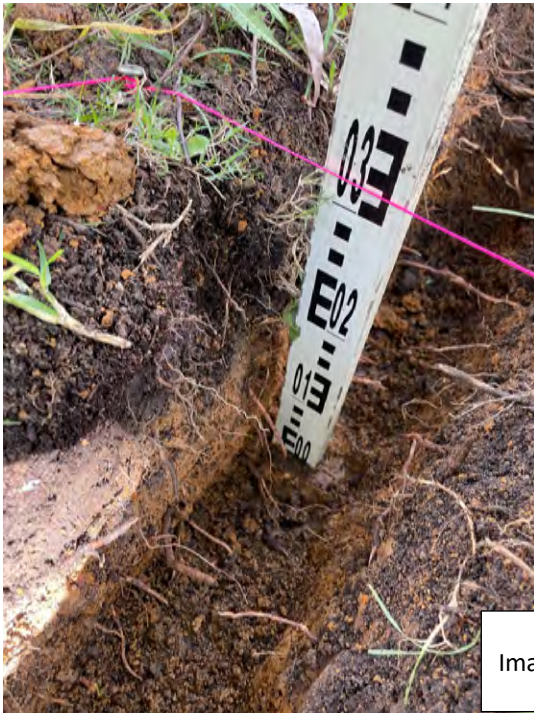
Image indicating trench depth
