HAZARDOUS MATERIALS DEMOLITION/REFURBISHMENT REPORT SYDNEY CATHOLIC SCHOOLS

BLOCK B

CHAMPAGNAT CATHOLIC COLLEGE MAROUBRA, NSW

24th August 2019

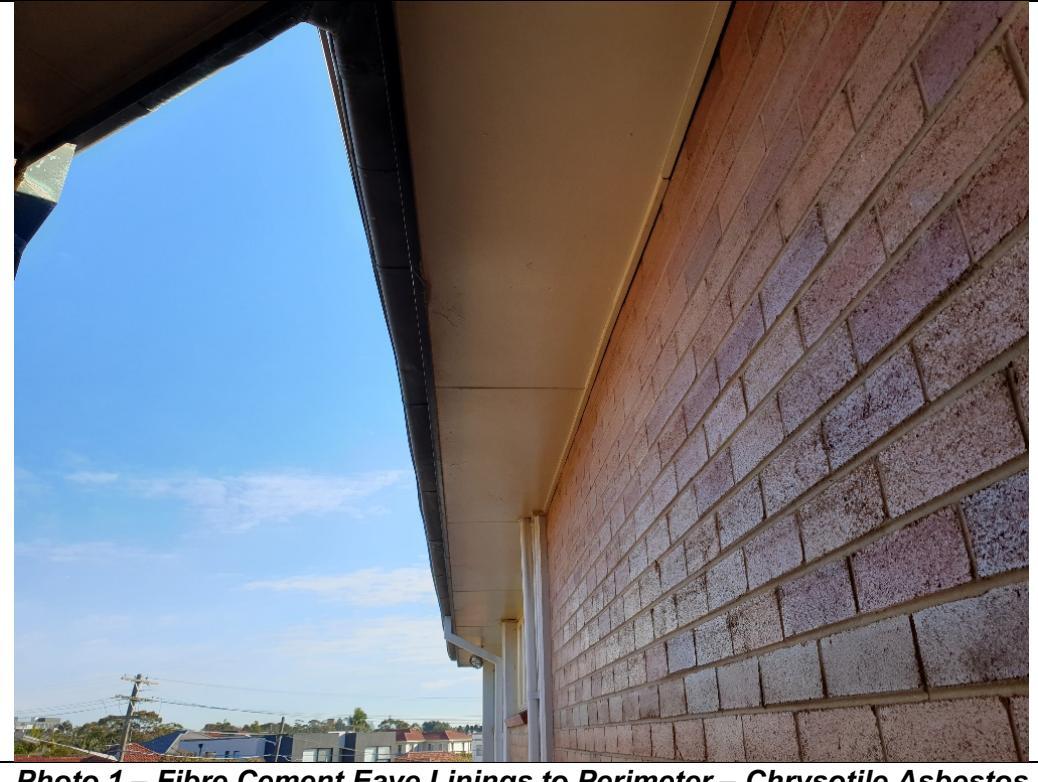
The upper level eaves to the perimeter of the building are lined with fibre cement sheeting (Photographs 1, 2, 3, 4, 5, 6 & 7). This material was found to contain Chrysotile asbestos (Samples 4 & 5). Where the fibre cement eave linings are present, they should be removed as asbestos-based material.

Photo 1 – Fibre Cement Eave Linings to Perimeter – Chrysotile Asbestos Present

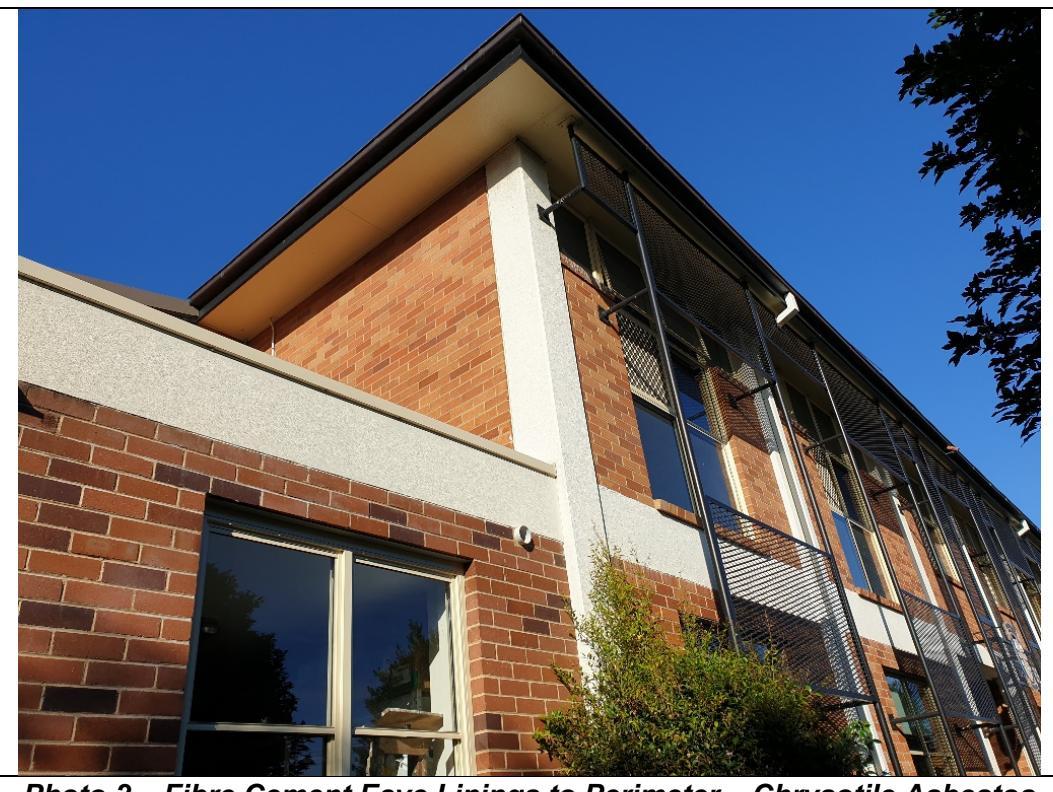
Photo 2 – Fibre Cement Eave Linings to Perimeter – Chrysotile Asbestos Present

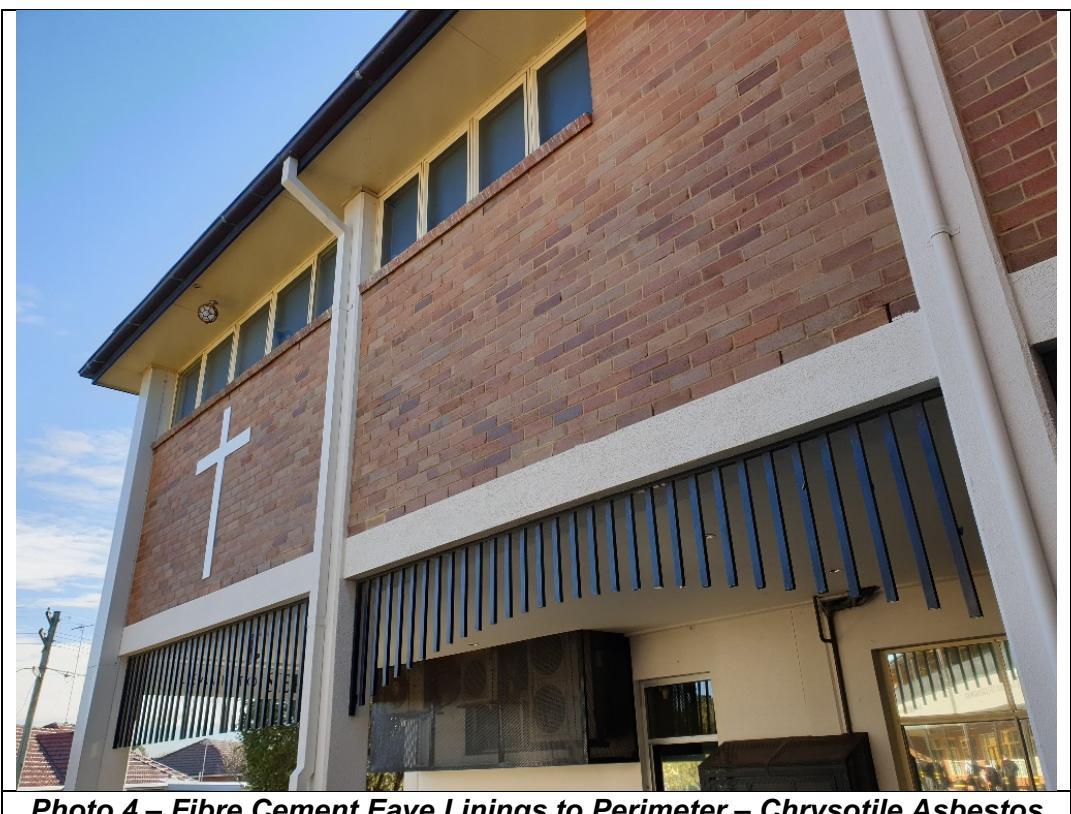
Photo 4 – Fibre Cement Eave Linings to Perimeter – Chrysotile Asbestos Present

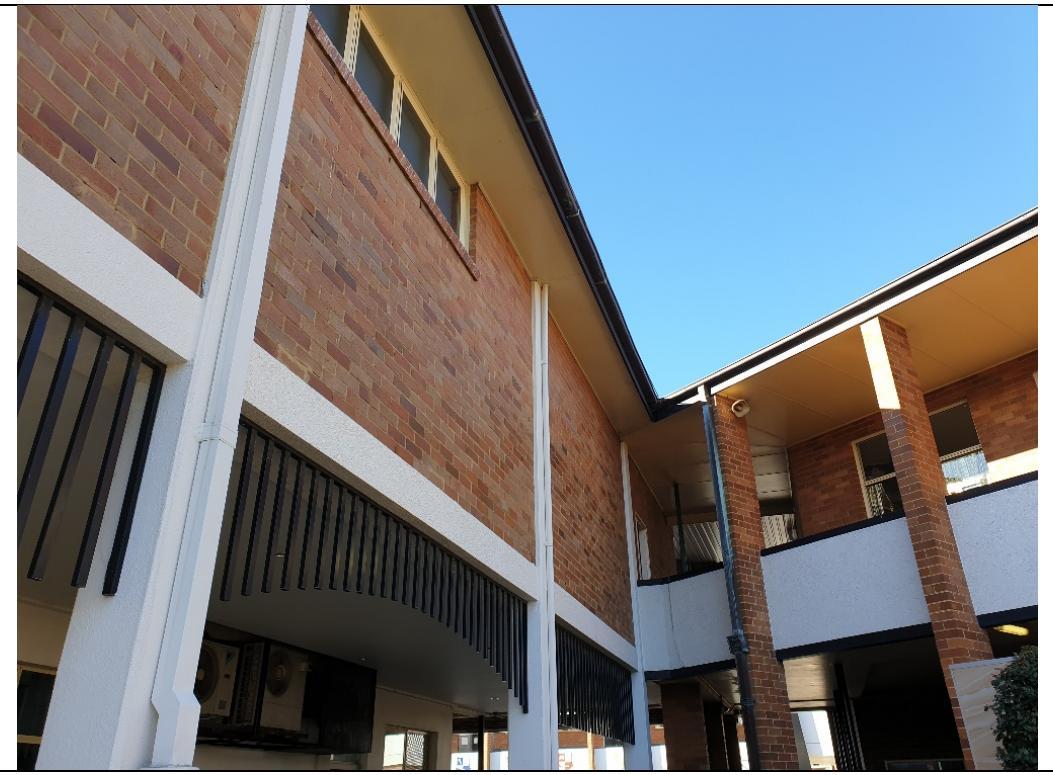
Photo 5 – Fibre Cement Eave Linings to Perimeter – Chrysotile Asbestos Present

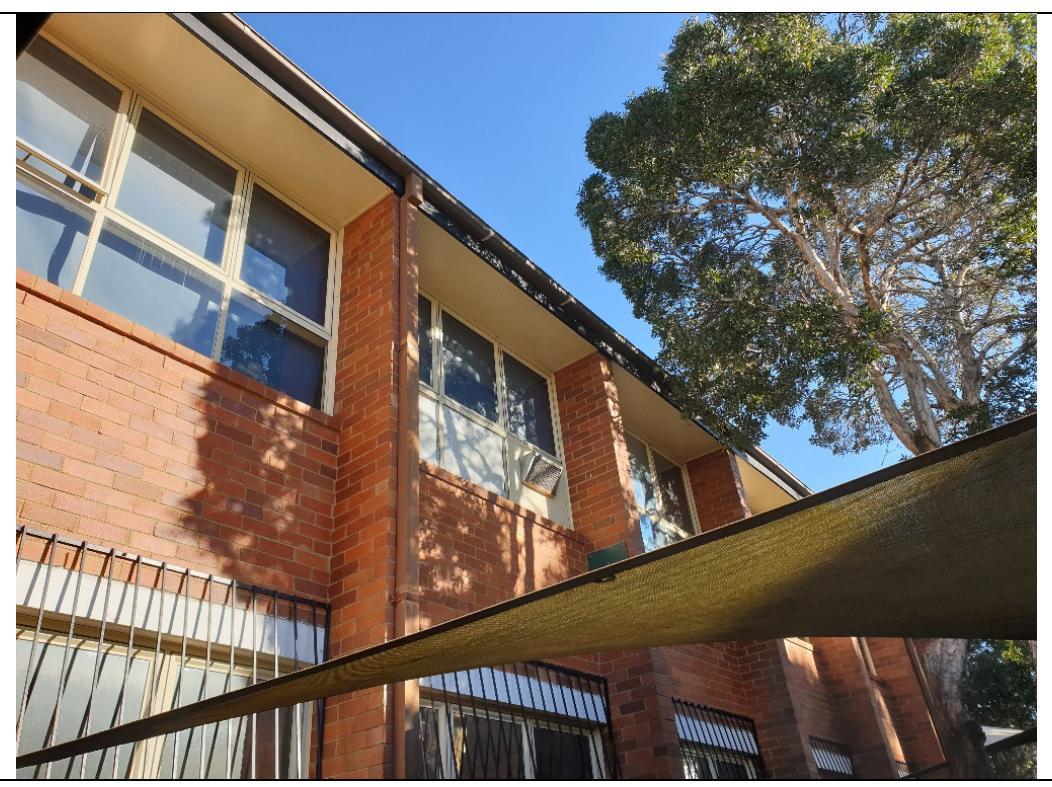
Photo 6 – Fibre Cement Eave Linings to Perimeter – Chrysotile Asbestos Present

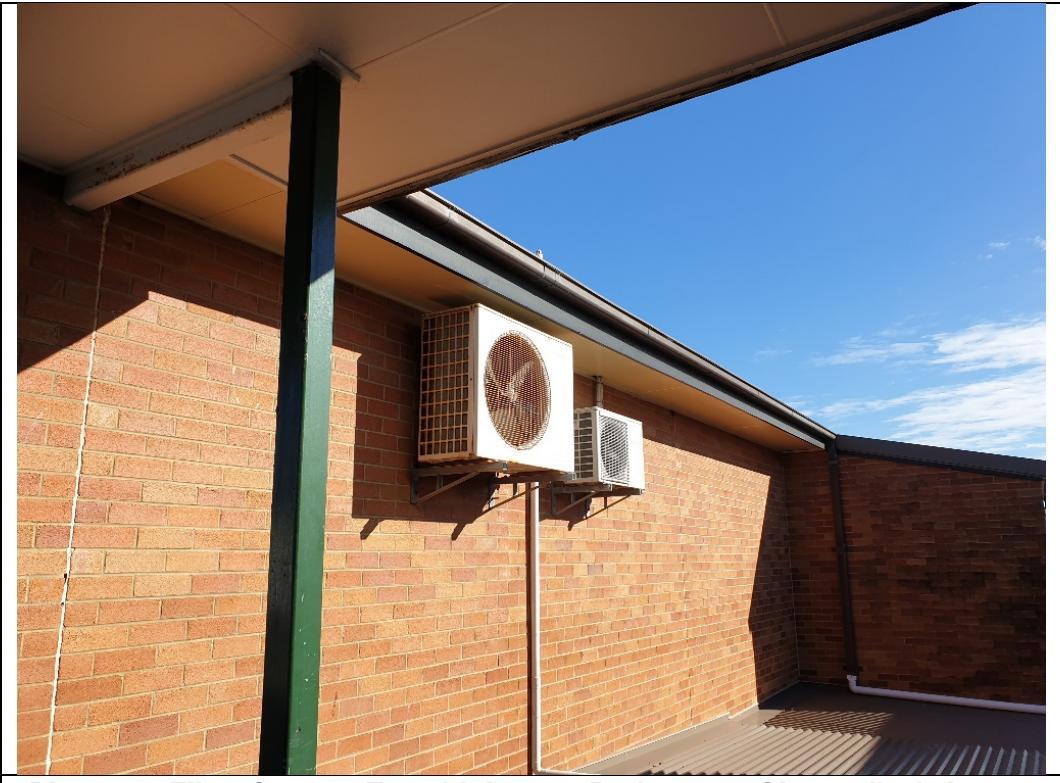
Photo 7 – Fibre Cement Eave Linings to Perimeter – Chrysotile Asbestos Present

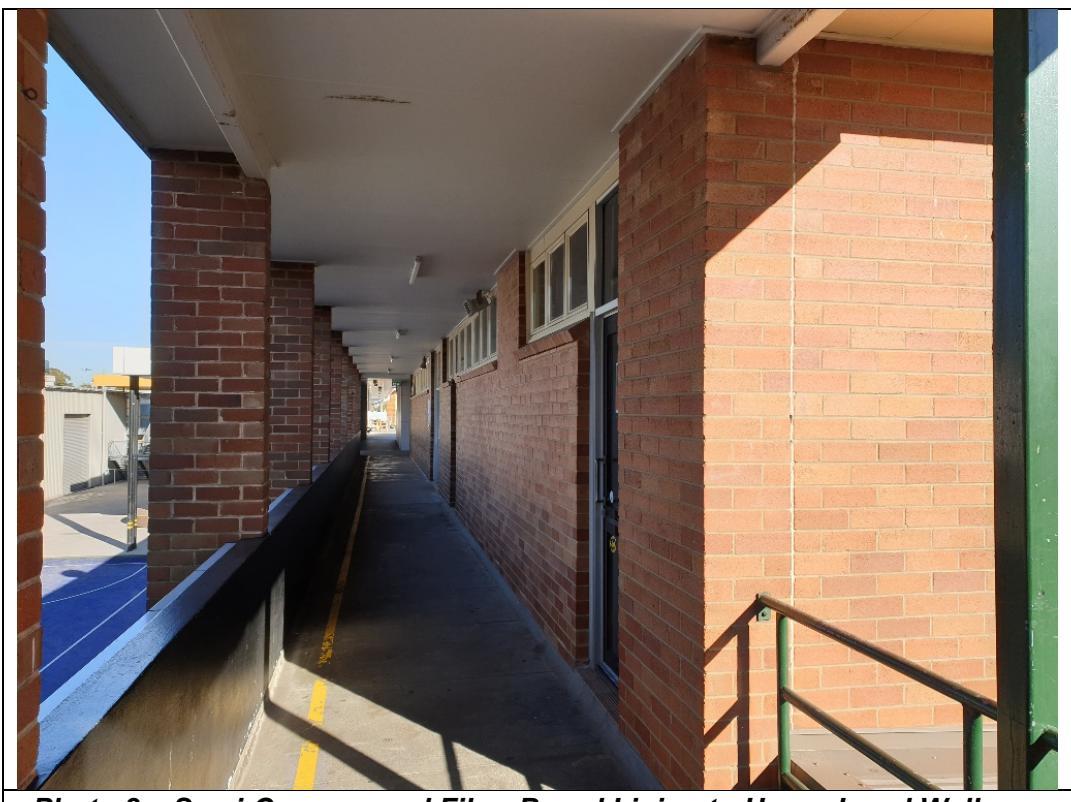
The upper level walkway awning on the southern side of the block is lined with semicompressed fibre board sheeting which was found to contain Chrysotile asbestos (Samples 6 & 7; Photographs 8 & 9).

Photo 8 – Semi-Compressed Fibre Board Lining to Upper Level Walkway Ceiling – Chrysotile Asbestos Present

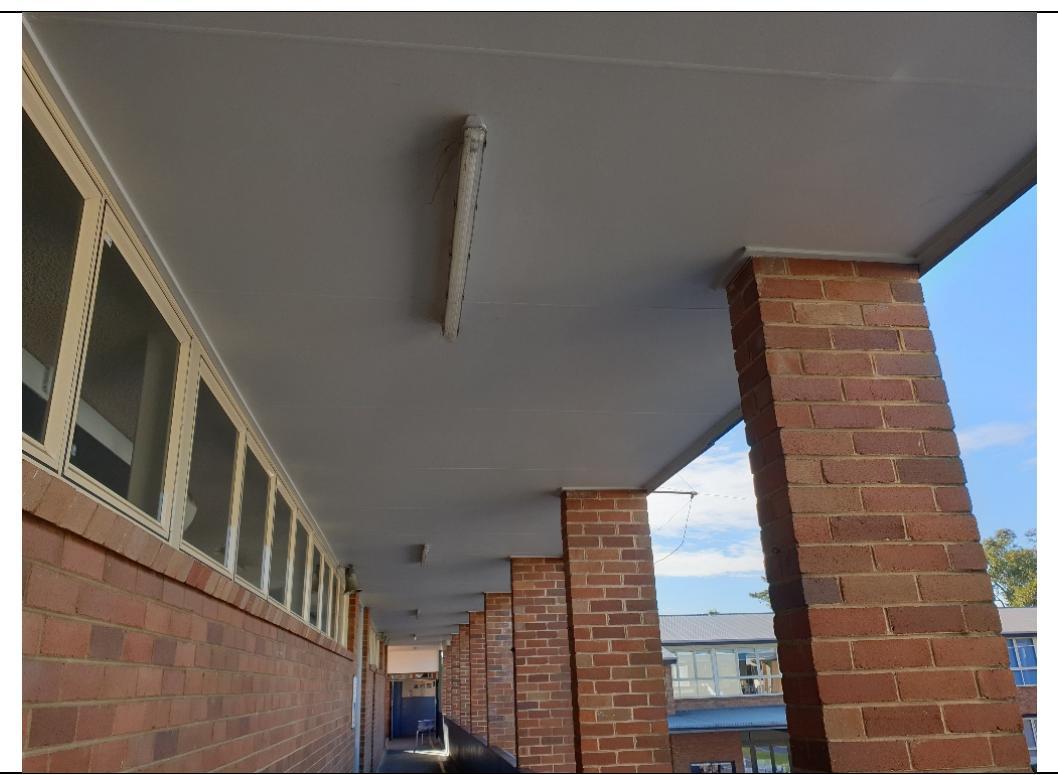
Photo 9 – Semi-Compressed Fibre Board Lining to Upper Level Walkway Ceiling – Chrysotile Asbestos Present

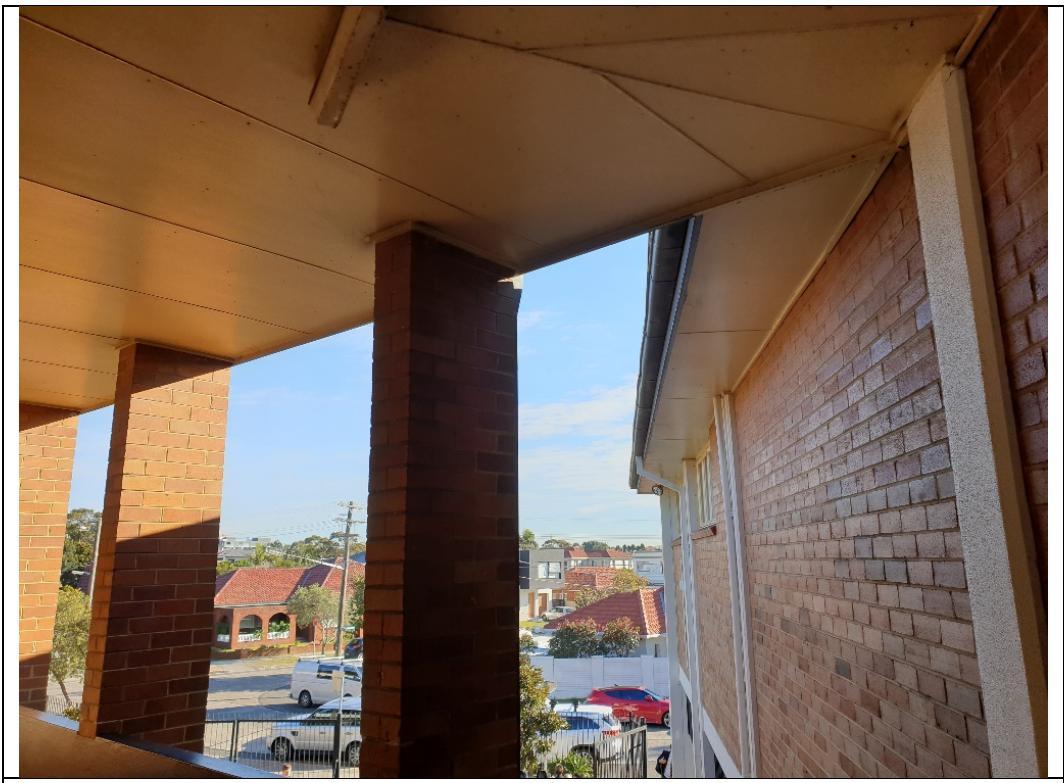
The upper level walkway awning connecting Block A to Block B on the western side of the block is also lined with semi-compressed fibre board sheeting which was found to contain Chrysotile asbestos (Samples 8 & 9; Photographs 10 & 11).

Photo 10 – Semi-Compressed Fibre Board Lining to Upper Level Walkway Ceiling from Block A – Chrysotile Asbestos Present

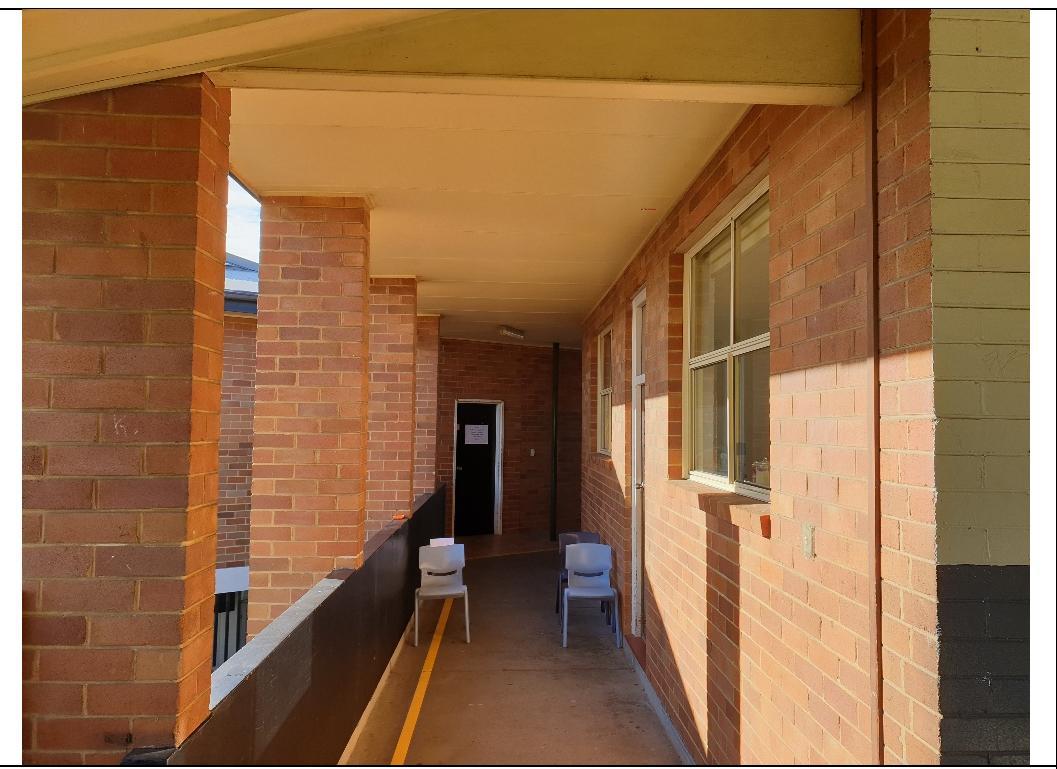
Photo 11 – Semi-Compressed Fibre Board Lining to Upper Level Walkway Ceiling from Block A – Chrysotile Asbestos Present

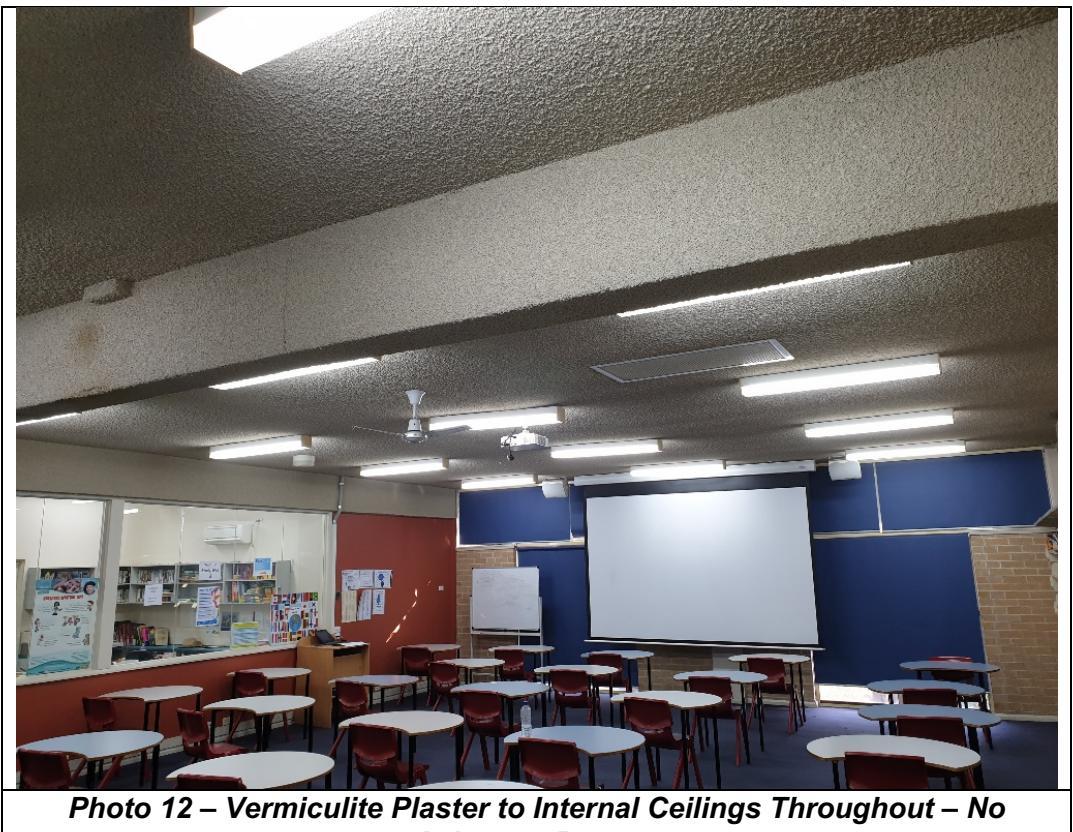
Vermiculite plaster has been used extensively to the internal ceilings of Block B and Photographs 12, 13, 14, 15 and 16 show some examples of the areas surveyed. Previous sampling and analysis of some of the internal ceilings of Block B have returned negative asbestos results in the past. An additional three (3) random and representative samples were collected from various points within the block during the current survey and all samples were found to be asbestos free (Samples 1, 2 & 3). Together with the past and current findings of similar material analysis, the vermiculite plaster applied to the ceilings throughout this block may be reasonably assumed to be asbestos free.

Asbestos Present

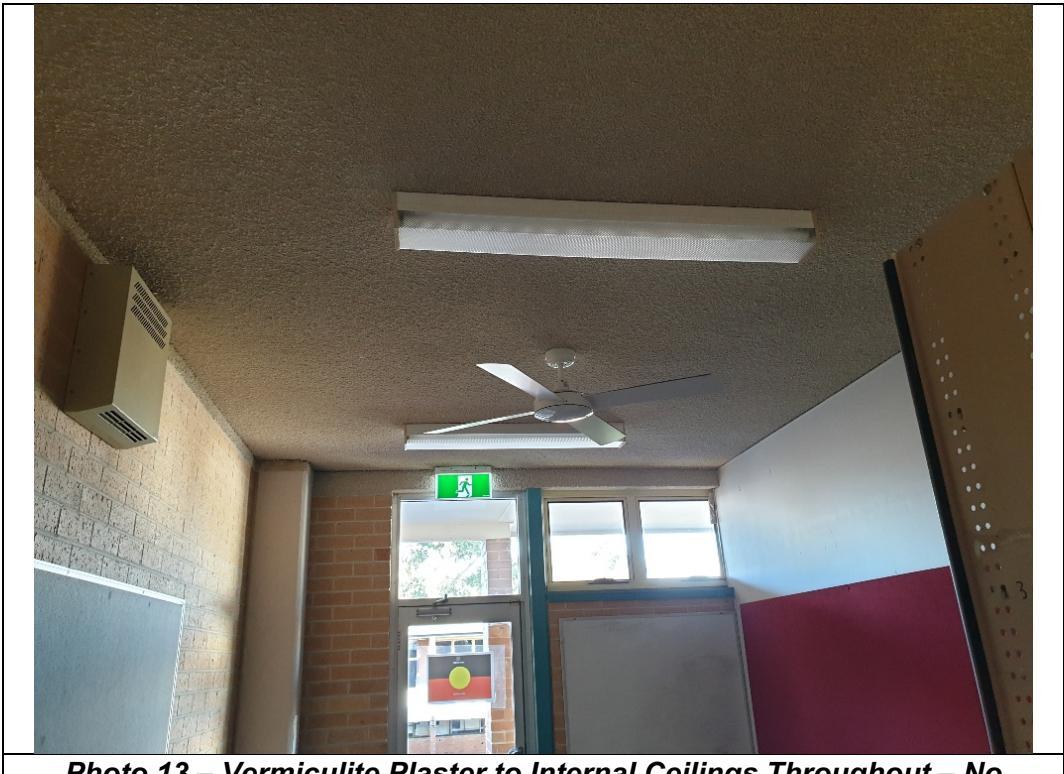
Photo 13 – Vermiculite Plaster to Internal Ceilings Throughout – No Asbestos Present

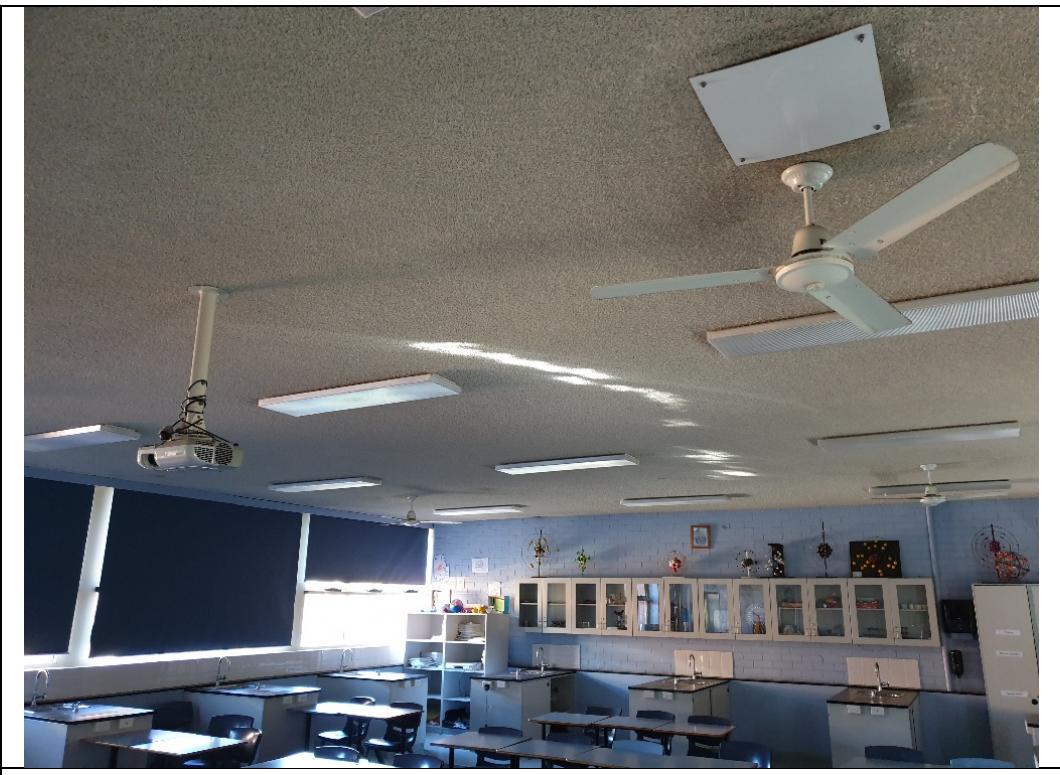
Photo 14 – Vermiculite Plaster to Internal Ceilings Throughout – No Asbestos Present

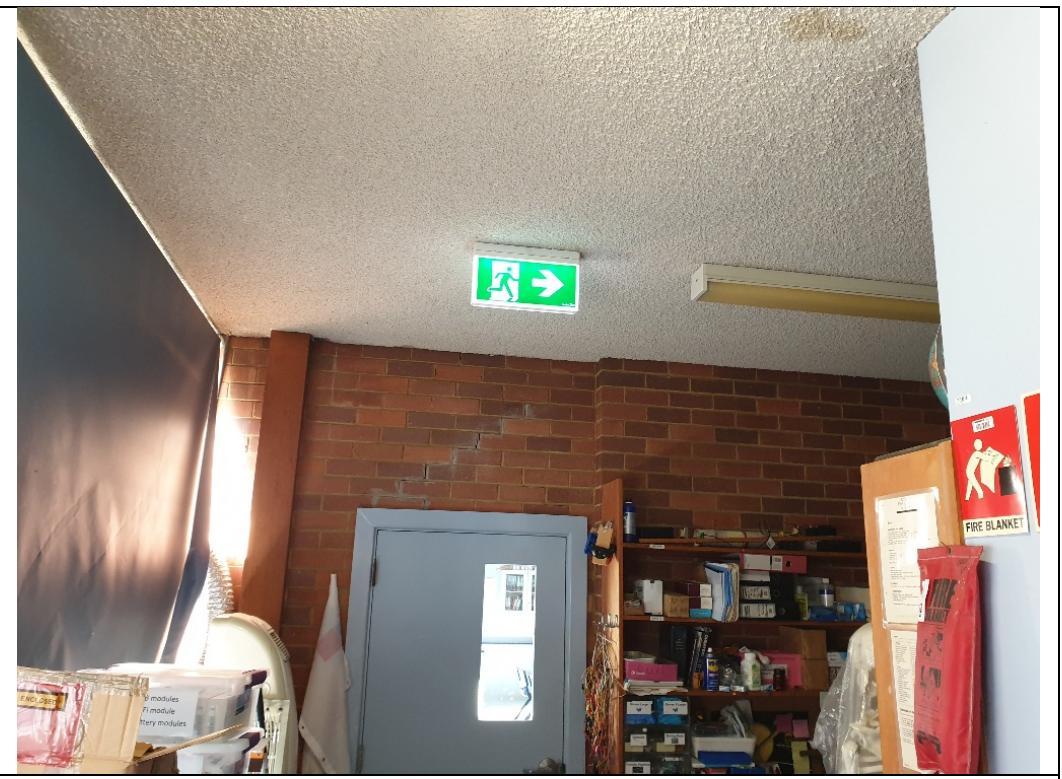
Photo 15 – Vermiculite Plaster to Internal Ceilings Throughout – No Asbestos Present

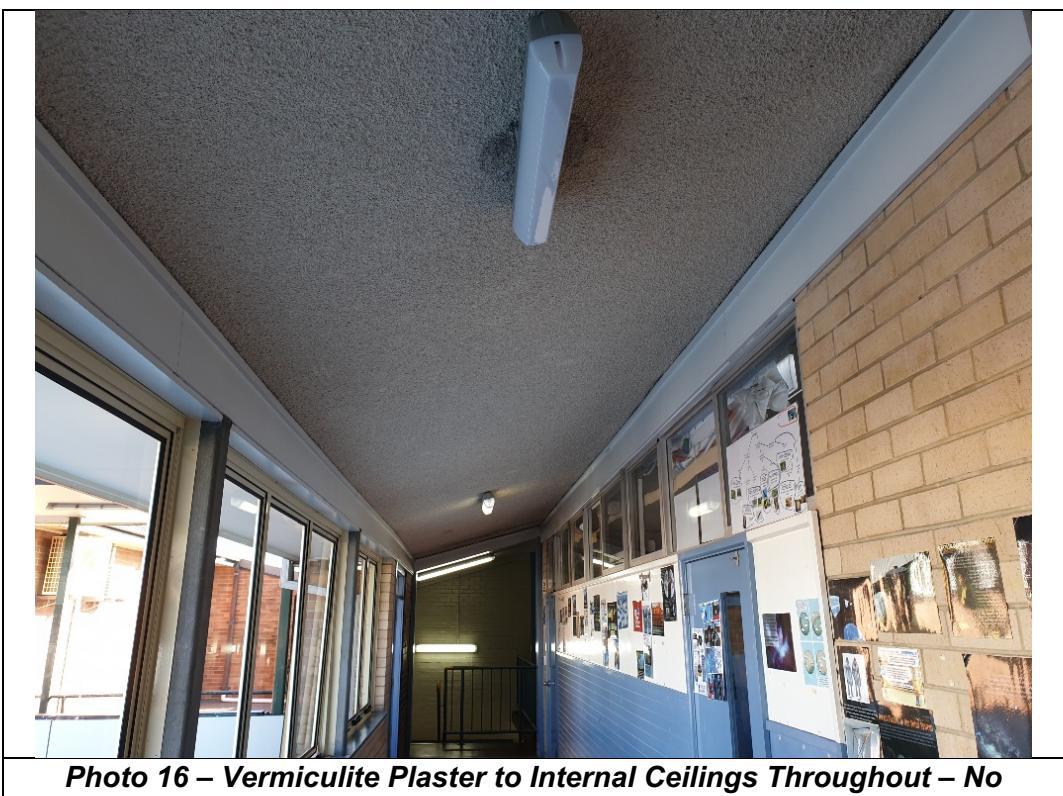
Asbestos Present

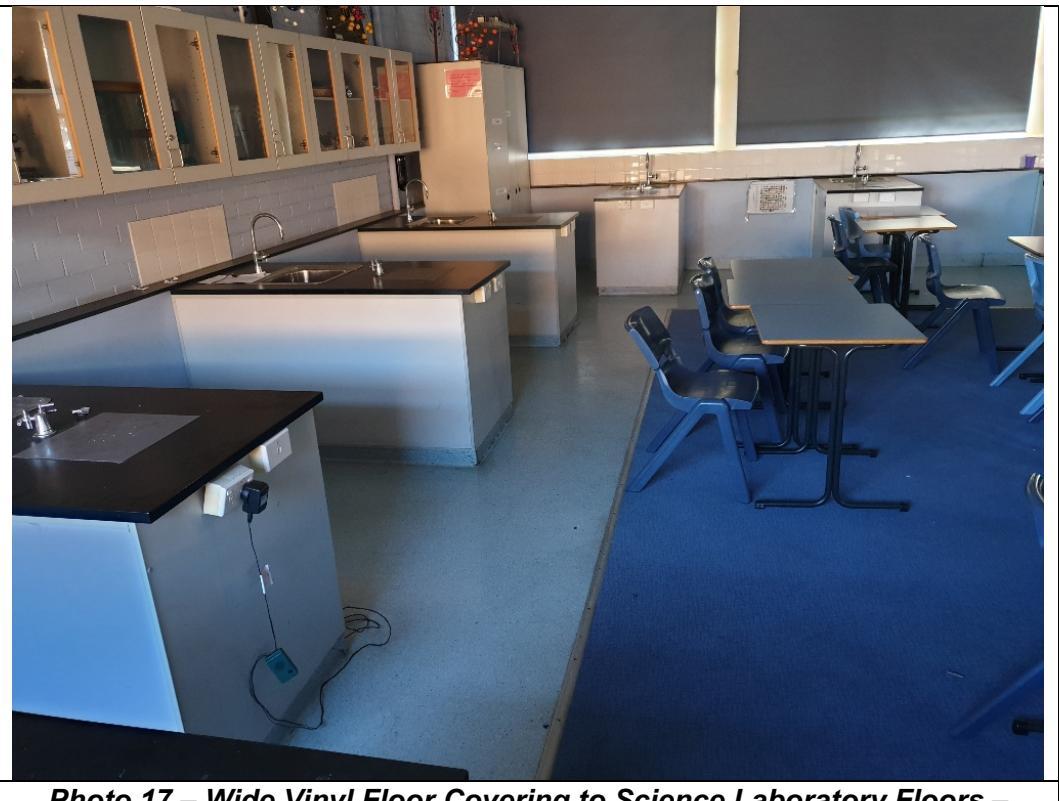
Wide vinyl flooring has been used to cover the rear sections of the floors of the science laboratory rooms (Photographs 17 & 18). This material was found to contain Chrysotile asbestos (Sample 10).

Photo 17 – Wide Vinyl Floor Covering to Science Laboratory Floors – Chrysotile Asbestos Present

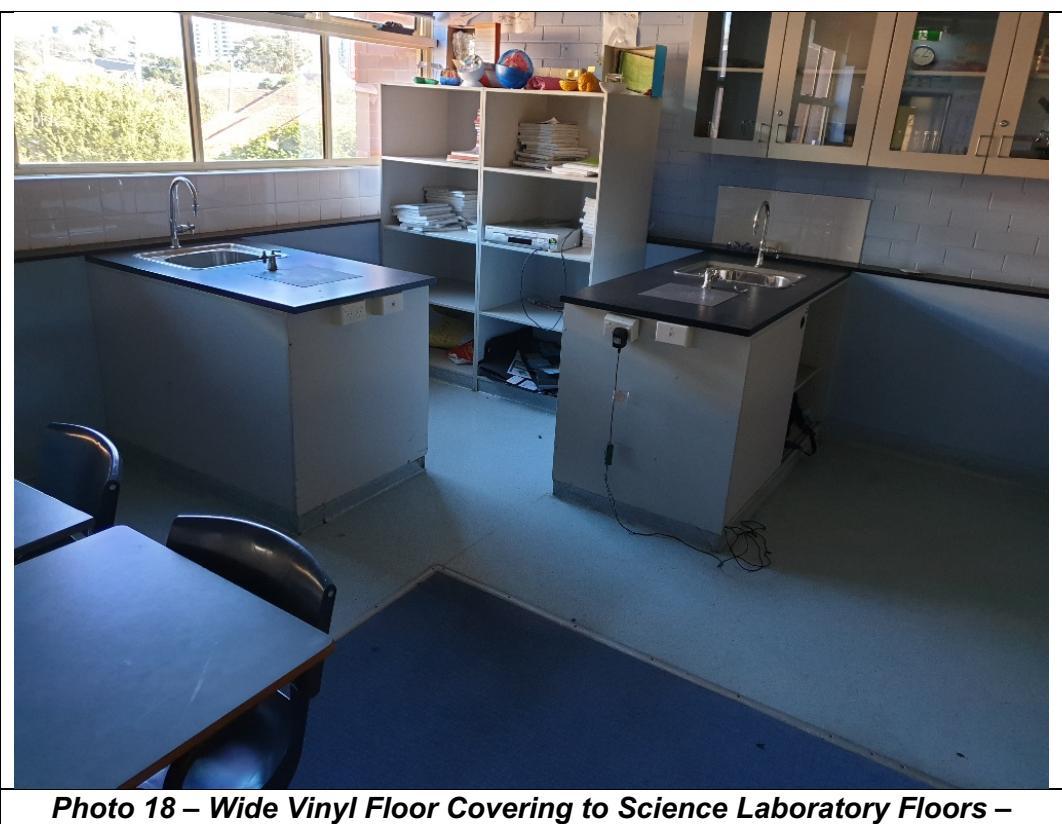
hoto 18 – Wide Vinyl Floor Covering to Science Laboratory Floors – Chrysotile Asbestos Present

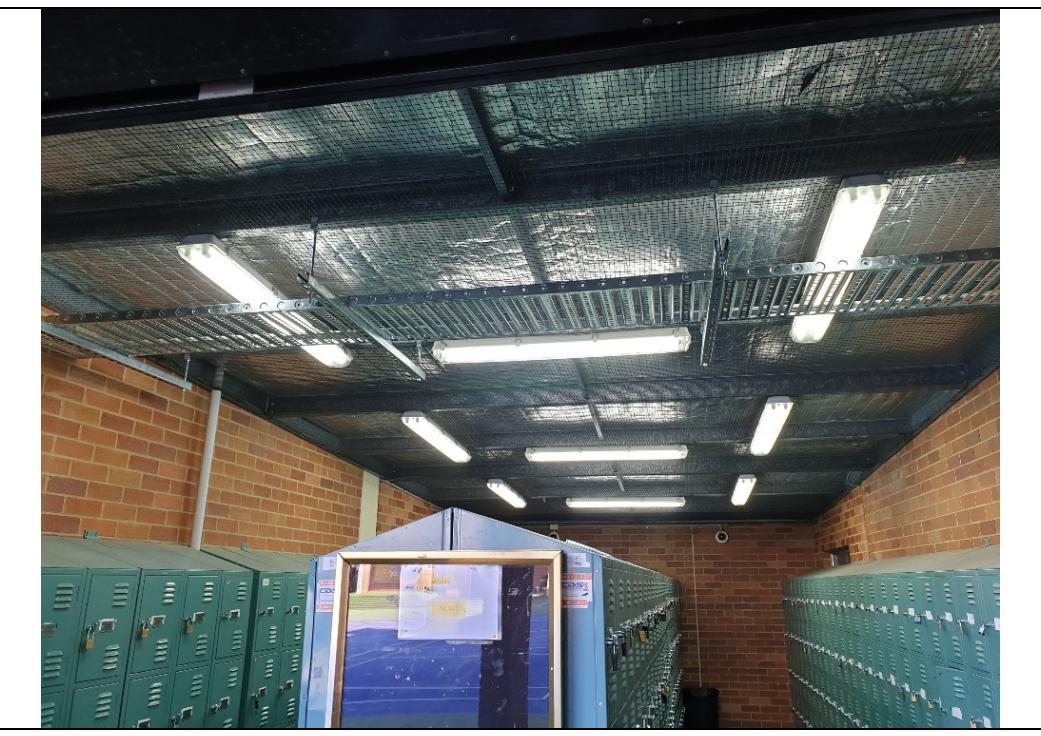
Photo 19 – SMF Present as Ceiling Insulation Throughout

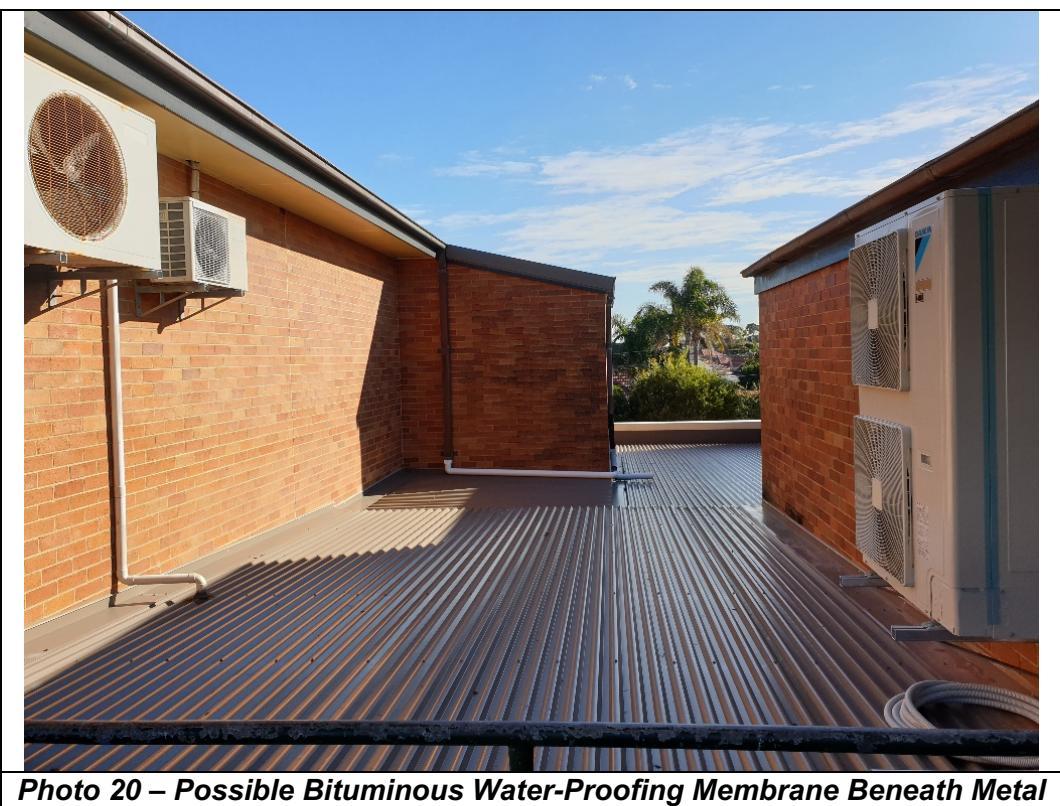
It is assumed that a bituminous membrane acting as water-proofing for the roof is in place beneath the flat section of roof of the block as shown in Photograph 20. In an effort to maintain the integrity of the roof and membrane during the current survey it was decided that deeming the presence of asbestos-based bituminous membrane was appropriate until demolition works are to commence. If it is found that a bituminous membrane exists beneath the metal roof lining during demolition works, this material should be assumed to be asbestos-based and tested for asbestos content or removed under controlled conditions on the assumption that it contains asbestos.

Lining – If Present, Test for Asbestos Before Disturbing
