## ***Arboriculture Impact Assessment***

**Silver Pond Investments Pty Ltd  
ATF Silver Pond Unit Trust**

Date: 1 February 2022  
Reference: 20221863  
Revision No: 6

| Site Details | 18 – 32 Holdsworth Avenue & 21 – 41 Canberra Avenue, St Leonards | | |

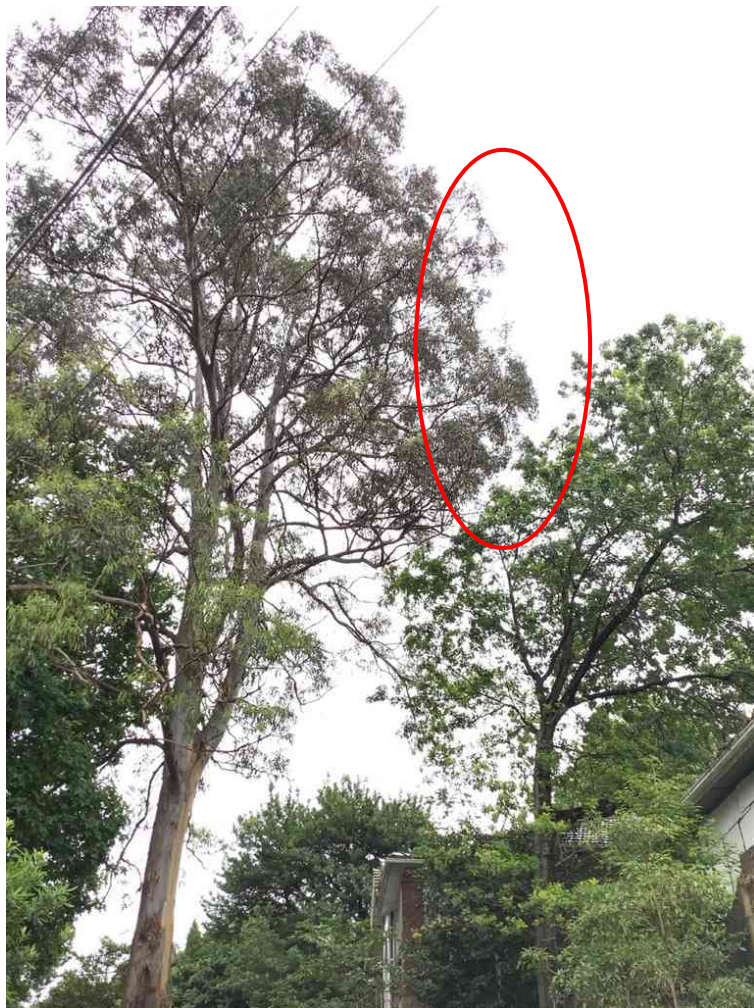
Figure 4. Tree No. 14 canopy pruning (facing west)

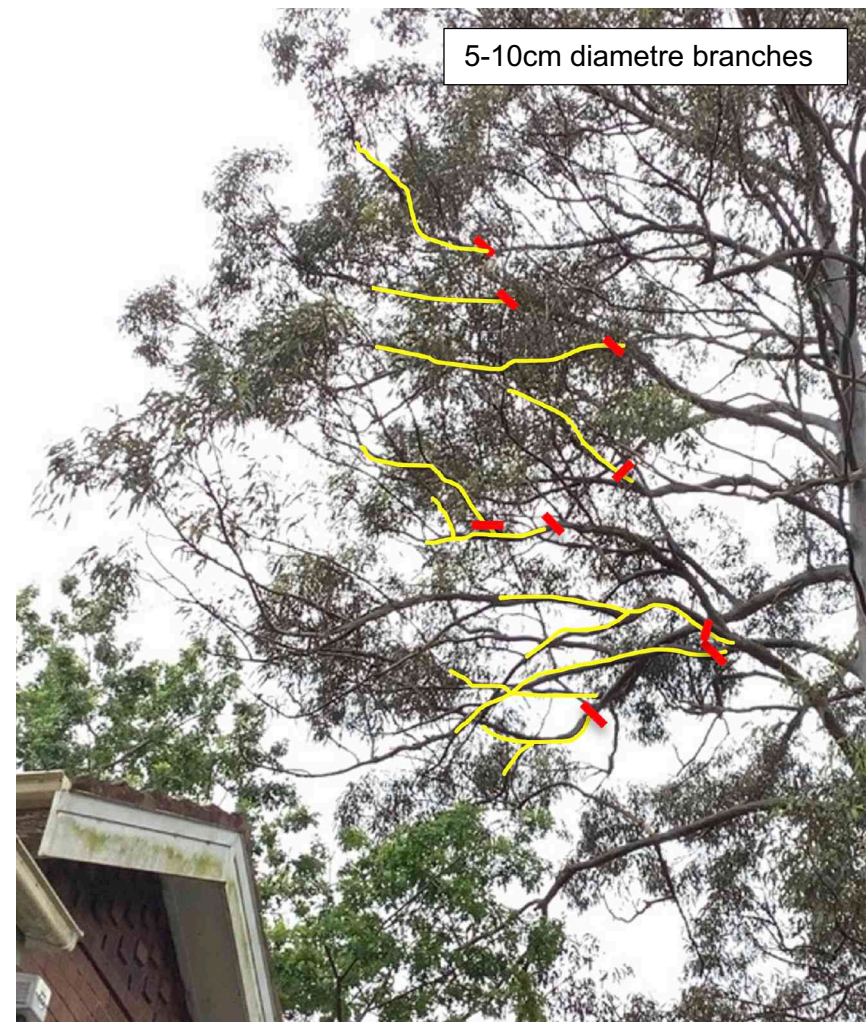
Figure 5. Tree No. 14 branch pruning (facing east)
