ARBORICULTURAL IMPACT ASSESSMENT (AIA) REPORT V4

Prepared For:	Hyecorp Property Group
Site Address:	13-19 Canberra Avenue, St Leonards
Inspection Dates:	8 February 2021 (Preliminary Tree Inspection) & 15 June 2021 (Additional trees added)
Report Date	25 June 2021 Updated 29 June 2021 Plan revision 42 - 13/10/2021

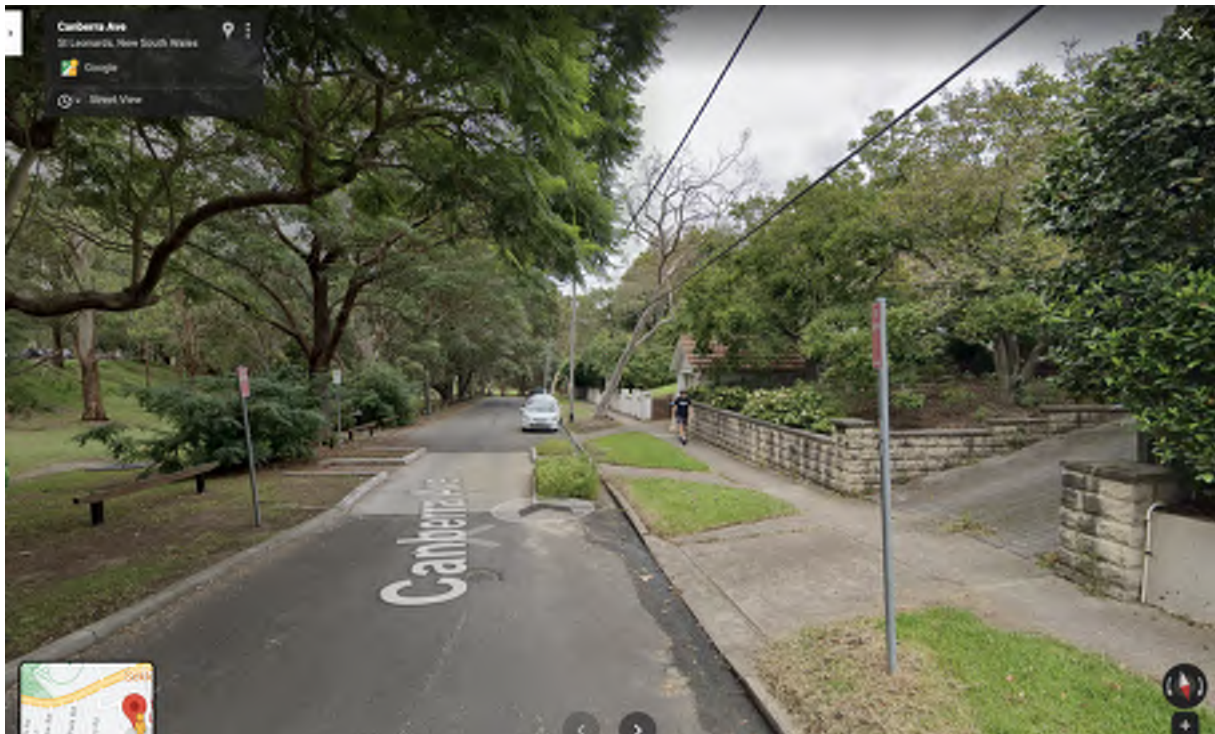
- 3.2.2 At the time of writing, insufficient detail had been received to comment on the Pedestrian Link.
- 3.2.3 The vehicular point of entry falls at the front of property No 15 with an assumption made the current road narrowing islands will require either removal or modification (See Photo 1).

Photo 1: Approximate location of complex's vehicular access (Red dotted lines). Note road narrowing bays and low foliage ST6 Jacaranda Newlands Park. Ground protection (Blue) required beneath canopies.

- 1.1.7 Rumble boards are required beneath the canopies of ST8, ST9 & ST10 and to be placed between the Newlands Park perimeter railing and the asphalt road surface. It is anticipated trucks turning will require this additional space for manoeuvring purposes (photo 1).
- 1.1.8 Protective fencing should not be required for any street tree located north of Duntroon Avenue or trees behind the timber perimeter fence of Newlands Park.
- 1.1.9 T22a *Jacaranda* located within property 21 Canberra Ave has canopy which extends above No 19 Canberra Ave. At the time of writing it remains unknown if pruning is required.
- 1.1.10 In the event stormwater connection is required to drain within Newlands Park, it is recommended the trench occurs between ST9 and ST10 (Appendix 2).

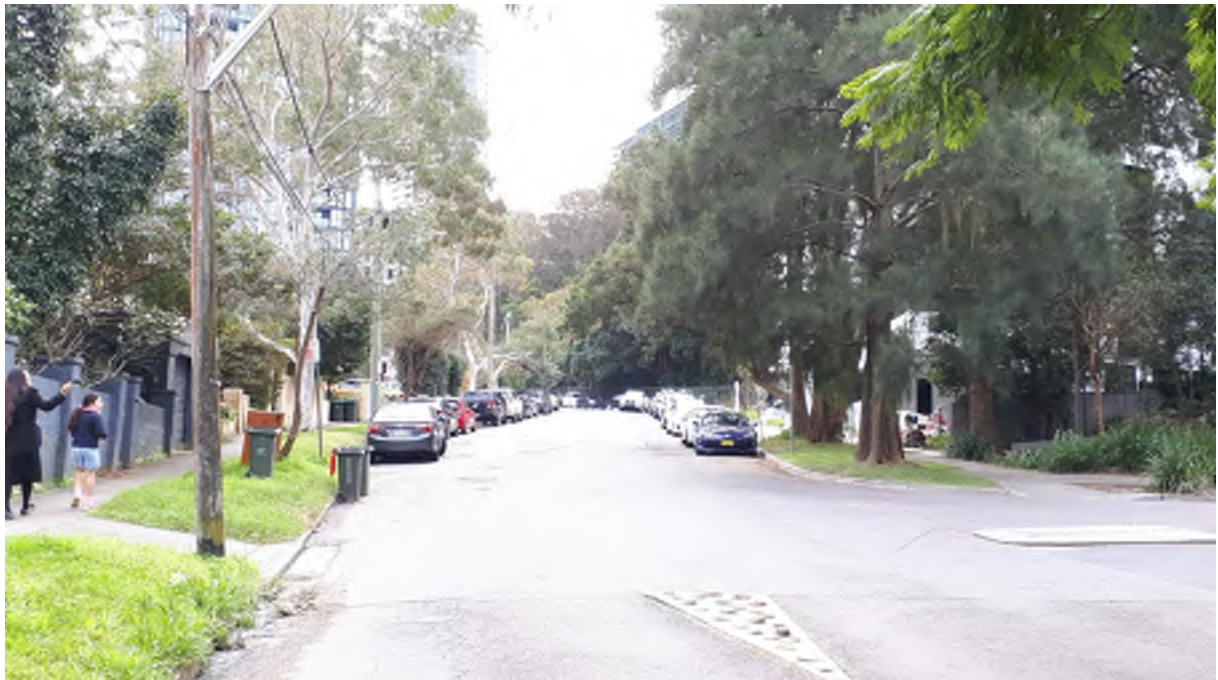
Photo 2: Casuarina trees RHS road - pruning of low branches required.

Road overhang and crown lifting is required for: ST2, ST3, ST7, ST8 and ST9.
All pruning is to be performed in accordance with AS4373-2007 Pruning of amenity trees. Council to be approached for pruning.

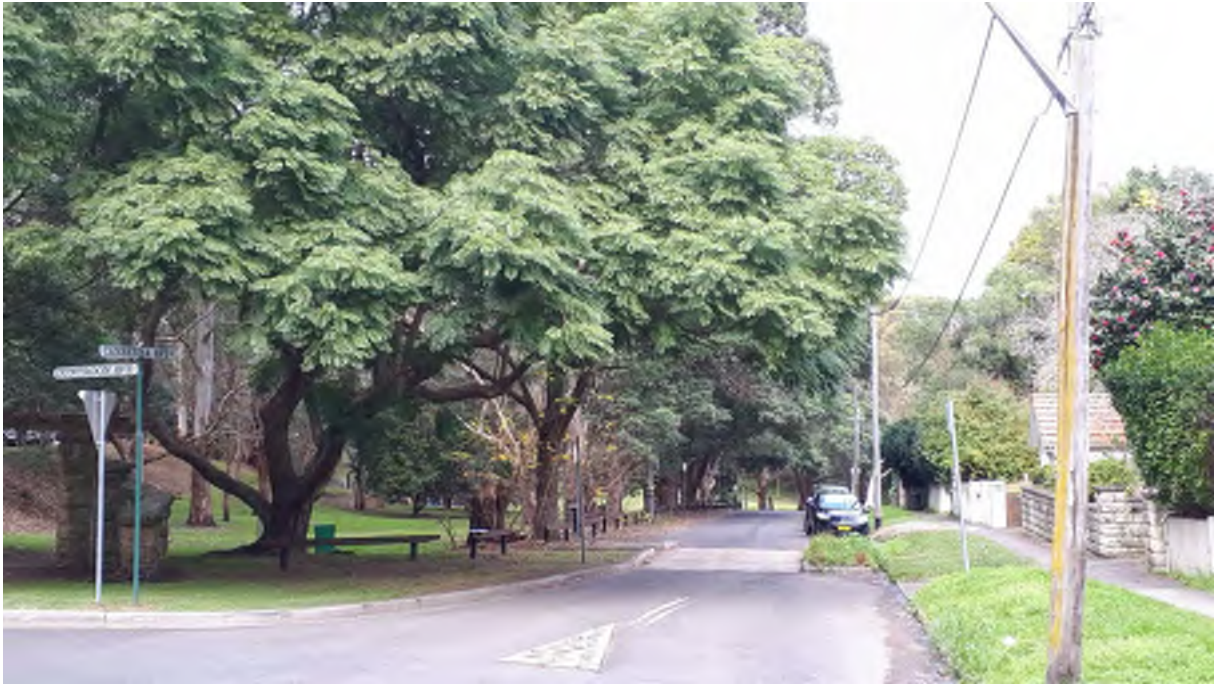
Photo 3: Canopy overhanging Canberra Ave. Photo looking south. Development opposite trees.

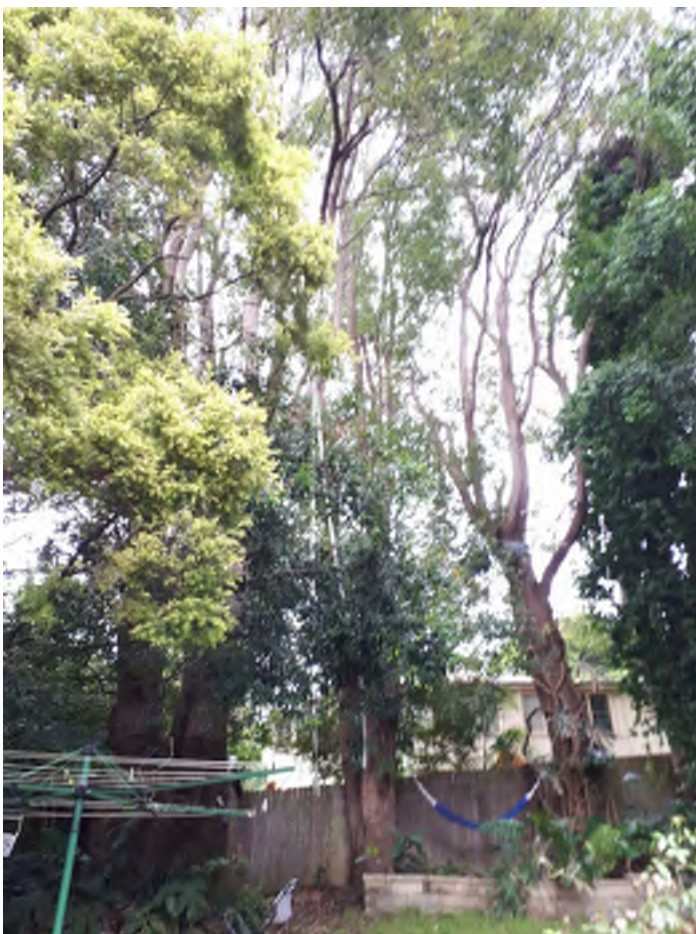
- 3.2.4 The proposed child care facility occupies the entire rear (western boundary) of the building (Childcare Level 1 Detail Plan DA-5010). Camphor laurels are the dominant tree species with a very high fruit production and therefore an unsuitable species for the land usage.

Photo 4: Large Camphor laurels along rear western boundary of property No 13 have historically been lopped at 4 metres.

- 5.1.1 All trees within the site are removed being trees T1 – T23 inclusive. Their retention is not possible and/or Camphor laurels not suitable for child care centre.
- 5.1.2 ST1: It is recommended this small street tree Bottlebrush located in front of property No 13 Canberra Avenue be removed and replaced upon construction completion. It is anticipated the extent of works, the tree’s relatively small size and location, damage is highly likely and unavoidable.
- 5.1.3 Pruning selective street trees for road clearances purposes is recommended prior to the commencement of any site works. Branches from a number of trees appear to be lower than the legal height clearance of 4.3m. Pruning to prevent lower branches being torn/broken due to trunk manoeuvring beneath.

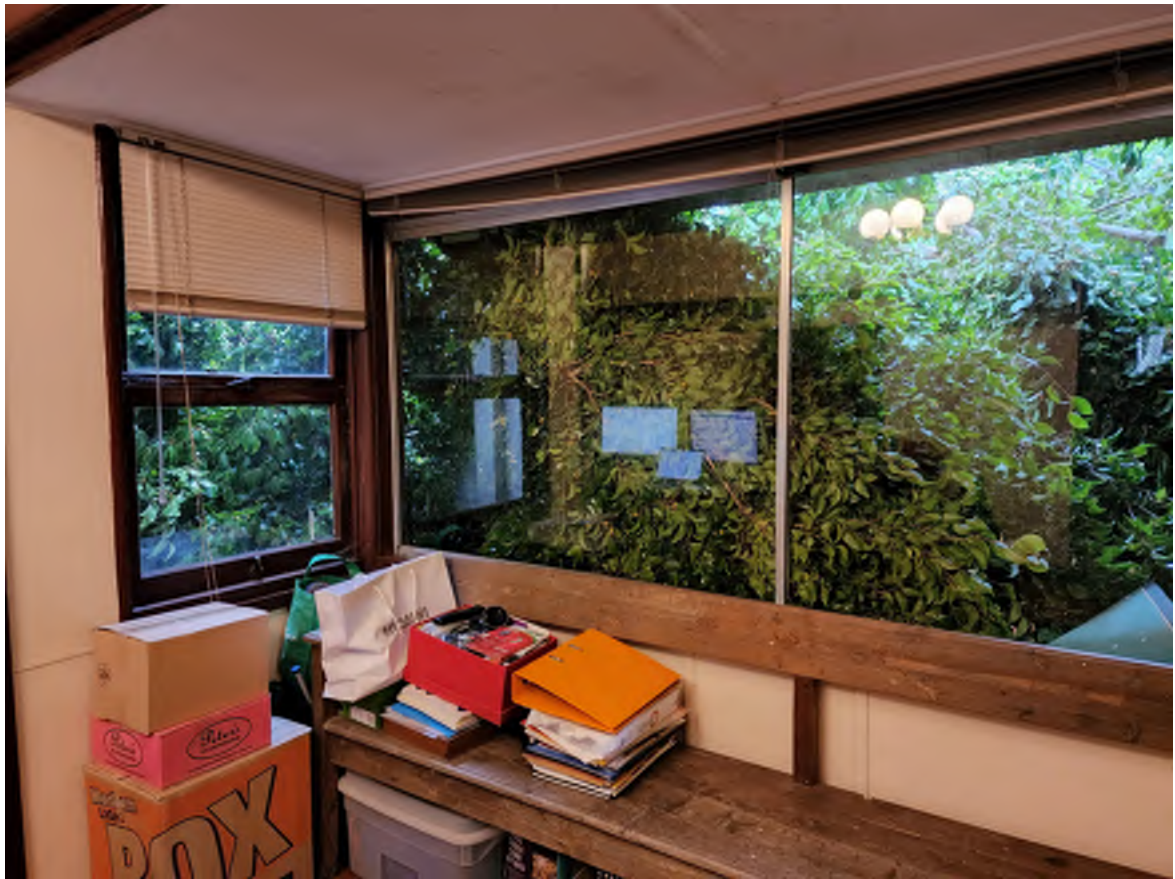
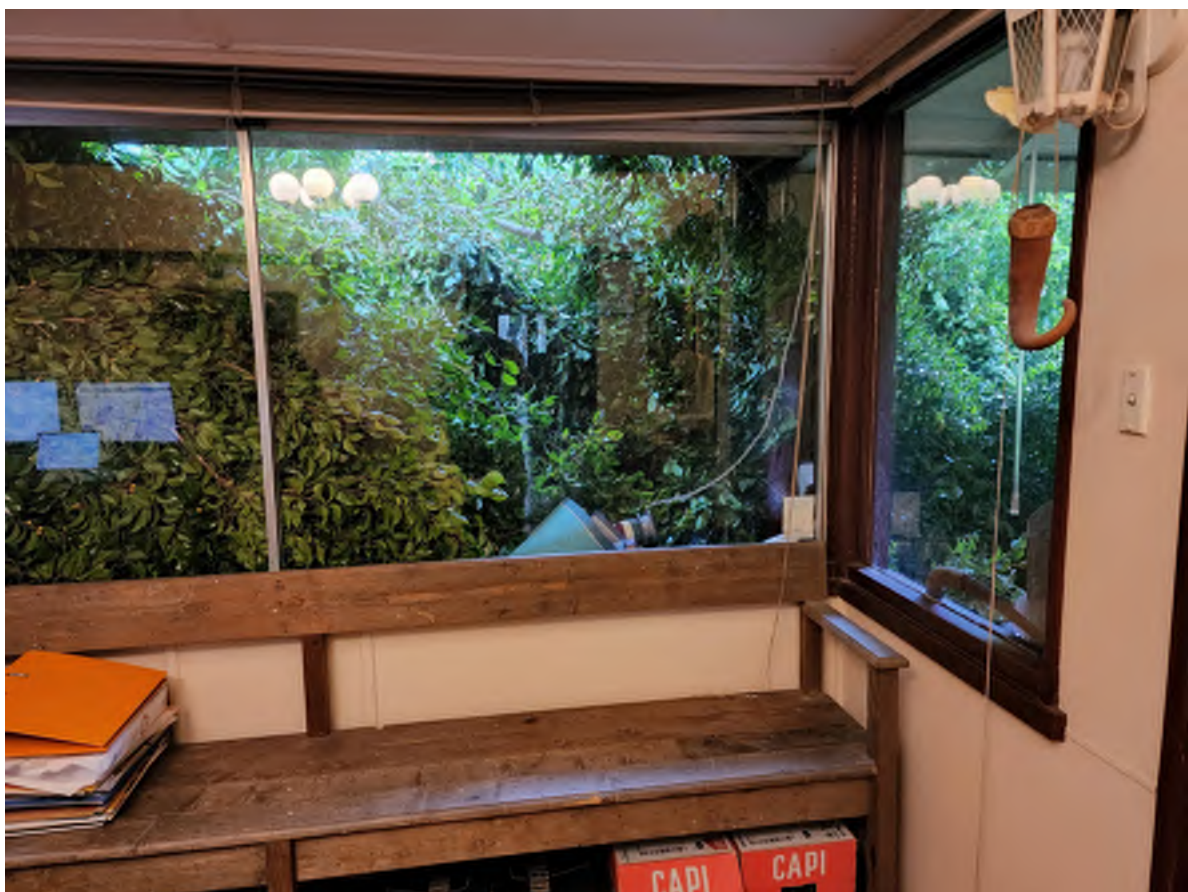
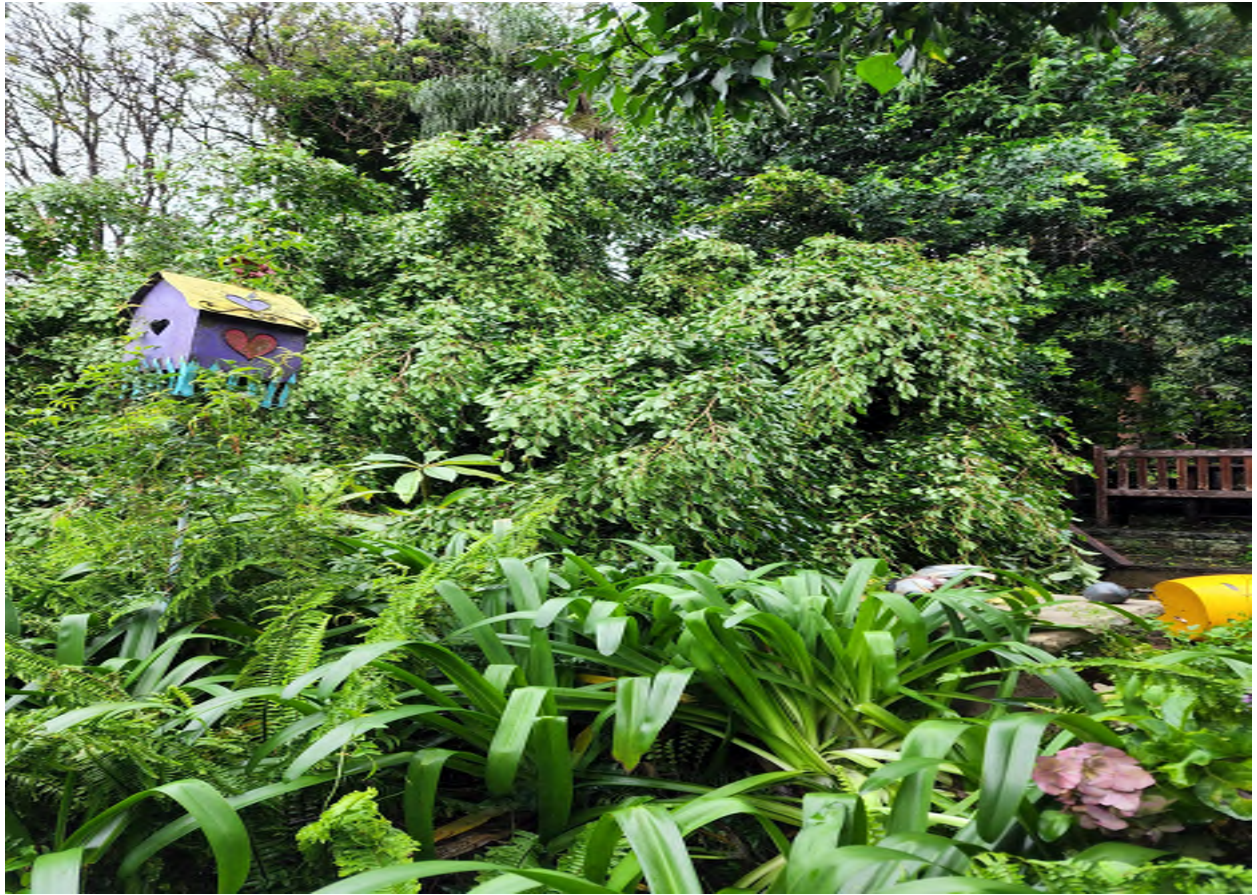
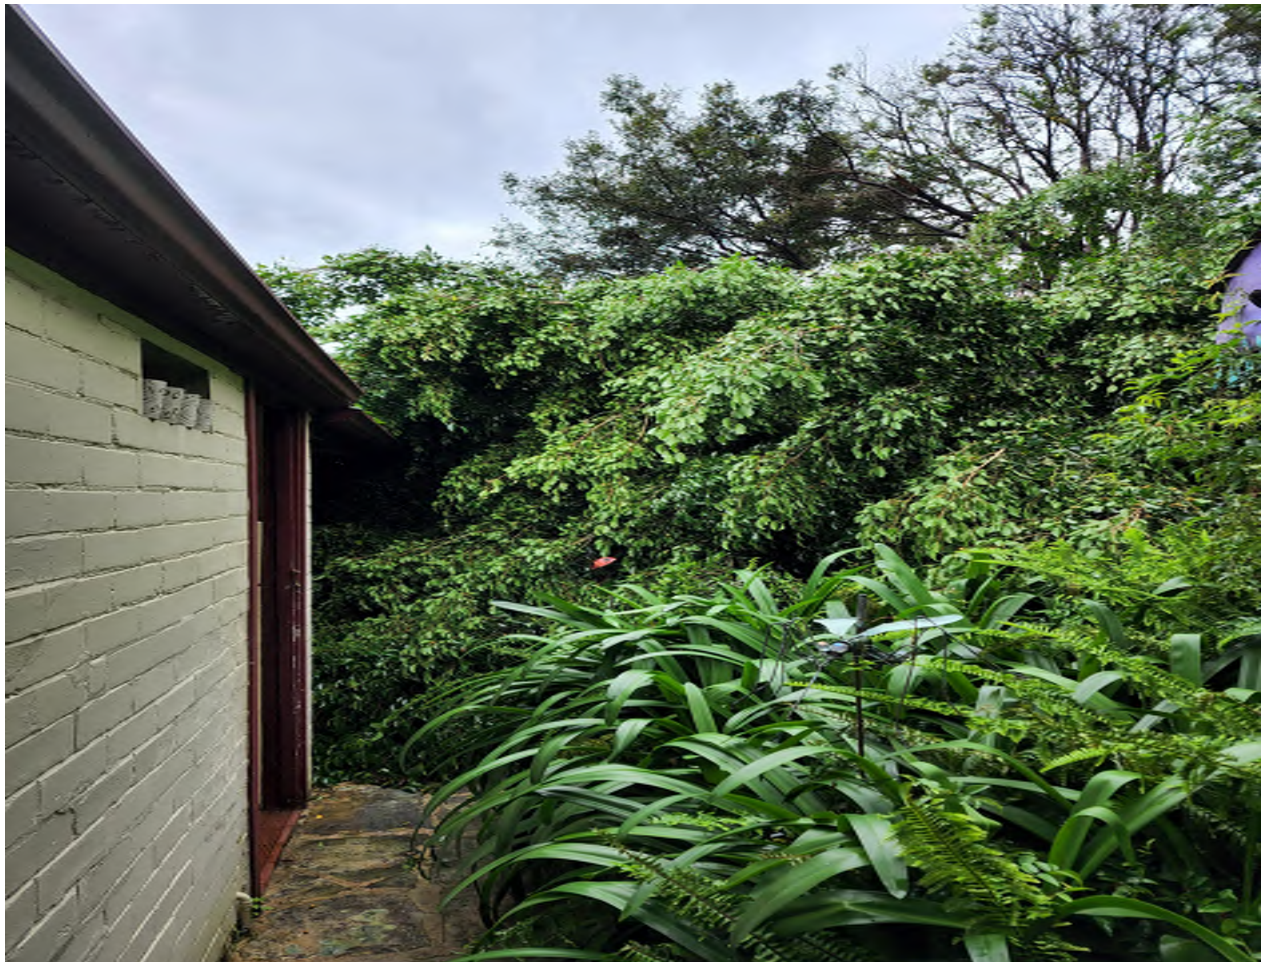
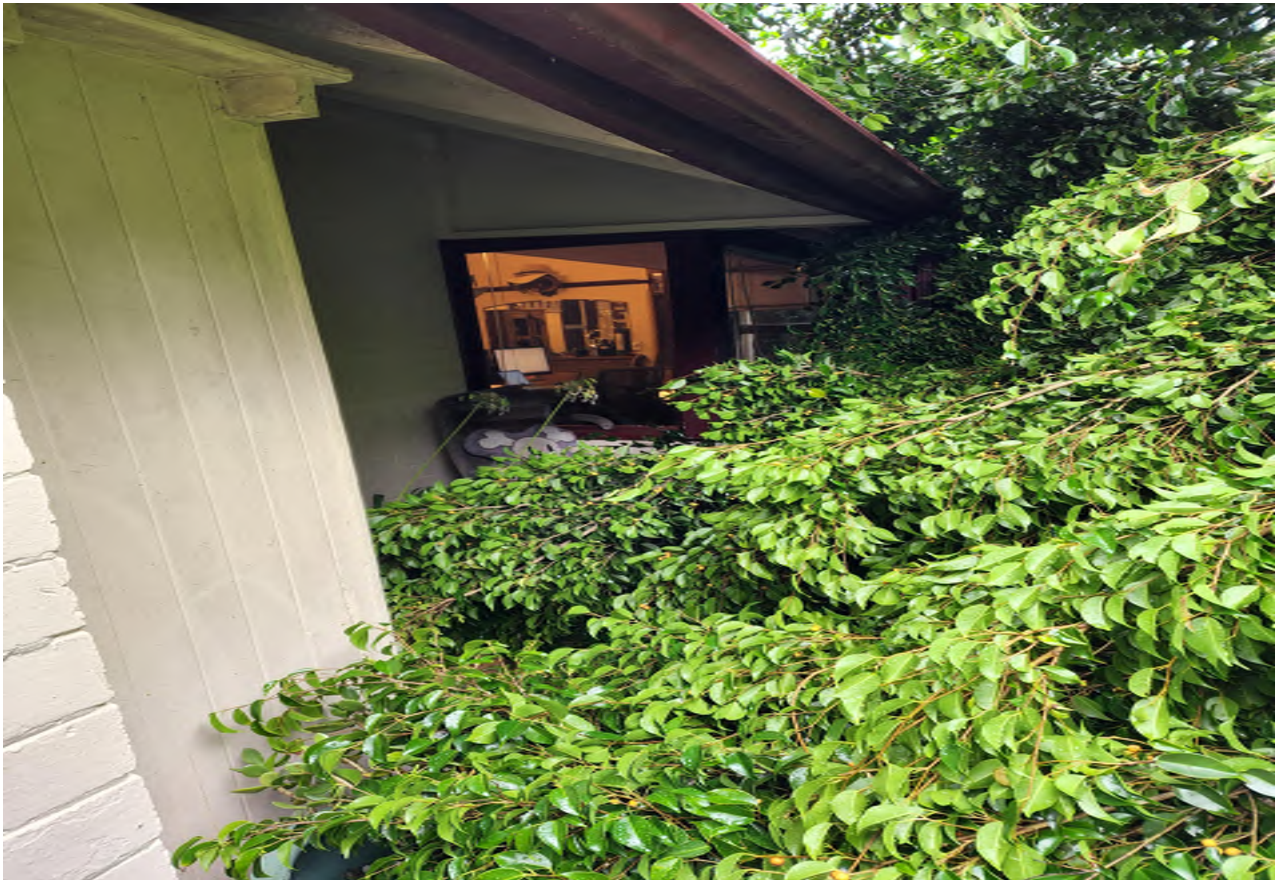
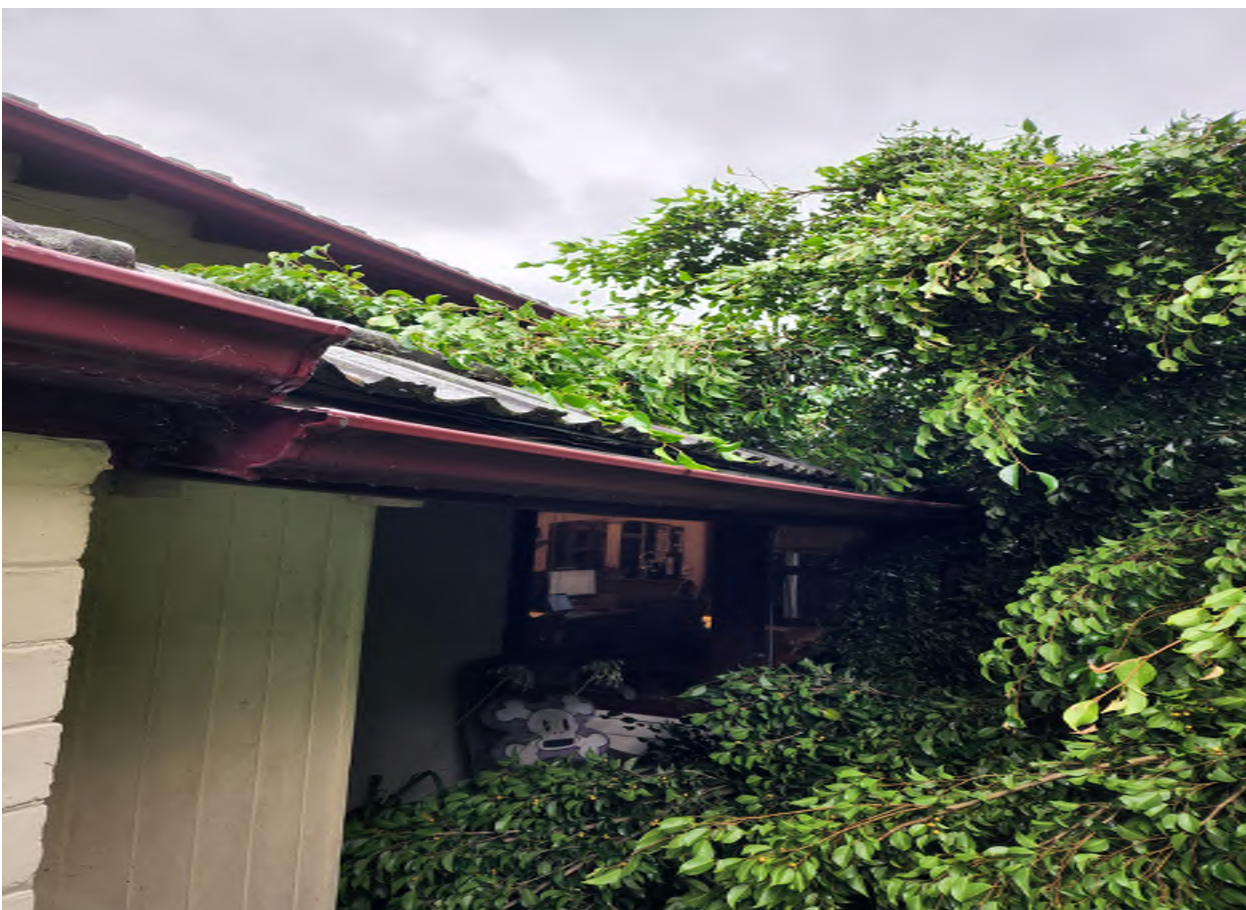
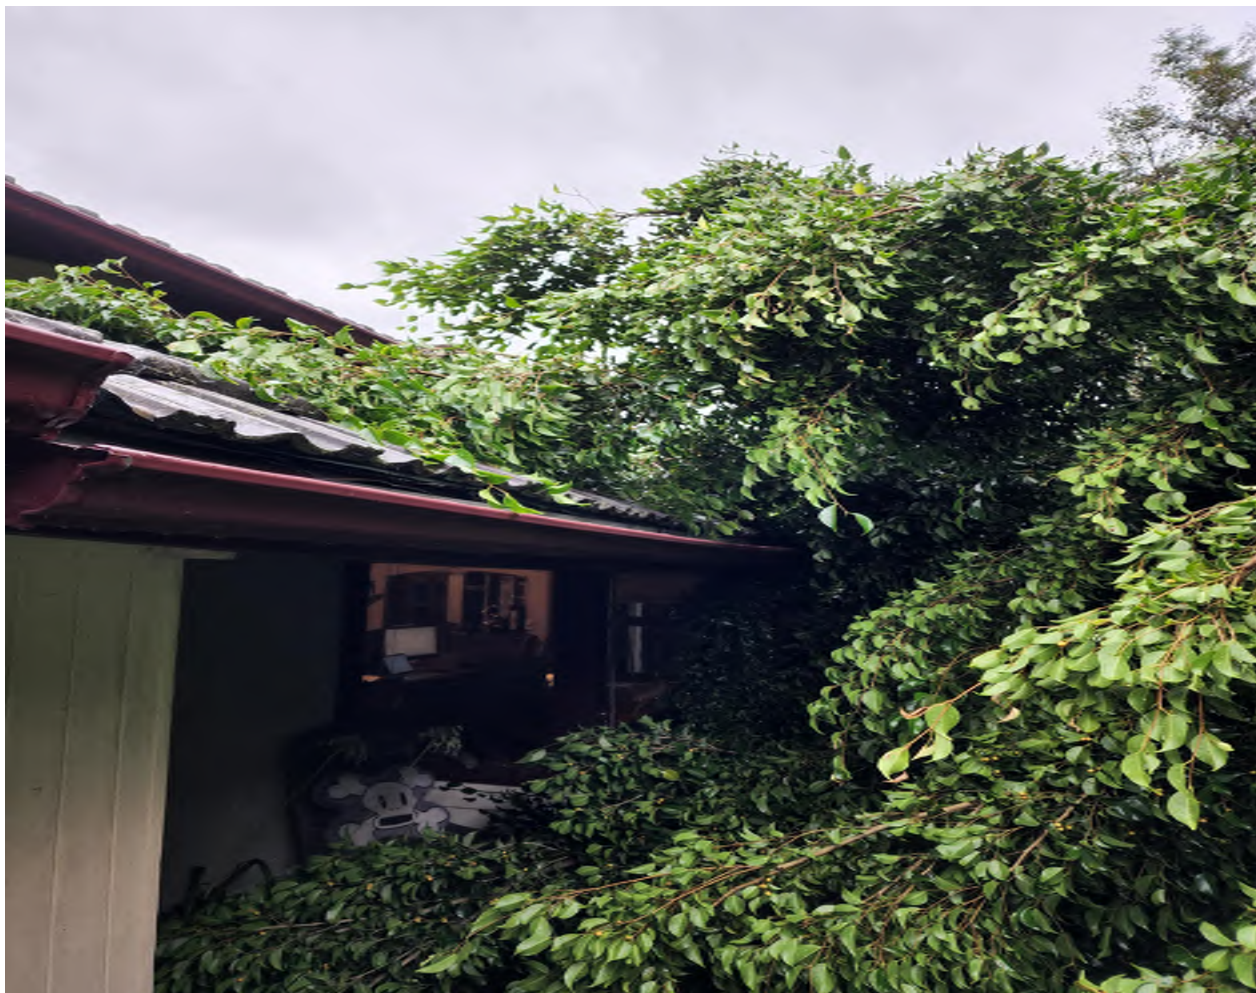
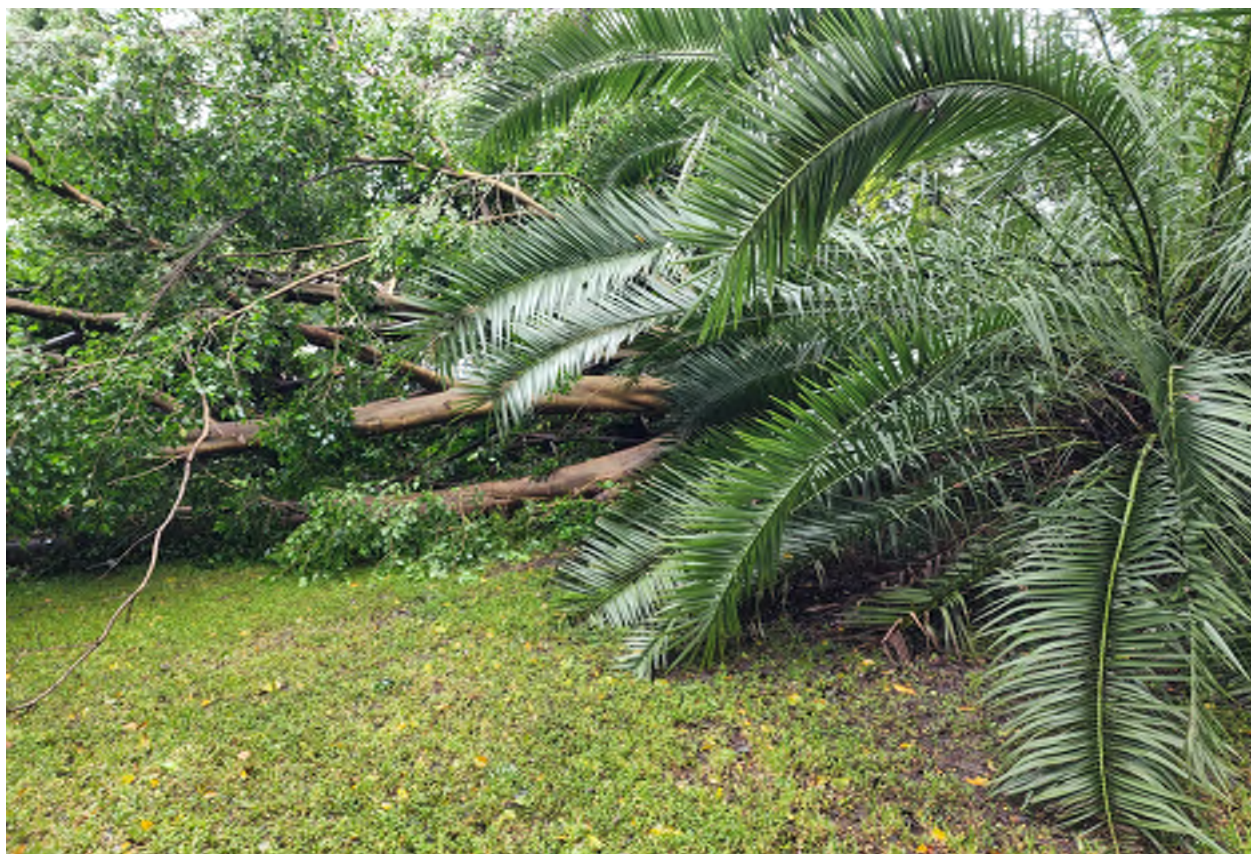
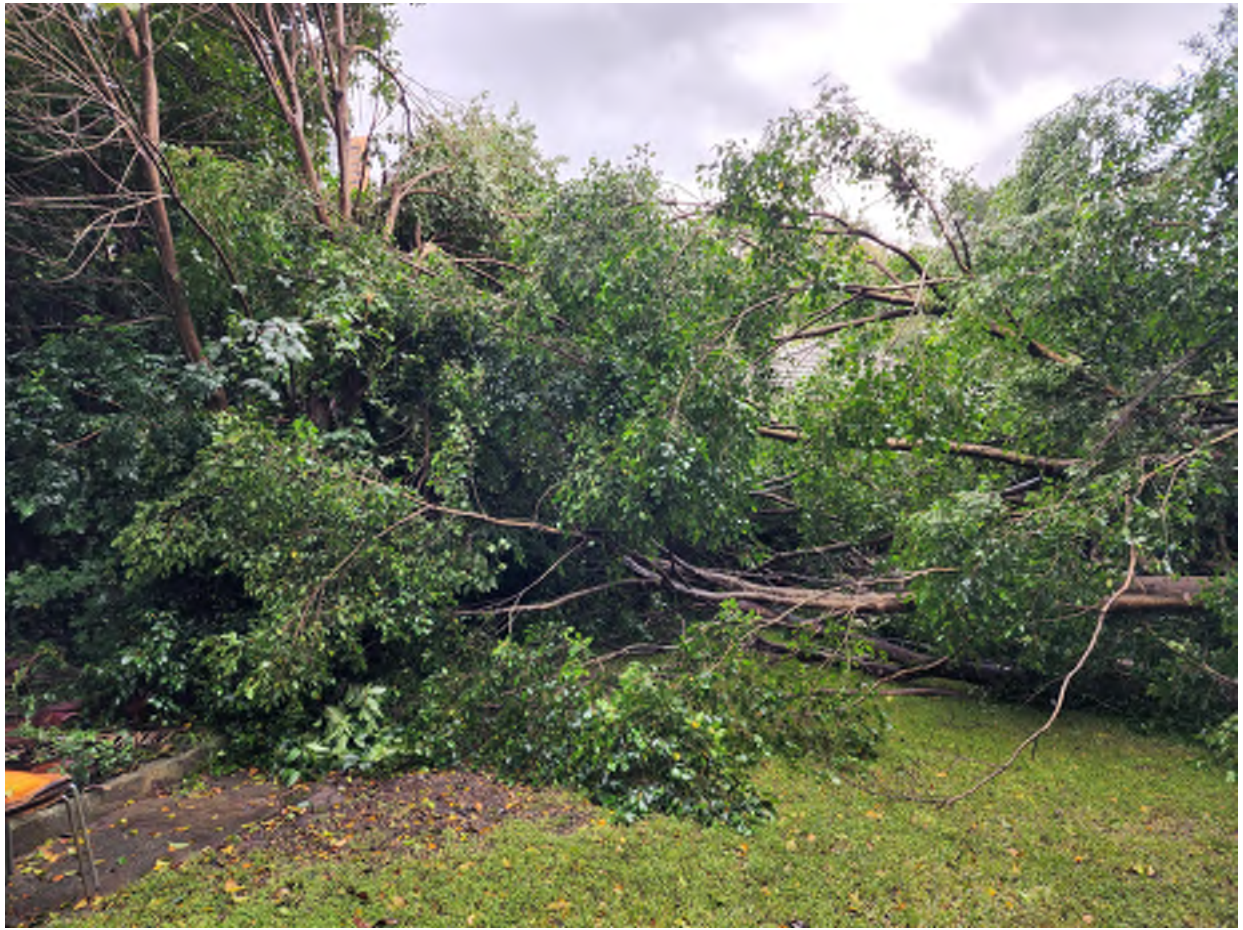
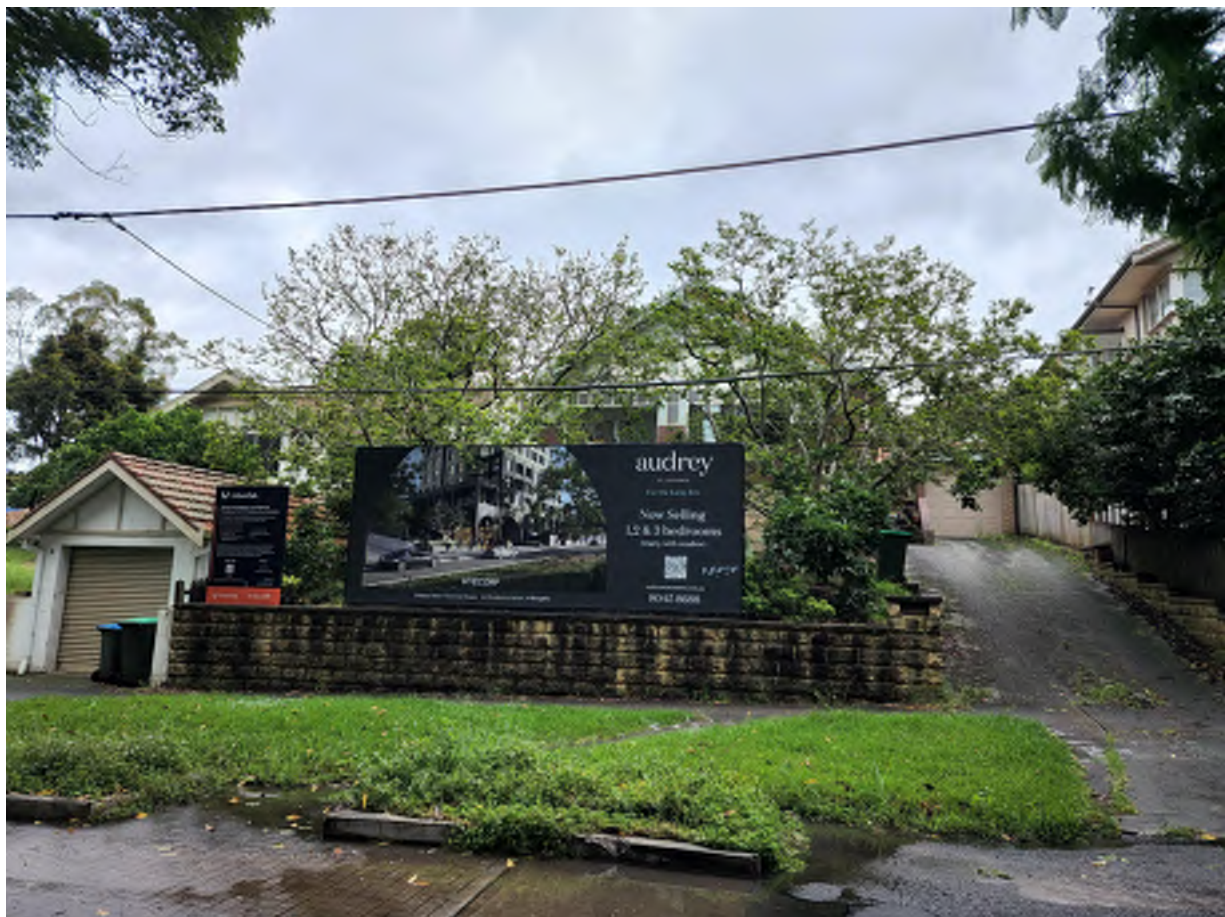
T4 Fallen Tree - Taken from 11 Canberra Ave

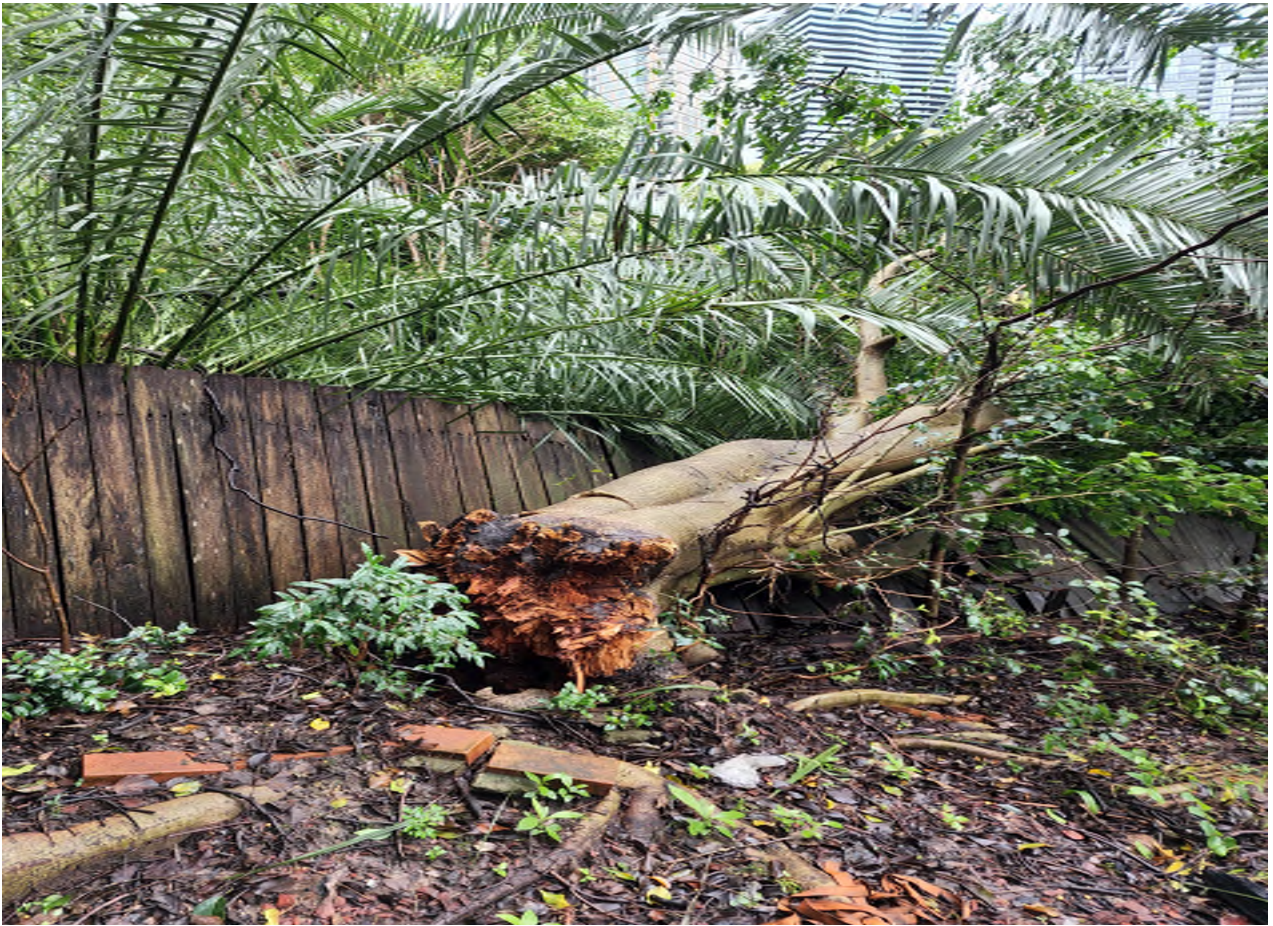
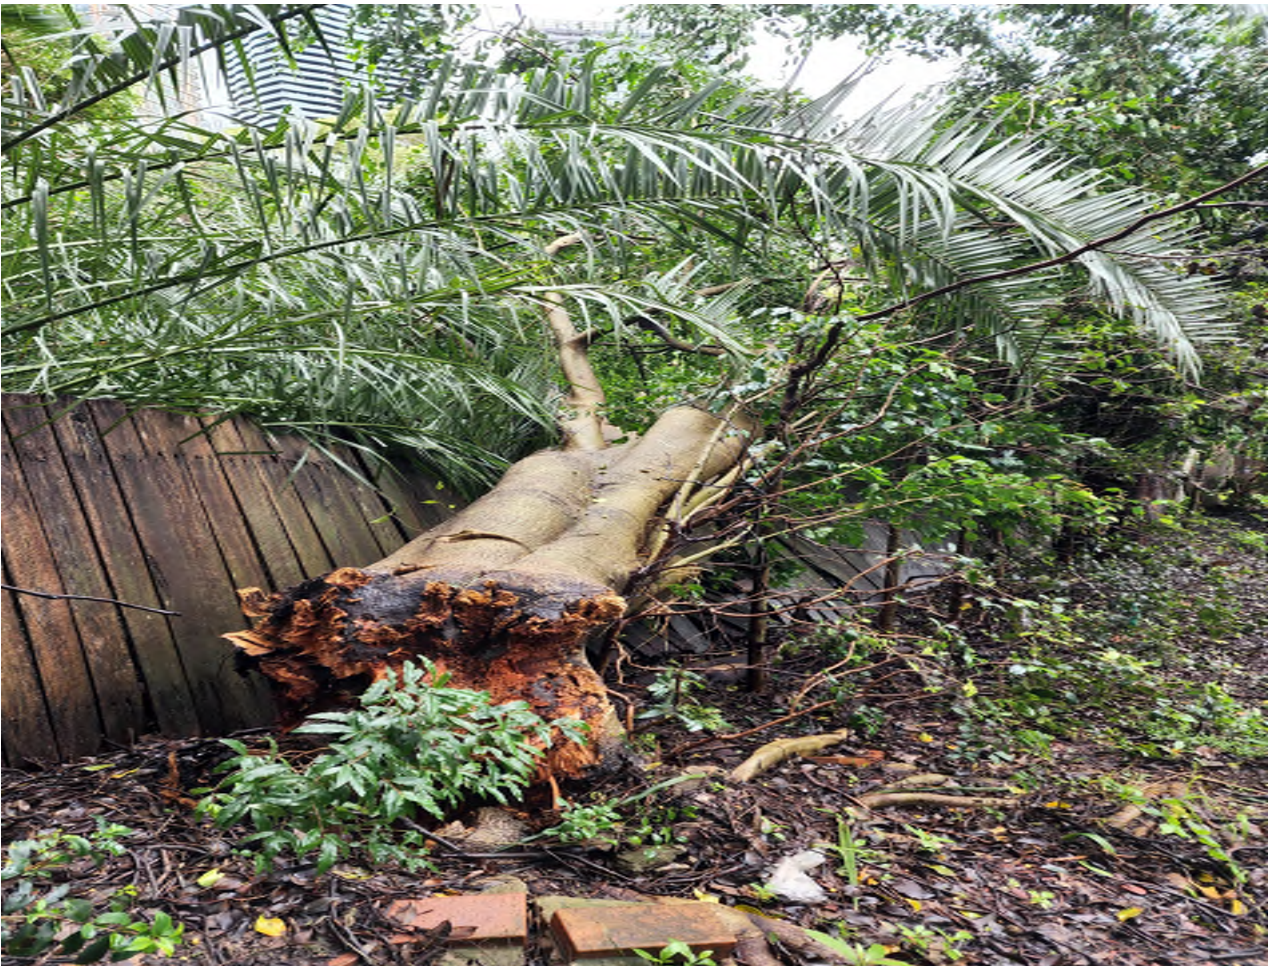
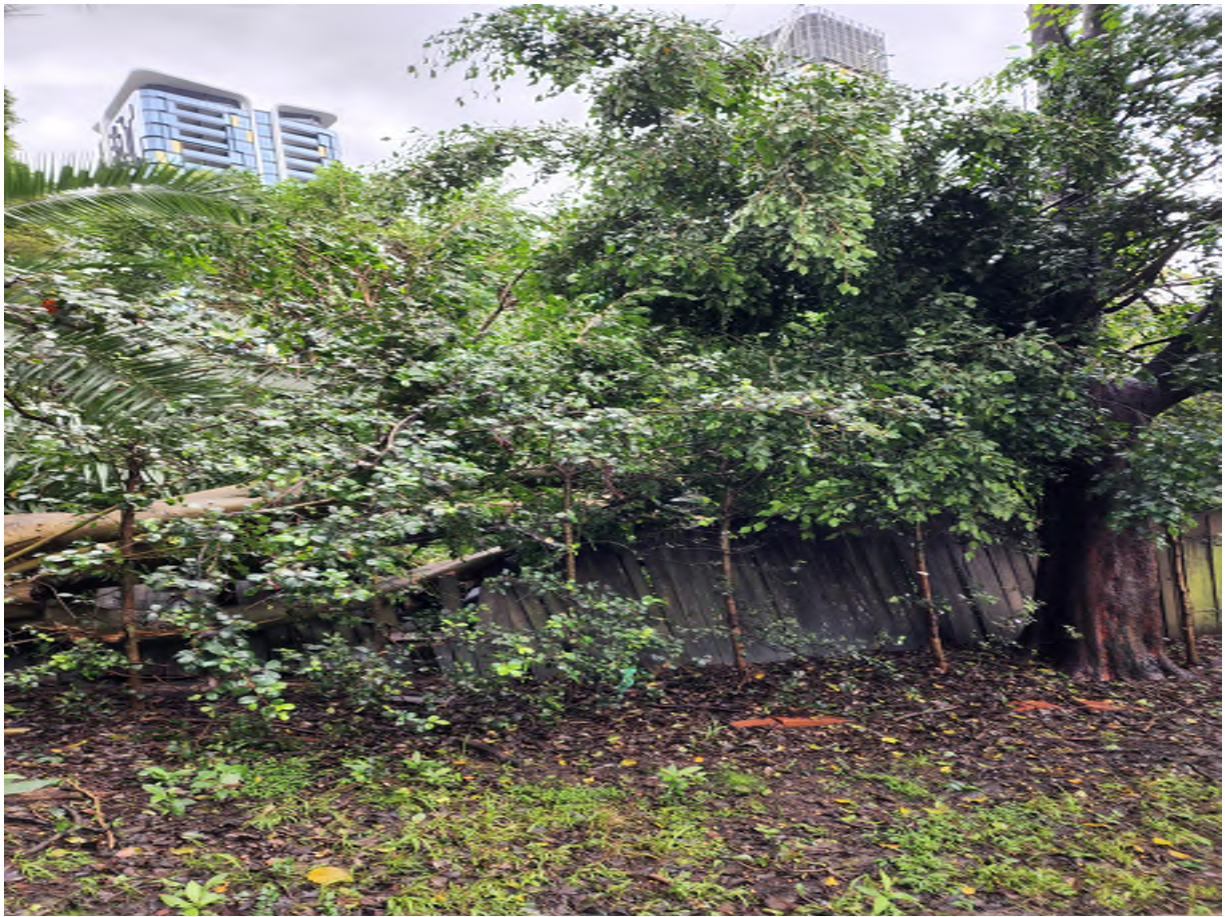
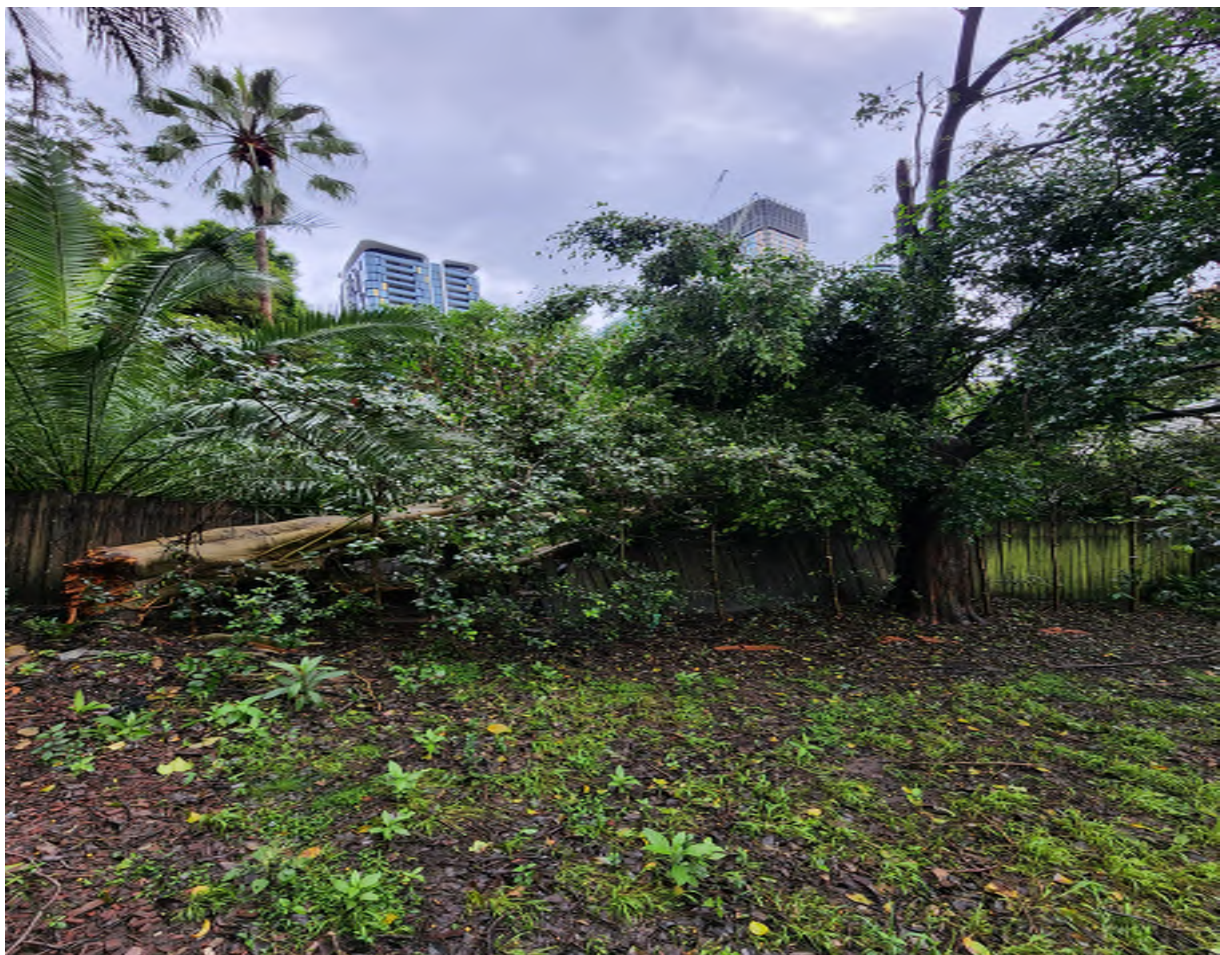
T4 Fallen Tree - Taken from 13 Canberra Ave

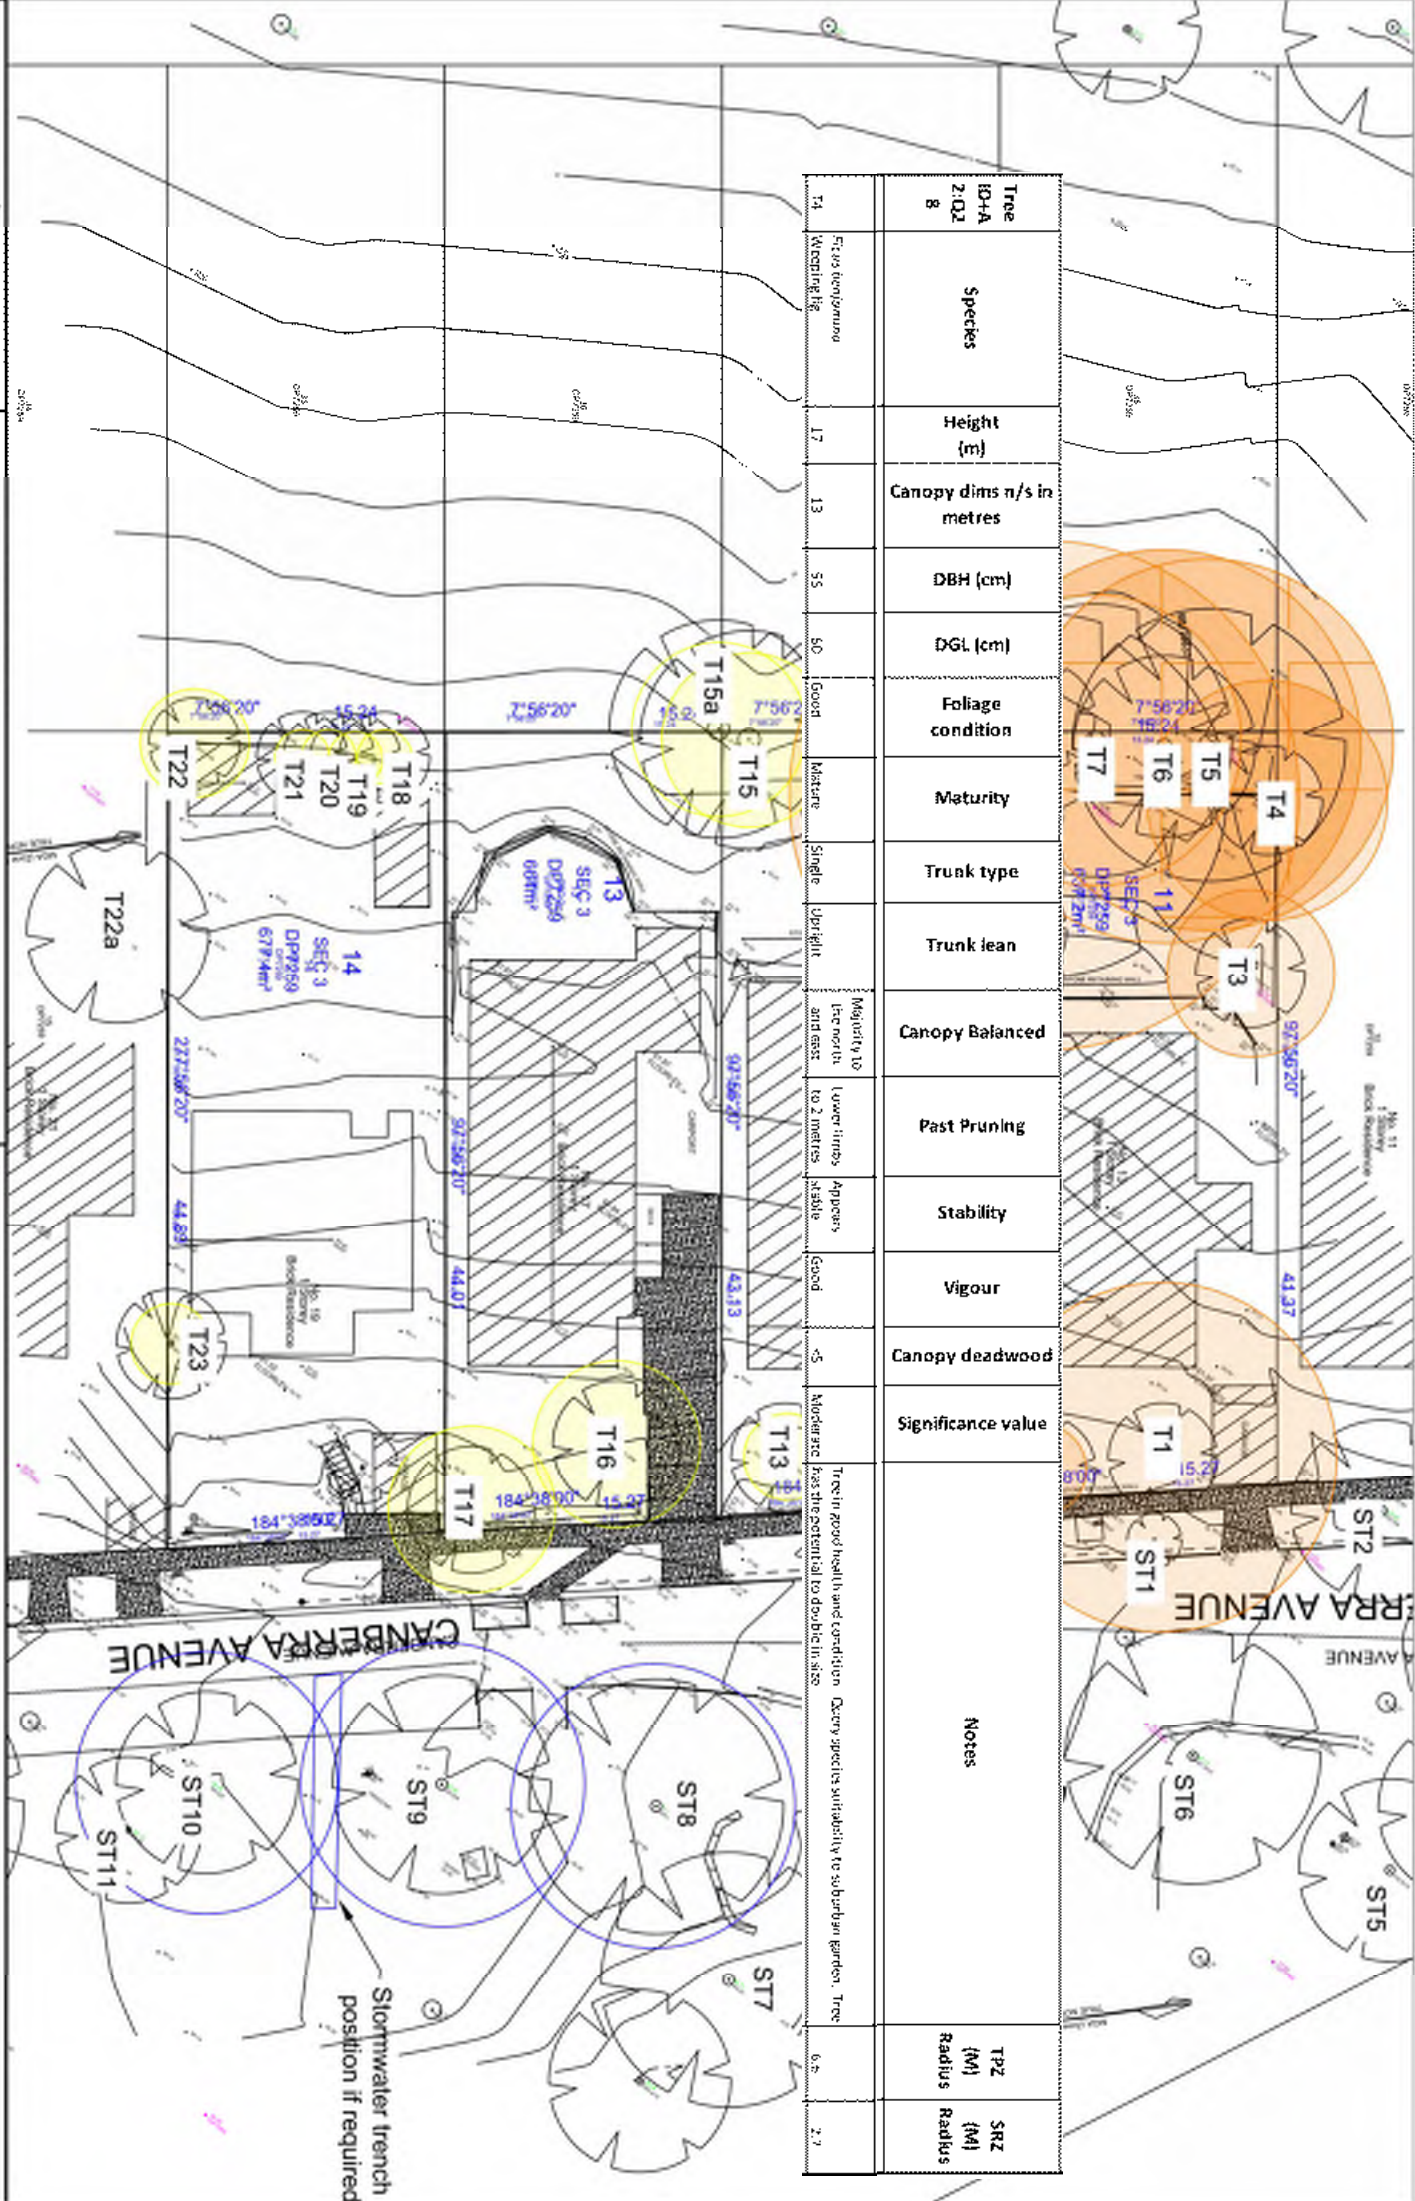
Margot Blues Consulting Arborist
Title: Tree Identification
DATE: 6/27/2021
Project: A2 13-19 Canberra St, St Leonards.cwg
Scale: Relative to supplied documents

THIS EXTRACT IS INCLUDED TO SHOW THE EXACT LOCATION OF FALLEN TREE T4
