Report on Geotechnical Assessment

Proposed Development Lot 35 DP878862, Talbingo

Prepared for Ironstone Development Group Pty Ltd

> Project 206726.01 April 2023

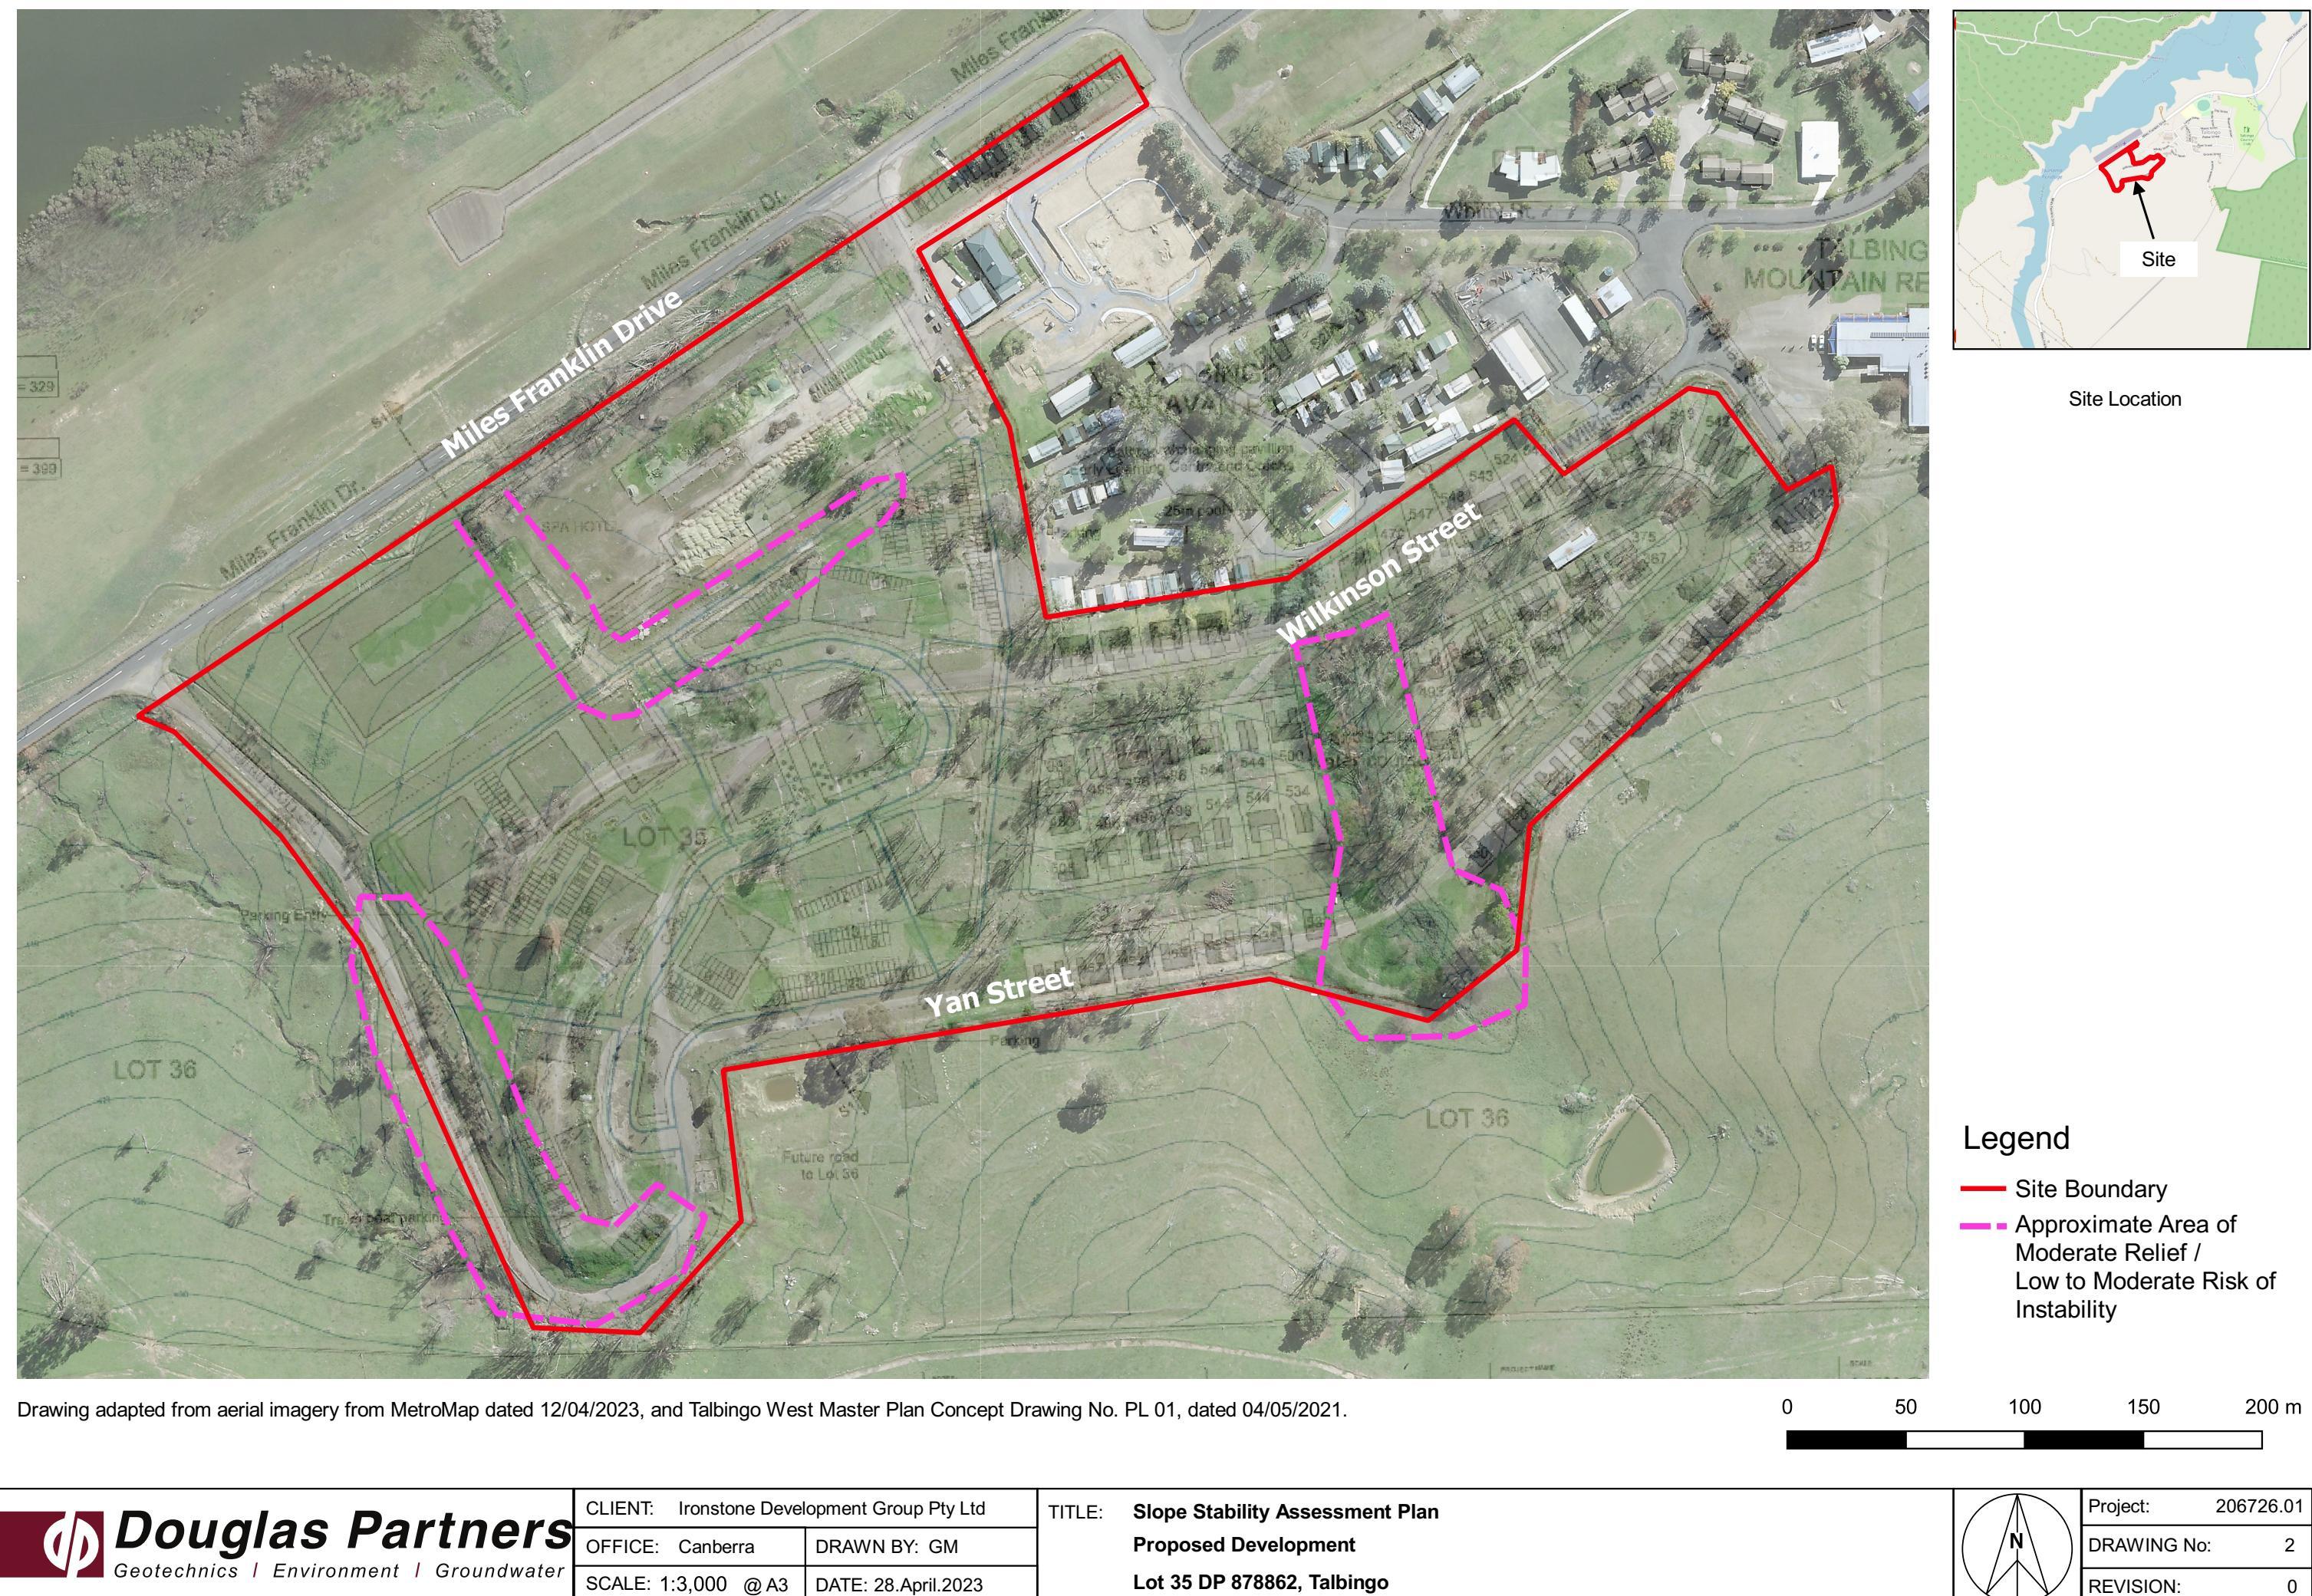
The topographic slope in various sections of the site (i.e. adjacent drainage gully) is moderate/low to moderate risk of instability (refer Drawing 2) and accordingly, it is anticipated that some allotments need to consider design and construction techniques that take account of the ground slope and Class P conditions. Classifications within these areas would also be dependent on the extent of bulk earthworks.

In summary, it is considered that most of the site is classified as VERY LOW to LOW risk of damage to property occurring as a result of slope instability. Three areas are considered of LOW to MODERATE risk (refer Drawing 2) due to the greater ground slopes. Notwithstanding the various risk categories nominated, development of the site for residential purposes is considered feasible with erosion control measures and suitable dwelling design required in the slightly steeper areas in the north and southwestern sections of the site and the central eastern portion around the gully (form creek line) and the existing farm dam.

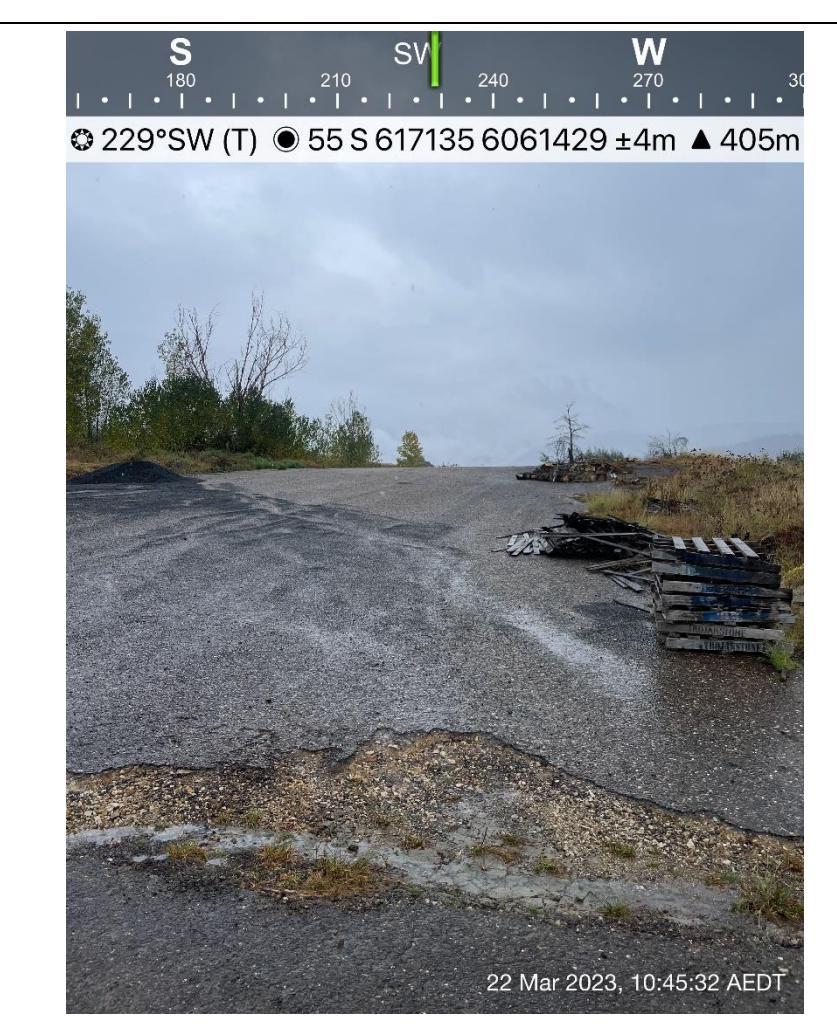
- Large hardstand area (including both asphaltic concrete surface and concrete slabs) was observed in the north-eastern corner of the site, which was accessible vis Miles Franklin Drive. Large stockpiles of soils, construction debris/materials and green waste materials were noted across the area;

Photo 15: General view of a large hardstand area located in the north-eastern corner of the site, with stockpiles.

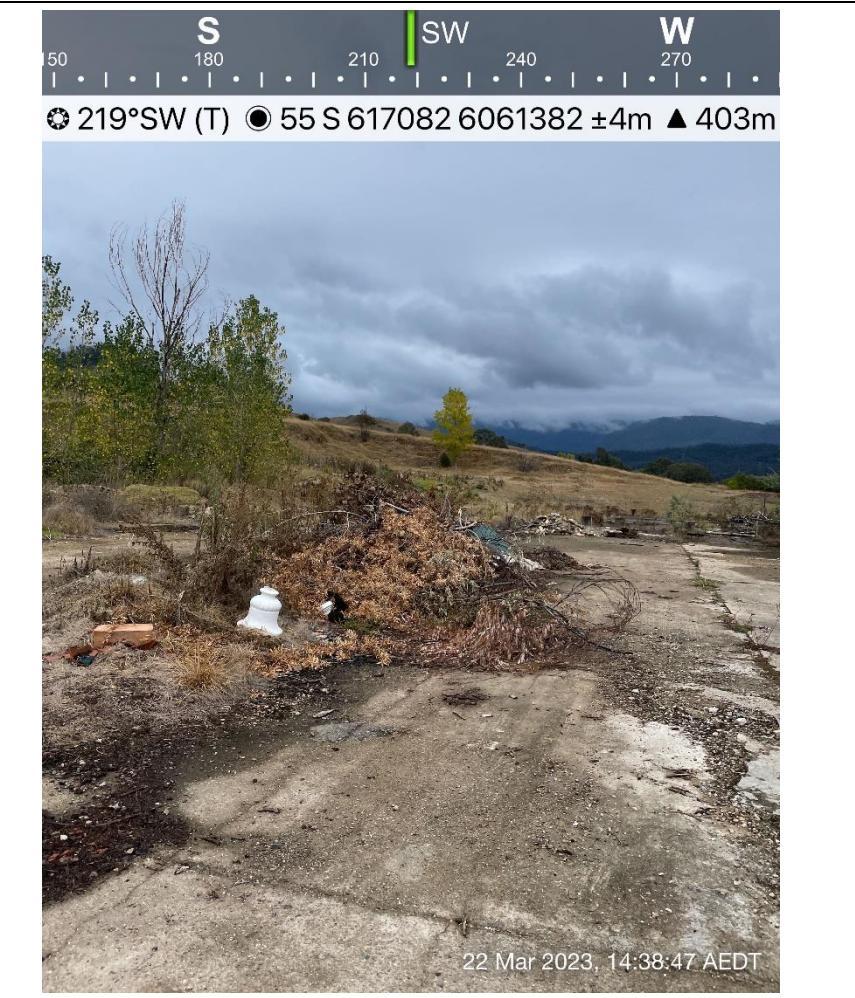
Photo 16: General view of stockpiles of green waste and materials and miscellaneous rubbish located at the large hardstand area at the northeastern corner of the site.

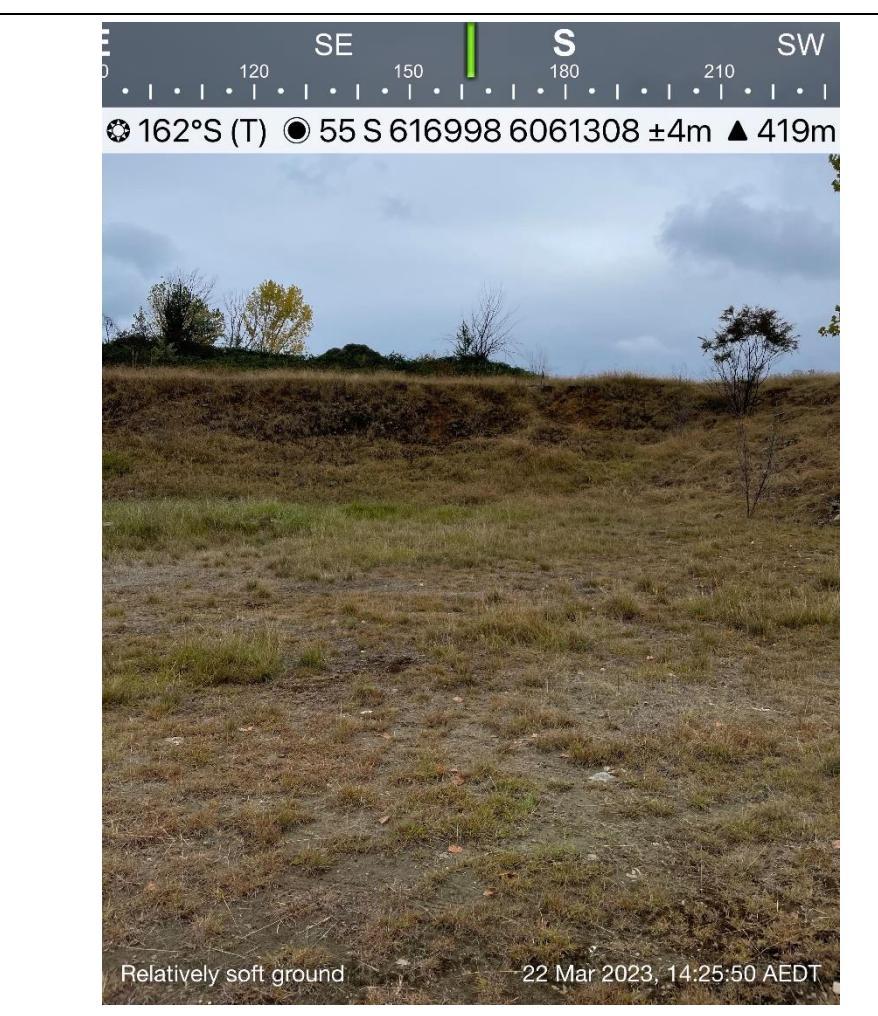
- An embankment of up to ~6 m in height was noted in the northern (central) portion of the site; relatively soft ground was observed in the southern corner at the bottom of the embankment, which may be due to the recent above average rainfall;

Photo 17: General view of the relatively soft ground located in the southern corner of the bottom of the up to ~ 6 m high embankment.

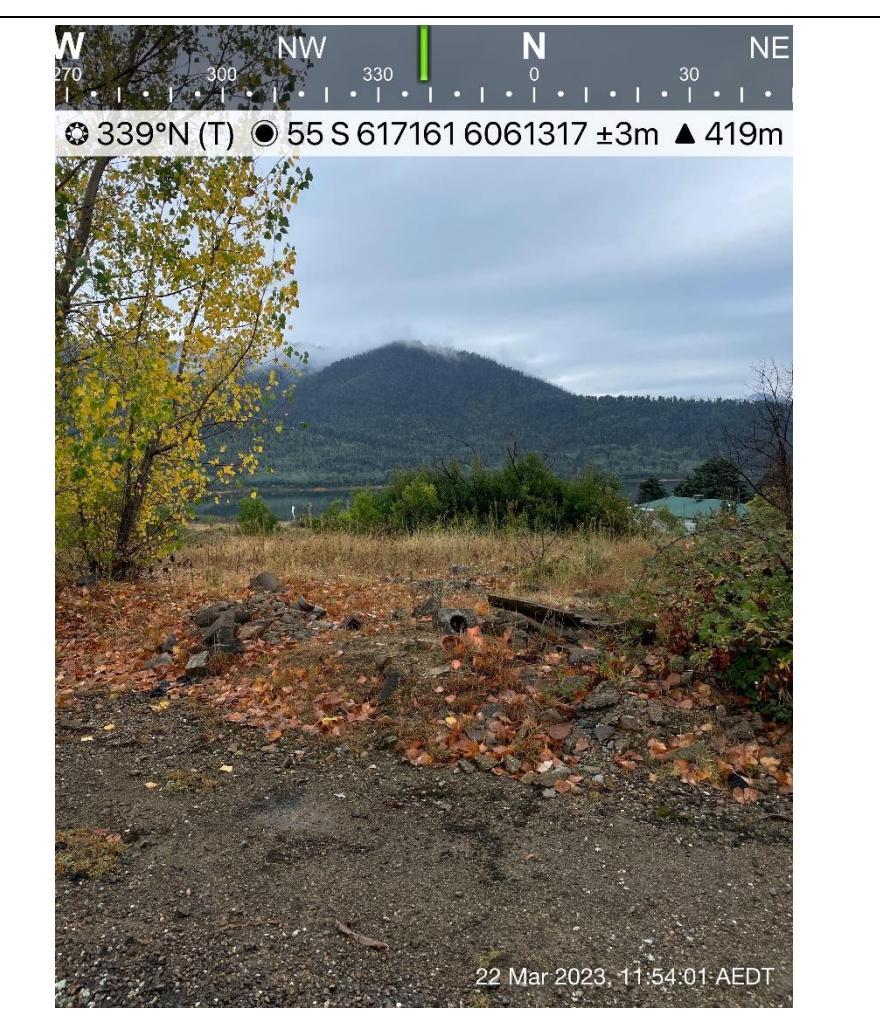
Photo 18: General view of a stockpile of soils and building rubbles.

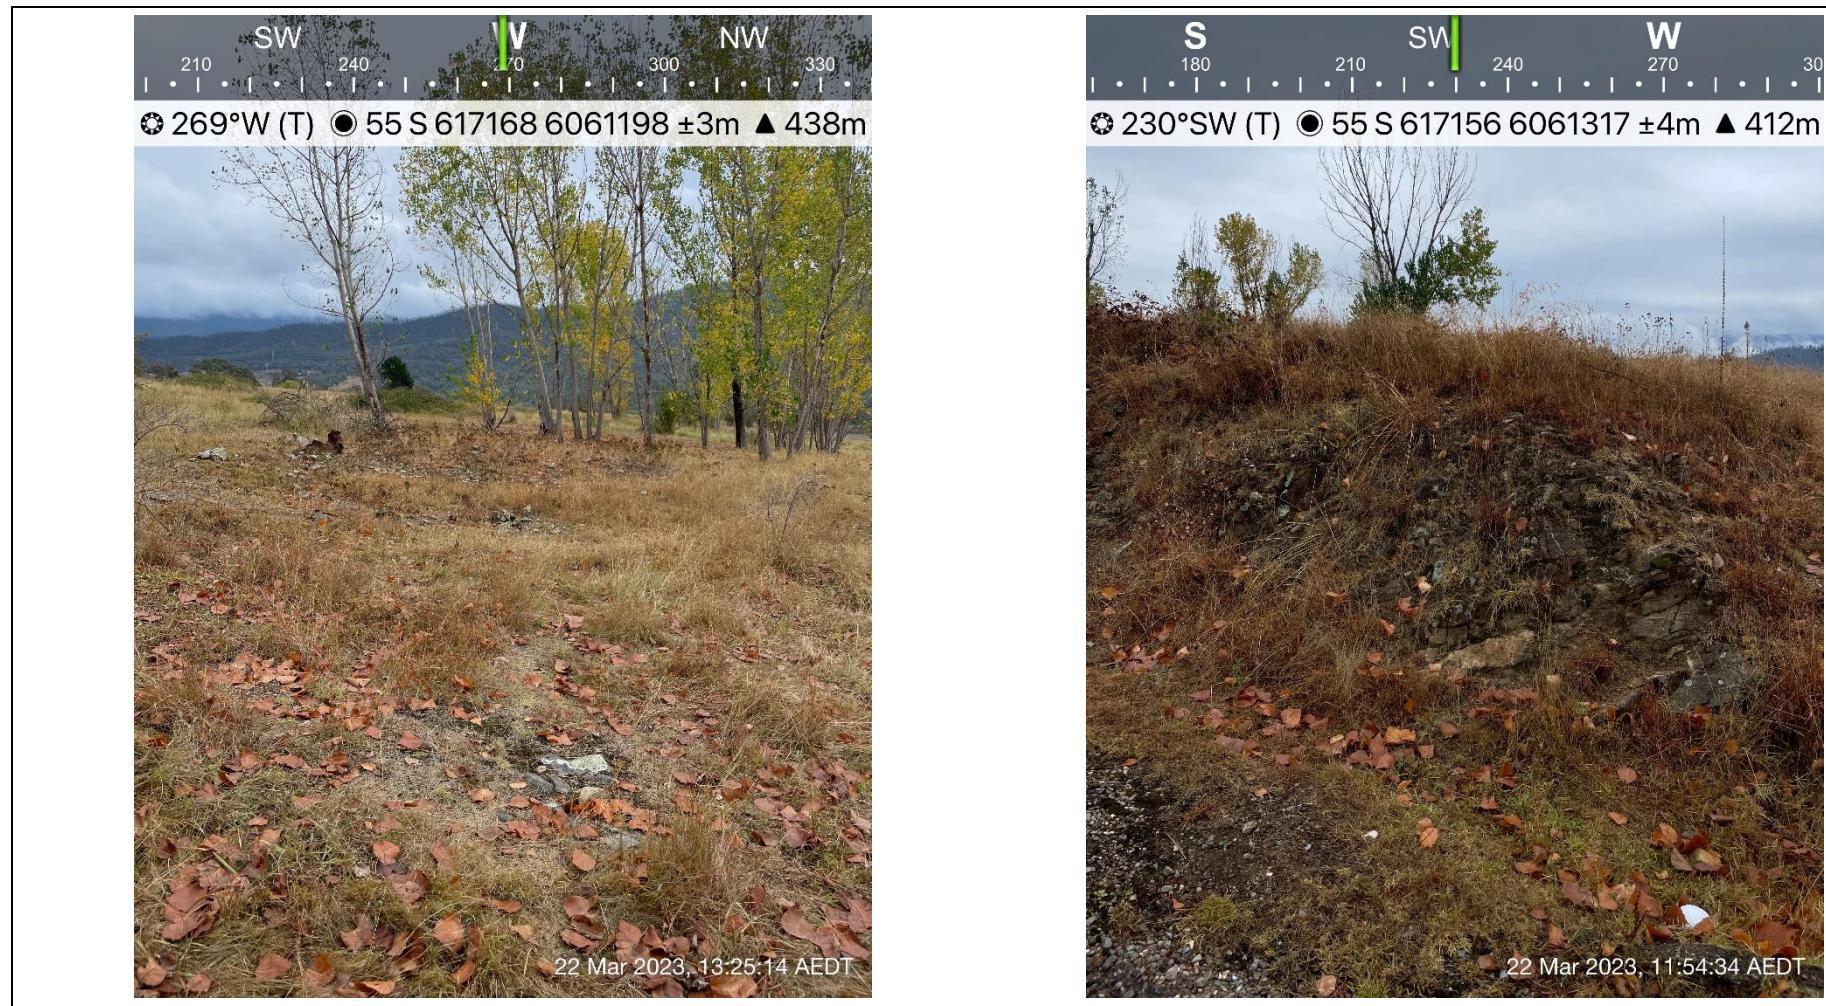
Photo 21: General view of rock outcrops at the central portion of the site.

Photo 22: General view of weathered rock exposed in the embankment at the northern portion of the site.

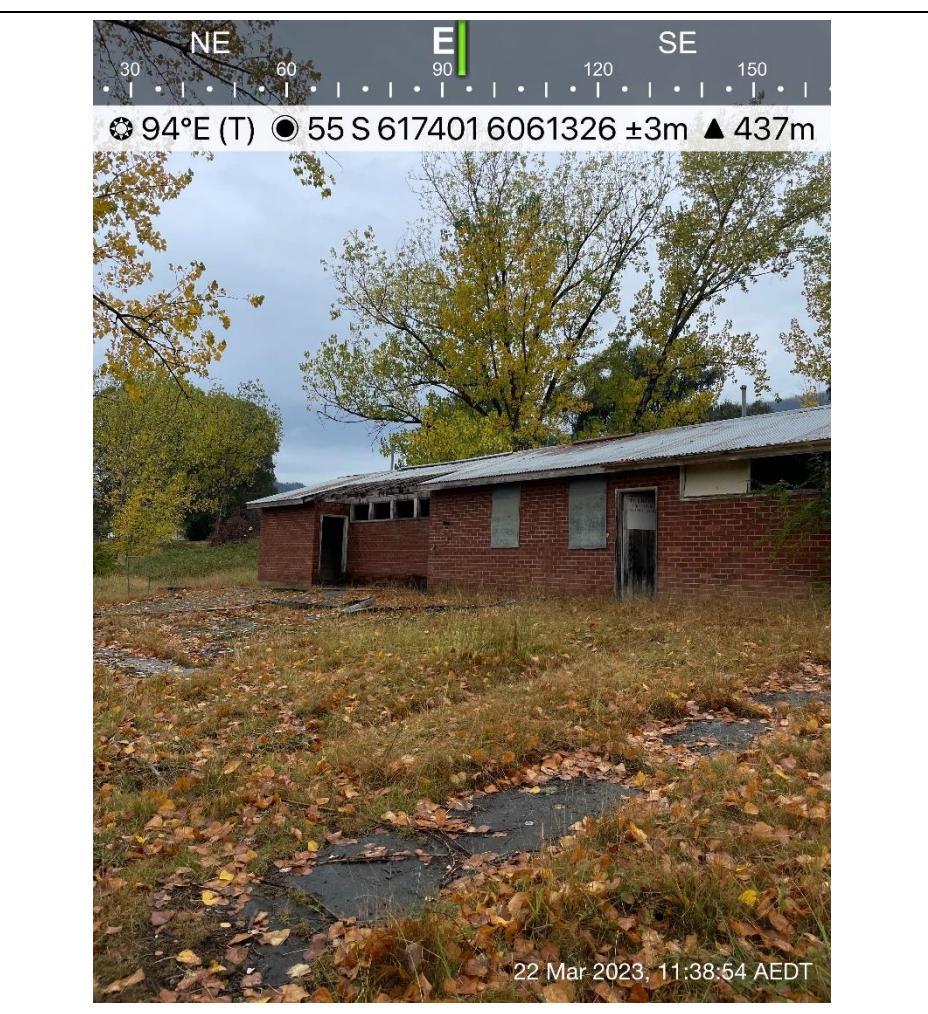
Photo 25: General view of an existing structure (former Talbingo Fire-Squad Training Area) located in the eastern section of the site.

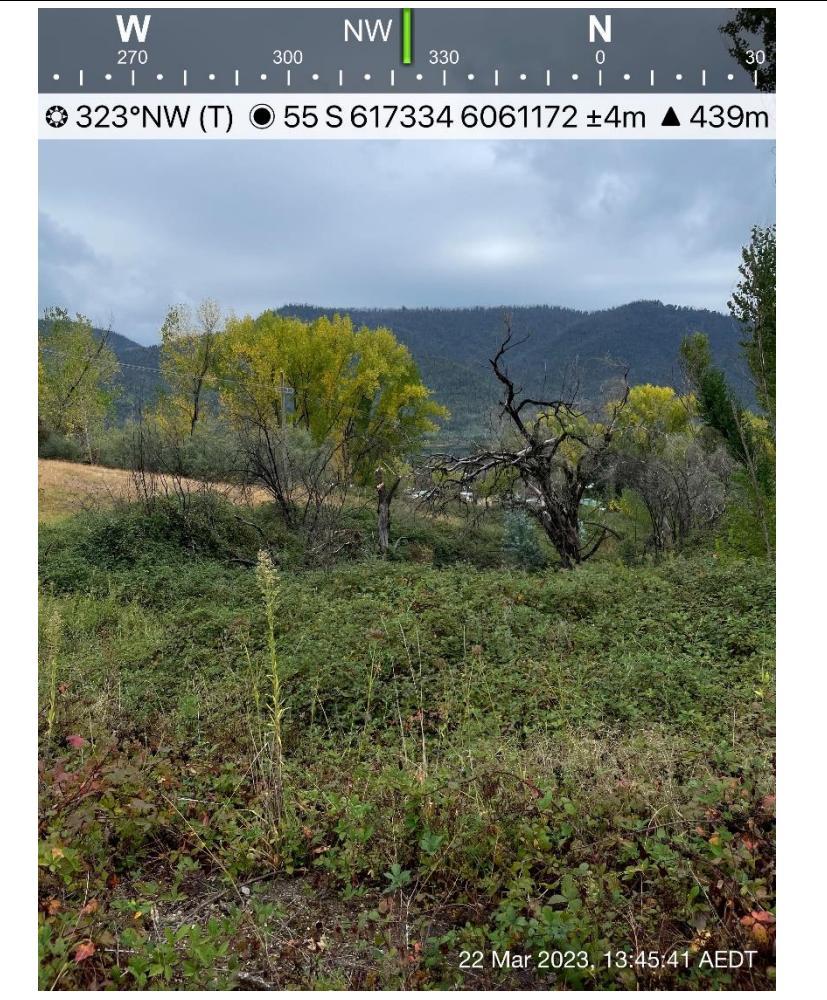
Photo 26: General view of an existing gully (former creek line) located in the eastern portion of the site.
